Office of Transport Safety Investigations

BUS SAFETY INVESTIGATION REPORT

STA BUS MO 1504 FIRE
SYDNEY HARBOUR BRIDGE
6 MAY 2016

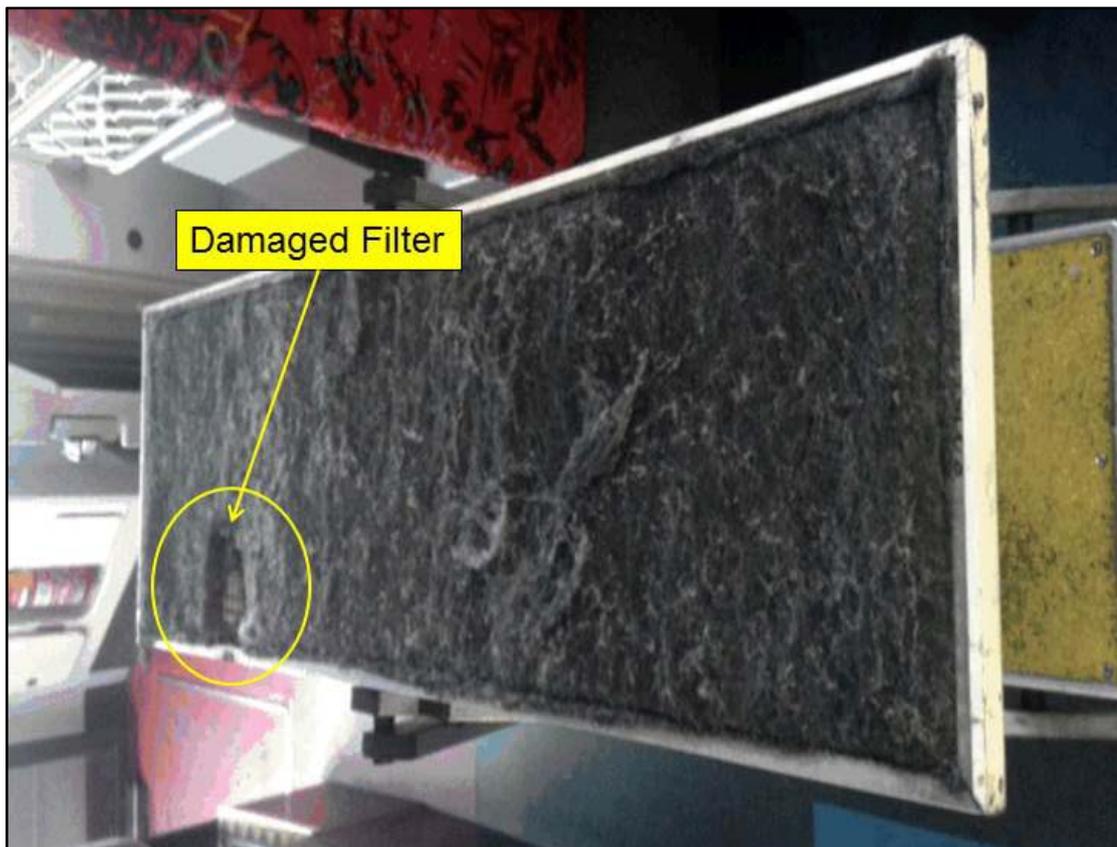
Figure 1: Fire damage to air conditioning filter

- 2.1 The air conditioning return air filter was removed to enable the examination of the electrical circuit boards. The air conditioning filter exhibited damage consistent with hot material falling from the circuit board mounted above the filter (refer *Photograph 1*). The heat-affected area was restricted to the air filter, circuit board and adjacent electrical wiring.

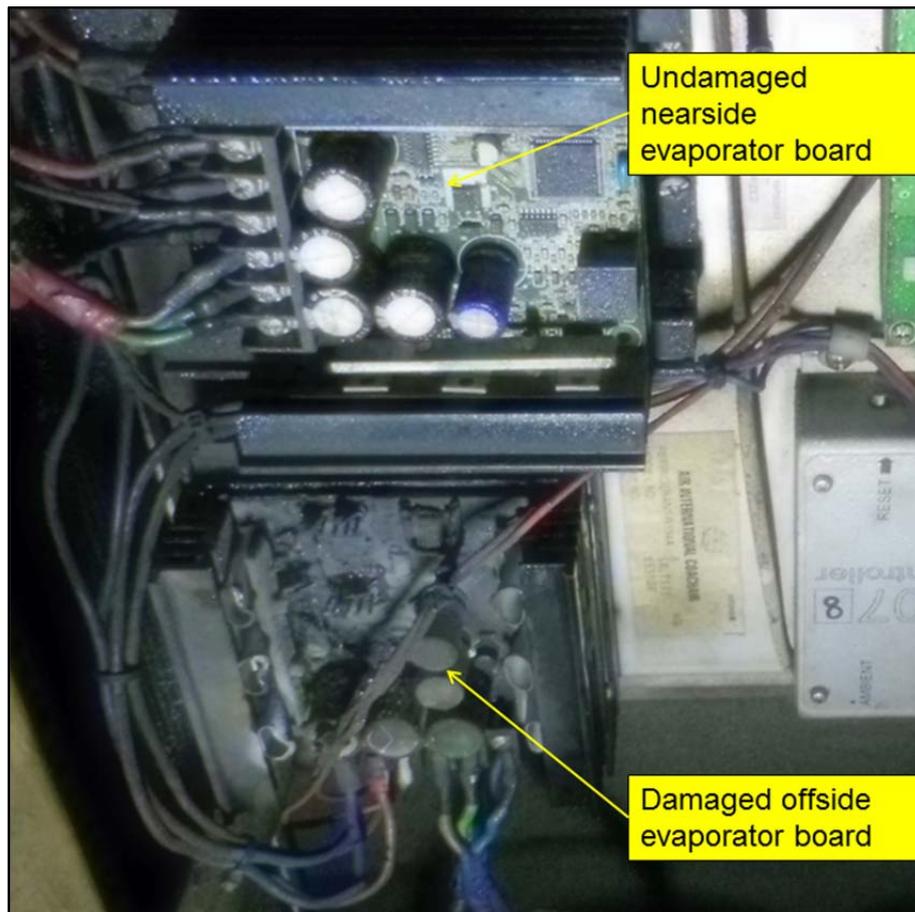
Figure 2: Roof mounted air conditioning circuit boards

- 2.2 With the filter removed, further examination revealed that the damage was confined to the offside² evaporator fan circuit board.

- 2.3 It was likely that the fire ignited in the offside fan circuit board. The fire most likely extinguished either when the circuit breaker ‘tripped’³, or when the air conditioning power supply was switched off. It is likely that the circuit breaker tripped when the heat affected electrical components short-circuited the board’s power supply.
- 2.4 The offside fan’s control circuit board was fire damaged. Whilst the nearside fan’s circuit board remained undamaged (See *Photograph 2*).

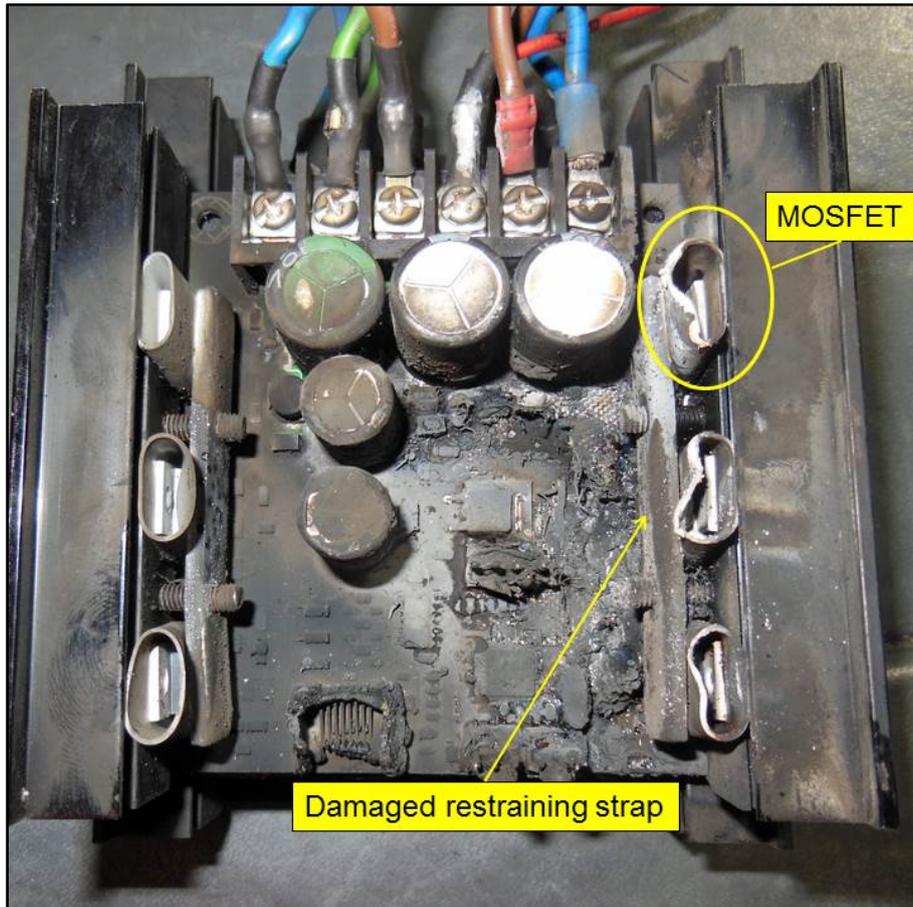
Figure 3: Damaged circuit board

2.5 The examination of the damaged circuit board revealed that a failed Metal–Oxide–Semiconductor Field-Effect Transistor (MOSFET) mounted on the circuit board was most likely the ignition source of the fire (see *Photograph 3*). These are two likely scenarios:

- The MOSFET was damaged during manufacture.
- The MOSFET was damaged when the unit was installed in the bus.

- 3.1 The ignition source of the fire was most likely a result of a short circuit of a MOSFET on the offside air conditioning circuit board.

- 3.2 It is possible the MOSFET was damaged during manufacture or when the control unit was installed in the bus.
- 3.3 Maintenance contractors may not have fully diagnosed and / or repaired faults as per the maintenance records as from the 3rd of January 2016 to March 2016 (see *Figure 4*).

- 4.1 All bus operators have an assurance process for work carried out by contractors, to ensure that work carried out complies with manufacturer's specifications and is conducted by competent personnel.
- 4.2 All bus operators provide bus drivers with robust emergency response procedures that include the isolation of electrical power supply.
