TECHNICAL INSPECTION FINDINGS

FIRE INVOLVING STATE TRANSIT BUS 2204 ST

CREMORNE, SYDNEY

22 MARCH 2011

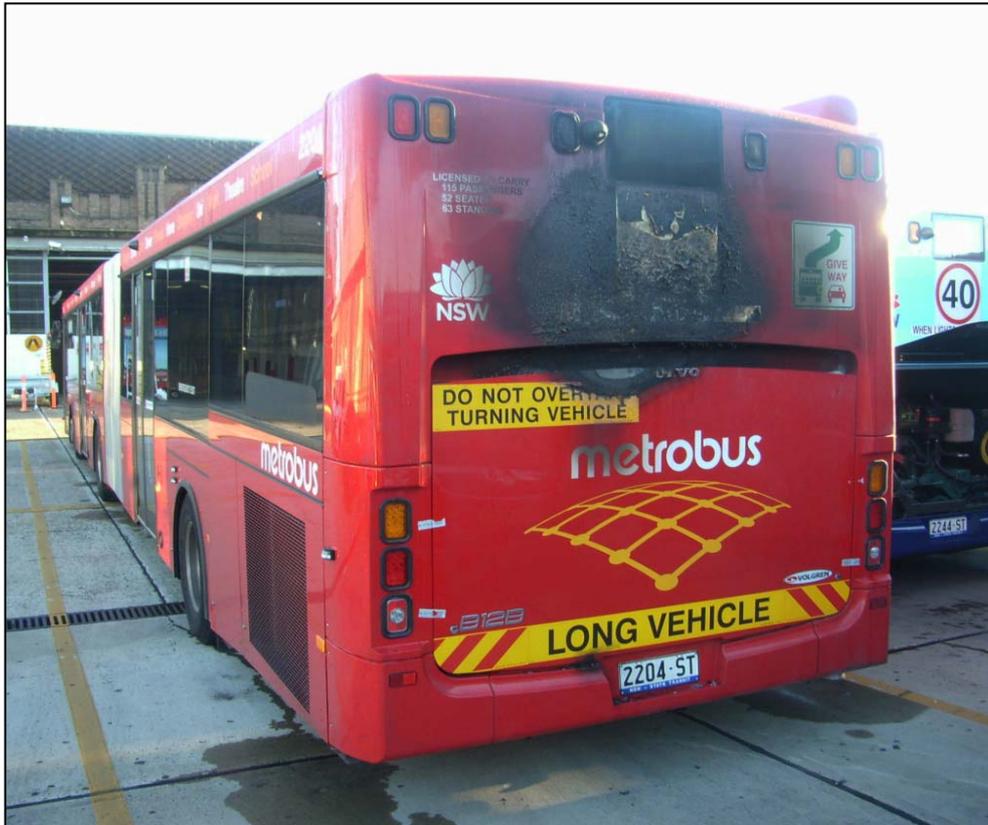
Damage to the exterior of the bus was confined to the aluminium engine bay hatch cover, the fibreglass body panel above the hatch, the reversing camera housing and centre 'wig wag' lights (visible in *Photograph 1*).

Photograph 1: Fire damage to the exterior

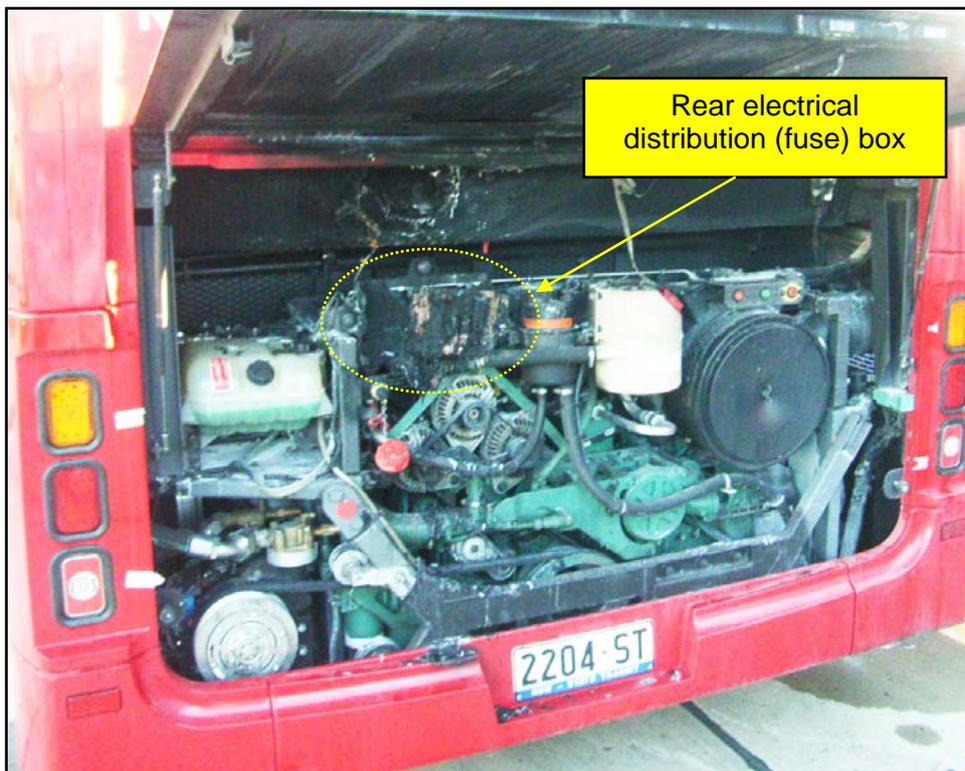
Examination of the engine compartment established that the fire had ultimately been extinguished by the onboard fire suppression system in sufficient time to limit the spread of fire to other engine components and combustible materials. This concentrated the pattern of fire damage around a specific area within the engine compartment; that of the rear electrical distribution (fuse) box which contains a range of plastic components.

Photograph 2: Overview of the fire damage within the engine bay

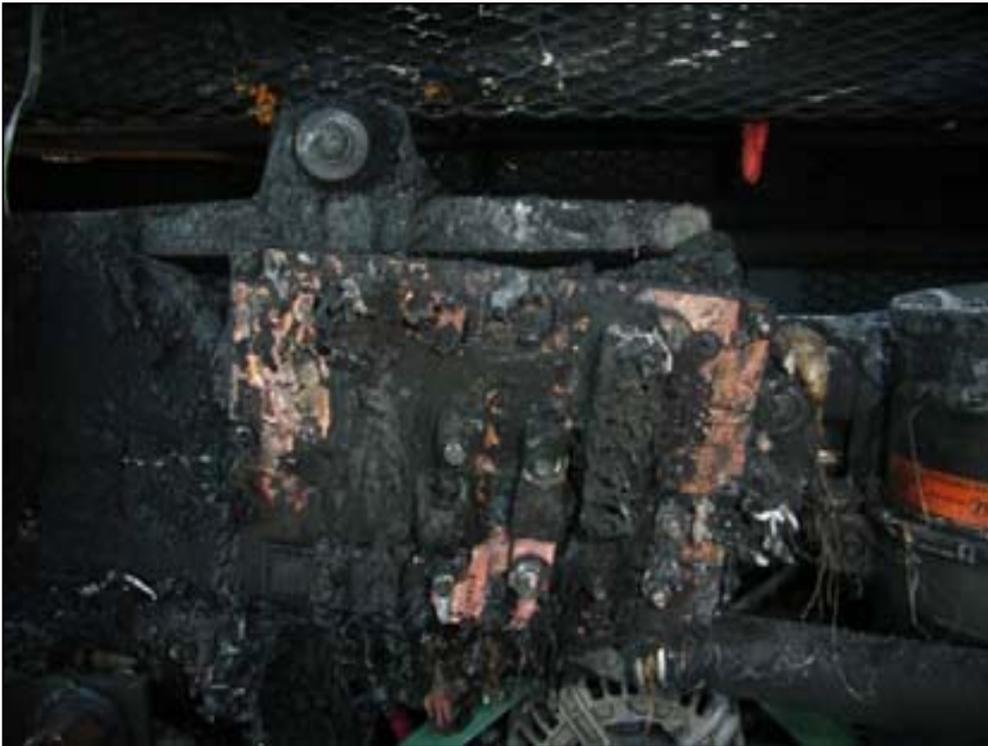
Photograph 3: Fire damage to the fuse box

Within the engine compartment, the outer plastic covering of the rear electrical distribution (fuse) box had completely burnt away leaving the circuit board exposed. Despite the heat that would have been generated within the compartment, all other wiring remained intact.

“The heat damage evident at the lower terminals for the air-conditioning circuit fuses located in the engine bay electrical fuse panel fitted to 2204ST was consistent with arcing damage resulting from a poor connectivity of either the terminal lug to the terminal post (loose terminal lug fastener) or poor crimping of the cable in the terminal lug..... This heat damage from this arcing would be sufficient to propagate heat to the surrounding polypropylene housing of the fuse enclosure to induce ignition of the housing..... As this fuse panel is fed from a direct feed from the alternator bank, the heat build up from this arcing would have continued until the engine had stopped, adding to the heat load of the fire”.

It is considered most likely that the heat source which initiated the fire was electrical in origin and was caused by loose wiring connectors on the fuse box. The heat caused the main electrical box, which sits above and to the left of the alternators and is made predominately of plastic, to catch fire. The fire then gained sufficient intensity to burst a pressurised detector tube of the fire suppression system. This in turn activated a valve that released water mist under high pressure from a sprinkler pipe which extinguished the fire before it spread to other engine components.

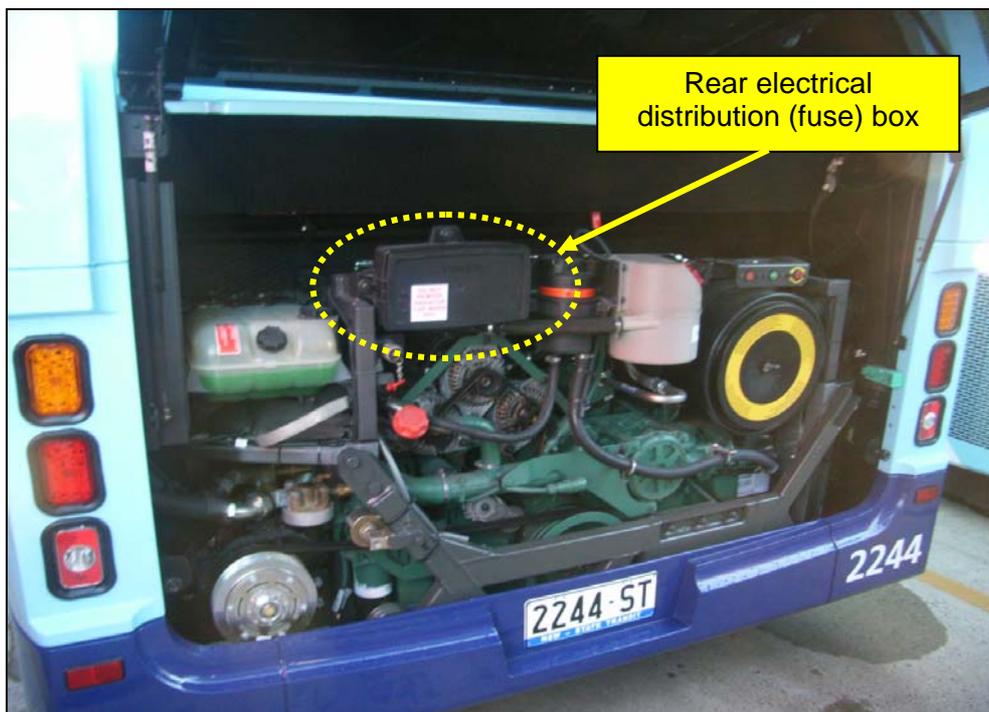
Photograph 4: Fuse box in the engine compartment of identical bus

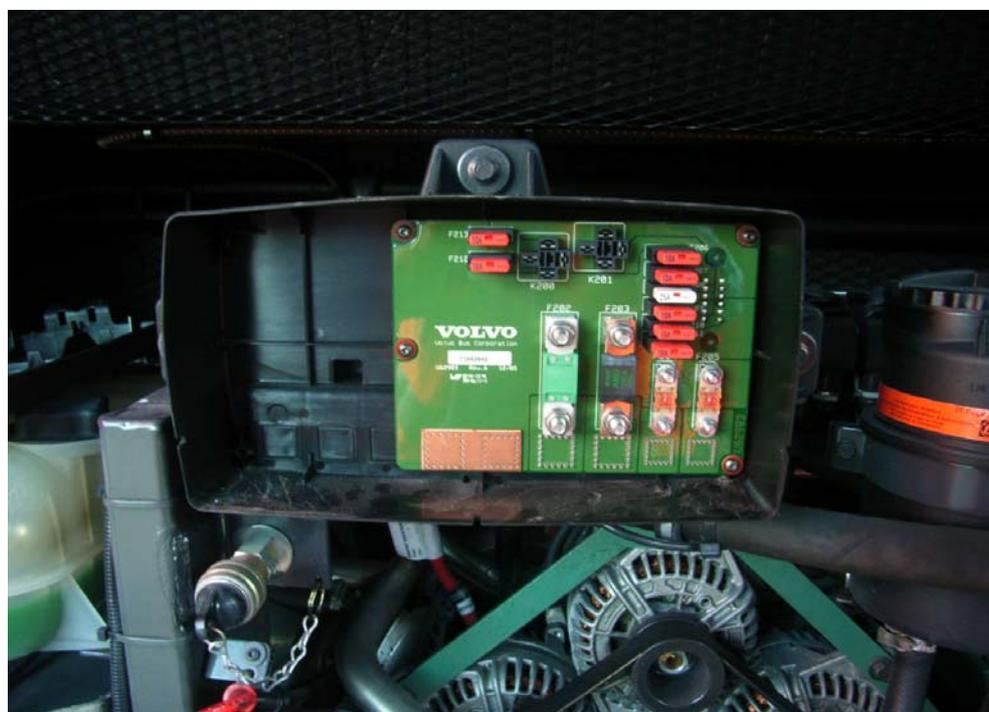
Photograph 5: Interior of a fuse box of identical bus

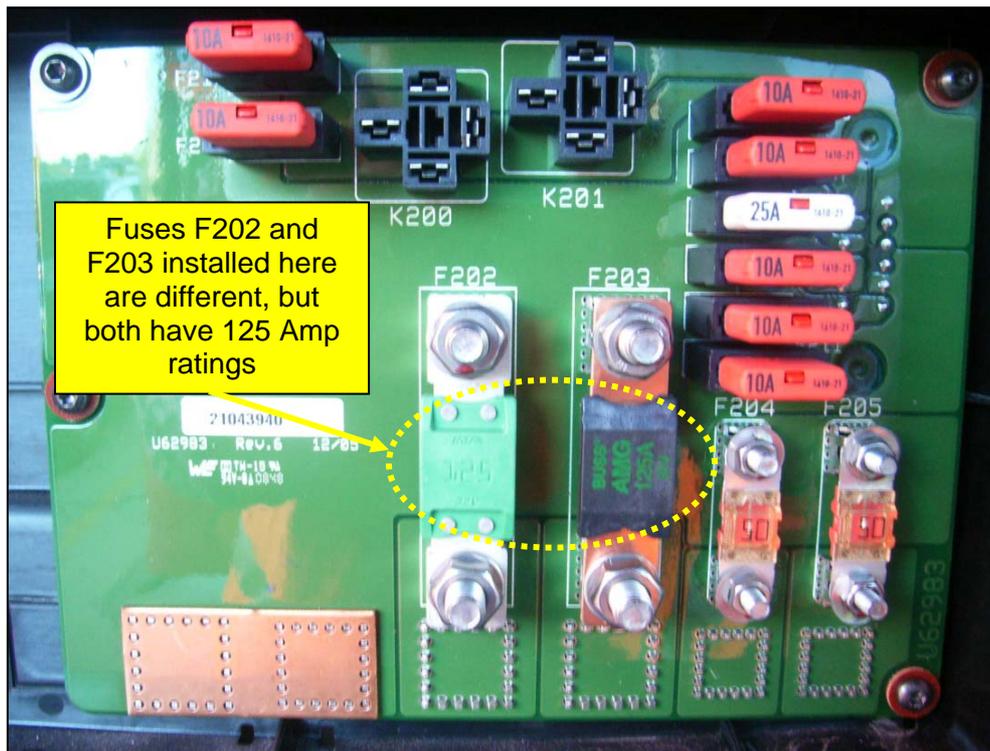
Photograph 6: Fuse ratings of those installed in identical bus

Insert 37-200 specifies the fuse ratings for F202 as 150 Amps and Fuse F203 as 100 Amps.⁴ Both the fuses installed in the identical bus (2244 ST) differed from the specified ratings, being rated at 125 Amps (see *Photograph 6*). It was later found that the specifications for fuse amperages in *Insert 37-200* were not consistent with the specifications in Volvo’s original *Bodybuilding instruction (BBI)* (see *Table 1*).

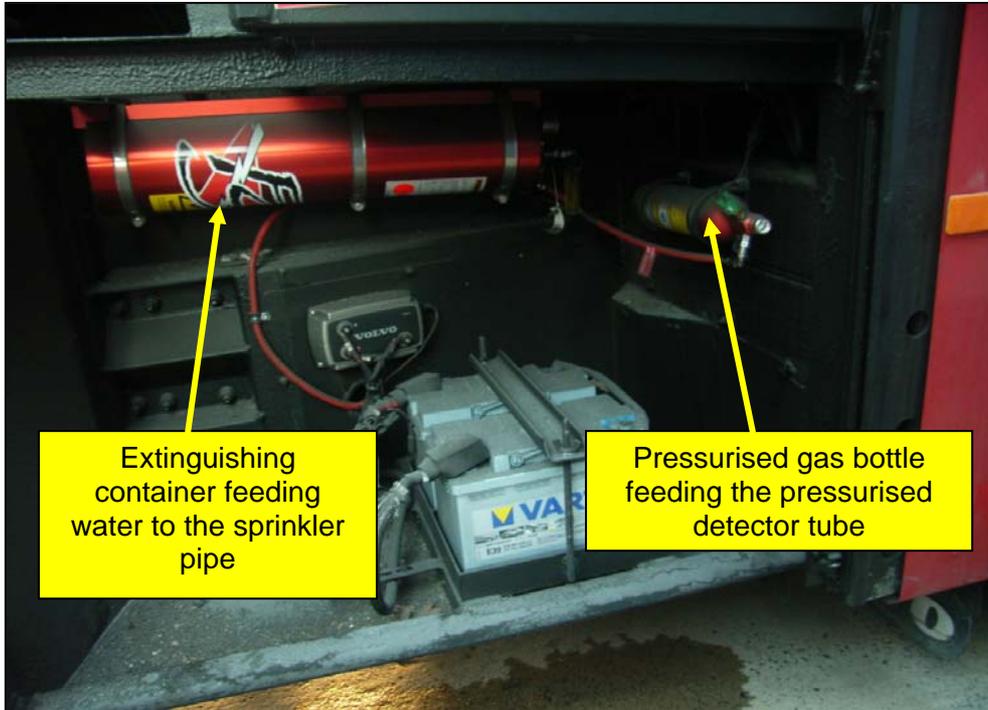
Photograph 7: The holding containers for the fire suppression system

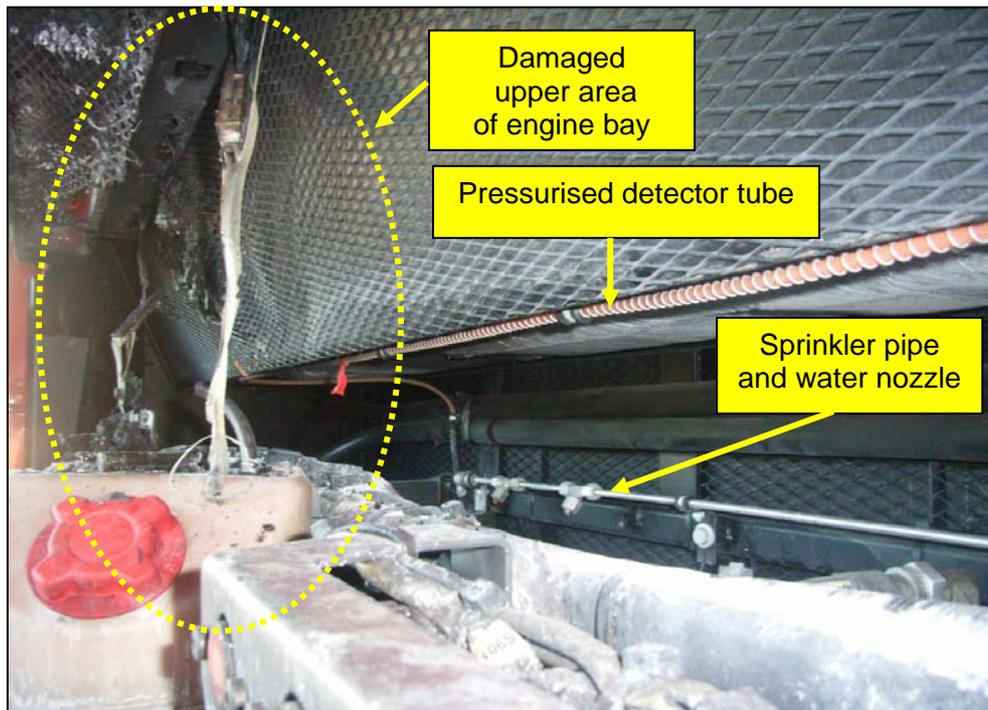
Photograph 8: Relative positions of the fire damage, detector tube and sprinkler pipe in the engine bay

Photograph 8 also depicts the position of the detector tube relative to the concentration of fire damage to the fuse box and the mesh and insulation adjacent to the air vents above it. While the FSS ultimately extinguished the fire, there may be a case for reviewing the positioning of the detector tube to optimise earlier detection of a fire.
