Office of Transport Safety Investigations

**FIRE INVOLVING GRASSHOPPER TOURS BUS TV 6139
NIMBIN, NSW**

13 JANUARY 2012

BUS INCIDENT FACTUAL FINDINGS

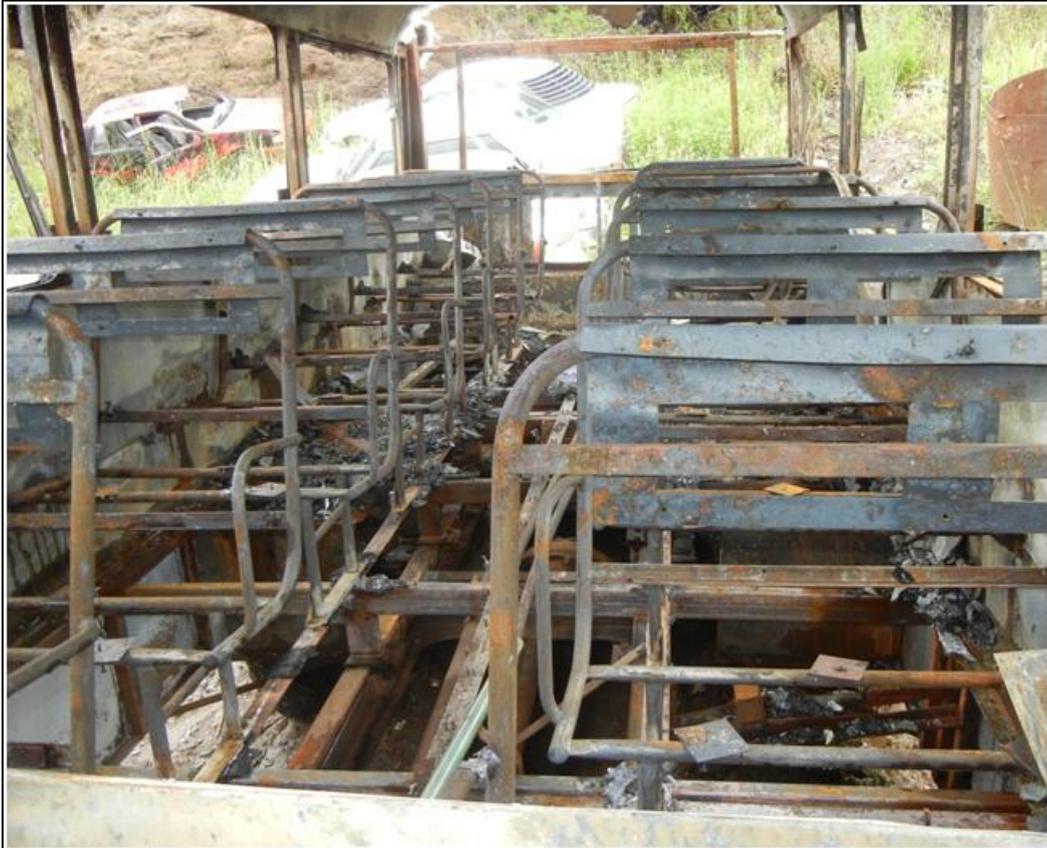
After confirming all passengers were accounted for and were a safe distance from the bus, the Driver phoned the emergency number '000' at 5:00pm to alert the Police and Fire Brigade. Police and Rural Fire Service units arrived on scene at 5:22pm by which time the bus was totally destroyed with everything other than the metal frame, side panels, seat frames and roof being consumed in the blaze (see *Photograph 1*).

Photograph 1: Surviving bus metal components

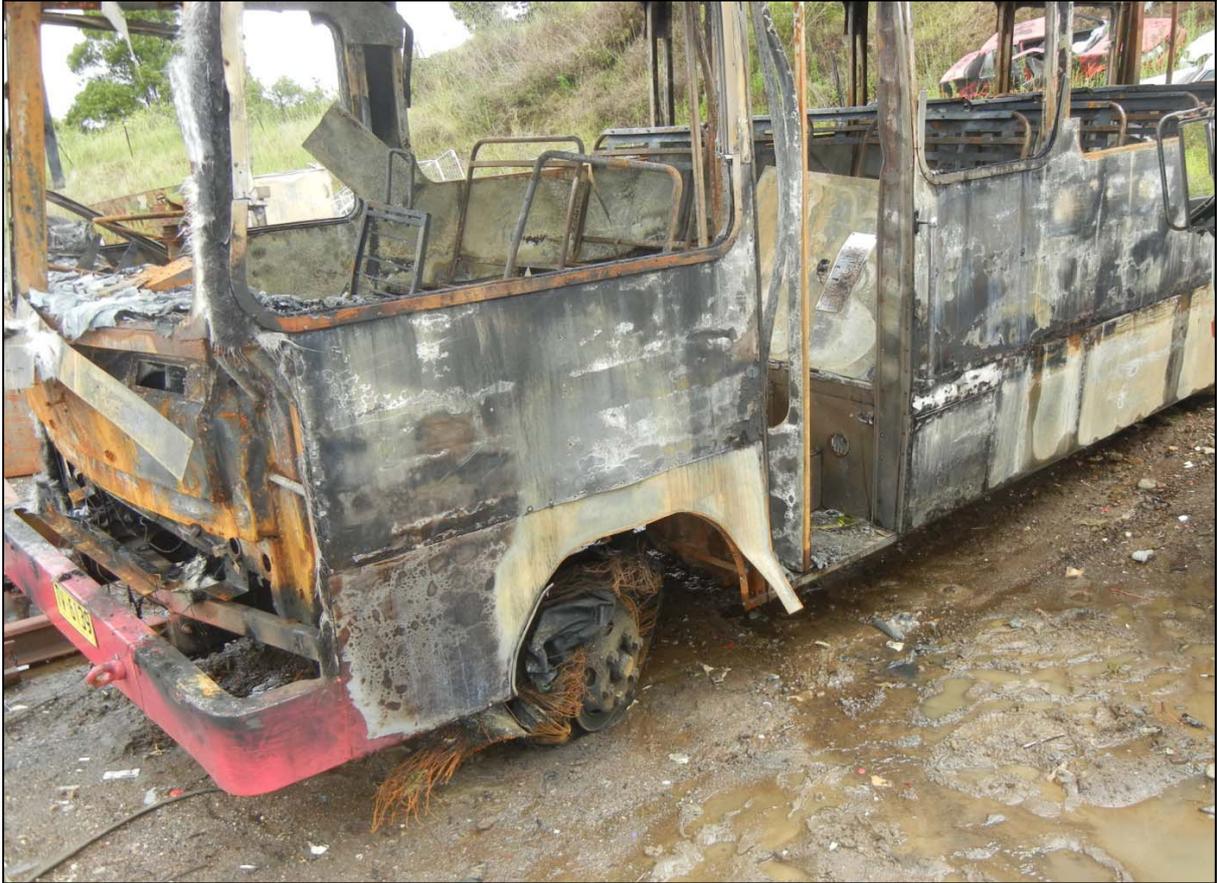
The bus was a 1984 ISUZU 38 model SBR422, chassis number CJ873089, owned and operated by Grasshopper Tours of Byron Bay. The Operator held current NSW accreditation (No. 36632) to operate long distance, tourist and charter (LDTC) services. The bus had a front mounted engine next to the driver's position. It was fitted with bench type seats, and had a centre aisle and a single front nearside entry/exit door with an emergency rear window exit (see *Photographs 2 and 3*).

Photograph 2: Location of single entry/exit door

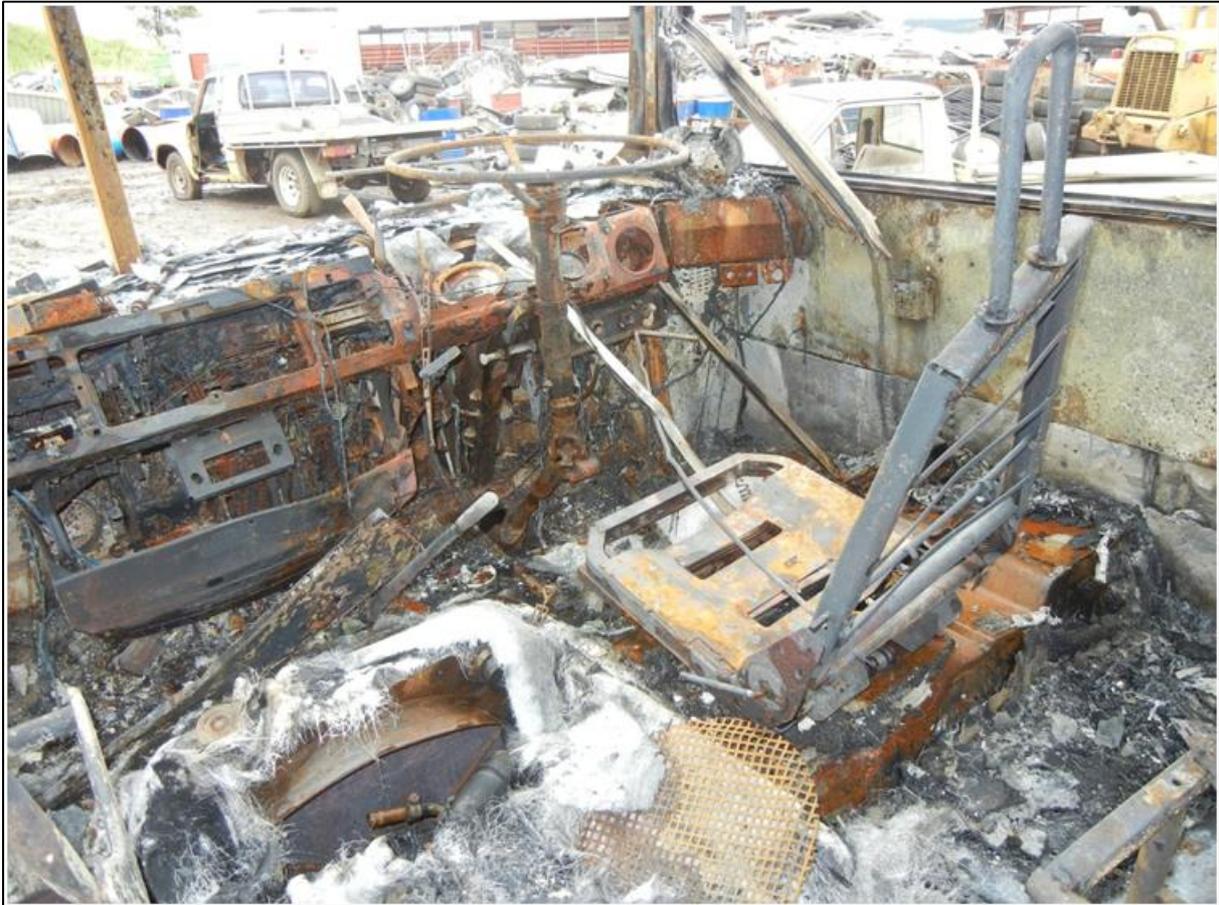
The bus was inspected by an OTSI investigator on 17 January 2012 in company with the Accredited Operator at a holding yard in West Lismore to which it had been recovered after the fire. The examination of the bus was hampered by the condition of the wreckage. It had suffered the consequences of exposure to the environmental conditions, which included significantly wet weather, over the four days that had elapsed since the fire. Rust was well established (see *Photograph 3*). An effort to locate an undamaged bus of the same vintage and model for reference purposes was not successful.

Photograph 3: Indicative of the condition at time of examination

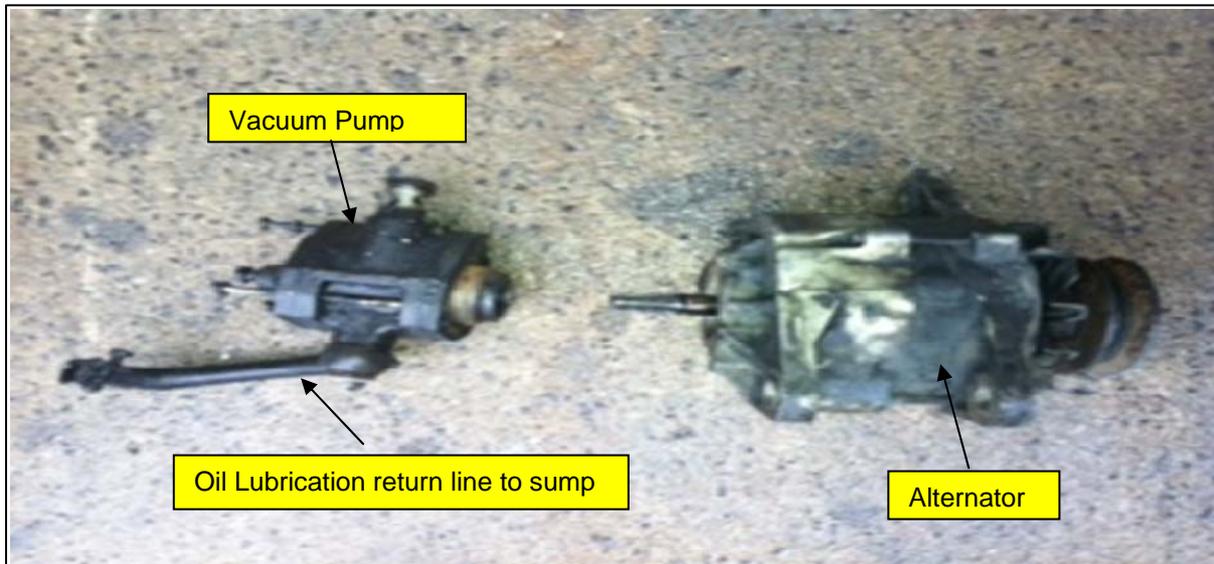
Examination of the alternator where an oil lubricated vacuum pump was attached revealed major damage. (*Photograph 4* depicts separated undamaged replacement components.) The purpose of the vacuum pump was to assist braking, with its lubrication coming from the engine with a return line direct into the engine sump. The residue and burn pattern on this side of the engine were consistent with an oil fuelled fire, indicating the likelihood that the seat of the fire was in the immediate vicinity.

Based on the examination, it was concluded that the fire was most probably caused by either an electrical short in the alternator or the seal on the shaft from the alternator to the vacuum pump leaking oil. The heat from an electrical short at the alternator could have affected the membrane seal around the shaft from the alternator to the vacuum pump, allowing oil to leak from the pump and ignite. Alternatively, the seal on the shaft could have leaked, allowing oil from the pump to

enter into the alternator or sufficiently close to ignite the oil. Both situations provide an ignition source and fuel for a fire. After the fire had commenced, additional fuel from the oil lines to the vacuum pump would promote the fire, allowing it to spread to the fibreglass engine cover and then to the interior furnishings of the bus.

Photograph 4: Spare undamaged vacuum pump and alternator

The Driver's initial observation of the location of the source of smoke through the inspection flap, and the existence of dark smoke that is typically associated with an oil fire, supports the conclusion that the fire originated in the vicinity of the alternator and vacuum pump.
