Office of Transport Safety Investigations

TECHNICAL INSPECTION FINDINGS

LODGES BUS SERVICE COACH FIRE

20 MARCH 2012

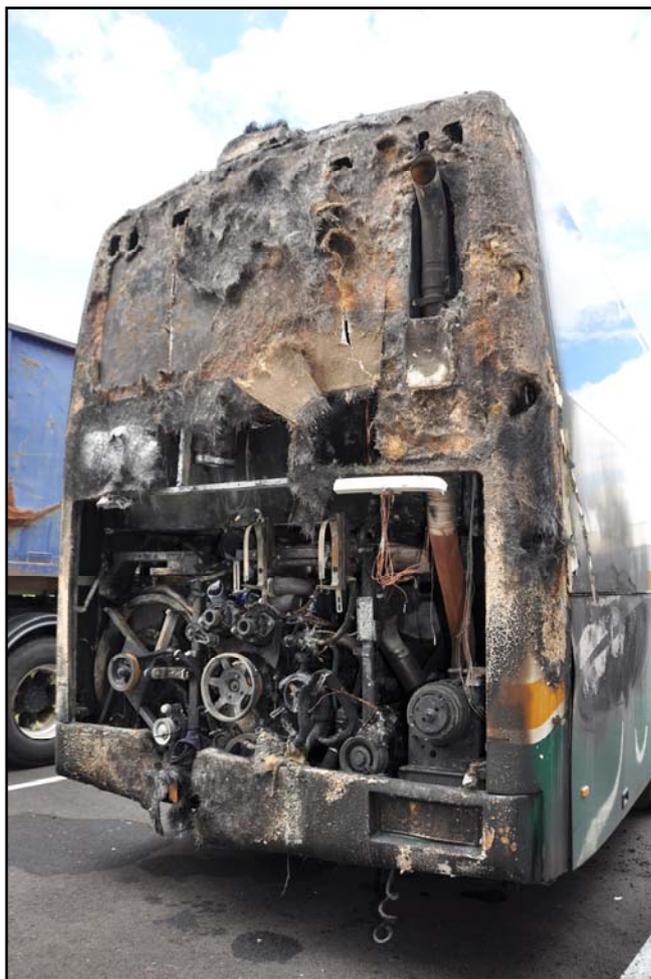
All components in the engine bay, particularly in the vicinity of the turbocharger, were damaged, as were the covering hatch of the engine bay and the body panels above and to the sides of the hatch (see *Photographs 1 and 2*). The rear window was shattered in the process of extinguishing the fire.

Photograph 1: Fire damage

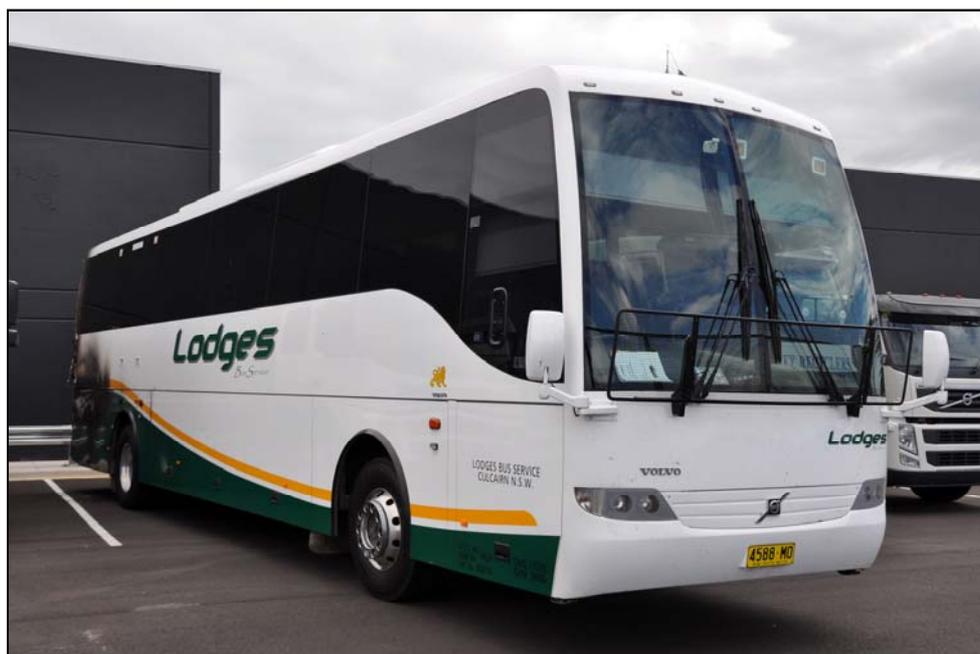
Photograph 2: Rest of coach in good condition

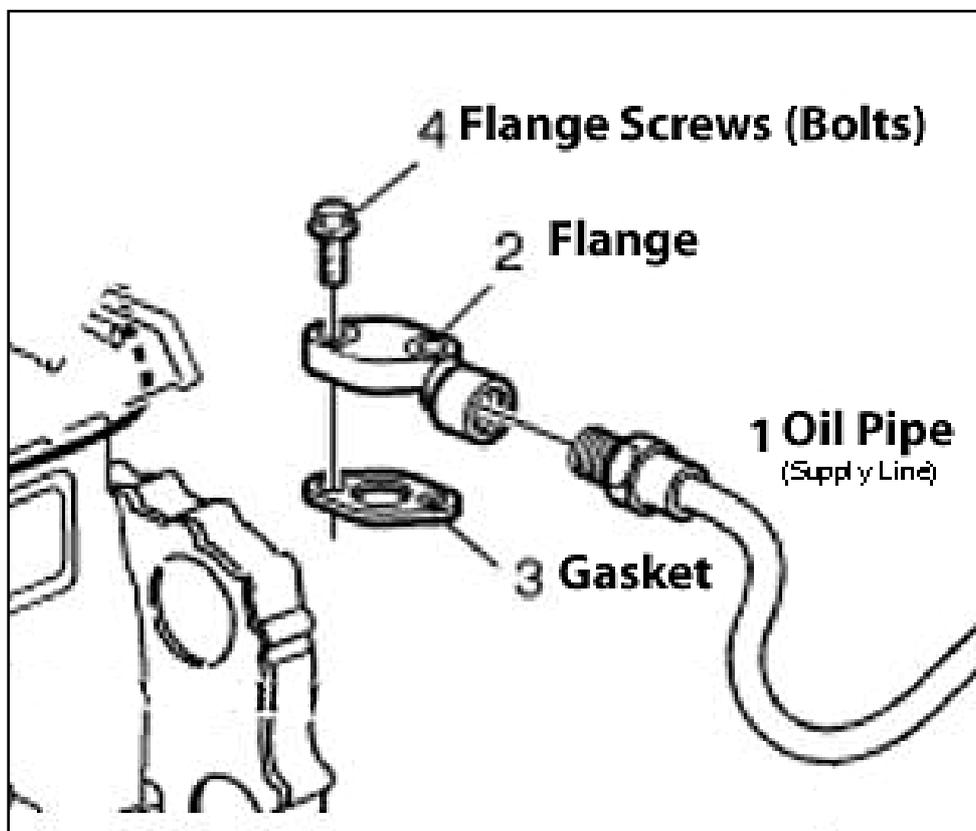
Turbocharger and associated piping. The engine is fitted with a Holset HX40W turbocharger. The turbocharger is lubricated and cooled by the engine oil and is additionally water cooled. As oil flow is critical for its operation, it is very important that inspection, servicing and maintenance of the engine lubrication system are conducted thoroughly. The oil pipe from the engine enters the turbocharger via a brass block called a flange, which belongs to the 'oil system function group' (see *Figure 1*). The flange is fastened to the top of the turbocharger and its purpose is to secure the oil supply pipe to the turbocharger. Oil from the engine sump supplies oil via the oil pipe and flange unit to the turbocharger at 300 to 550 kPa.

Figure1: Oil System Function Group

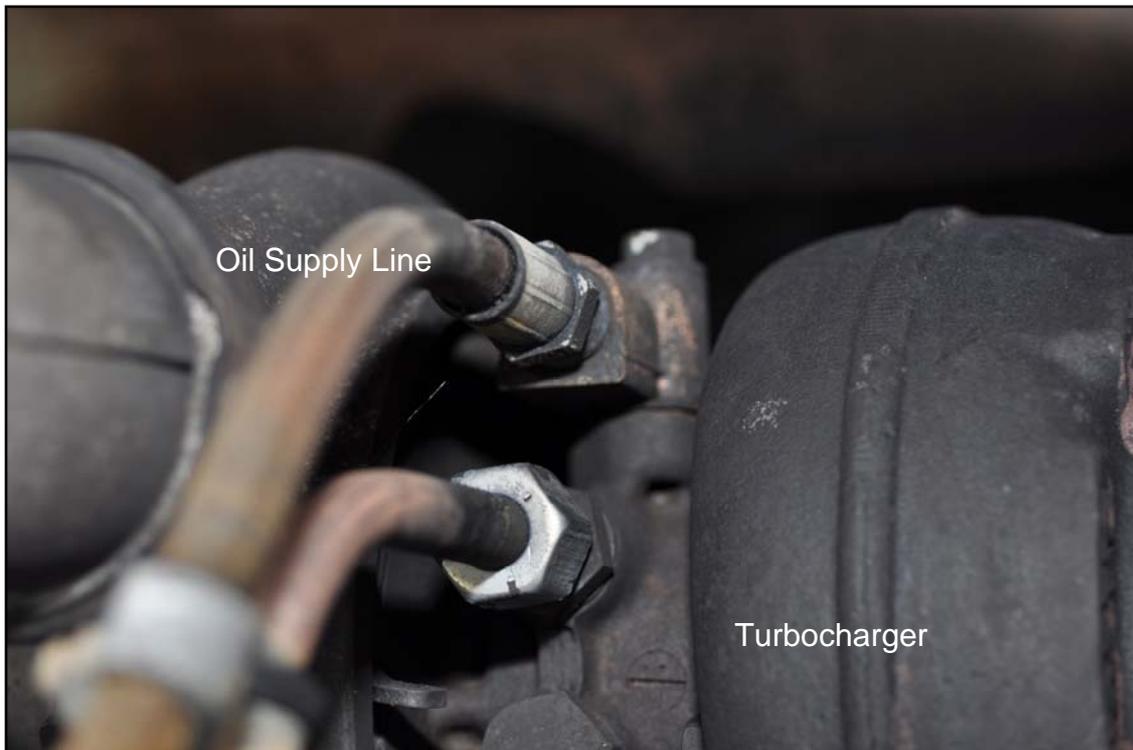
Inspection of the turbocharger revealed that the oil pipe was sitting loosely within the flange housing but was not fastened (see *Photographs 3 and 4*). This situation is likely to have caused the fire by permitting oil being supplied to the turbocharger under high pressure to spray over the hot turbocharger surface and ignite.

Photograph 3: Main oil supply oil line sitting within flange unit but not secured

The fire was caused by the main oil supply line to the turbocharger becoming loose, allowing oil to escape under high pressure and spray over the hot turbocharger and exhaust components of the engine.

Checking the integrity of the turbocharger and oil supply line during routine servicing, together with utilisation of a thread locking system, would constitute appropriate remedial action to prevent a recurrence of this type of engine fire.

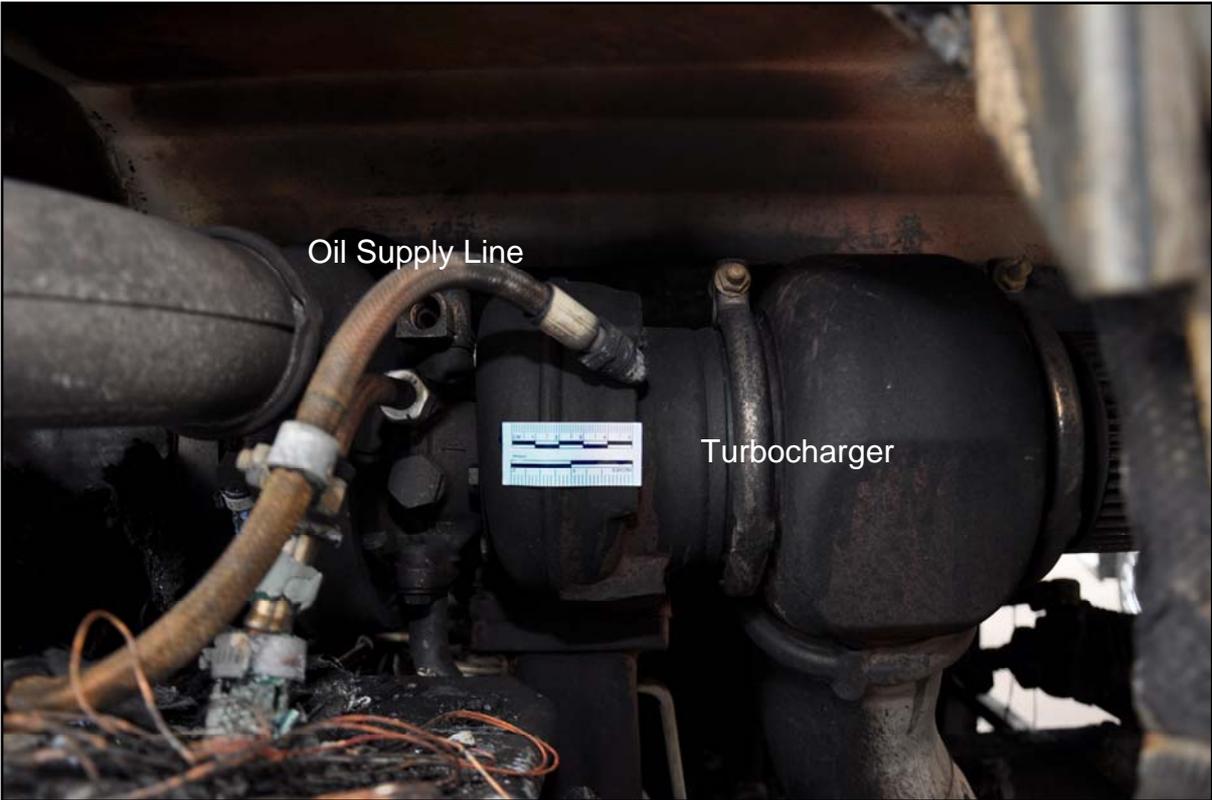
Photograph 4: Oil supply line sitting in front of turbocharger

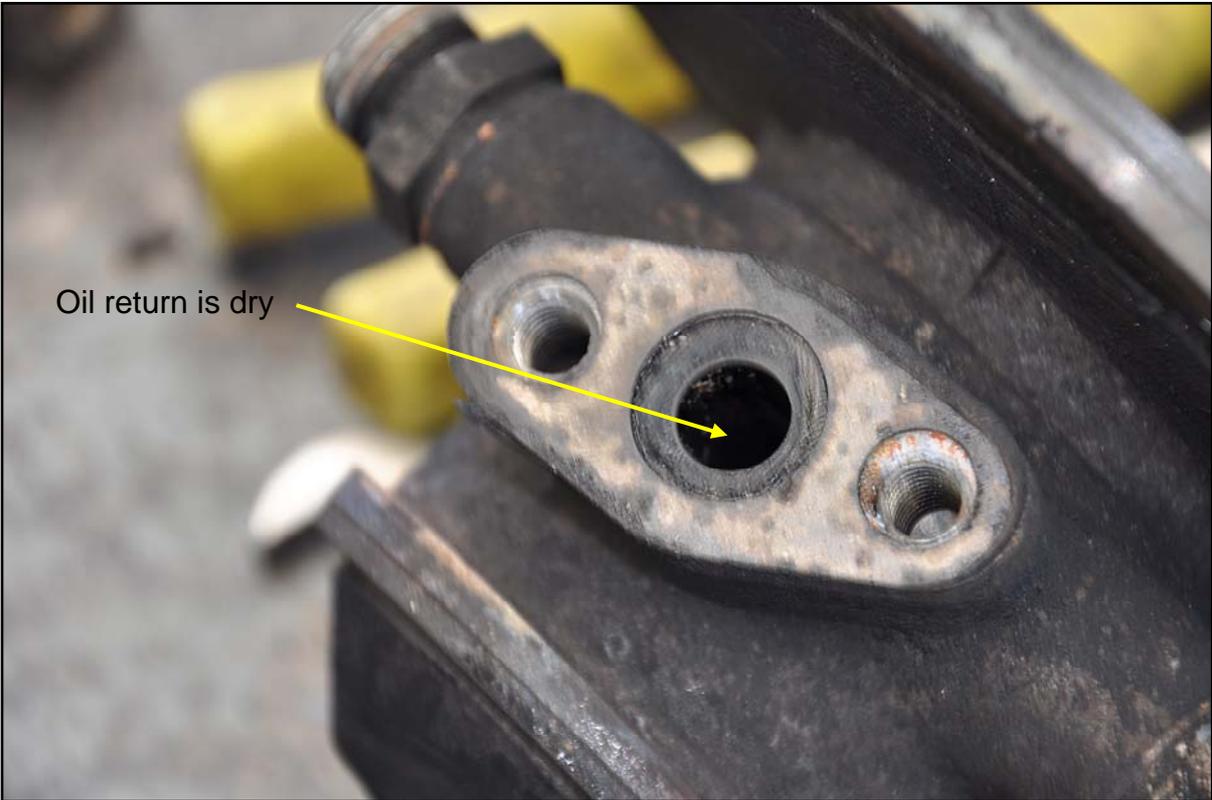
Other areas. On examination, the oil return housing and piping that fixes to the underside of the turbocharger were found to be dry (see *Photograph 5*), indicating that the turbocharger had been starved of oil as, normally, the oil return pipe would be saturated with oil.

Photograph 5: Oil return housing.

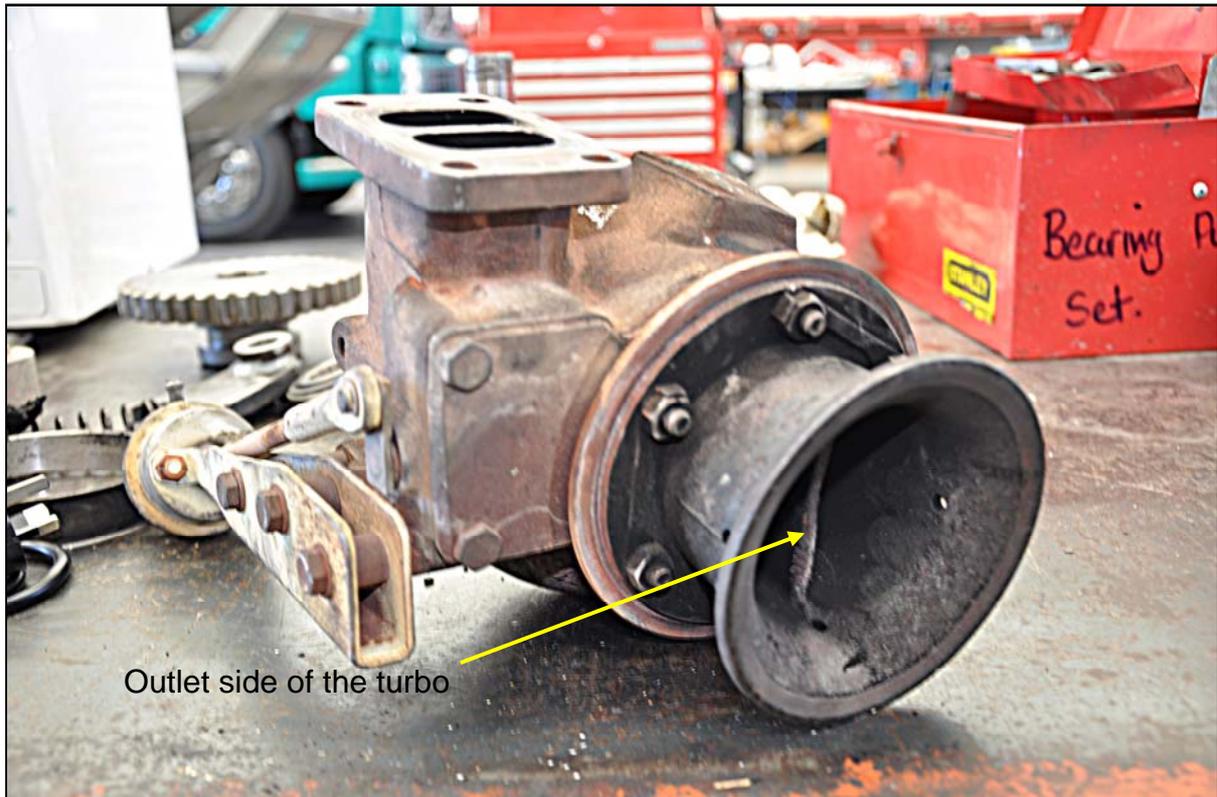
An examination of the exhaust system found it to be dry indicating that a faulty turbocharger seal or bearing was not the cause of the fire. Normally, when turbocharger seals and bearing become worn, the exhaust system is saturated with oil as oil bypasses the system. When the exhaust system was dismantled it appeared dry and normal in colour (see *Photograph 6*).

Photograph 6: Exhaust portion of the turbocharger dry and normal in colour

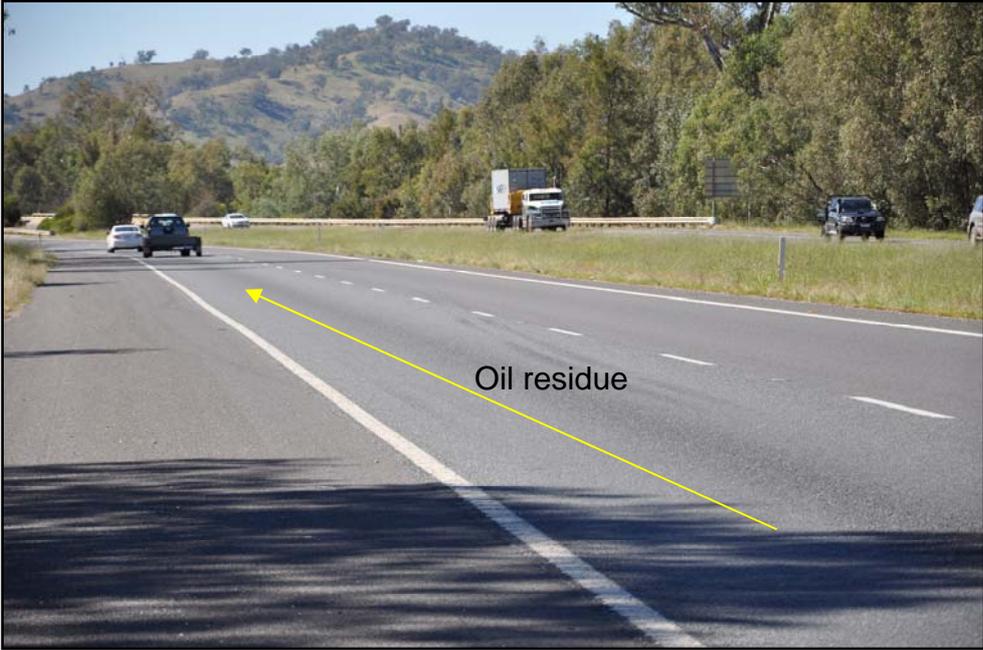
An inspection of the Hume Highway revealed an oil residue trail for several kilometres leading up to the point where the coach was stopped at the Albury off-ramp. This was consistent with a loose oil supply line working its way free and spraying oil under pressure over the hot turbocharger components, then dripping oil onto the roadway as the vehicle proceeded (see *Photographs 7 and 8*).

Photograph 7: Oil residue on the Hume Highway for several kilometres

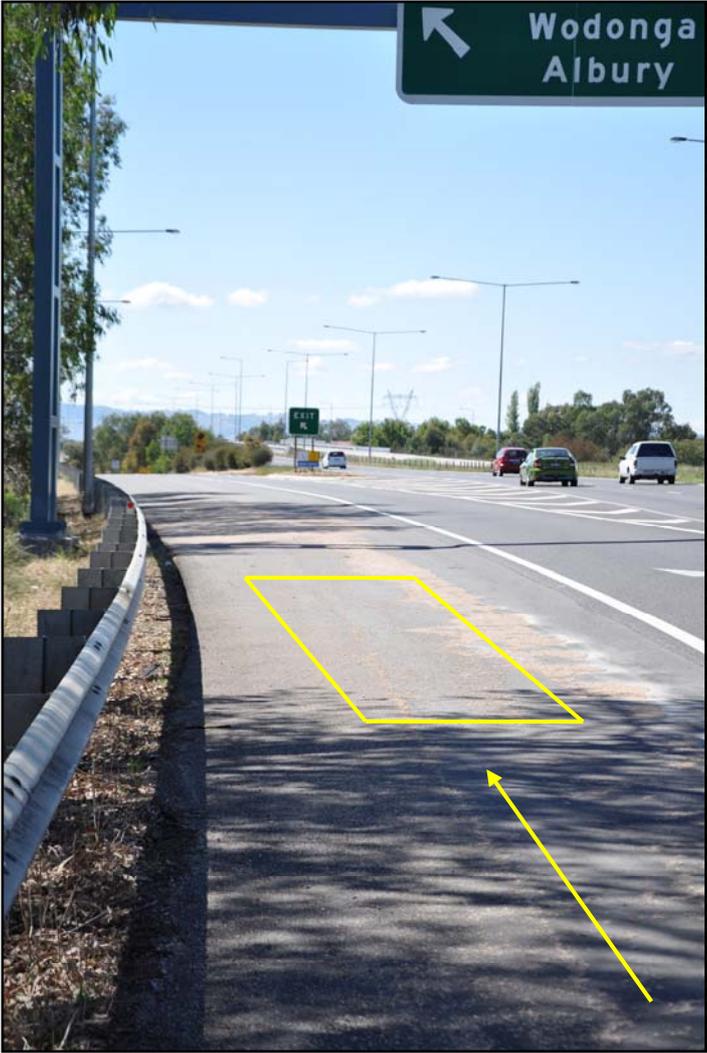
Photograph 8: Vehicle stopped just prior to Albury off-ramp

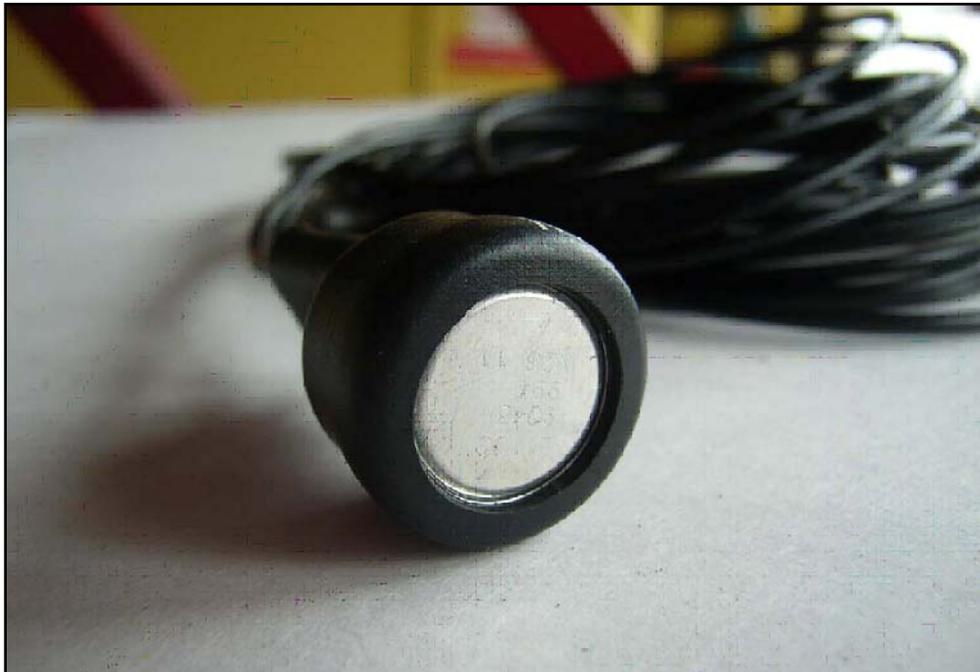
Photograph 9 shows a warning sensor similar to those typically fitted to Volvo B7R buses and coaches. Detection and activation of the system takes place automatically. In the event of a fire, the plastic coating around the detector probe melts and the internal wires contact, creating an open circuit which energises a relay. Once energised, the relay activates two red warning lights on the driver's dashboard, as well as an audible alarm to the bus or coach operator. The system does not operate independently of a power supply.

Photograph 9: Fire warning sensor fitted to B7R coaches
