Office of Transport Safety Investigations

BUS SAFETY INVESTIGATION REPORT

FIRE INVOLVING STA BUS MO4878

29 JULY 2011

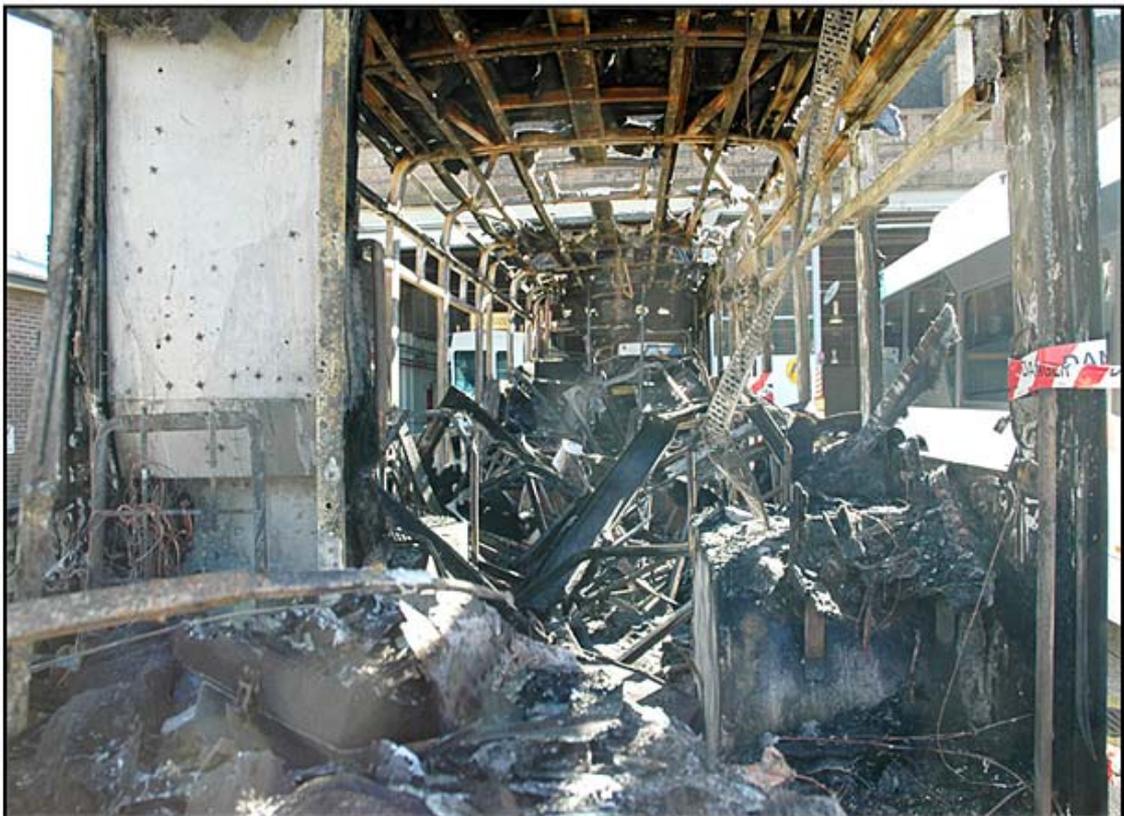
- 1.1 At about 7.38pm² on Friday 29 July 2011, a State Transit Authority (STA) bus (MO4878) caught fire on Beachamps Road at Hillsdale when returning empty to the Port Botany STA Depot. Despite attempts by the driver and Fire and Rescue NSW units, the bus was destroyed (see *Photograph 1*).

Photograph 1: Bus interior

1.19 The roof, windows, all interior fit-out and most of the side panels were destroyed by the fire. The stainless steel welded frame remained substantially intact but the sections supporting the roof in the middle of the bus were severely distorted. The flooring and inspection hatches at and towards the rear of the bus sustained significant fire damage but the tyres, wheels and chassis remained intact. The air-conditioning unit housed in a fibreglass pod and mounted on the roof at the rear of the bus was destroyed. The driver's console, including steering wheel and dashboard, and the driver's separation shield were all destroyed as was all internal electrical wiring, the CCTV cameras and the PTIPS unit.

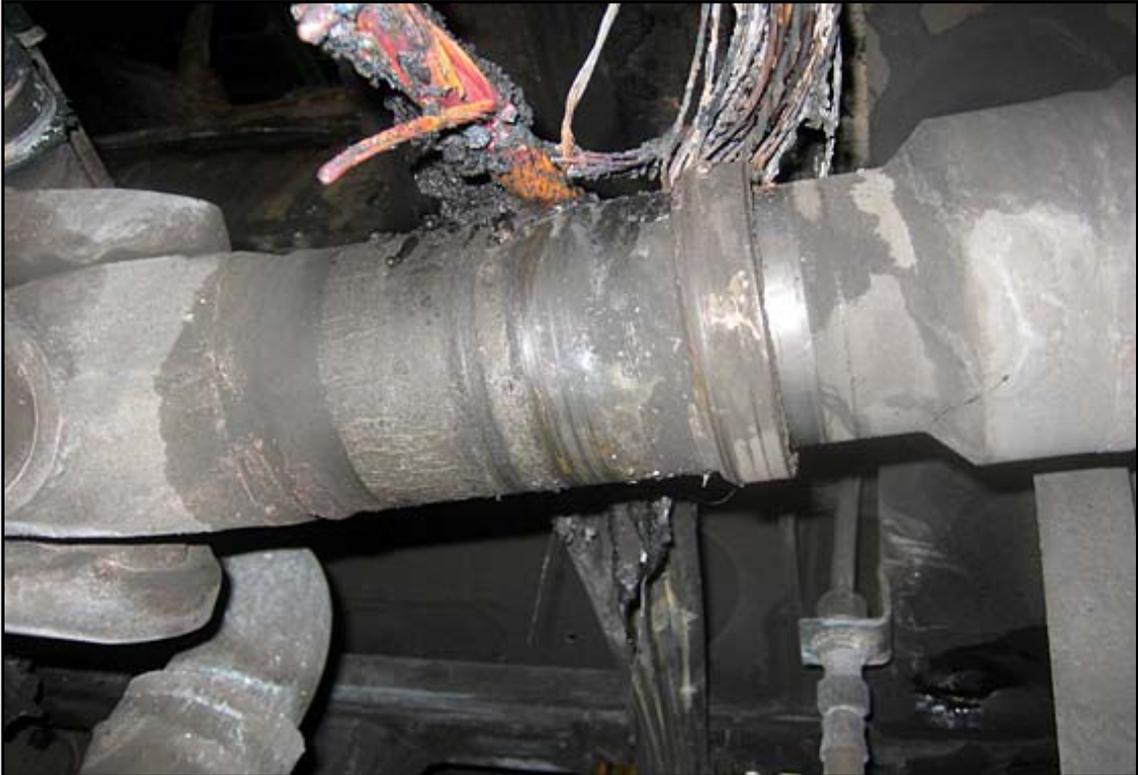
- 2.7 The main electrical loom from the batteries was burnt through with the remnants resting on the drive shaft (see *Photograph 2*). However, there were no markings on the drive shaft to indicate this cabling had come into contact with the shaft while the bus was moving. It was concluded, therefore, that the fire melted the plastic cable ties holding the wiring harness clear of the engine thereby allowing the harness to fall onto the drive shaft. Examination of several other undamaged buses of the same model and age showed the wiring harness was firmly secured and well clear of the drive shaft.

Photograph 2: Electrical loom on tail shaft

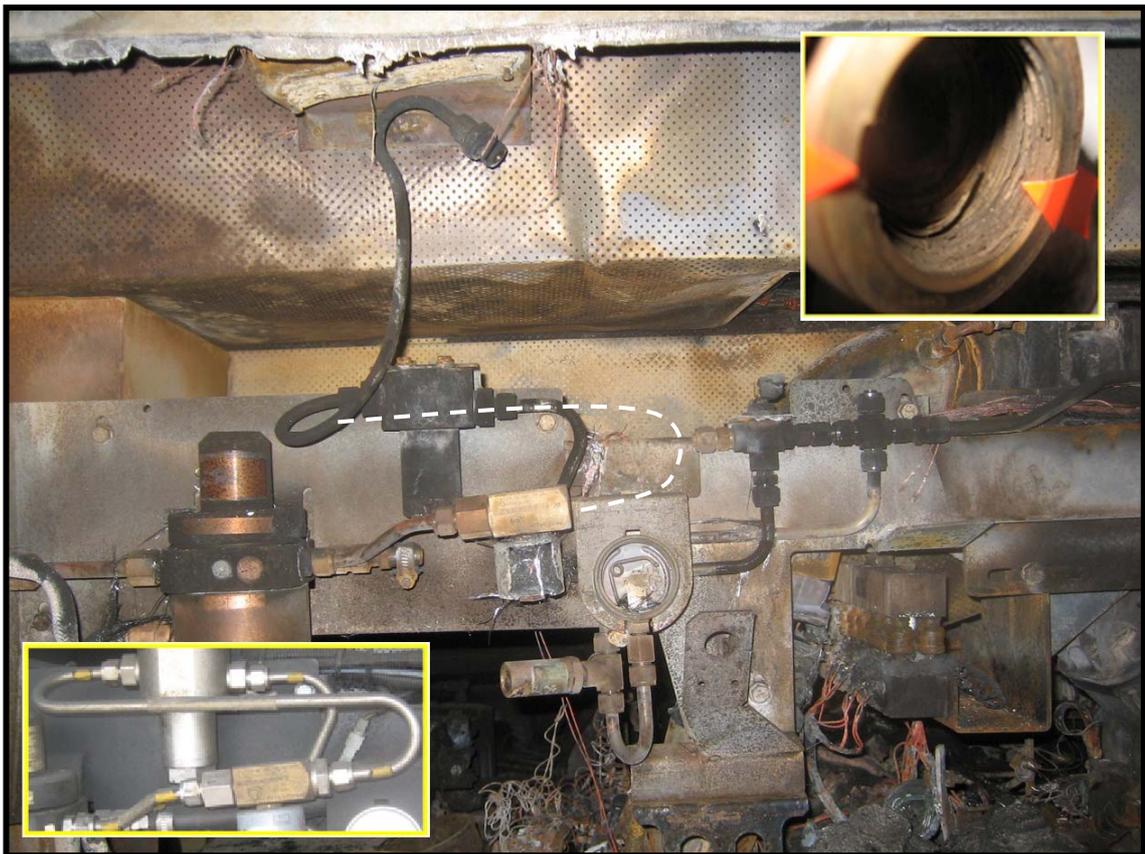
- 2.13 Examination of the bus found that the CNG fuel line was intact between the supply cylinders and the engine high pressure solenoid valve where a male threaded fitting manufactured from stainless steel had been torn out of a brass female fitting, stripping the internal brass thread. This component failure can be attributed to the combined effect of pressure in the gas supply line and heat from the fire, given that brass has a higher coefficient of thermal expansion than stainless steel.¹⁰ The fuel line, with the stainless steel fitting attached, was bent well away from the brass fitting indicating that the line had been under considerable pressure when the fitting failed (see *Photograph 3*).

Photograph 3: Ruptured CNG line-compared with an undamaged line

- 2.14 When the fitting failed, CNG vented through the ruptured line and was ignited by the fire. This caused a jet of flame to shoot out from the bus and partially across the roadway. The event was captured on the video recorded by the driver on his mobile phone and similarly by nearby witnesses who subsequently posted their video footage on YouTube. All videos show the back of the bus alight along with the interior and engine bay before the gas ignited.

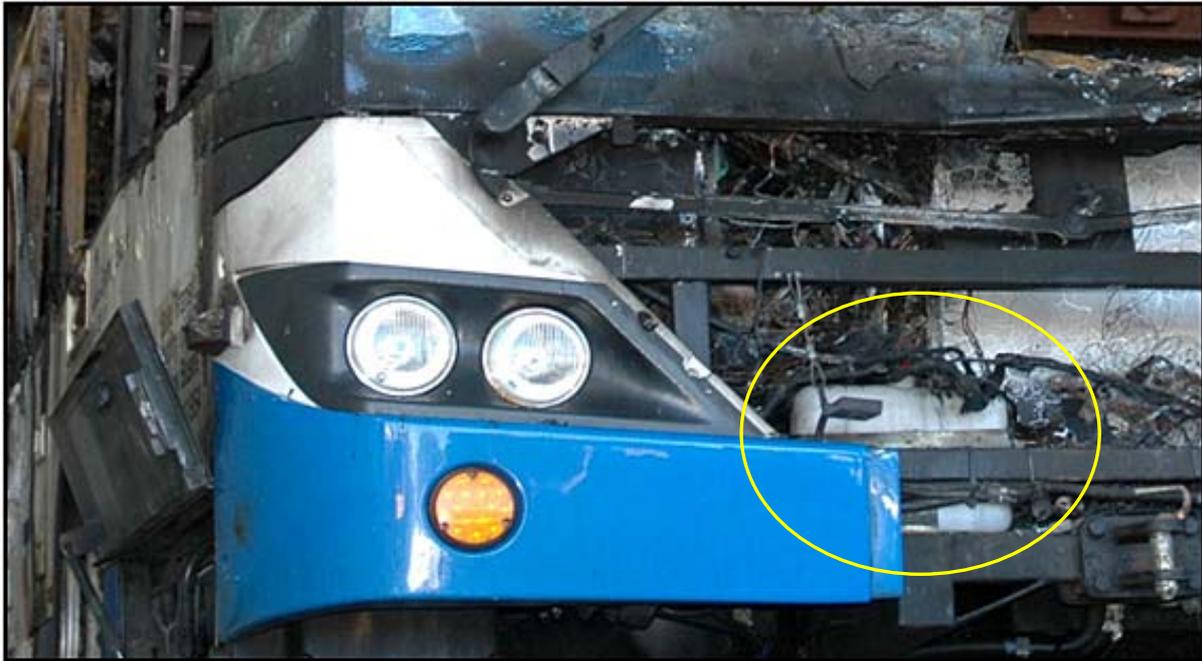
- 2.25 Examination of the interior section of the heat exchanger on the offside of the bus showed a clear line where the lower section had not melted, indicating that the coolant in the lower section had prevented it from melting. The coolant header tank mounted at the rear of the bus had completely melted indicating that the reservoir was empty prior to the fire. In contrast, the plastic windscreen washer bottle located in the front of the bus remained intact and was full of water, although all other components around it had been destroyed (see *Photograph 4*). The conditions as described are indicative of the possible loss of coolant in the heat exchanger and coolant reservoir before the fire commenced. A significant loss of coolant would result in a substantial rise in the operating temperature of the engine.

Photograph 4: Windscreen washer bottle

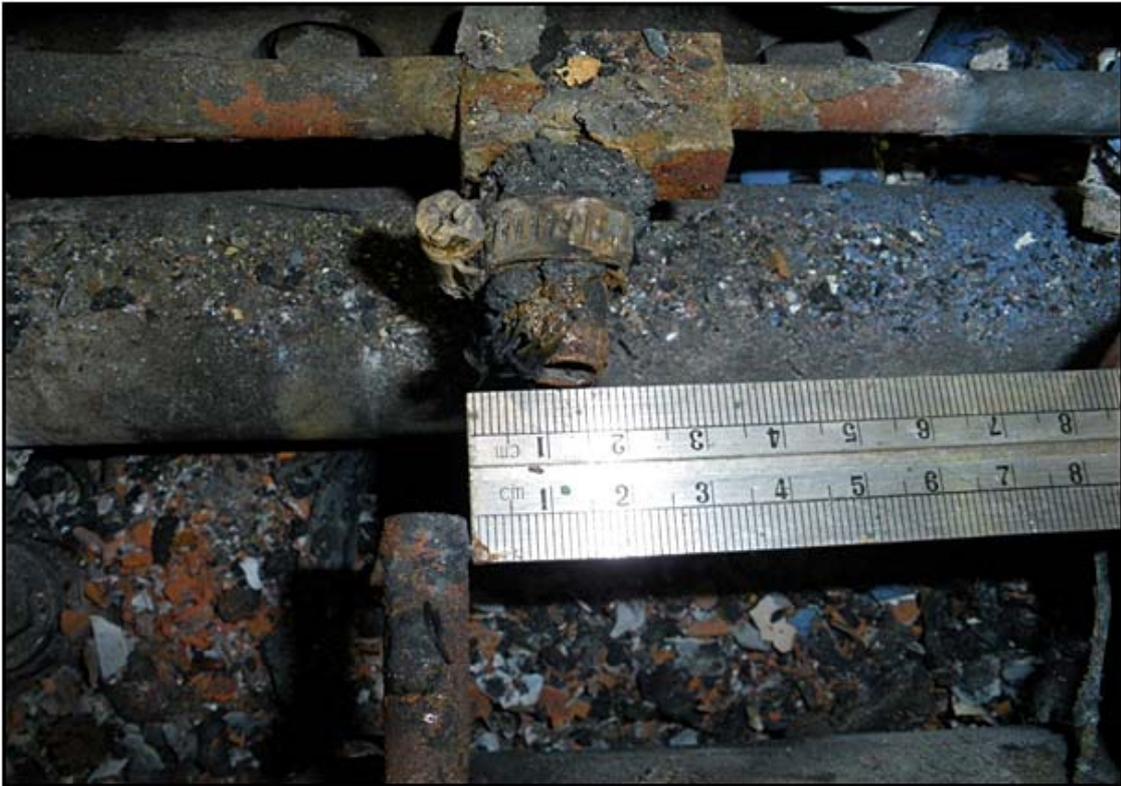
- 2.26 With the engine removed from the bus, a more detailed inspection was made to determine the cause of the fire. Examination of the coolant system showed the flexible rubber connection between the coolant return line from the turbocharger and a 'T' fitting was destroyed by the fire (see *Photograph 5*). The steel piping from the turbocharger was 18mm out of alignment with the 'T' fitting to which it was connected. This misalignment would have placed additional stress on the rubber hose, exacerbated by engine vibration. The coolant return line was supposed to have been replaced on 14 December 2010 but was not (see *Servicing and Maintenance*).

Photograph 5: Coolant return hose fitting misalignment

- the replacement of the return coolant line and connecting hose fitting on all their Mercedes Benz OC500 LE CNG model buses;
- the calling of tenders for the retrofitting of fire suppression systems on all their Mercedes Benz OC500 LE CNG model buses; and

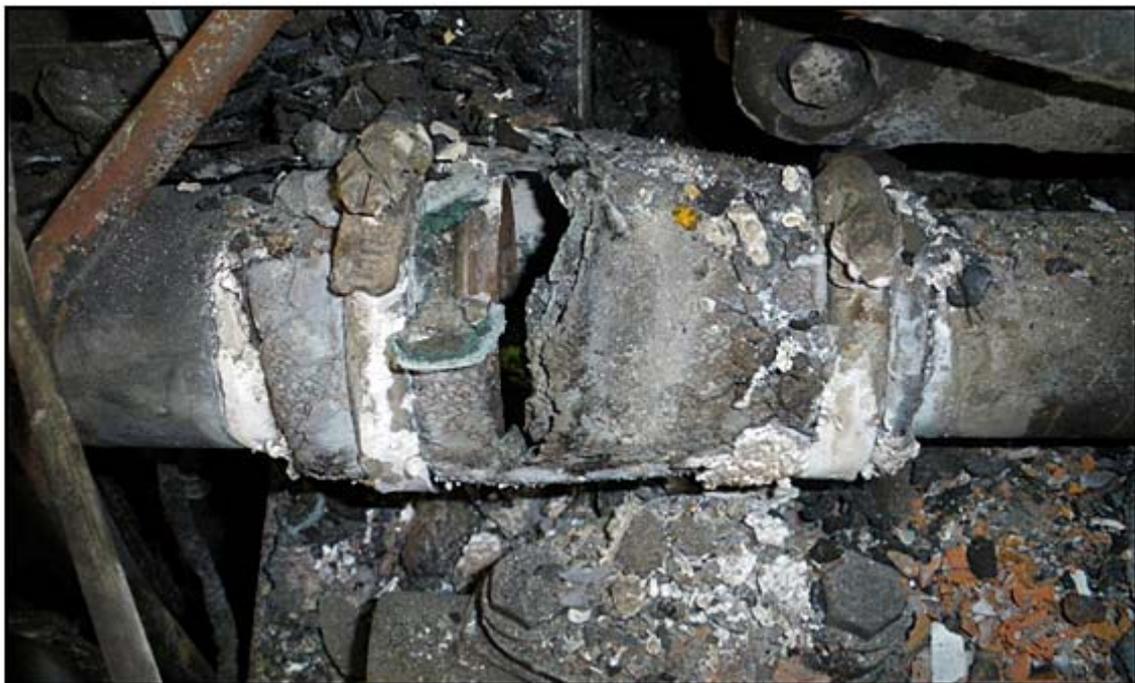
- 2.27 There was also a split and fire damage to the flexible rubber reduction fitting on the main coolant supply pipe running along the top of the engine block, near the engine compressor (see *Photograph 6*). The main coolant reduction hose had also been severely damaged by fire on the top surface. It could not be determined if coolant leaking from the split in this hose was the cause of the fire or was a consequence of the fire.

Photograph 6: Main coolant line reduction hose

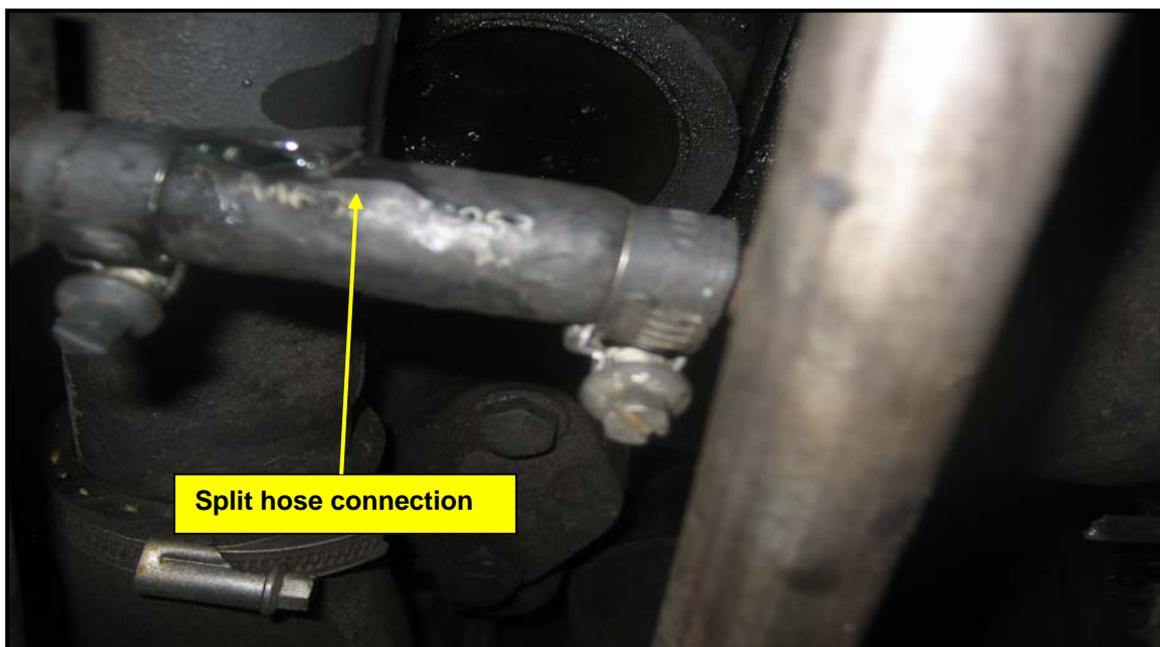
2.28 On 11 August 2011, the flexible rubber connection between the coolant return line from the turbocharger and a 'T' fitting was found to have split on another OC500 LE CNG bus. This split in the hose resulted in a considerable amount of coolant being sprayed onto the engine (see *Photograph 7*). On this occasion the driver received a low coolant alarm and responded immediately by turning off the engine's ignition. He reported observing a large amount of steam emanating from the top of the engine. It is believed this steam was caused by the water content in the coolant boiling off on coming into contact with the hot surface of the engine.

Photograph 7: Split coolant return rubber connection

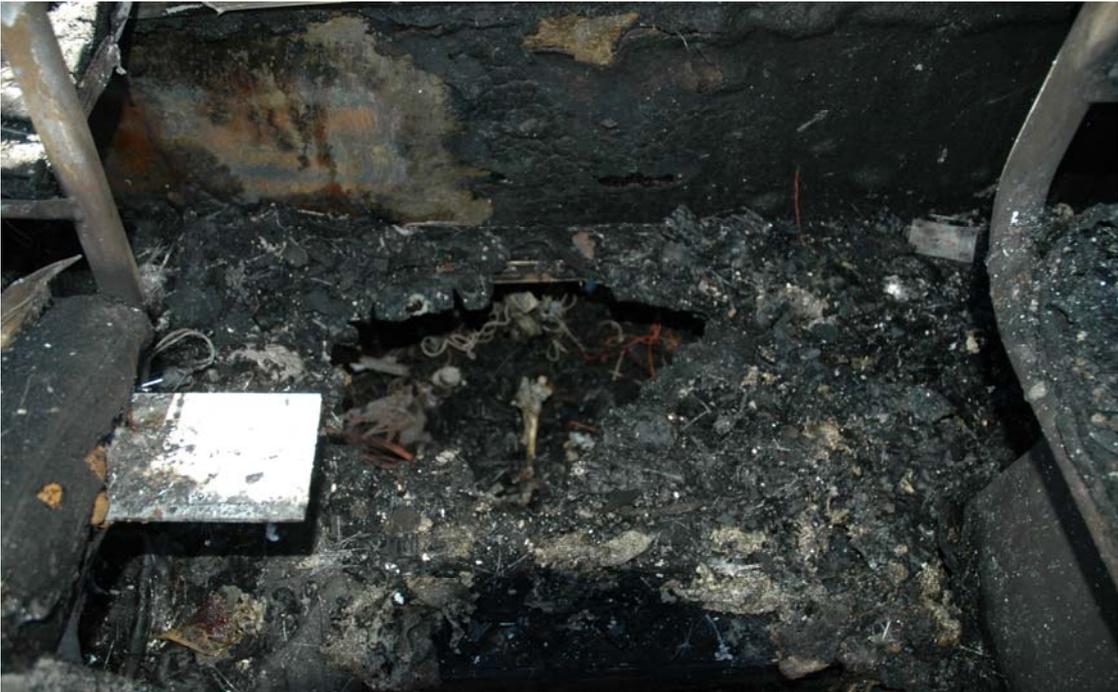
- 2.41 Analysis of the fire pattern on the underneath of the floor of the bus and on the engine indicated that the fire initially entered the inside of the bus through the small rearmost floor hatch which had completely burnt through (see *Photograph 8*). The second last floor hatch had also been severely damaged by fire although not burnt through completely. The hatch under the rear passenger bench seat was also severely damaged although there was a section of stainless steel shielding under the hatch.

- 2.42 As evidenced by the fire pattern radiating from the small hatch, the fire spread into the interior of the bus around the hatch then along both sides of the rear passenger seat, to both sides of the bus and towards the roof. This is consistent with the video evidence, the driver's statement and there being comparatively limited damage to fibreglass side panelling.

Photograph 8: Rear floor hatches

2.43 The floor hatches were not protected with stainless steel shielding like the other areas of the engine bay except for the rear seat hatch which, despite having some shielding, was still severely damaged. Also, the floor hatches are made of much thinner plywood than the rest of the floor; 12mm compared to 16.2mm. These bus floor hatches provided the area of least resistance to the fire and allowed the flames into the interior of the bus.
