Office of Transport Safety Investigations

TECHNICAL INSPECTION FINDINGS

CITY SIGHTSEEING TOURS BUS FIRE

7 SEPTEMBER 2012

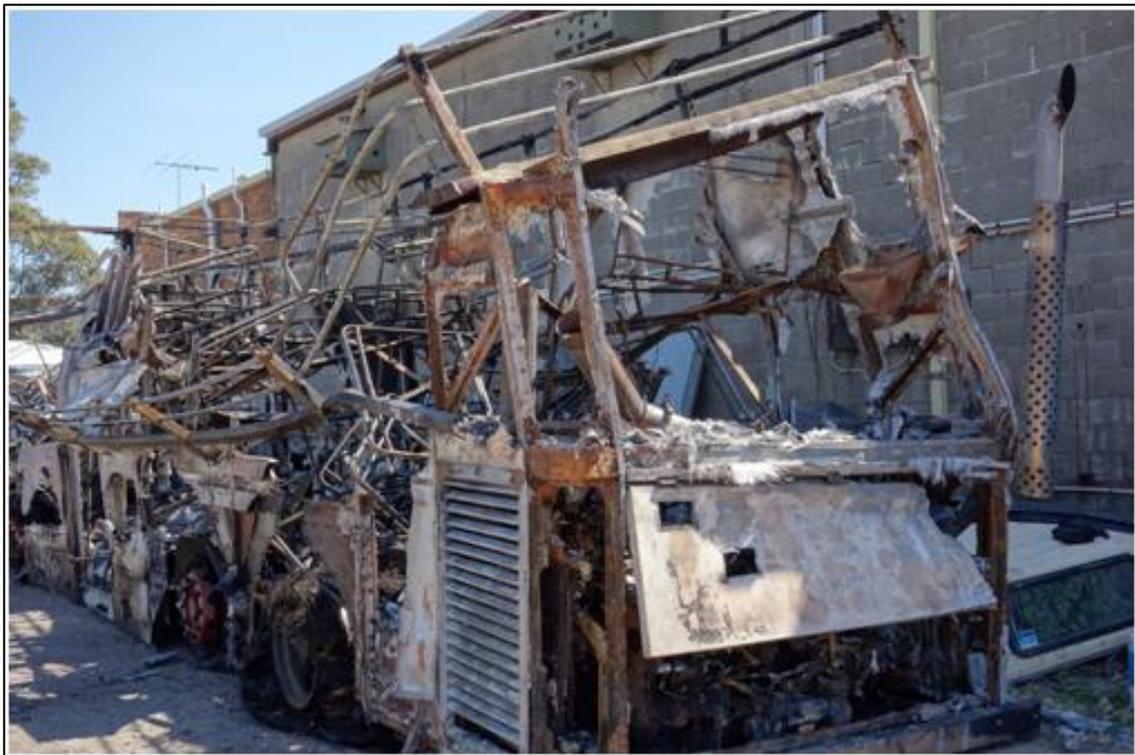
Photograph 2: Post-fire condition of bus

The intensity of the fire was such that all that remained was the steel framework of the bus, some sections of body panels and various parts of the engine and drive train. The only area that remained relatively untouched was the front driver's side wheel (see *Photograph 3*). Nobody was injured as a result of the fire.

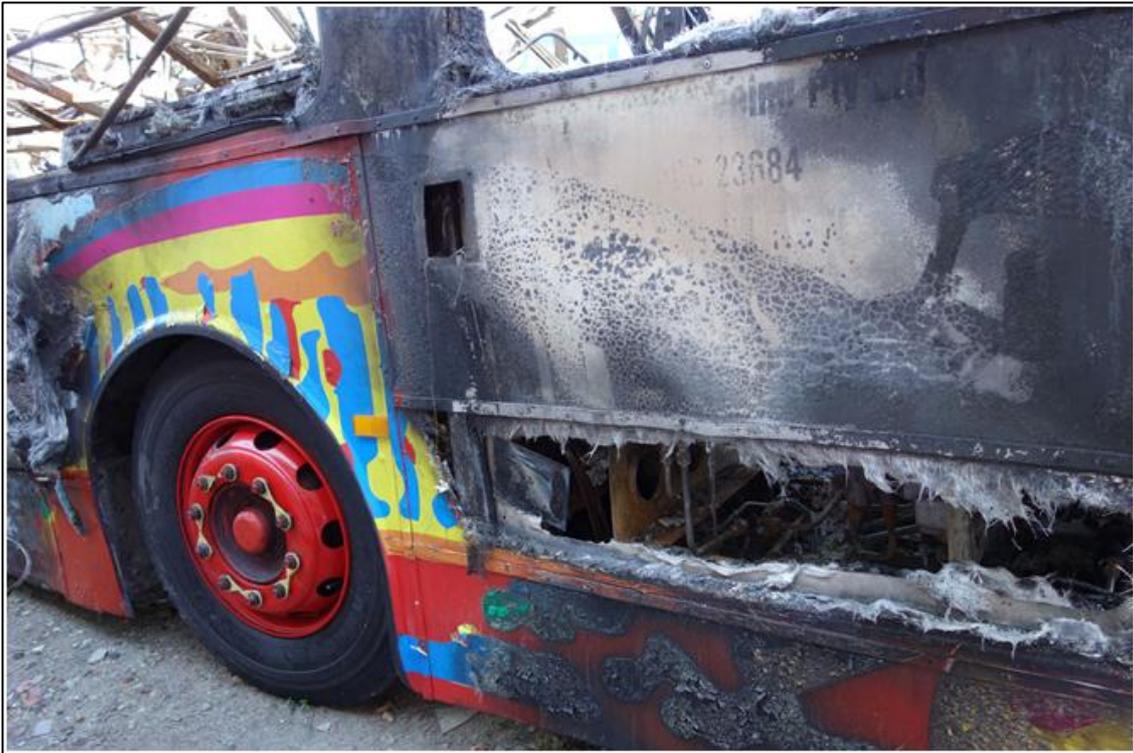
Photograph 3: Front driver's side of bus

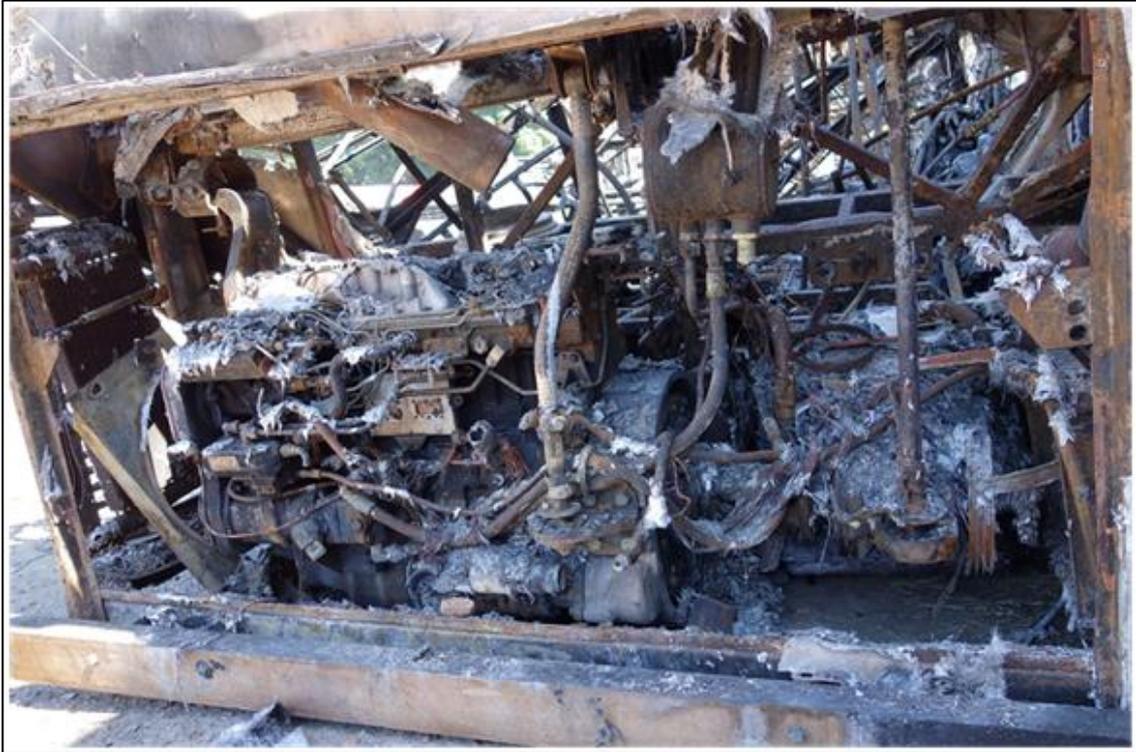
General damage to engine. The engine was substantially damaged with many engine parts partially or completely melted (see *Photograph 5*).

Photograph 5: Engine compartment

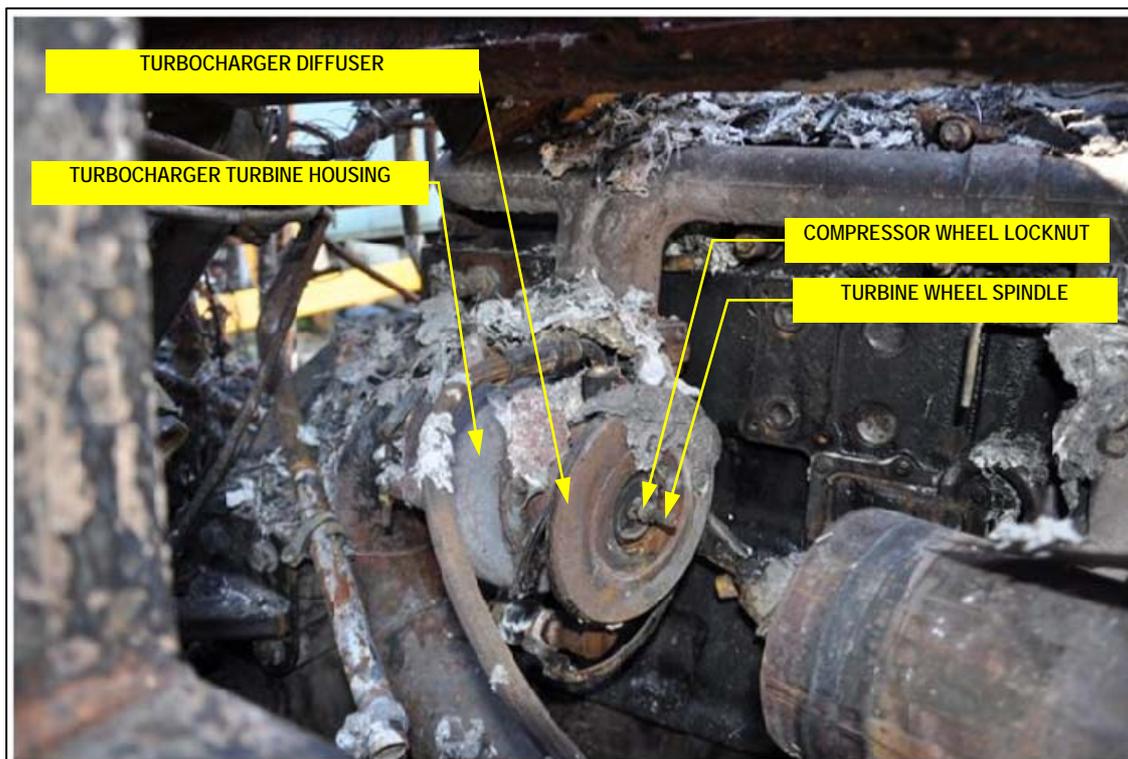
An inspection of the turbocharger revealed that the compressor housing had completely melted with the remains still visible on and below the diffuser. The turbine wheel spindle was still in-situ with the compressor wheel locknut still in place; however, the compressor wheel was missing (see *Photograph 7*). It was noted that the turbine wheel spindle could still be easily rotated by hand, indicating that the oil flow to the turbocharger did not fail, since otherwise, the bearings would have seized.

Photograph 7: Fire damaged turbocharger

There is no evidence of a bearing failure initiating this fire. Instead, it is probable that the compressor wheel disintegrated causing damage to the casing with consequent oil leakage from the turbocharger.

When the bus was inspected after the incident, it was found that the turbocharger compressor wheel and the surrounding casing were missing. On the basis of this evidence, it is considered most probable that the loss of power was the result of disintegration of the compressor wheel. This would have been followed by oil leakage due to consequent damage to the housing. The turbocharger would have been operating at a temperature sufficiently high to ignite the oil.

It is probable that the fire was caused by the turbocharger compressor wheel initially disintegrating, causing damage to the turbocharger casing with consequent oil leakage from the turbocharger. Oil then contacted a hot engine part and ignited. As the engine continued to run, oil was pumped out at a high rate to fuel the fire, which ultimately engulfed the entire bus.

If the bus had been equipped with effective fire detection and suppression systems, it is probable that early detection and suppression of the initial fire would have prevented the development of the fire.
