Office of Transport Safety Investigations

TECHNICAL INSPECTION FINDINGS

MAKEHAM'S COACHES BUS FIRE

4 JANUARY 2013

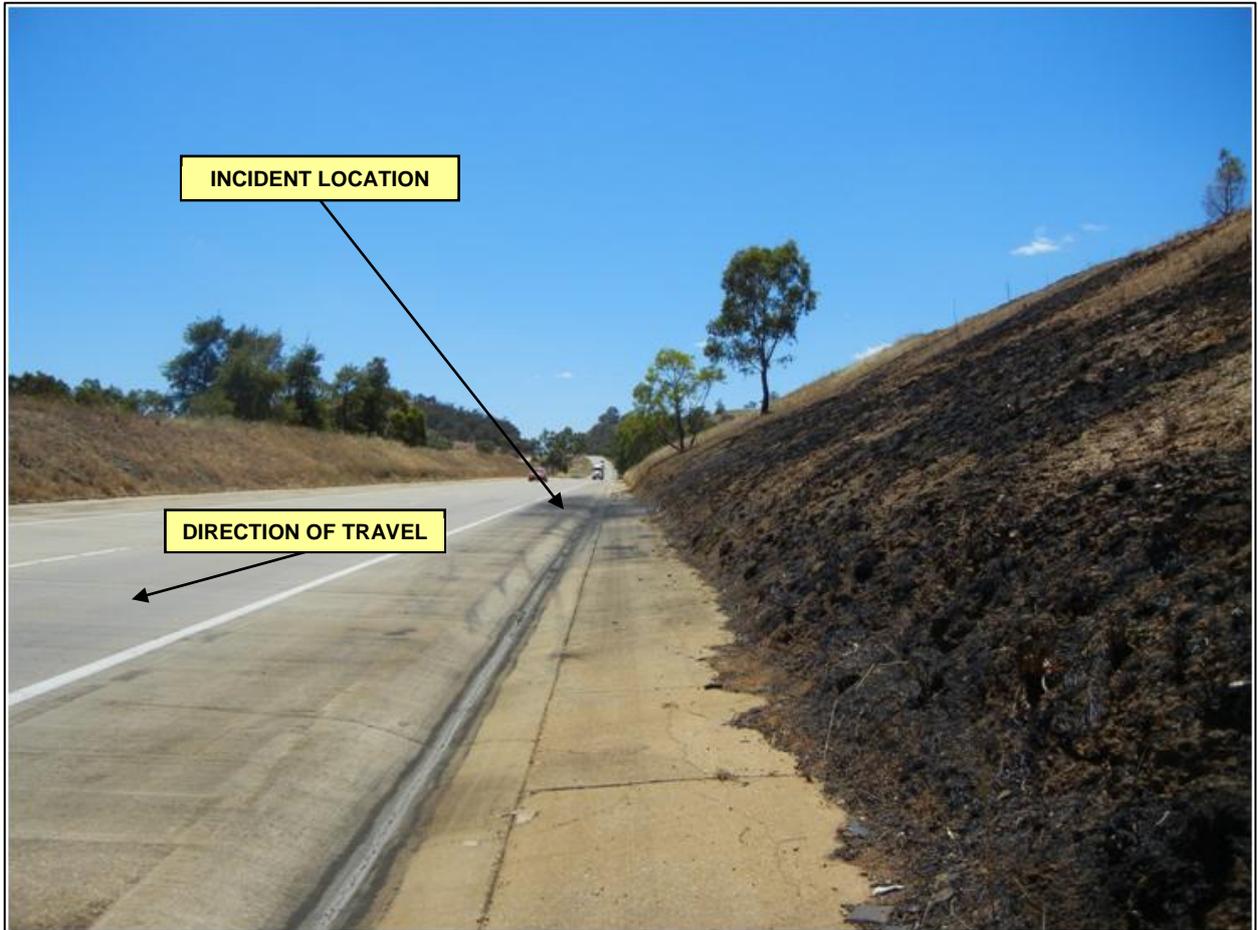
Photograph 1: Hume Highway incident location

The driver said he slowed the bus as quickly and safely as possible, decided on a suitable place to pull over, and pulled to the side of the Hume Highway where it was a lot wider and safer (see *Photograph 1*). He shut the engine down and noticed a fire alarm warning light illuminated on the dashboard.

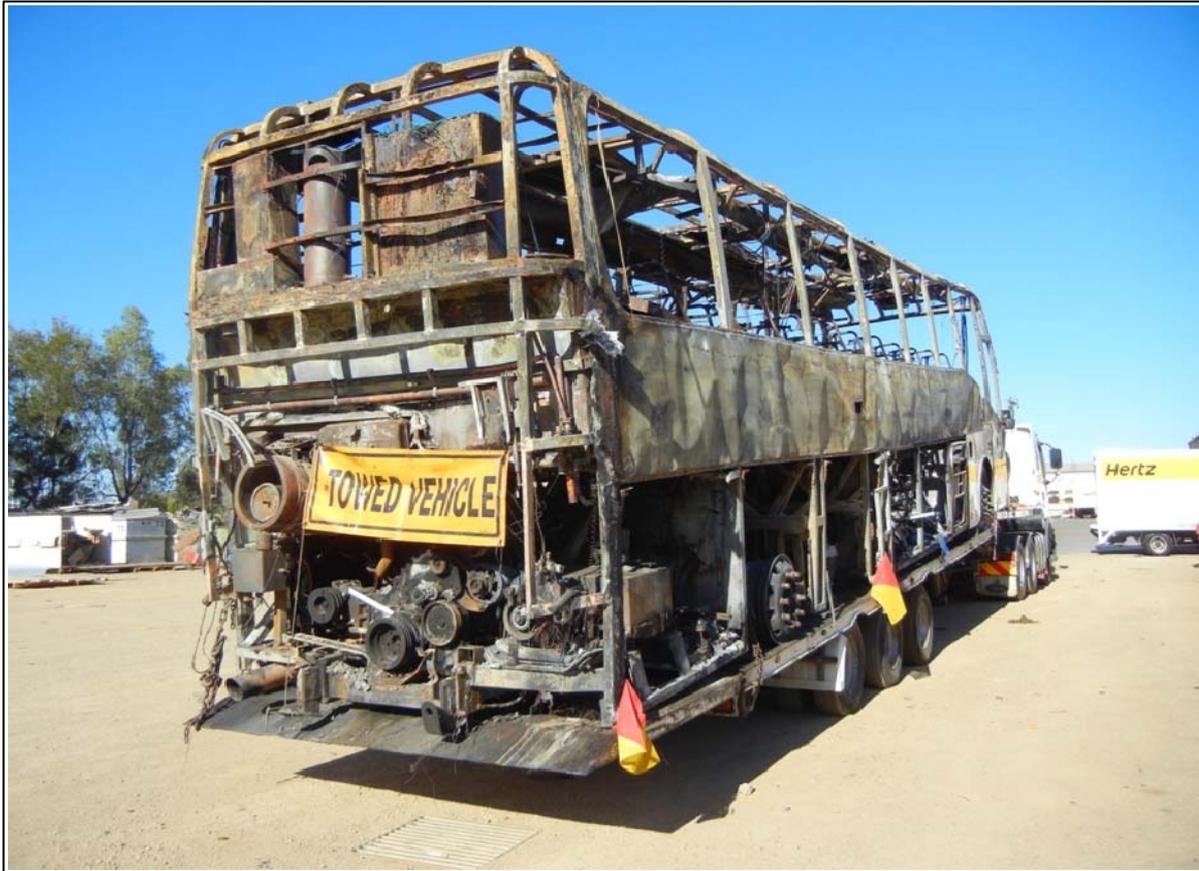
Photograph 2: Post-fire condition of bus

The extent of damage to the bus can be seen in *Photograph 2*.

The fire intensity was such that most of the combustible components of the bus were damaged beyond repair. The front right tyre and wheel, and some surrounding panels, were the only areas that remained relatively intact.

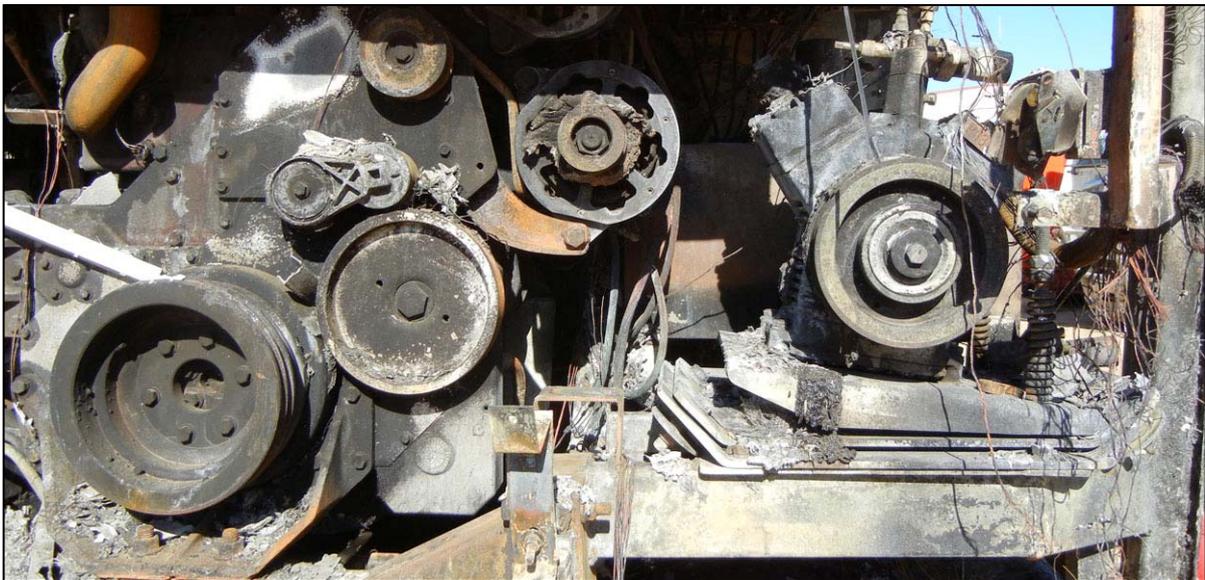
Photograph 3: Engine compartment

General damage to engine. The engine was substantially damaged with many parts partially or completely burnt or melted (see *Photograph 3*). The insulation was burnt off the electrical wiring and the batteries were burnt and melted. All plastic and rubberised material and some alloy parts were also completely or partially melted.

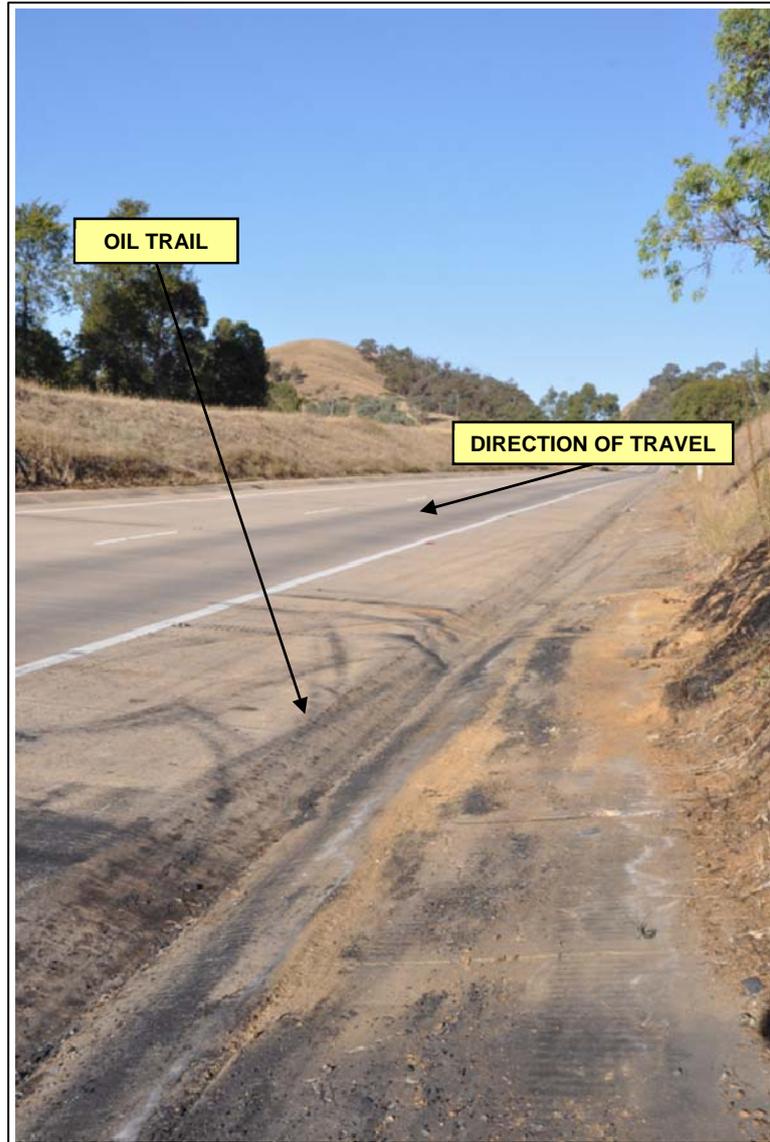
Photograph 4: Oil trail

A site inspection on the Hume Highway two days after the fire showed an oil trail for at least 100 metres leading to where the bus eventually stopped (see *Photograph 4*). The oil trail was in three separate lines of a continuous series of droplets, increasing in size as the bus slowed and eventually stopped. The oil trail ended at the centre rear of the engine compartment and followed the probable line of motion as the bus moved from the left lane into the breakdown lane of the highway. It is likely that this oil was leaking from an oil supply line, but not at such a rate as to cause engine failure, since the engine continued to run even as fire was consuming the flammable materials of the engine compartment.

The evidence above indicates the probability that the fire was initiated by leaking oil coming into contact with a hot surface in the engine compartment.

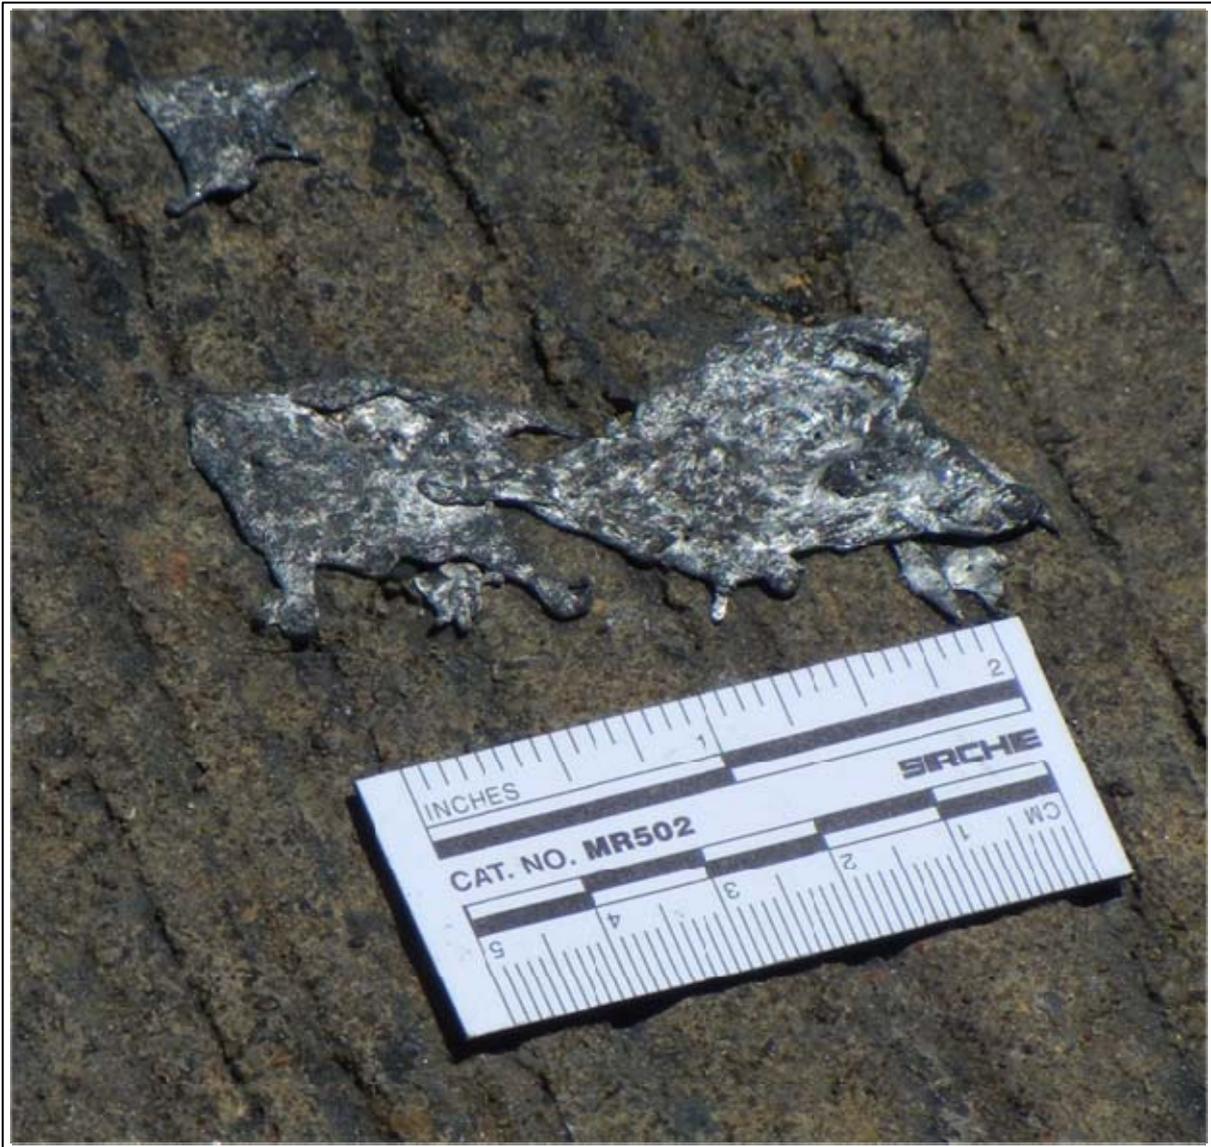
Photograph 5: Solidified molten alloy on road

Also noticeable along the path of the bus was a trail of solidified melted alloy (see *Photograph 5*). These drips were visible for over 300 metres leading to where the bus eventually stopped. At the site where the bus stopped were larger amounts of the solidified melted alloy which came from alloy engine parts (see *Photograph 6*). This confirms that the temperature in the engine compartment was high for a considerable time before the bus stopped and that the fire had initiated well before the start of the alloy trail.

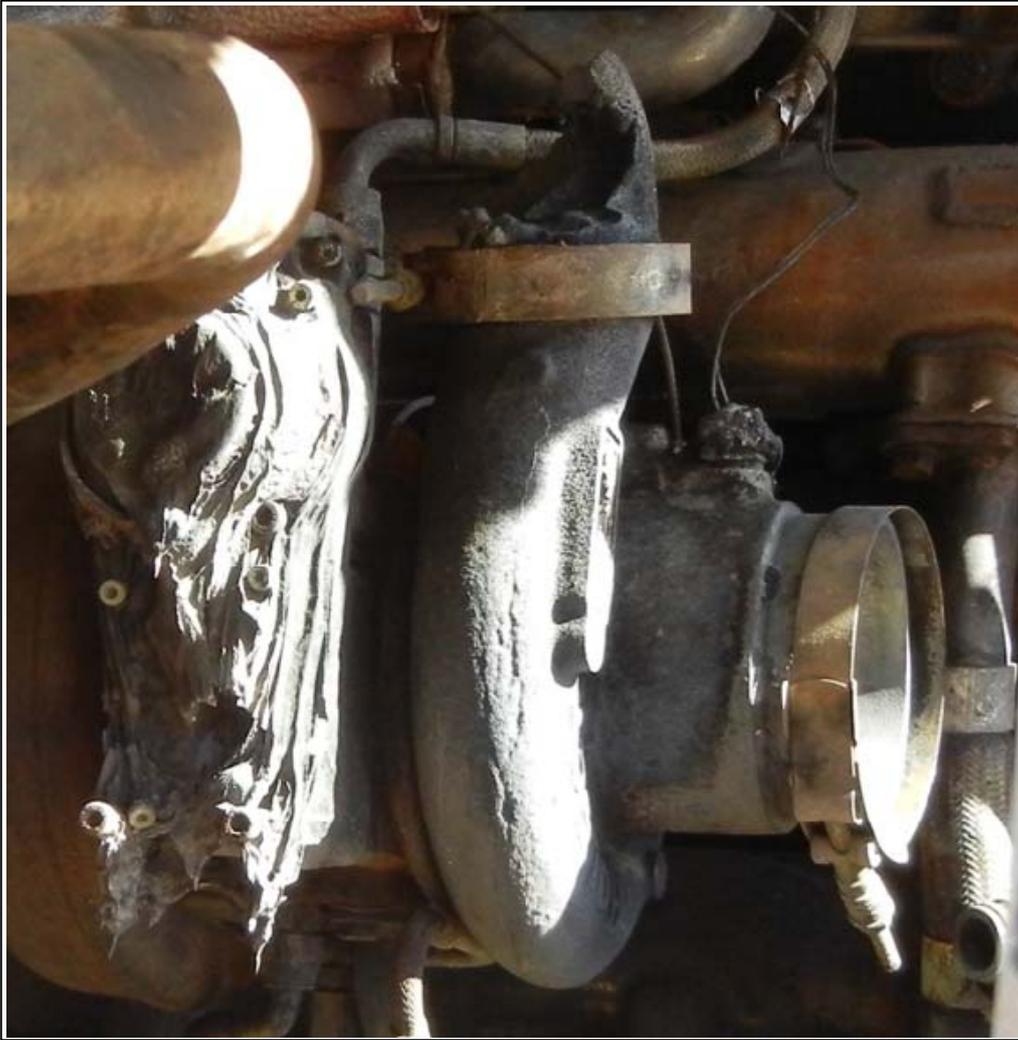
Photograph 6: Heat damaged alloy turbocharger

The turbocharger was another area which was closely examined. There was no visible evidence that the turbocharger was damaged before the fire.
