Office of Transport Safety Investigations

## BUS INCIDENT FACTUAL FINDINGS

### FIRE INVOLVING STATE TRANSIT AUTHORITY (STA) BUS MO 1189

14 February 2013

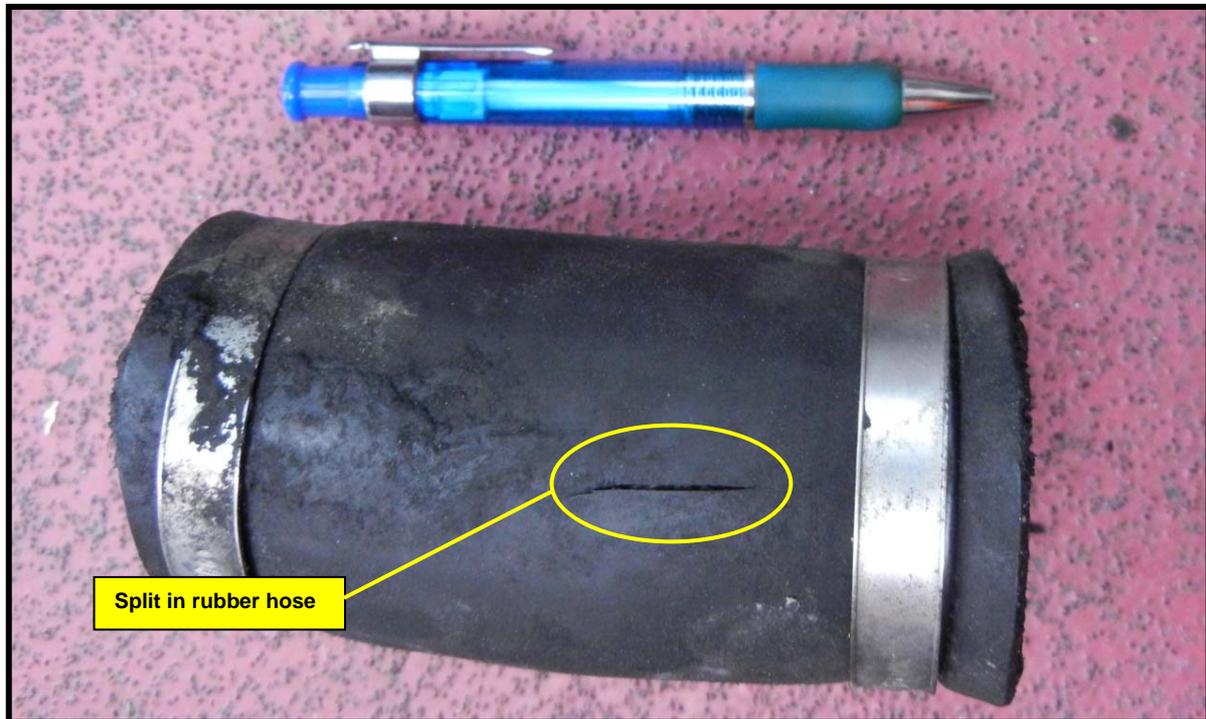
After Police and Fire and Rescue units departed, STA mechanics, who had been dispatched from the Ryde Depot, inspected the bus and found a rubber connecting hose on the main coolant supply return line had split (see *Photograph 1*). This hose was replaced, the coolant topped up, and the bus driven back to the Depot.

**Photograph 1: Split in connecting hose**

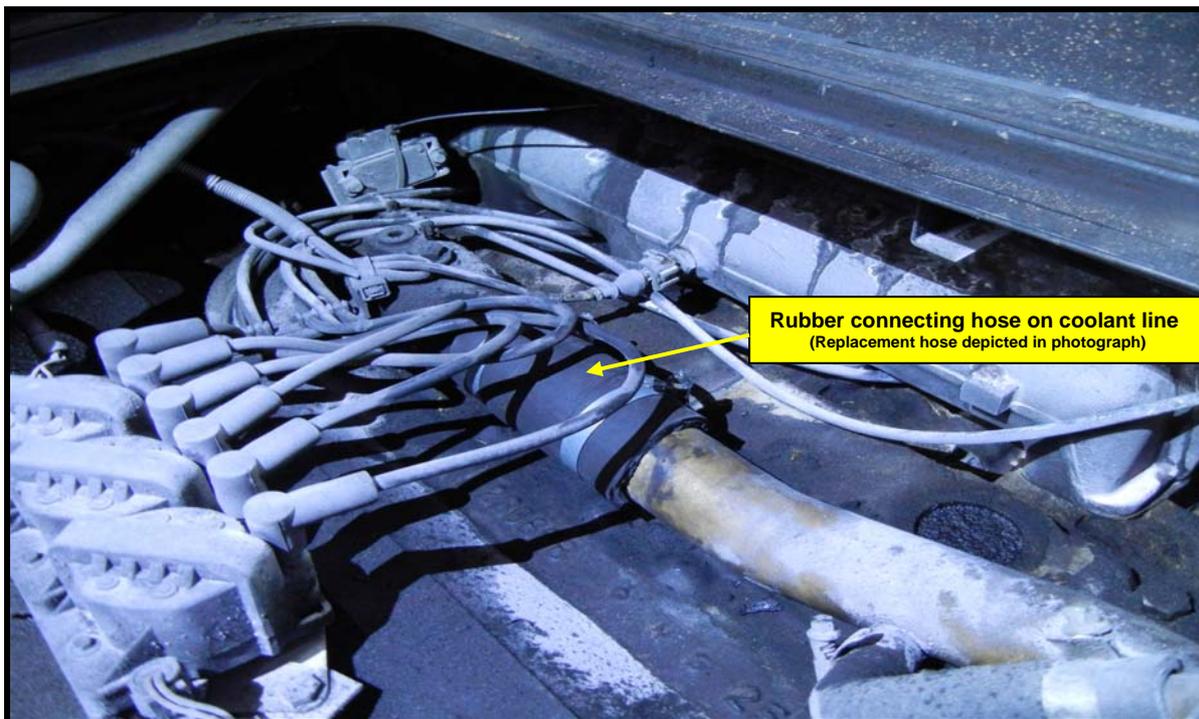
OTSI and STA investigators inspected the bus on its return to Ryde Depot. The inspection confirmed the fire was due to the split rubber connection hose on the main coolant return line which ran across the top of the engine block (see *Photograph 2*).<sup>2</sup> This allowed coolant to spray over the top and side of the engine and onto the hot exhaust manifold located on the near of the engine. The coolant used in the bus cooling system consists of a mixture of 50% Glycol and 50% water and circulates under an operating pressure of 70kPa.

**Photograph 2: Coolant connection hose**

The split in the connecting hose was situated on the underside of the hose which is separated from the top of the engine block by only a small gap. Consequently, this part of the hose is not visible from direct observation especially from the service hatches in the bus floor above, so defects or damage in this area will not be detected during routine visual inspections. The difficulty associated with inspecting this hose is well illustrated in *Photograph 2*.

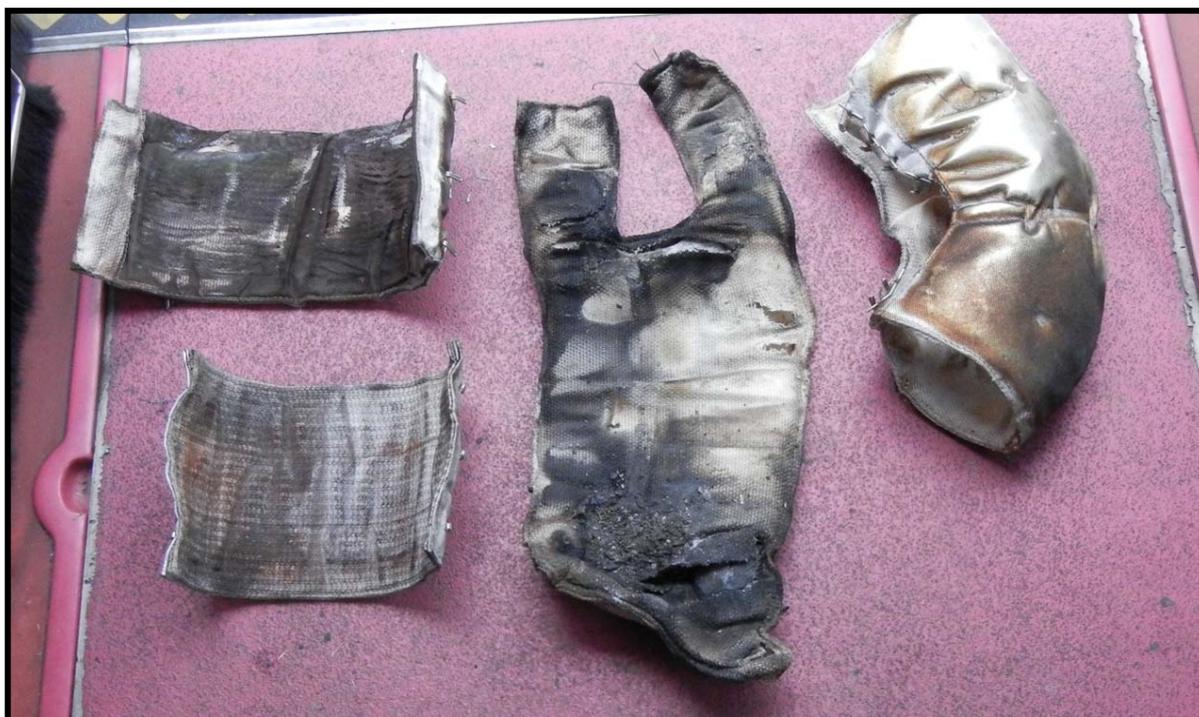
The lagging removed from the exhaust manifold was saturated with coolant and scorched in the area where it had been in contact with the manifold joining flanges (see *Photograph 3*). A section of lagging had ignited and burnt (see *Photograph 4*). Fire damage was restricted to the lagging on the exhaust manifold.

**Photograph 3: Exhaust lagging**

An analysis of the characteristics of ethylene glycol-based coolants indicates that under certain conditions coolant can ignite.<sup>3</sup> This occurs when the water content of the coolant evaporates, leaving pooling of the residual ethylene glycol. It can also ignite in circumstances where the glycol impregnates other materials such as lagging or shielding and is then exposed to the combination of a heat source and air.

Mercedes-Benz was approached seeking approval to reduce the amount of glycol in the coolant in this model bus. The manufacturer's permission is required for any deviation from their specification so that existing service arrangements and warranties on the buses are not affected. Subsequently, Mercedes-Benz confirmed the availability of a suitable non glycol-based coolant. STA intends to progressively introduce this product into its fleet of Mercedes O405NH buses.

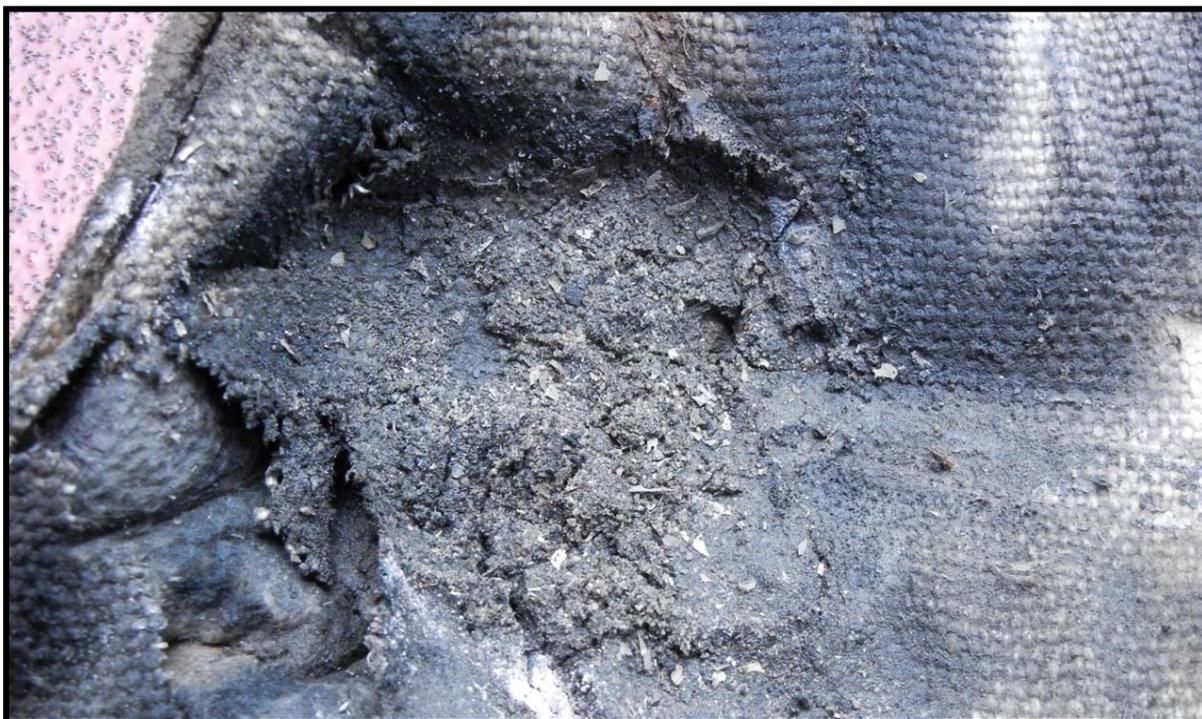
**Photograph 4: Burnt lagging**
