Office of Transport Safety Investigations

TECHNICAL INSPECTION FINDINGS

FIRE ON APPLE CITY COACHES BUS 3503MO

1 NOVEMBER 2013

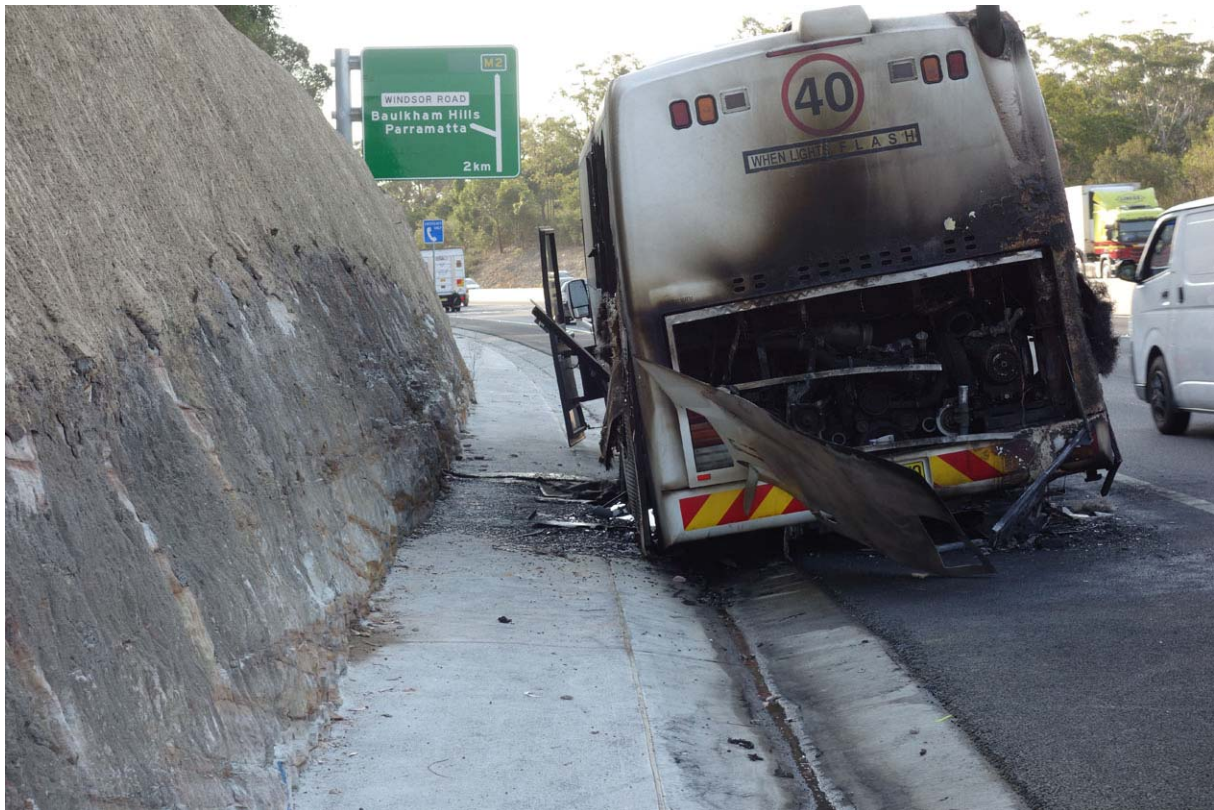
Photograph 1: Breakdown lane and rock face

At the point where the bus came to a stop, the westbound roadway comprised two general traffic lanes bounded by a breakdown lane on the left and a dedicated bus lane on the right. At the left of the breakdown lane was a stabilised rock face as shown in *Photograph 1*. There was sufficient room between the bus and the rock face for the passengers to be evacuated and to move forward of the bus to a safe

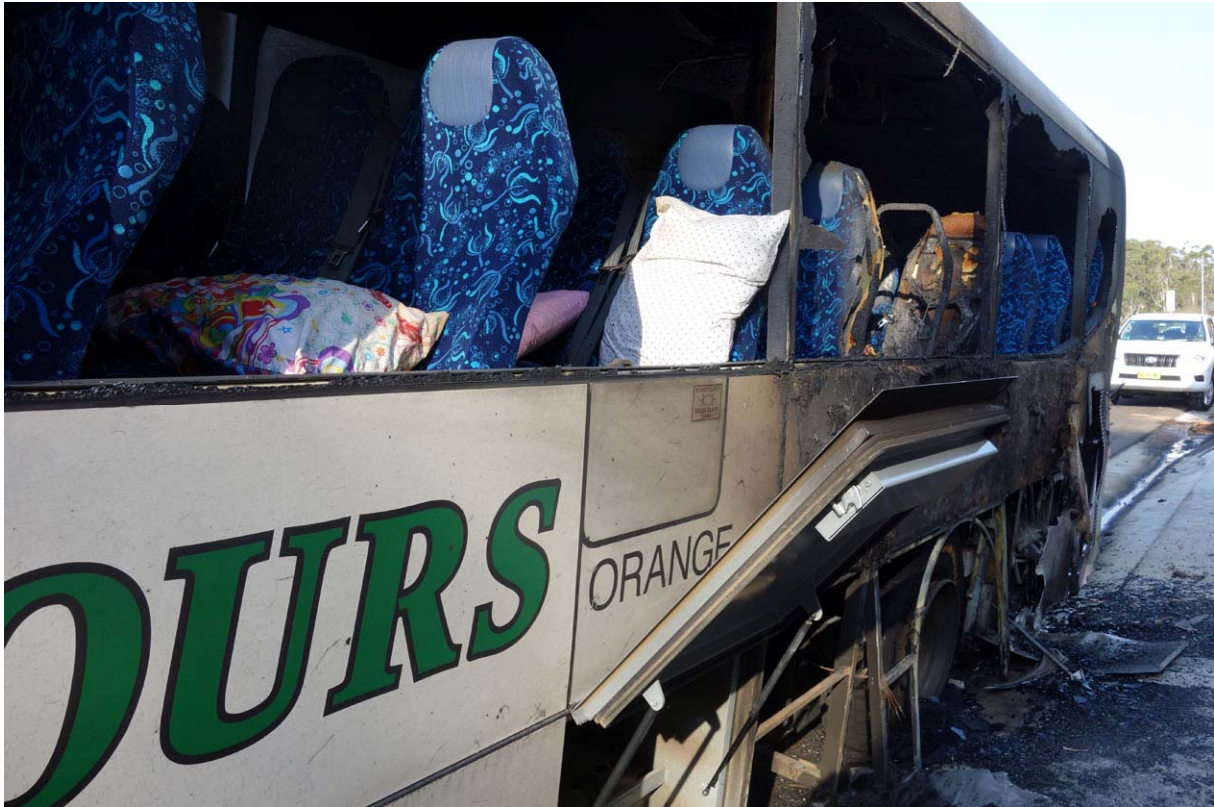
Photograph 2: Damage to left rear of bus

The bus was examined at the scene of the incident. The body had been extensively damaged by the fire, with the greatest damage being to the sides of the bus from the rear axle to the back panel, as shown in *Photograph 2* below.

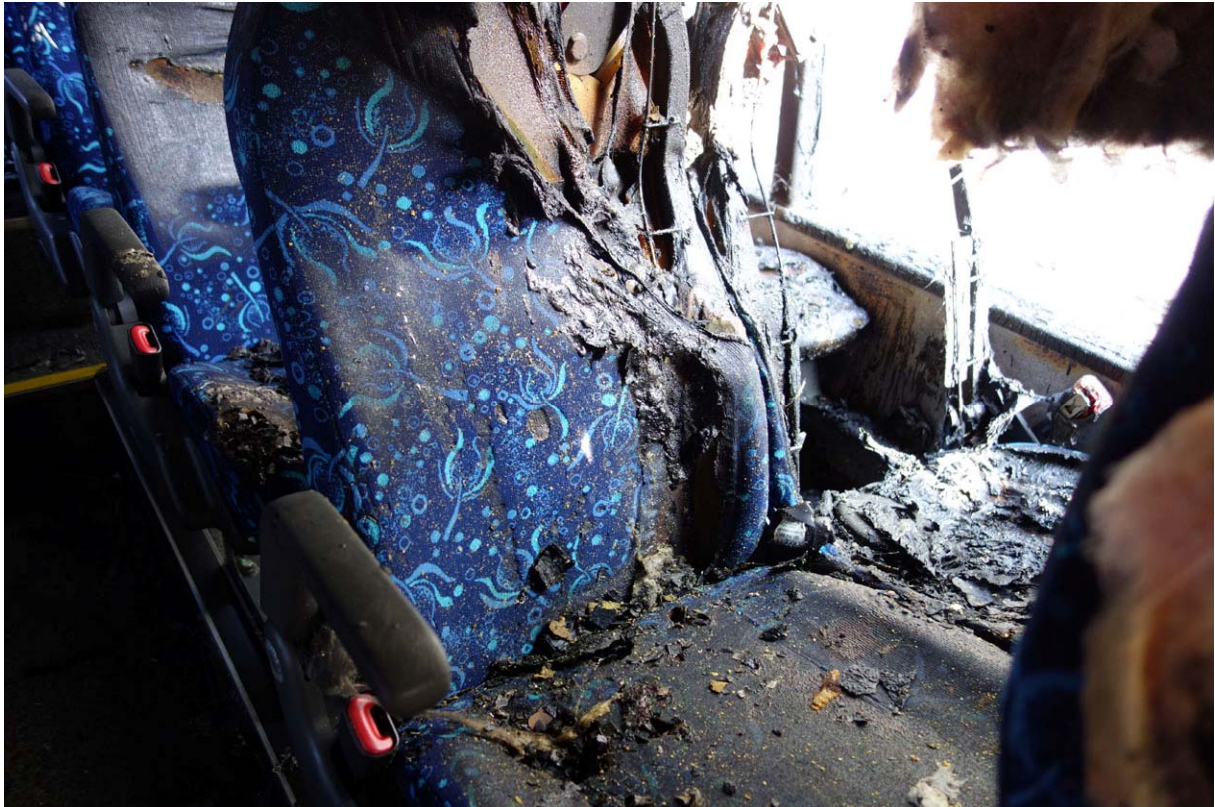
Photograph 3: Damage to rear seats

The interior of the bus was also extensively heat affected, with significant damage to the seats at the rear. The damage to the seats was greatest near the left rear windows (see *Photograph 3*), suggesting that the fire had been transmitted to the interior of the bus through the windows rather than through the floor which had suffered relatively little damage.

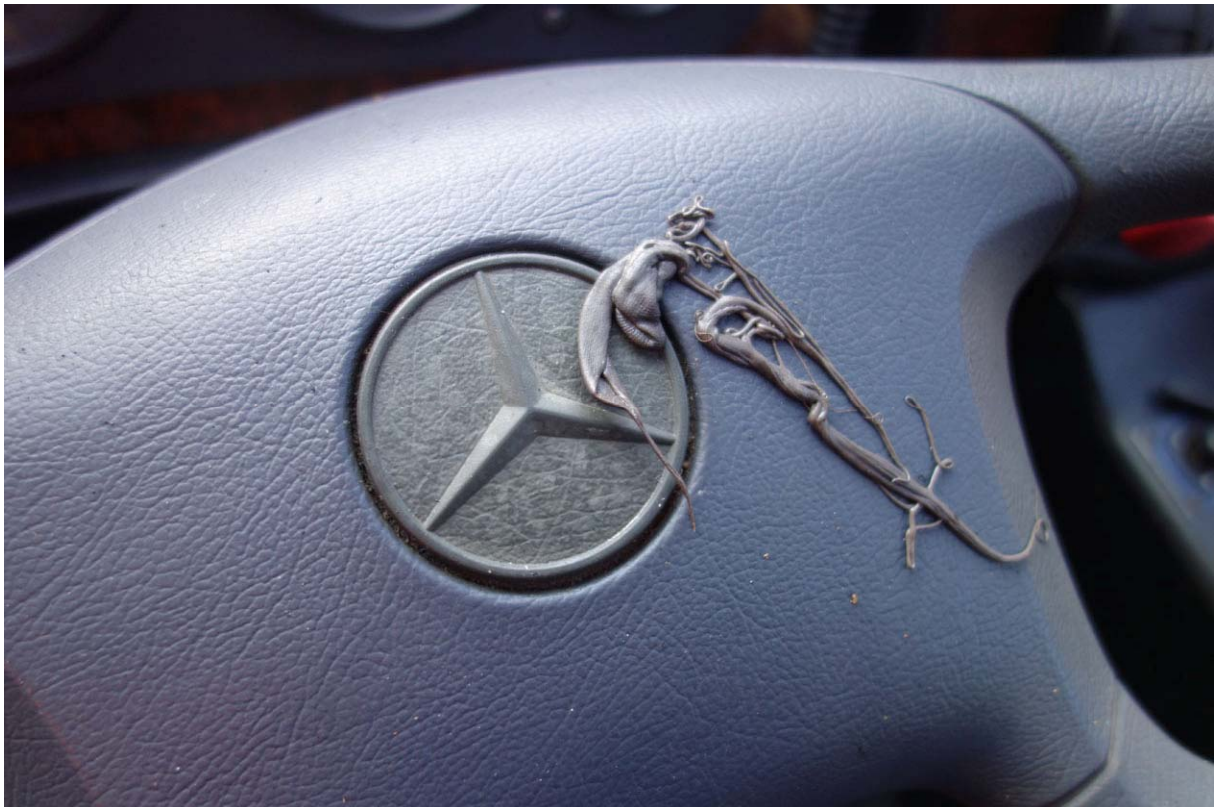
Photograph 4: Molten plastic from driver's blind

Although the seats toward the front of the bus were not burned, the driver's windscreen blind had melted in places and dripped onto the steering wheel (see *Photograph 4*) indicating that a high temperature had been present throughout the bus.

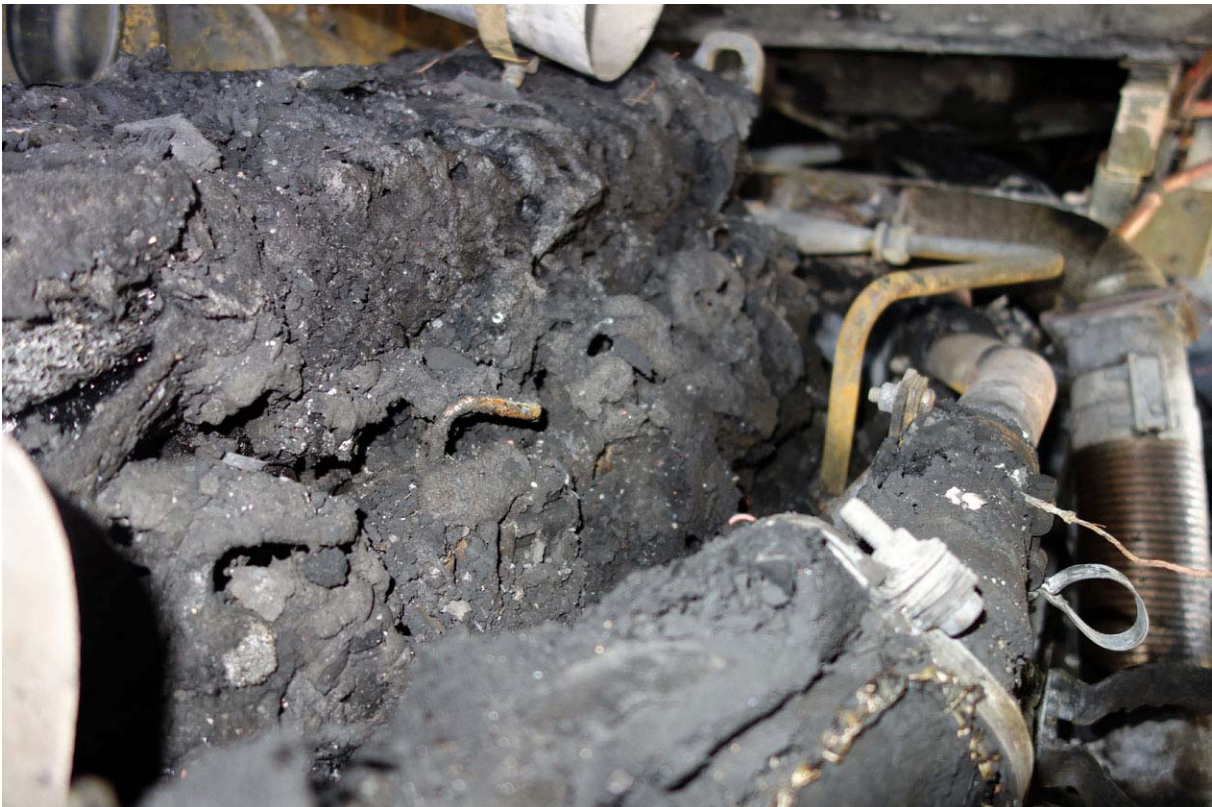
Photograph 5: Damage to right side of engine

The bus's rear-mounted engine had been destroyed by the fire, with most flammable materials totally consumed and alloy components severely burnt and charred. The most severe damage was on the right of the motor, when viewed from the rear, and involved the cylinder head and fuel injection system. The extent of this damage can be seen in *Photograph 5*.

It is significant that alloy components in this area of maximum damage showed evidence of burning rather than melting, suggesting that they were directly involved in the fire, rather than having been affected by high temperatures from a heat source that did not directly involve them. In contrast, a number of components on the other side of the engine were melted, as seen in *Photograph 6*.

The high level of damage on the right side of the engine suggests that this was the area in which the fire commenced. While the location of the turbocharger and exhaust on the left side of the engine reduces the likelihood of either of these

The location of the greatest damage around the cylinder head and fuel injection system suggests the probability that the fire involved diesel fuel. This is supported by the report that flaming liquid was seen on the roadway beneath the bus and running into the gutter. It seems likely that the fire was started by leaking diesel fuel coming into contact with a hot surface in the engine compartment. Because of the fire damage to the engine, the cause of the fuel leak could not be established.

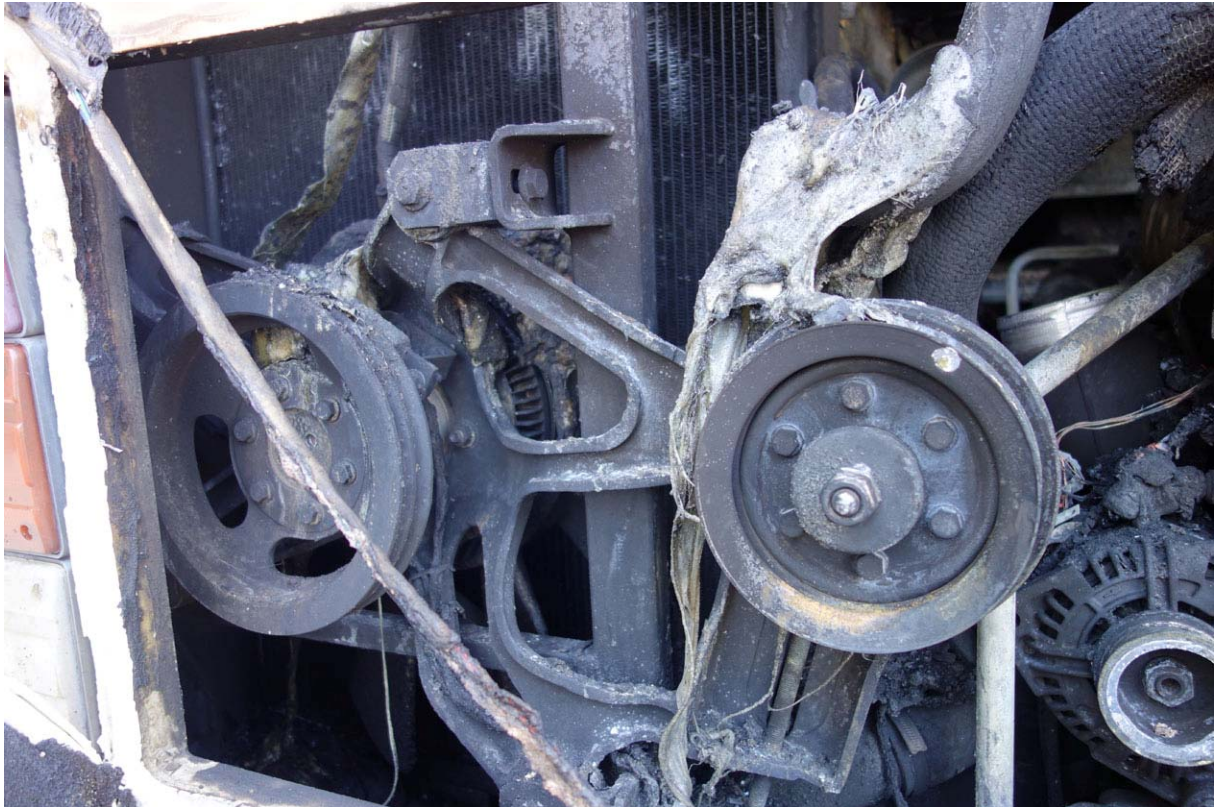
Photograph 6: Melting of components on left of engine

The temperature reached as a result of burning diesel fuel in an enclosed space would have been sufficient for the fire to spread to other combustible materials in the engine compartment, and to result in the level of damage seen in *Photographs 5 & 6*. The development of the fire would also have been facilitated by the fact that the bus continued to operate after the fire commenced, until the driver was made aware of the presence of smoke in the rear of the bus and was able to steer to the breakdown lane and to stop.

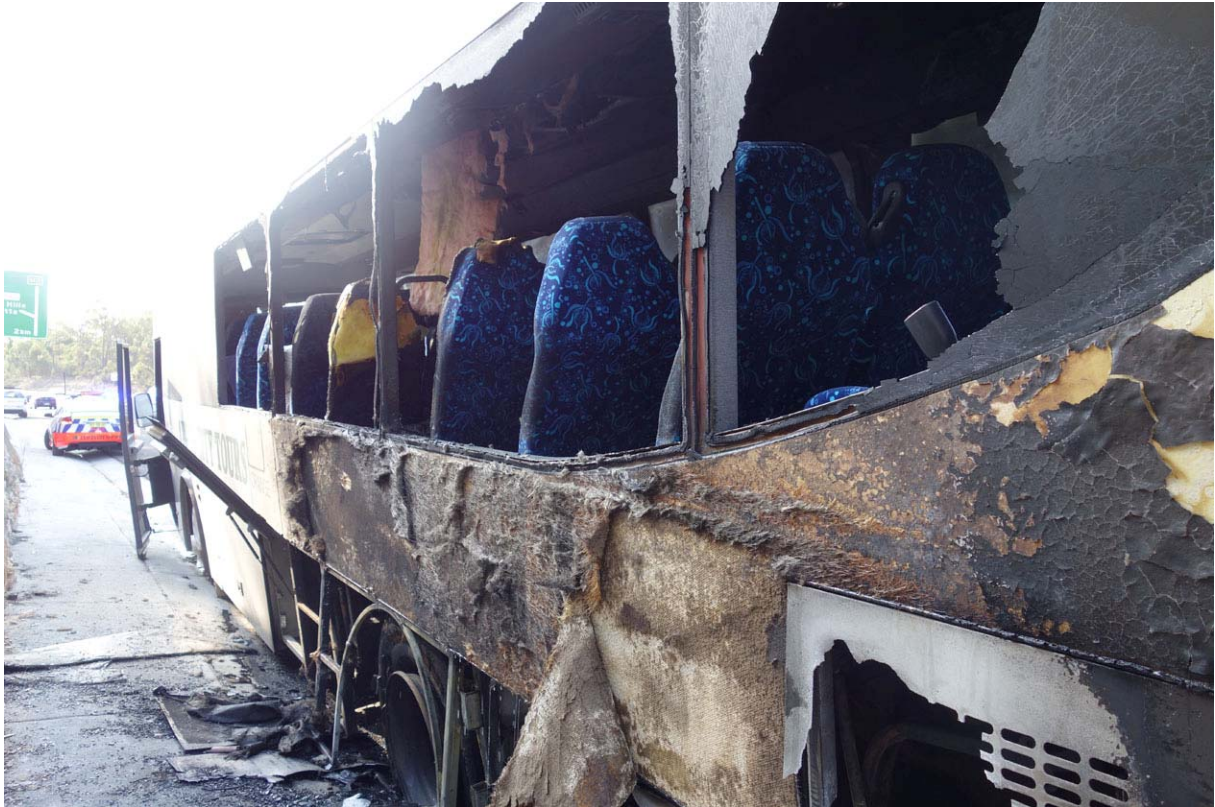
Photograph 7: Fire damage to side of bus

The damage to the rear tyres and to the sides of the bus, as seen in *Photograph 7*, indicate that the fire was spread to the left hand side of the rear axle by burning diesel fuel running down the slope of the roadway. The flames would then have travelled up the side of the bus causing the rear side windows to shatter, at which time the fire could enter the passenger space and involve the interior linings and seats before being extinguished. There was no evidence of the fire entering the passenger space of the bus through the plywood flooring.
