Office of Transport Safety Investigations

TECHNICAL INSPECTION FINDINGS

LEG INJURIES ON ARTICULATED BUSES

NOWRA COACHES

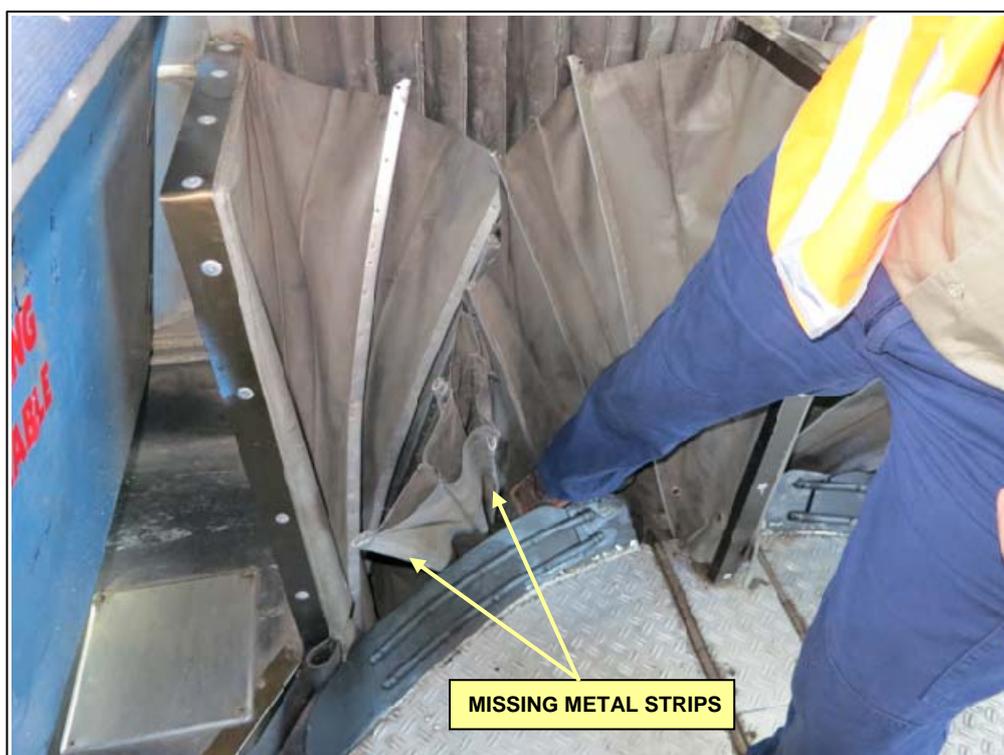
Photograph 1: Turntable area where schoolboy's leg was caught

Incident 1. At approximately 1525 on 20 August 2013, a seven-year old schoolboy was travelling on a Nowra Coaches bus when his leg fell into a gap between the flexible screening and the metal turntable section in the middle of the bus (see *Photograph 1*). He was standing on the turntable section at the time of the incident.

The inspection found that on 2426 MO, the bus where the schoolboy's leg fell into the well of the turntable area, the flexible wall area was damaged and missing two of the metal strips that increase the rigidity of the wall (see *Photograph 1*). There was also damage to the metal guide plate at the base of the screen; it was bent outwards which would make it easier for the screen to push over it. It could not be determined if this damage was pre-existing or the result of the incident.

- Clearly visible 'CAUTION NO STANDING ON TURN TABLE' signs have been posted to discourage passengers from travelling in the turntable area.
- All seating has been removed from the turntable area.
- Seats that faced the turntable area have been reversed to face away from the turntable.

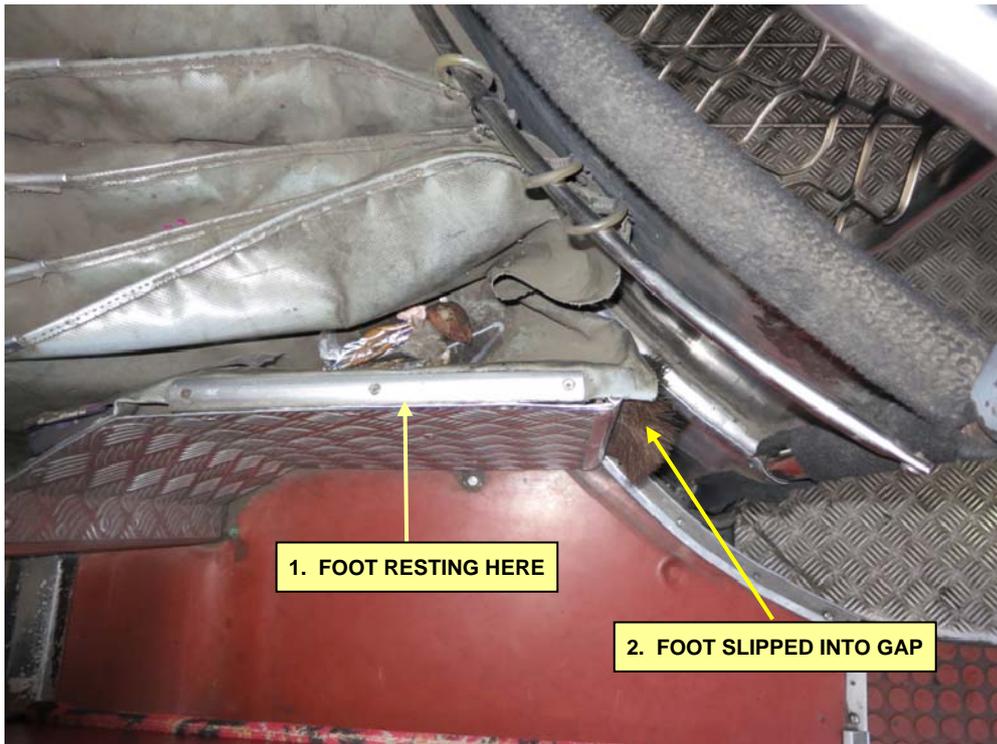
Photograph 2: Top view of screen area

The schoolgirl, who was seated in the rear-facing seats closest to the turntable was resting her foot on the top edge of a checker-plate screen which acts as a barrier to the side of the turntable (see *Photographs 2 and 3*). As the bus turned from Clipper Road into Kameruka Crescent (see also *Figure 1*) her foot slipped off into a gap which allows for rotation of the turntable. Her right foot became trapped between the moving parts of this mechanism. When the bus completed the turn her foot was released. The bus driver was not alerted to or aware that the incident occurred. The company was notified of the incident by the girl's parent later that afternoon. She sustained bruising and swelling to her right foot and was transported to hospital by her parents for further examination.

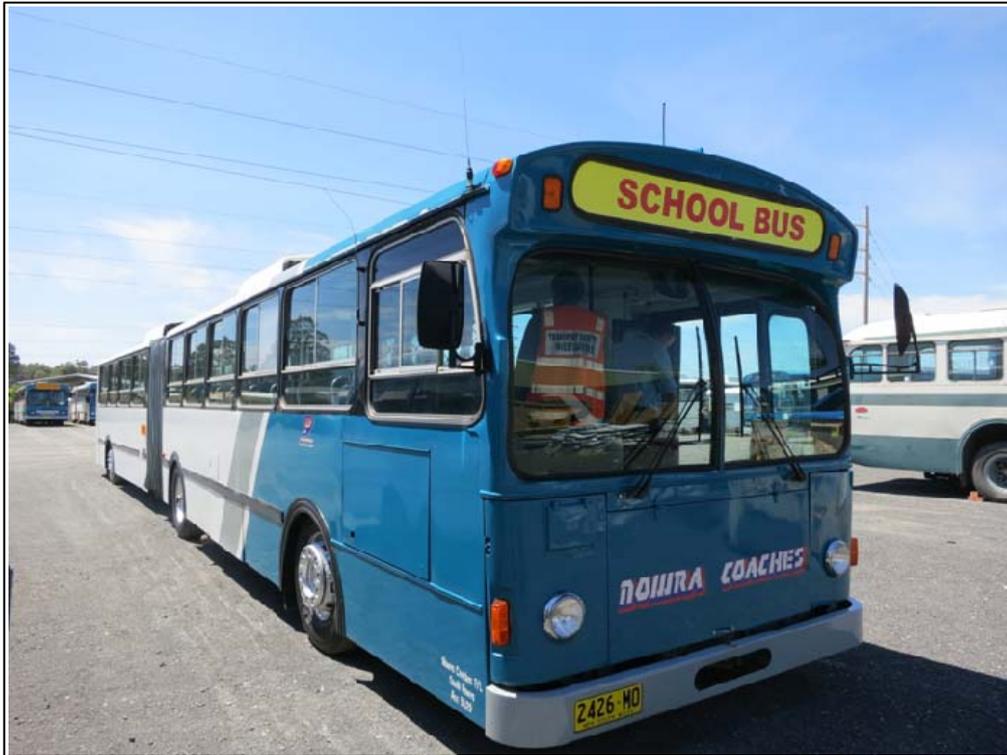
Photograph 4: 2426 MO

Both articulated buses were built in the early 1980s with bodies made by the Pressed Metal Corporation (PMC). The first bus was registered as 2426 MO (see *Photograph 4*). It has a MAN SG220 model chassis and first entered service in July 1983. The second bus was registered as 5155 MO (see *Photograph 5*). It has a Mercedes Benz O350G model chassis and first entered service in March 1984. In NSW there are approximately 270 articulated buses in service. Most of these are of a more modern design with improved safety around the turntable area. However, 1980s models are still in use in regional areas and there are approximately 23 still operating in NSW.

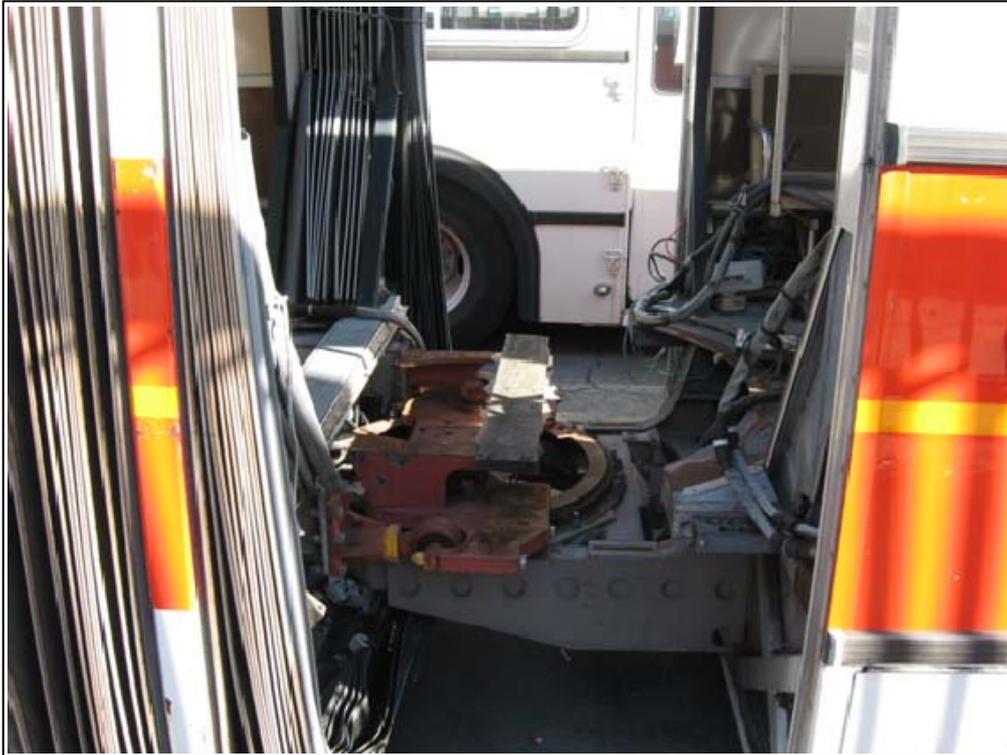
Photograph 6: Articulation joint (floor removed)

Articulated buses, like the two involved in these incidents, are a single-deck design. There are two rigid sections with a pivoting joint between the sections (see *Photograph 6*). A flexible polymer concertina wall arrangement joins the two sections

to allow for differential wall movement on each side of the bus when cornering. The area above the joint is covered by a stainless steel checker plate. The flexible wall sits above the turntable and is prevented from being pushed outwards by a metal guide plate welded to the turntable.

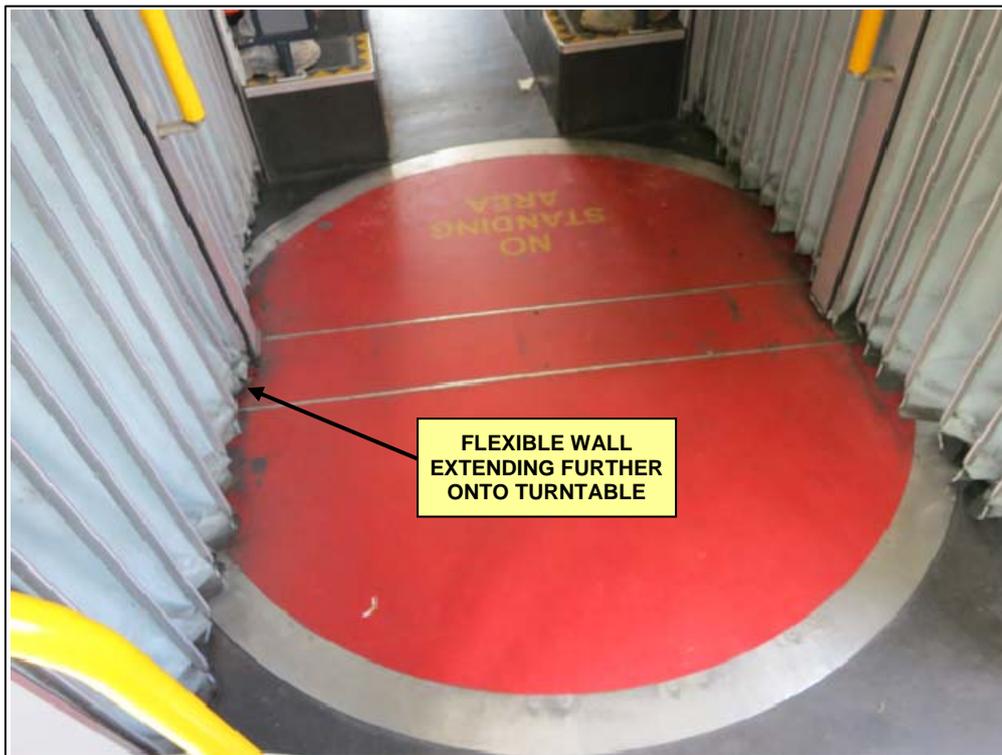
Photograph 7: Flexible wall on Volvo B12BLEA

flexible wall is also reinforced by a metal joining piece which gives rigidity to the structure (see *Photograph 7*). There is also a solid barrier between the passenger seating and the flexible wall barrier which eliminates the risk of passengers placing legs (or other body parts) into this area (see *Photograph 8*). It was determined that the likelihood of leg injuries occurring was reduced due to an improved design of the articulated area of the modern buses.

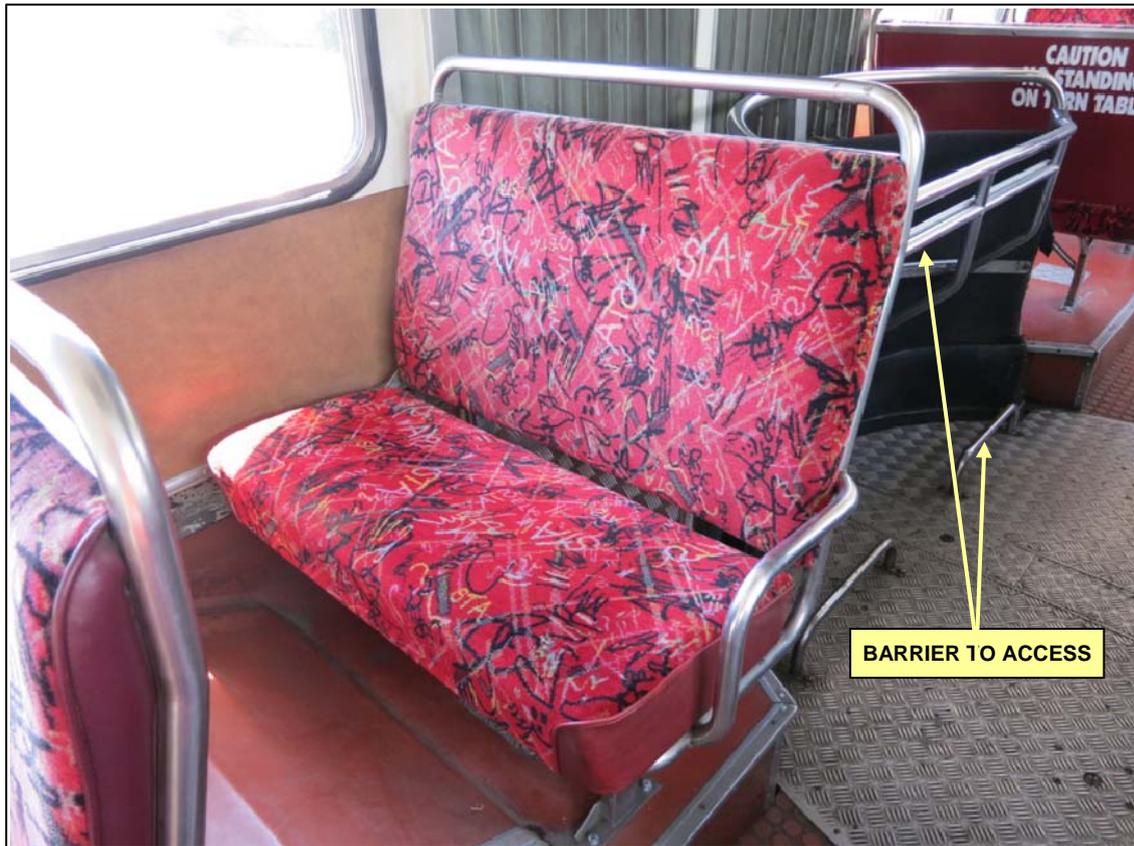
An inspection of 5515 MO, the bus where the schoolgirl's leg was trapped, found the seating had been modified since the accident in an attempt to reduce the likelihood of a recurrence (see *Photograph 9*). The seating that was facing the turntable was reversed to face away from the turntable. OTSI determined that this measure would be effective in reducing this risk as the temptation for passengers to place their leg on the barriers is removed.

Photograph 9: Seating reversed from original position.

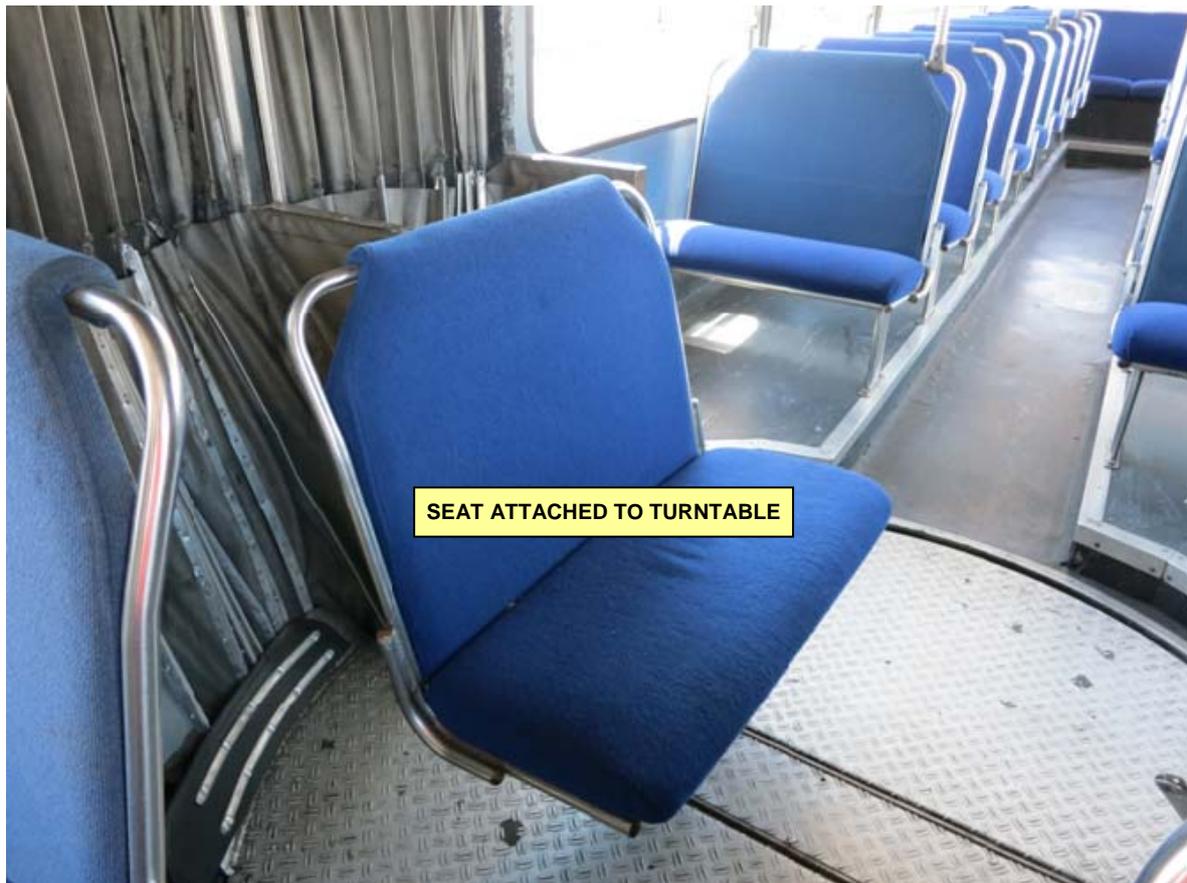
There was also a difference between the two buses in that the bag racks installed on 5515 MO provided a barrier to the flexible side wall. It was a different configuration on 2426 MO where these barriers were missing thus allowing direct contact with the flexible bus wall. One unusual aspect of 2426 MO was the placement of a seat on one side of the turntable (see *Photograph 10*). A positive aspect of this placement was that it blocked access to the flexible wall but it also presented a risk by allowing passengers to sit in this moving area. The seat was removed by Nowra Coaches following the inspection.

Photograph 10: Turntable seat.

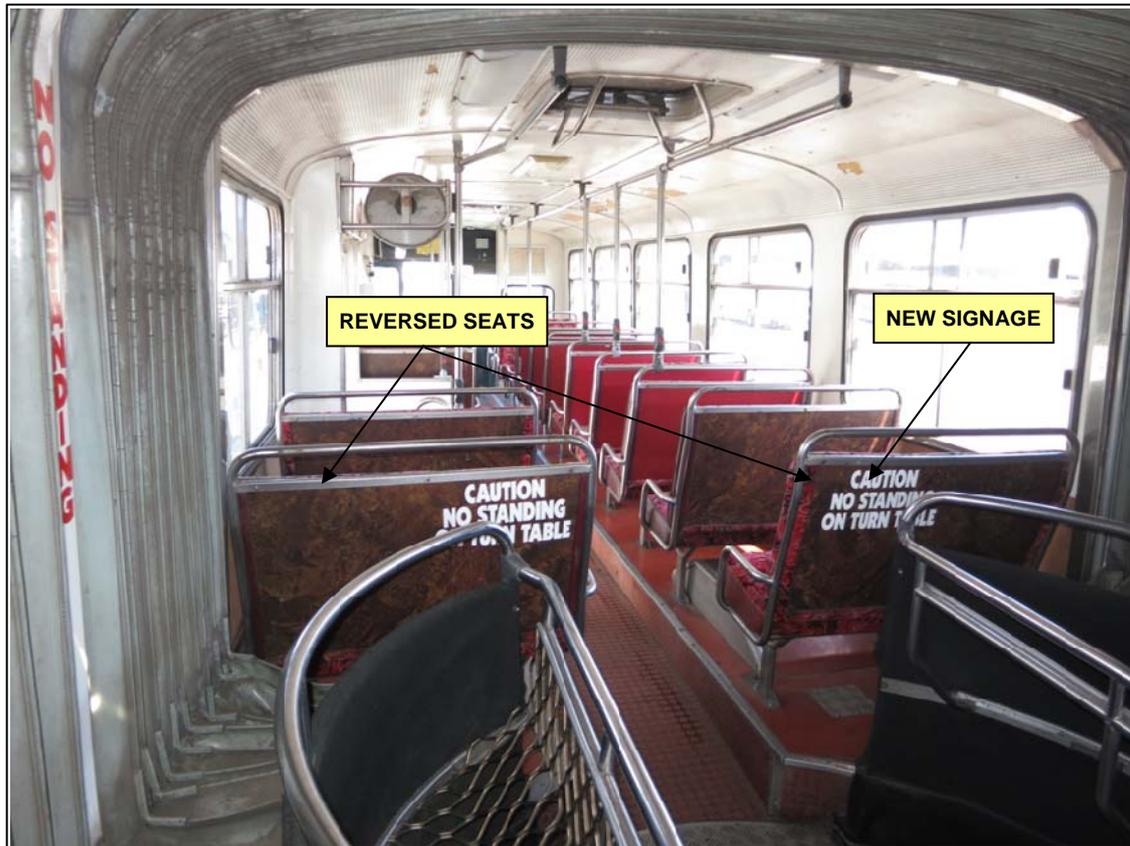
Photograph 11: Inside of 5515 MO

Another modification on both buses was new painted signage which prohibited standing in the turntable area (see *Photograph 11*). At the time of the second incident processes were in place to discourage passengers travelling in the bendy section. Signage was also being installed progressively after the first incident as part of the risk management process undertaken by the company.
