Office of Transport Safety Investigations

BUS SAFETY INVESTIGATION REPORT

UNINTENTIONAL OPENING OF BUS REAR DOORS

3 APRIL 2014

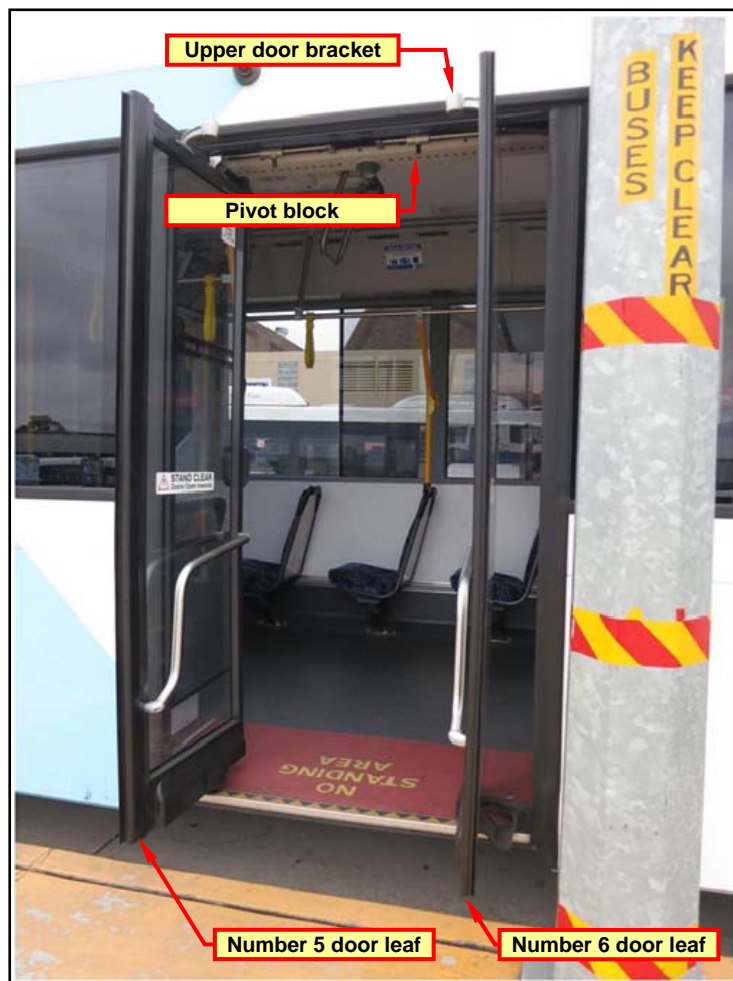
Photograph 2: Rear door opening of 2319 ST

relies on the door slide pivot block pin being retained by the upper door bracket (see *Photograph 2*). Due to the movement of the bus frame the pivot block pin needs to move vertically and laterally while it is being retained by the door bracket. The design of the FBT door system meant that there was no mechanical restriction to prevent the pin disengaging from the bracket recess. The pivot block pins were found to have disengaged from the brackets of door leaves 5 and 6.³

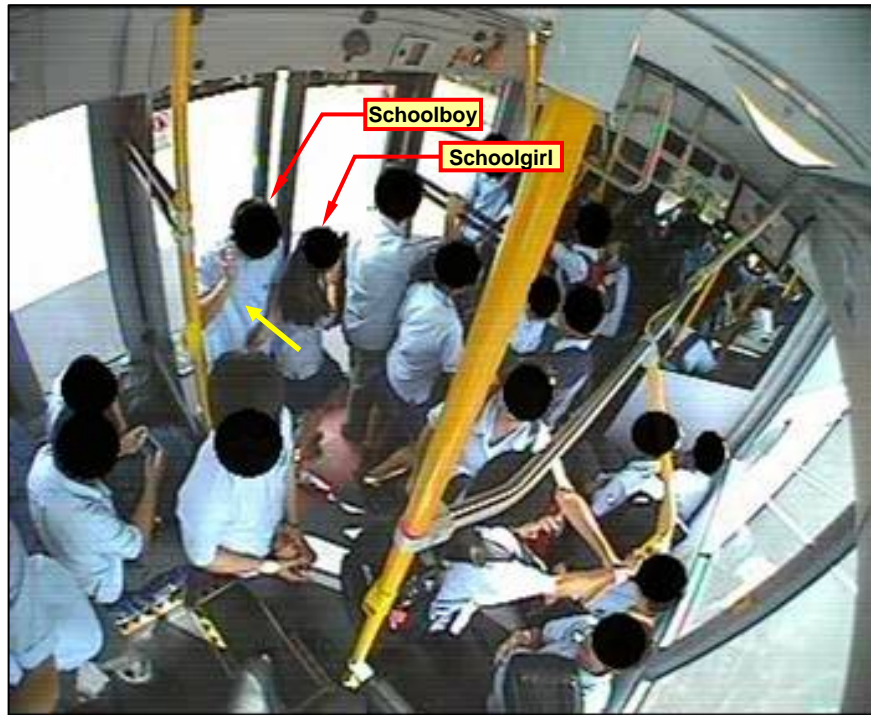
Photograph 6: Schoolgirl stumbles against schoolboy

- 1.17 As the bus was making the turn, a schoolgirl, standing in the vestibule area, stumbled and fell against a schoolboy (see *Photograph 6*). This was the initiating event. The schoolgirl was not holding on and had just finished talking with the schoolboys doing chin-ups. The schoolboy she fell against was standing unsupported facing away from the doors and talking on his mobile phone.
- 1.18 At 1509:52 both students fell against the rear doors. The initial impact from the schoolboy was mainly against number six door leaf and from the schoolgirl against number five door leaf. The combined force of the students falling against the doors caused the door slide pivot block pins to disengage from the door brackets. This meant that both doors were unrestrained and free to open. Both doors opened outwards and the two students fell out of the bus onto Buffalo Rd (see *Photograph 7*).

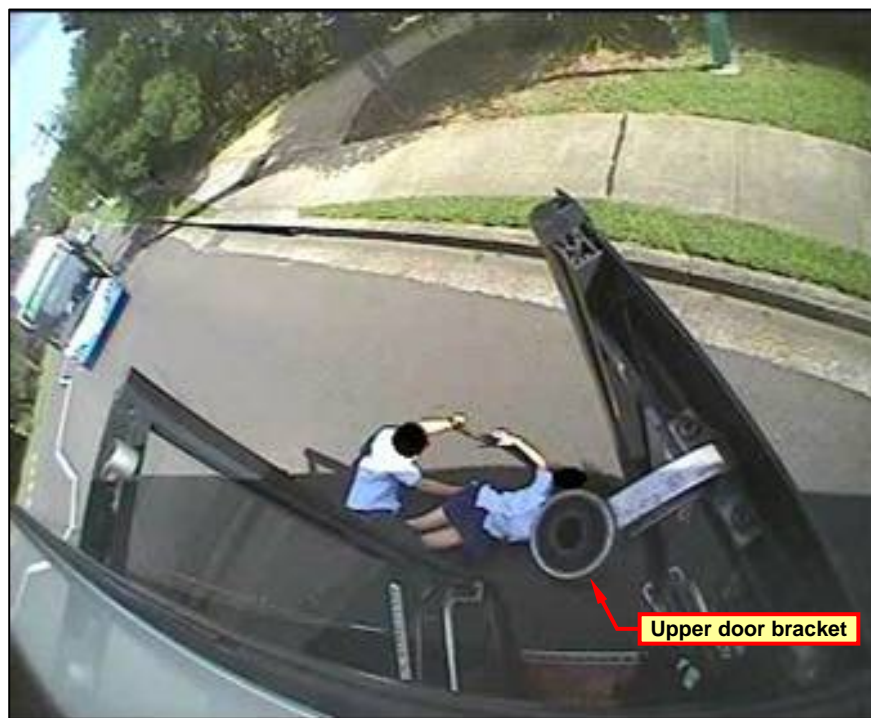
Photograph 7: Students fall out of bus (2319 ST)

- 1.19 After the students fell out of the bus, the rear doors continued to swing open and closed without restraint. The students who remained in the vestibule area attempted to hold the doors closed as the bus continued its journey. The bus at this time was travelling at approximately 31 km/h. The remaining students

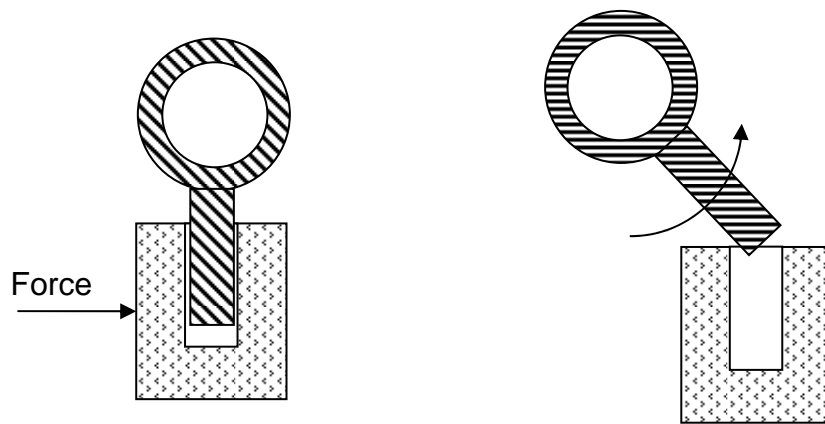
Figure 2: Pivot block pin disengaging from upper door bracket

- 2.4 The inspection of the bus by OTSI investigators on 4 April 2014 found the rear doors (door leaves 5 and 6) unrestrained and able to be moved freely. It was observed that the pivot block pins had disengaged from the door brackets (see *Figure 2 and Photograph 8*). There were no breakages of any parts and the electrical and hydraulic systems were fully operational. All warning and door alarm systems were functional.

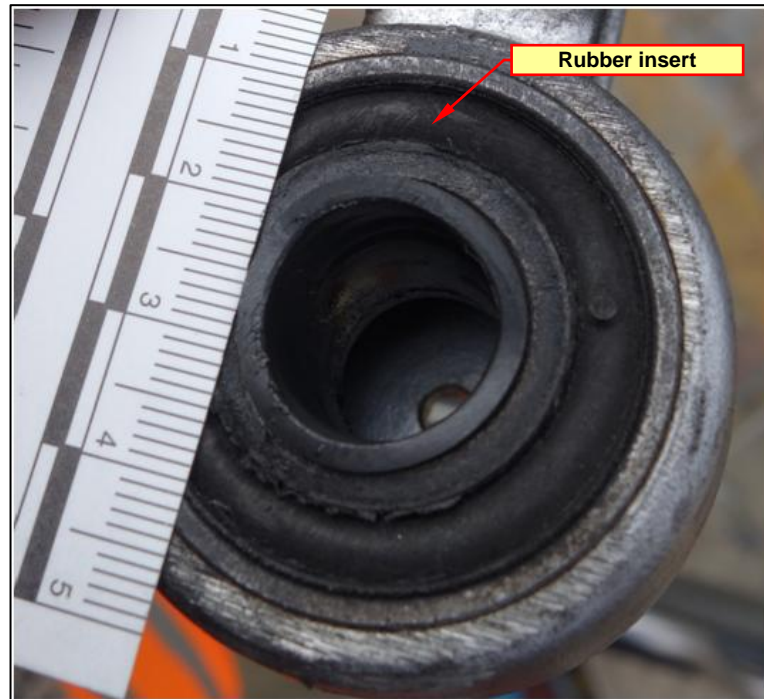
Photograph 9: Upper door bracket bush (door leaf 6)

- 2.5 There were signs of deformation of the internal bushes of the door bracket (see *Photograph 9*). This was consistent with horizontal force having been applied to the doors. The force was sufficient to cause the pin to rotate out of the bush.

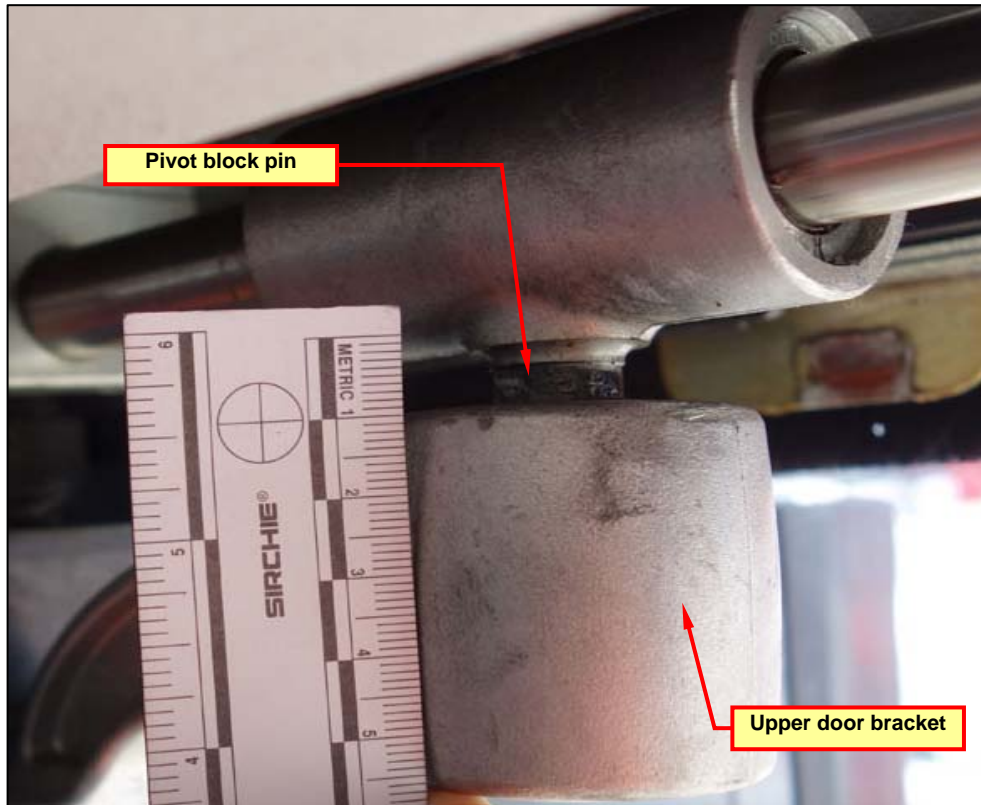
Photograph 10: Readjusted pivot block pin inserted into upper door bracket

- 2.7 It was also found that on door leaves 5 and 6 there was a difference in the length of pin engagement into the upper door bracket bush. According to the manual⁴ the pin clearance for the upper door guide bracket should not exceed 6 mm when the door is in the closed position (see *Photograph 10*). However, the inspection of the reassembled door following the incident found the pin clearance on both door brackets was within specification.

- 2.6 Following the inspection by OTSI investigators, the doors were re-assembled by STA personnel so that the doors were once again functioning. The reassembly of the upper door bracket with the pivot block pin revealed a number of problems with the door assembly. A STA inspection found that the number 6 door was visibly out of alignment with door 5. This was caused by the lower door post arm moving on its locating taper. This allowed the door to move out of alignment from its normal closed position.

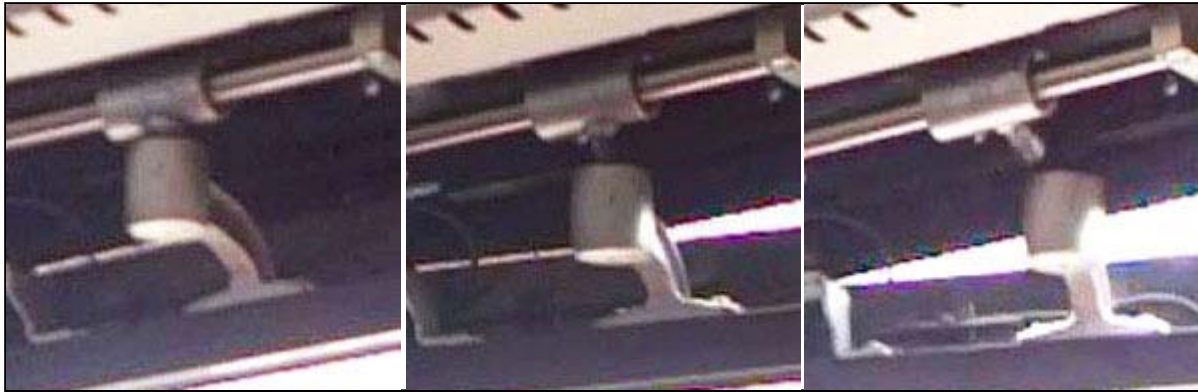
Photographs 11 a, b and c: Pivot block pin disengaging from upper door bracket

- 2.8 A separate OTSI inspection was conducted on 7 April 2014. On this occasion the doors on the bus were in the assembled position. A test was conducted to determine the amount of force required to open the doors. An adult male applied lateral impact force to the centre of door leaves 5 and 6 with his shoulder. While the force was not quantified, the door required repeated impacts before the pivot block pins disengaged from the door bracket. The disengagement of the pin from the bracket can be seen in the sequence of photographs (see *Photographs 11 a, b and c*). It should be noted that this test was conducted while the bus was stationary.

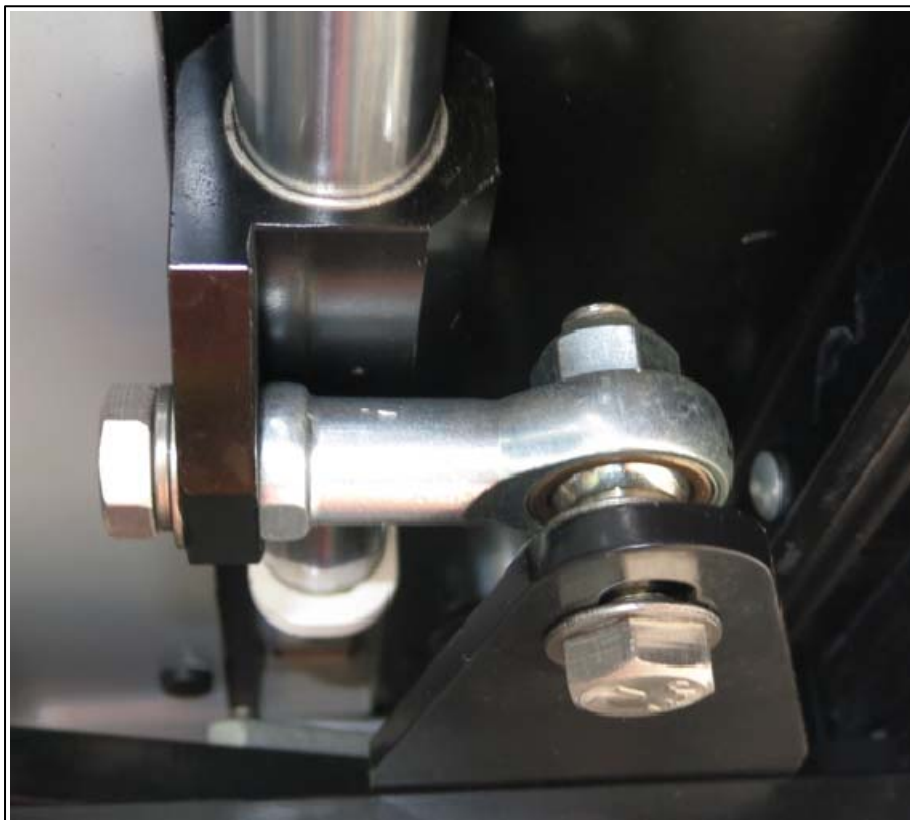
Photograph 12: Alternative door opening mechanism

- 2.9 The FBT door system installed on these Volvo B12BLEA model buses differed in its operation from door systems in place on other STA buses. There are a number of types of mechanisms installed across the STA fleet. An example of another door opening mechanism is shown below (see *Photograph 12*). This mechanism consists of a secure connection between the upper door bracket and the door slide pivot block. There are no reported incidents with this or other types of door mechanisms being unintentionally forced open by passengers.

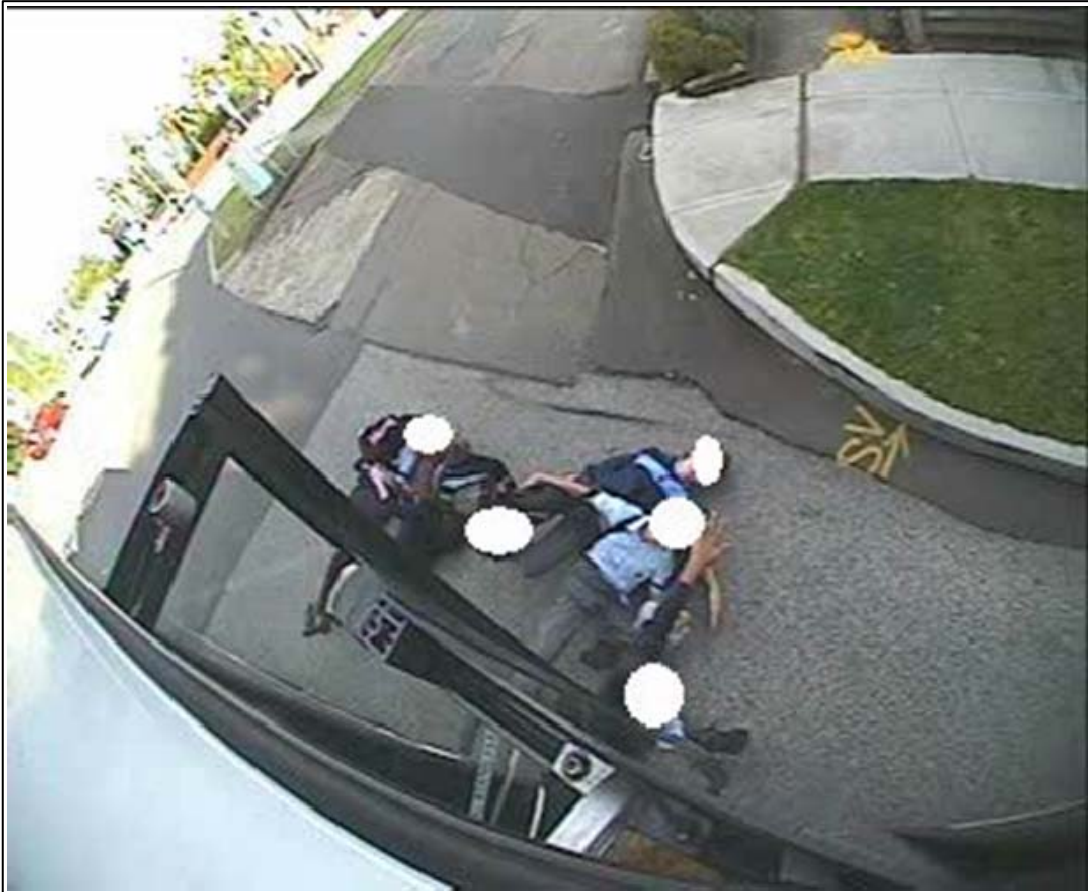
Photograph 16: Students fall out of bus (2318 ST)

- 2.21 The combined force of five students falling against the doors caused the upper door bracket to separate from the pivot pin of door leaf six. The first two schoolgirls fell out of the bus facing forwards, the next two schoolboys fell out of the bus facing backwards, and the last schoolboy fell forward onto the road (see *Photograph 16*). The students sustained minor injuries.
