Office of Transport Safety Investigations

TECHNICAL INSPECTION FINDINGS

HUNTER VALLEY BUS 4358MO FIRE

WANGI WANGI 19 MAY 2014

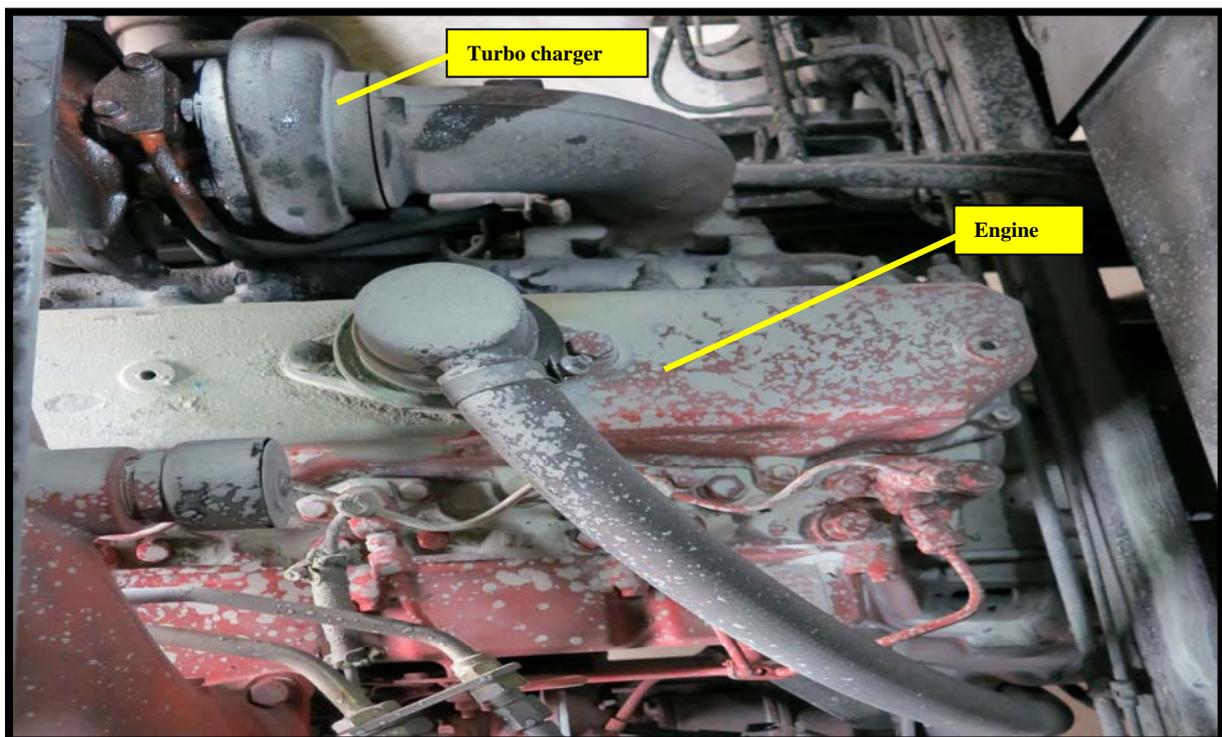
The driver was alerted to the fire by the driver of a following bus who observed flames and smoke emanating from the rear of bus. The driver immediately stopped the bus, shut off the engine and the electrical system, evacuated the twelve school children and discharged a portable fire extinguisher (dry powder) to extinguish the fire. The driver's prompt action prevented his passengers from being injured and prevented damage to the engine and ancillary items. (See photo 1)

Photograph 1 Engine and turbo charger

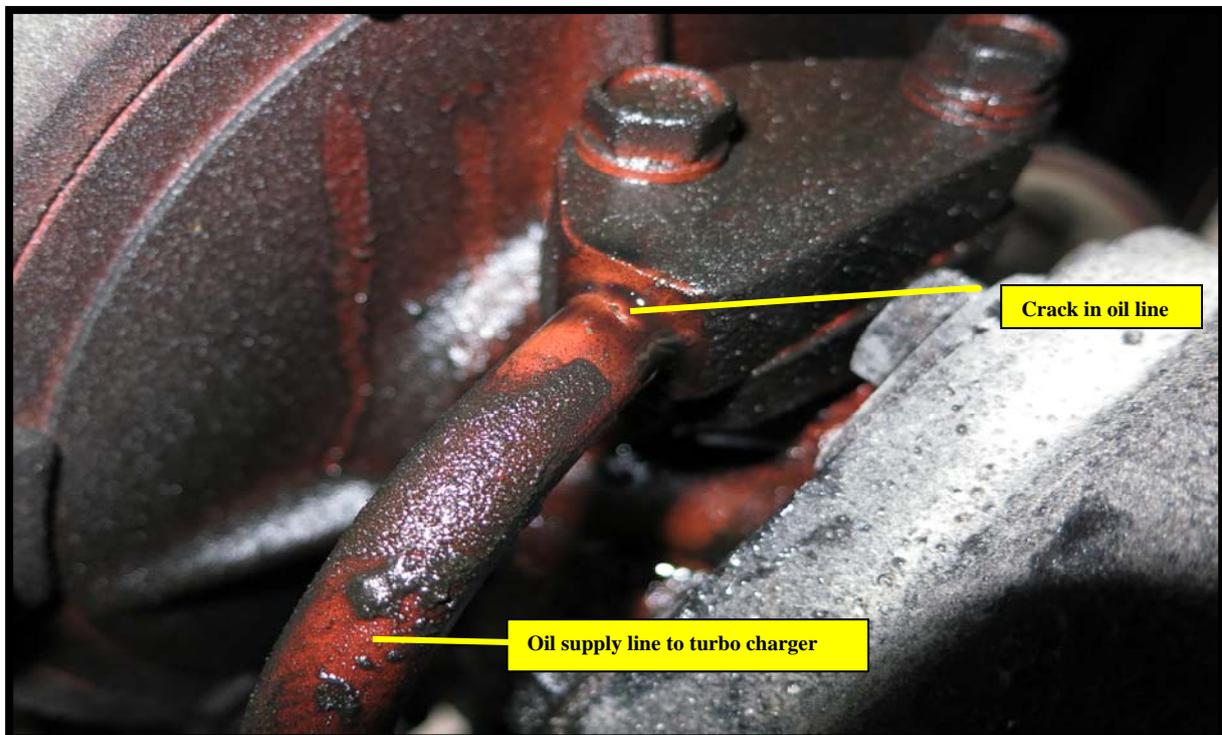
The inspection showed a fire pattern around the top of the engine block and turbo charger mounted on the left hand side of the block. There was no wiring or other damage caused by the fire. There was evidence of an oil spill in the fire-affected area and further inspection showed the oil lubricating line to the turbo charger had cracked where it went into the housing. With the engine running, the lubricating oil sprayed onto the hot engine block and exhaust manifold. (See *photo 2*).

Photograph 2 Turbo oil leak

The investigation determined that the fire was caused by a fracture in the lubricating oil supply line to the turbo charger mounted on the top of the engine block. Under pressure, the oil had sprayed onto the top of the engine block and exhaust manifold with the oil igniting when it came into contact with the hot surfaces.

Since there is no record of other problems associated with the seven buses in the Hunter Valley fleet, it is possible that the fracture in the lubricating oil supply line may have occurred during transportation of the engine from St Mary's or been inadvertently damaged during installation in bus 4358MO.

Hunter Valley Buses immediately conducted inspections on the remaining six Hino buses of their fleet at their three depots.
