## **BUS SAFETY INVESTIGATION REPORT**

**BUS WHEEL SEPARATION**

**MACQUARIE PARK**

**22 OCTOBER 2014**

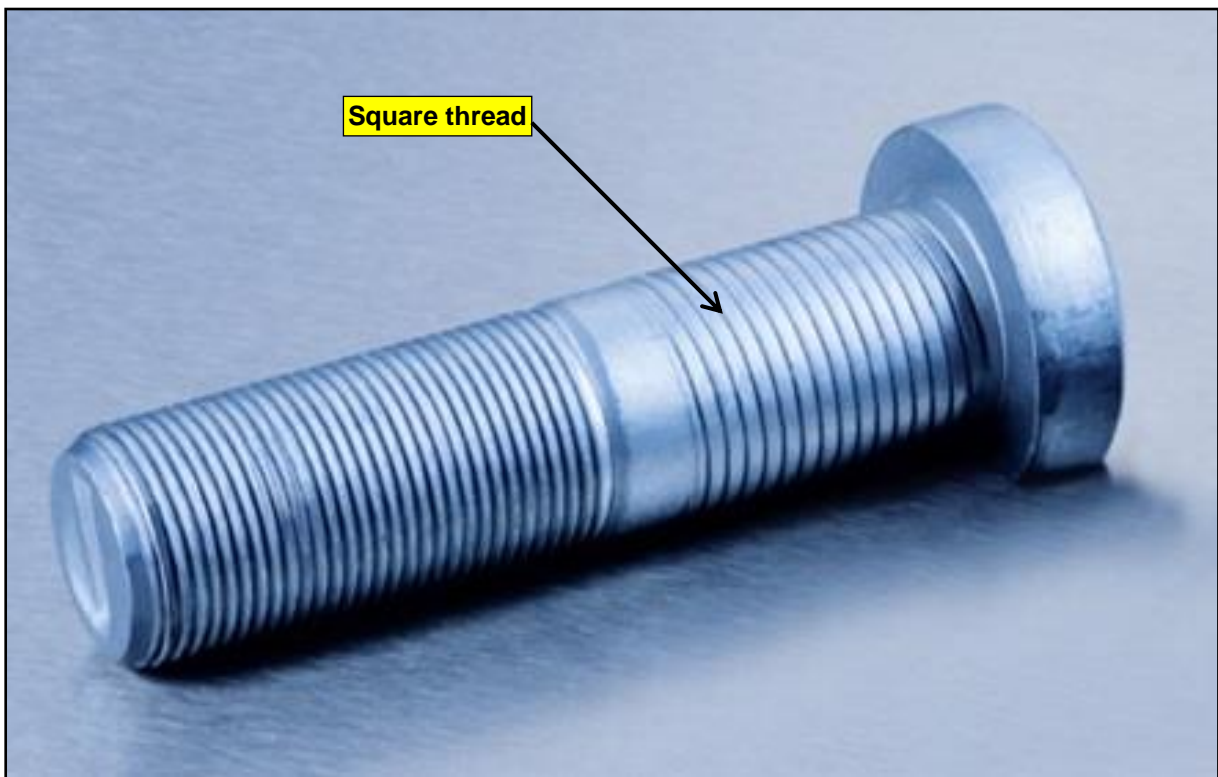
**Photograph 1: Wheel fixing bolt**

2.1 The dual rear wheels were fixed to the corresponding hub by means of ten bolts and nuts, with the bolt holes in the wheels sized so as to provide clearance around the bolts. The bolts were pressed into the hub with an interference fit between a square-threaded section on the bolt, and a marginally smaller hole in the hub. The type of bolt used is shown in *Photograph 1*.

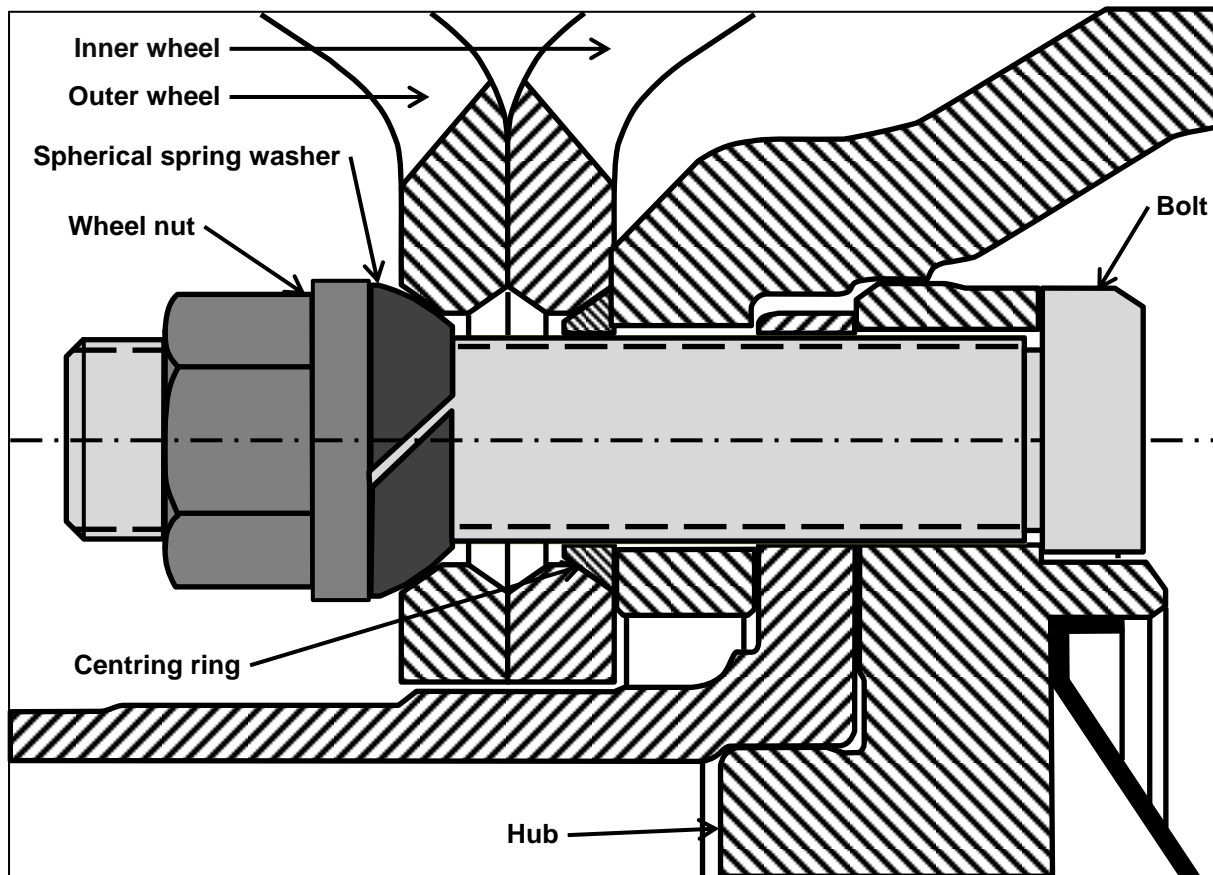
Figure 2: Wheel retention assembly (partial section)

2.2 Centring of the wheels relative to the axis of the hubs was achieved by the use of a tapered centring ring between the inner wheel and the hub, and a spherical lock washer between the outer wheel and the hub. This arrangement is illustrated in *Figure 2*.

- 2.3 As accurate centring of the wheel relative to the axis of rotation of the hub is achieved by means of the centring ring and spring washer rather than by positive radial contact between the wheel and the hub, control of the tension in the wheel bolts is critical. There must be sufficient tension developed in the bolts to prevent any movement between the wheel and the hub under operating conditions, so that the bolts are not subject to bending or shear stresses.

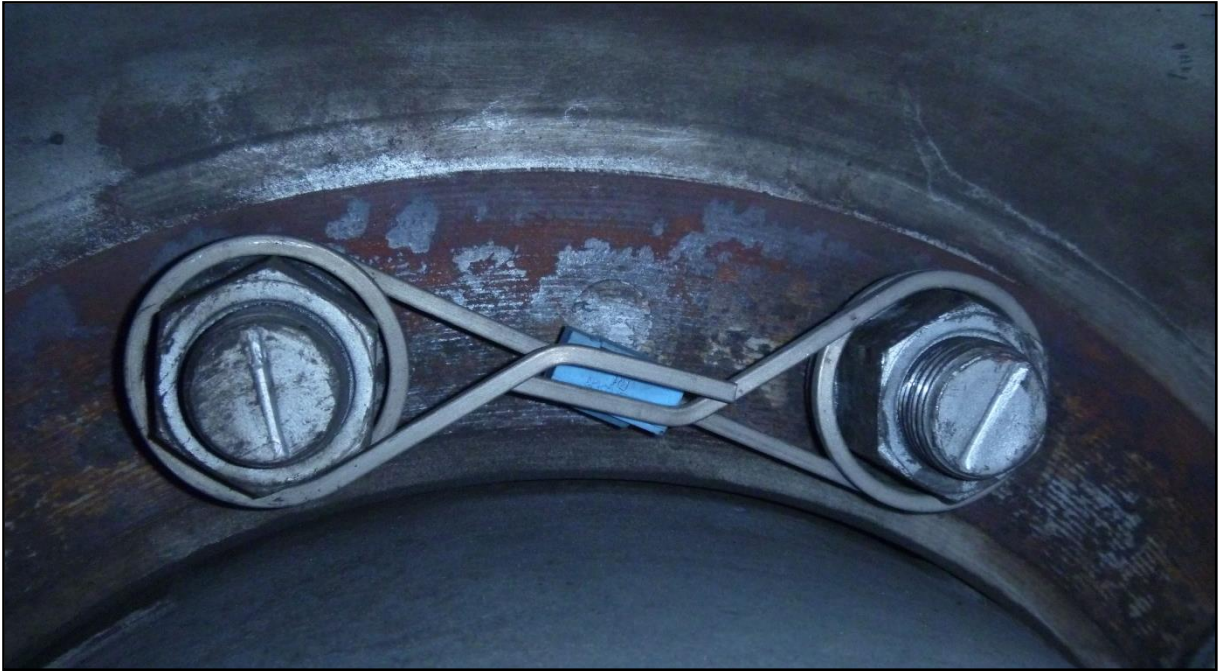
**Photograph 2: Checklock® nut retaining clip**

- 2.4 The wheel nuts were also fitted with Checklock® nut retaining clips, as shown in *Photograph 2*. As stated by the manufacturer<sup>1</sup>, their primary function “Provides a retaining function, reducing the likelihood of nuts loosening.”

- 2.6 Nut retaining clips such as were used in this case, are likely to reduce the tendency for wheel nuts that are not fully tightened to continue to loosen until they fall off with consequent complete detachment of the wheel. However, the wheel bolts will then be subjected to high shear and bending stresses, with the probability of ultimate failure due to fatigue if the loosening is not

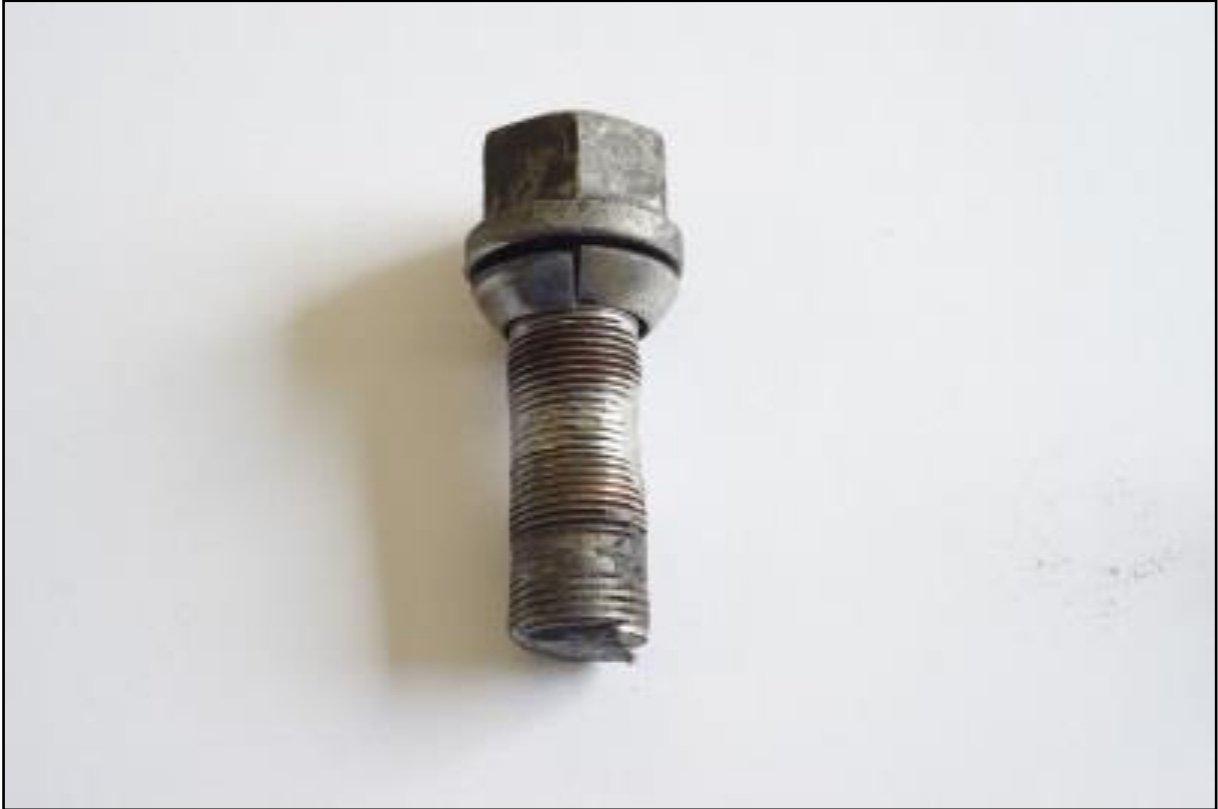
**Photograph 3: Recovered wheel bolt end with nut and washer**

detected. A bolt end recovered from this incident, with nut and conical spring washer in place (*Photograph 3*), shows evidence of movement between the wheels and the bolt over time, resulting in fatigue failure of the bolt.

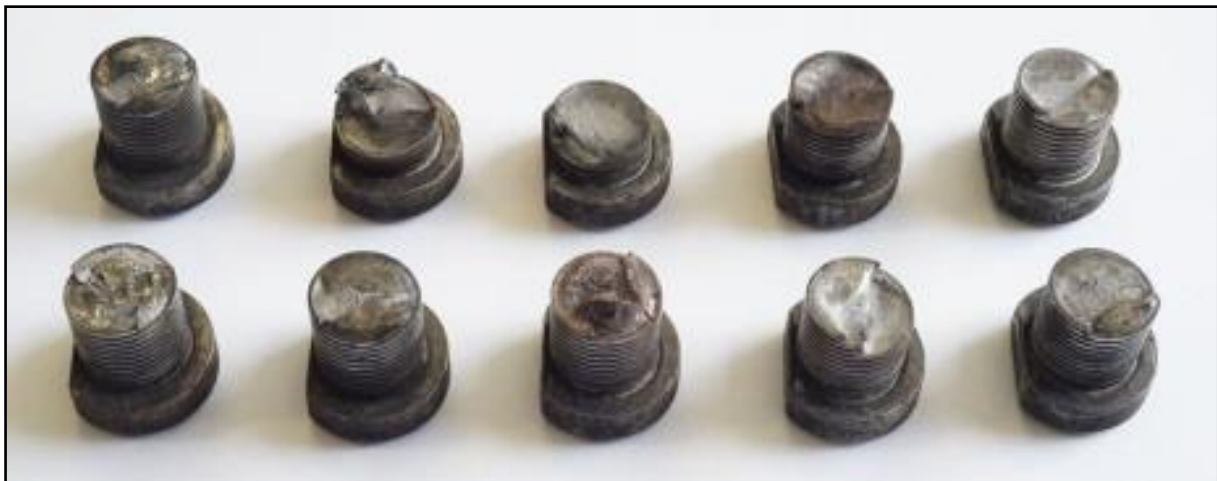
**Photograph 4: The broken wheel bolts**

- 2.10 The broken bolts can be seen in *Photograph 3*, and typical damage around the bolt holes of the outer wheel in *Photograph 4*.

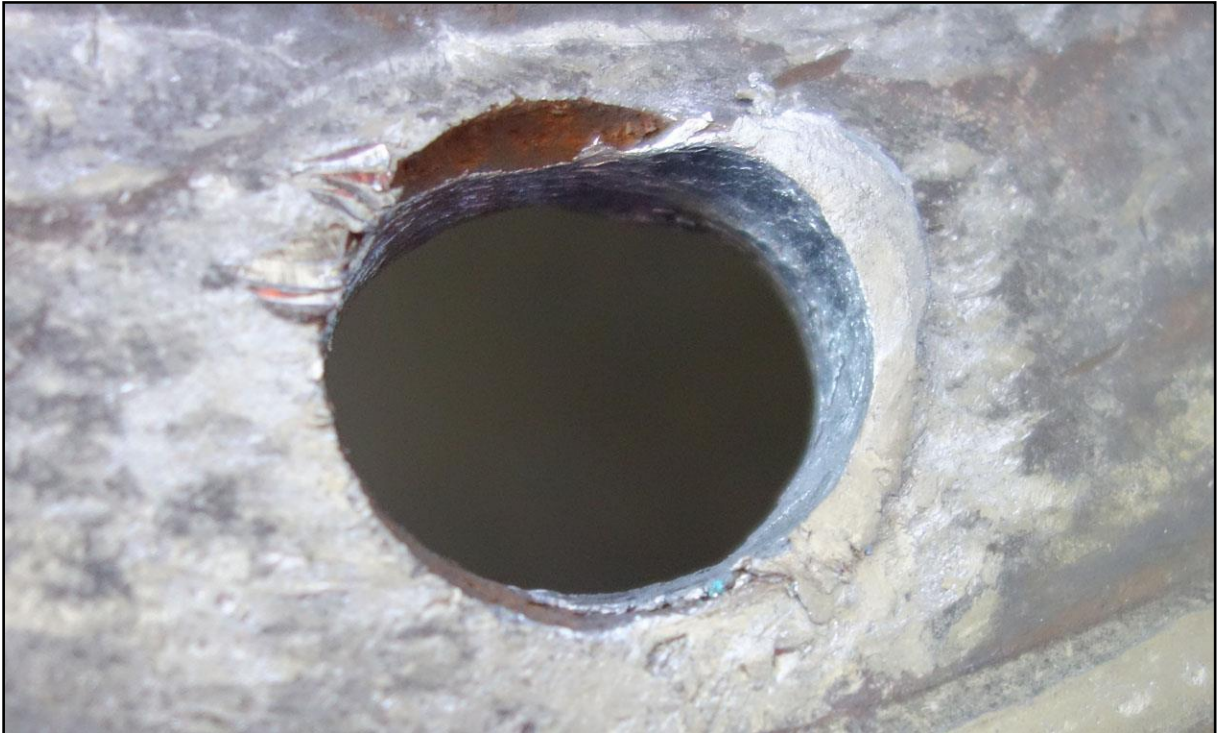
**Photograph 5: Outer wheel stud hole damage**

- 2.11 The degree of damage visible at the periphery of the wheel stud hole in *Photograph 5* indicates that movement had taken place between the wheel, the stud and the spherical spring washer for some time. Likewise the bolt failure pattern seen in *Photograph 6* exhibiting readily visible “beach marks”<sup>5</sup> with multiple initiation points is typical of a fatigue failure due to rotational bending over time. Two of the initiation zones also exhibits “ratchet marks”<sup>6</sup> due to the presence of multiple initiation points on slightly different planes.
- 2.12 The dark area on the fracture surface is most likely due to damage caused post-fracture by the method used to remove the broken bolt from the hub.

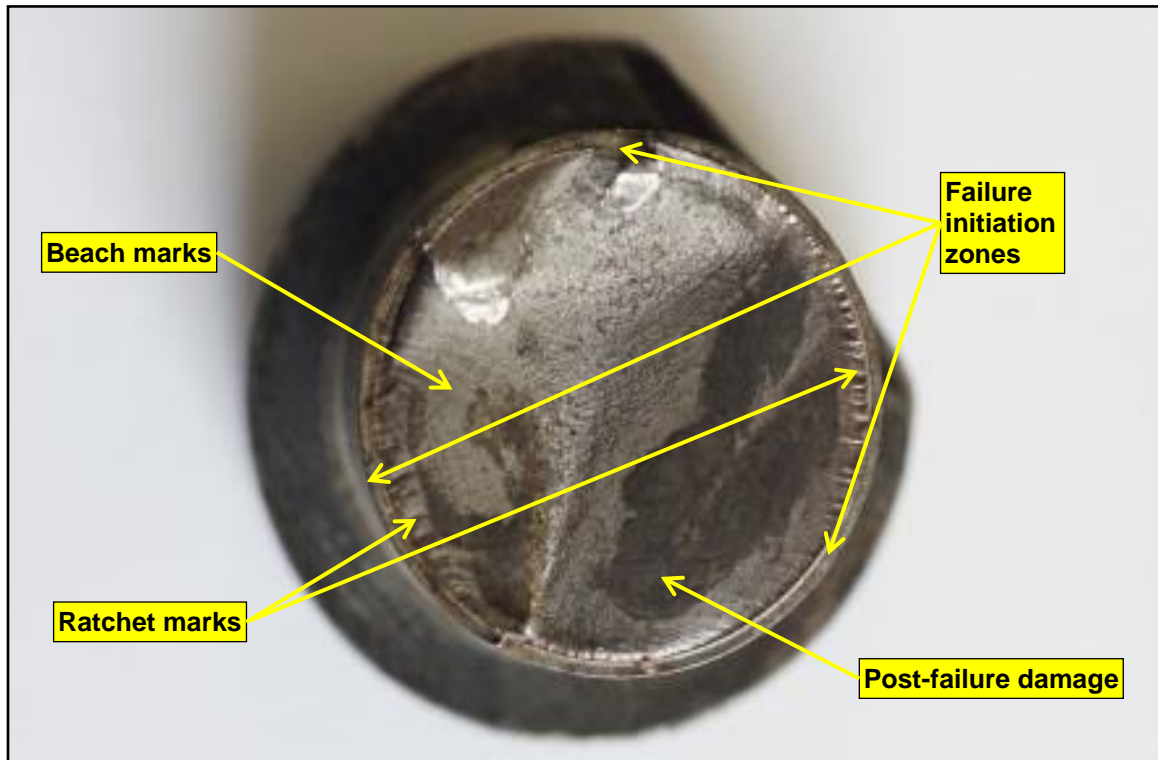
**Photograph 6: Bolt failure pattern**

- 2.13 STA commissioned a Consulting Metallurgist to examine the wheel bolts, nuts and washers recovered after the wheel loss. His conclusion was that the wheel bolts “...all failed as a result of the initiation and propagation of fatigue cracking.” He further stated that “Unless there are design issues associated with the clamping system, this type of failure is invariably associated with poor tightening procedures.”<sup>7</sup>
- 2.14 It is clear from the fact that all wheel bolts fractured, and the nuts remained present on the only recovered wheel bolt ends, that the nuts remained in place and the bolts failed progressively until the wheel was free to fall off.

- 4.1 Investigate the feasibility of introducing a practicable daily inspection methodology capable of detecting wheel nut loss of tension.
