BUS SAFETY INVESTIGATION REPORT

UNMANNED/UNCONTROLLED MOVEMENT

RESULTING IN DRIVER FATALITY

HURSTVILLE

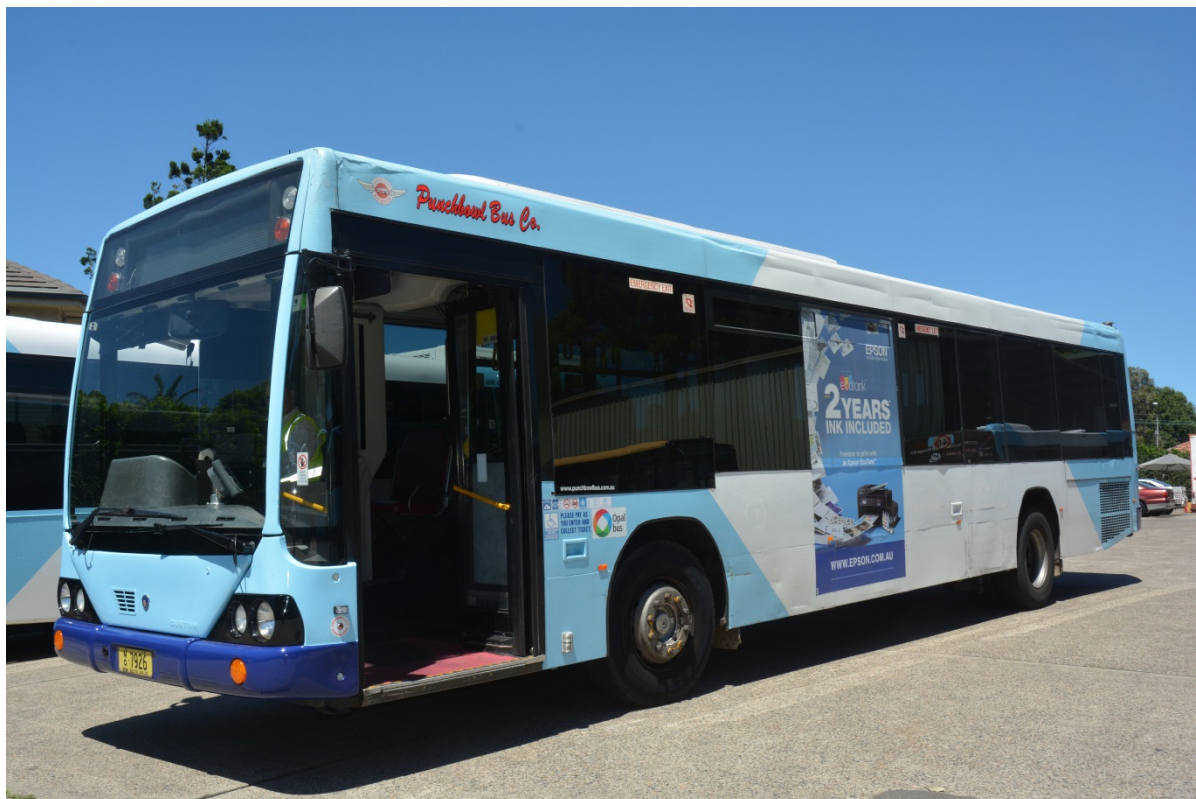
- 1.4 The bus was a Scania 2003 L94 model. It had one door opening, located at the front near side² of the bus (see Photograph 1). The bus had a Tare weight of 11220 kg and a seating capacity of 47 passengers with a standing capacity of 34 passengers. The bus's total Gross Vehicle Mass (GVM) when loaded is 19100 kg. The bus was empty at the time of the accident.

Photograph 1: Scania 2003 L94 bus, one door on near side

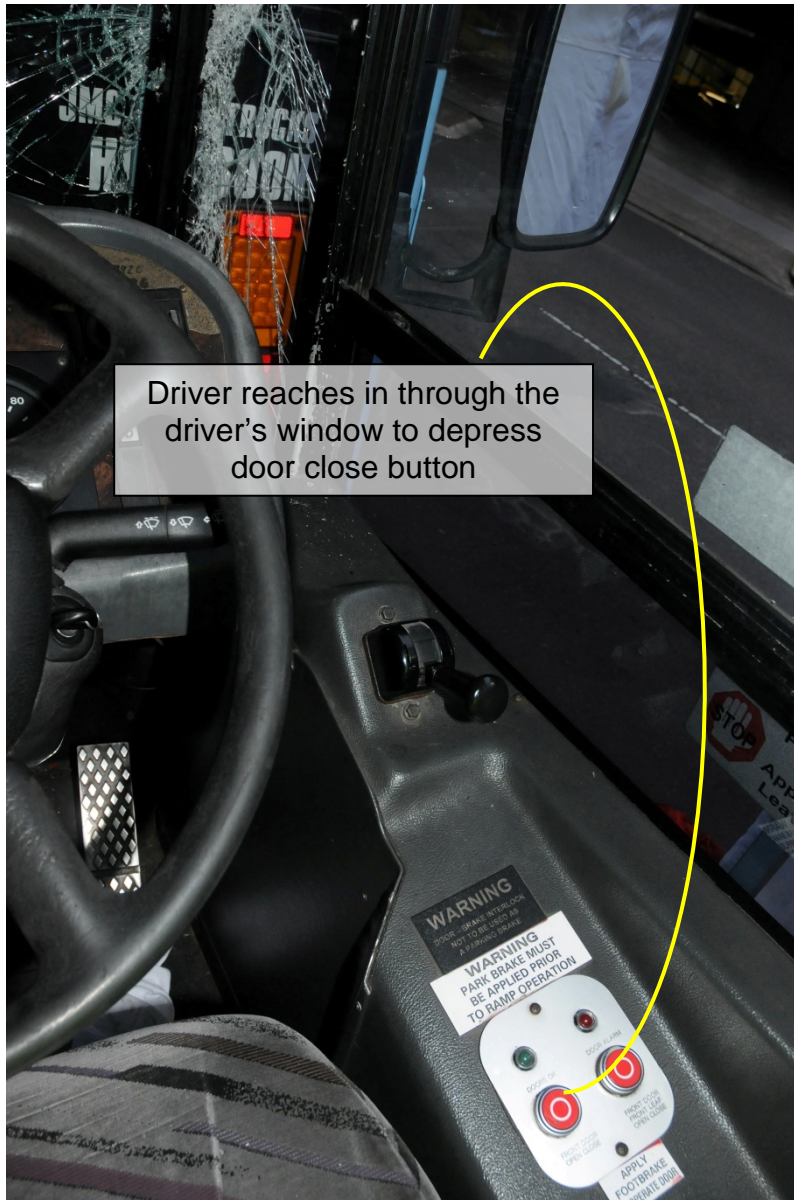
- 1.15 At approximately 1624 the driver disembarked the bus. The park brake had not been applied to the vehicle.
- 1.16 The driver exited the vehicle and operated a door close push button (see photograph 2) through the driver's side window. The driver then closed the window to secure the vehicle. The driver then began to walk towards the other PBC bus driver.

Photograph 2: Park Brake Buttons located in the L94 Scania

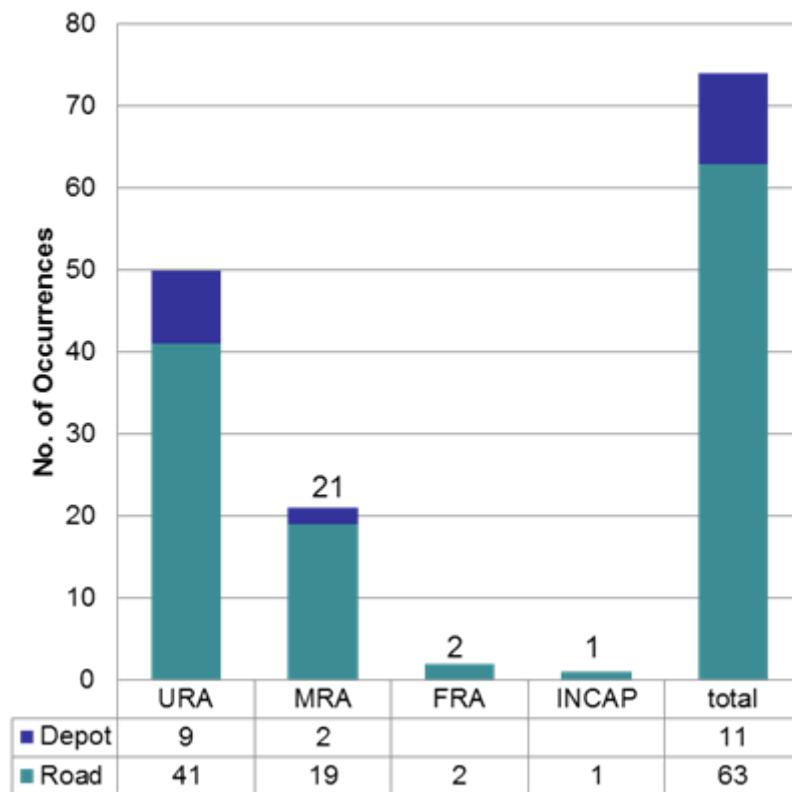
- 2.2 A review of available data found that in NSW since February 2010 there had been 56 reported bus rollaway events, none of which had resulted in fatalities. OTSI's incident database system had recorded 74 events since 2004.

Figure 2: OTSI graph depicting the 74 known reported rollaway incidents

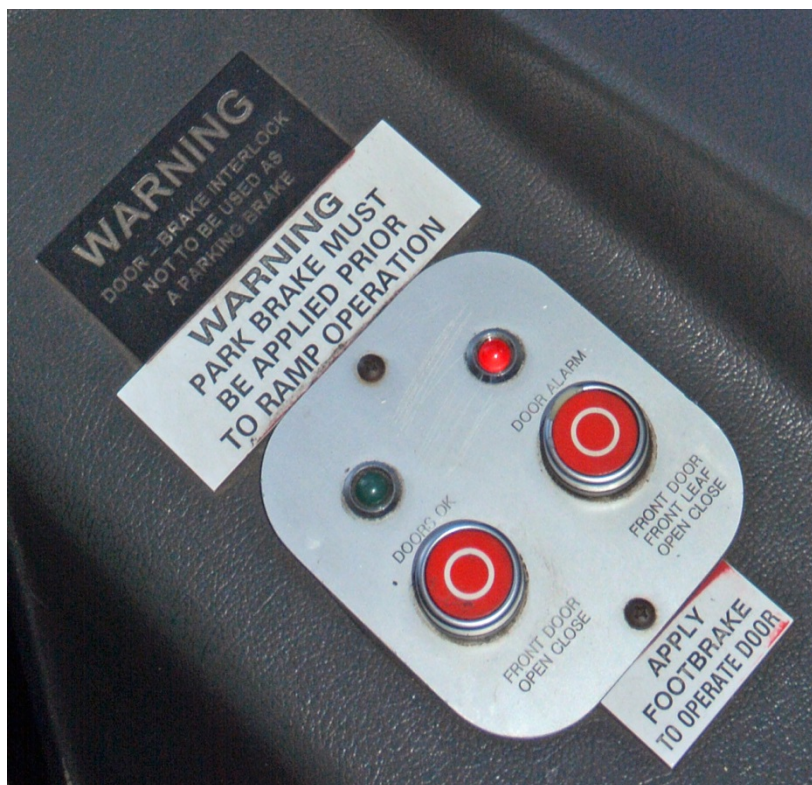
2.22 Three warning signs (stickers) were displayed in close proximity to the door push-button controller (see photograph 3). The signs read the following:

- WARNING Door- Brake interlock not to be used as a parking brake.
- WARNING PARK BRAKE MUST BE APPLIED PRIOR TO RAMP OPERATION, and
- APPLY FOOTBRAKE TO OPERATE DOOR.

Photograph 3: Photograph of MO7926 door controls and warning signs

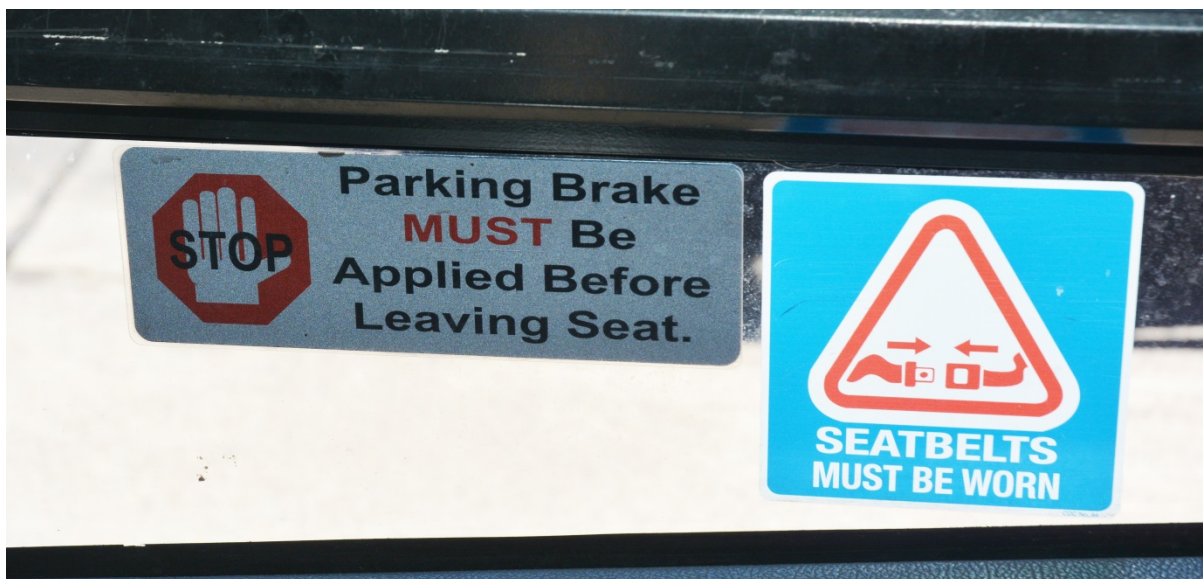
2.23 A warning sign was also displayed on the interior of the driver's side window and adjacent to the door push-button controller (see Photograph 4). The sign was to reiterate the message of ensuring the park brake is applied before leaving the driver's seat. The sign in large bold letters read as:

- PARKING BRAKE MUST BE APPLIED BEFORE LEAVING SEAT.

Photograph 4: Scania 2003 L94 warning sign inside of driver's cabin on driver's window

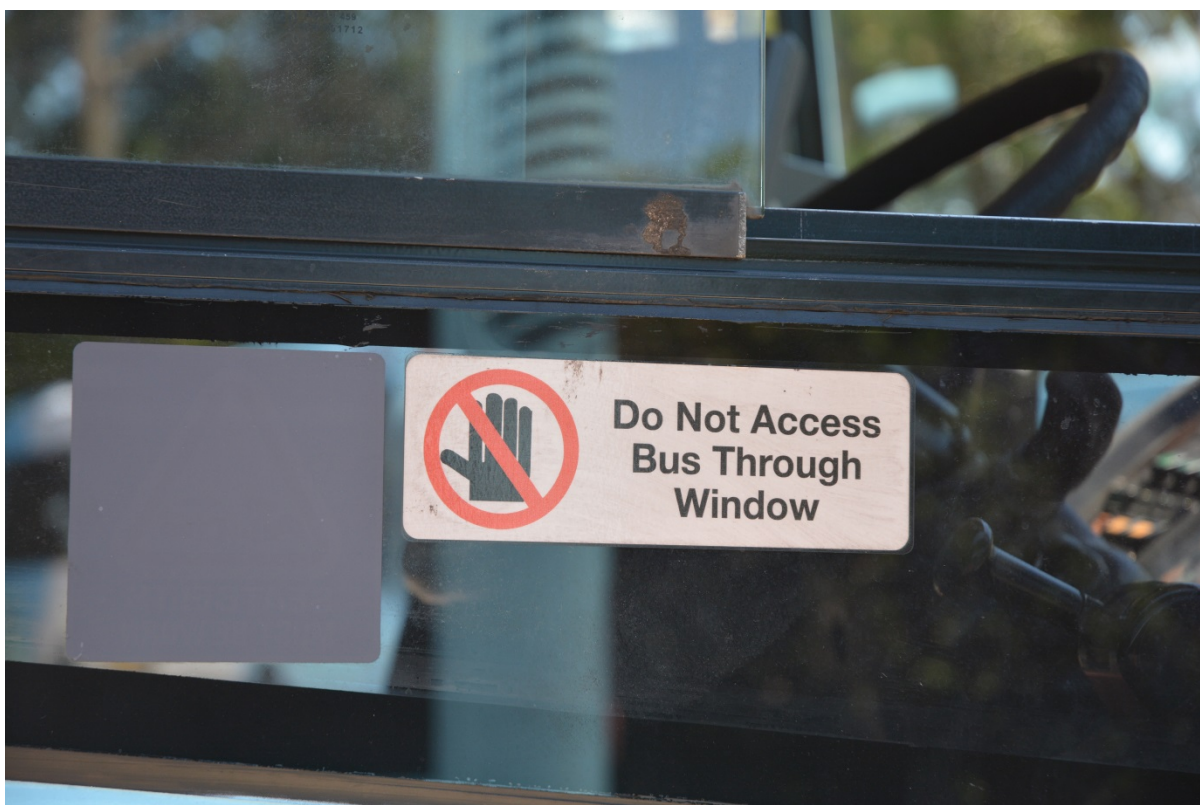
- 2.24 An additional park brake warning sign (sticker) was also displayed on the exterior of the lower driver's cab window (see photograph 5). This type of warning signage had been installed on most public buses in NSW as a result of similar incidents.

Photograph 5: Outside signage of driver's lower window, of the Scania 2003 L94 bus
