## **BUS SAFETY INVESTIGATION REPORT**

**STA BUS MO 1707 OIL AND COOLANT SPILL  
NORTH SYDNEY TO SPIT JUNCTION, NSW**

**17 MARCH 2016**

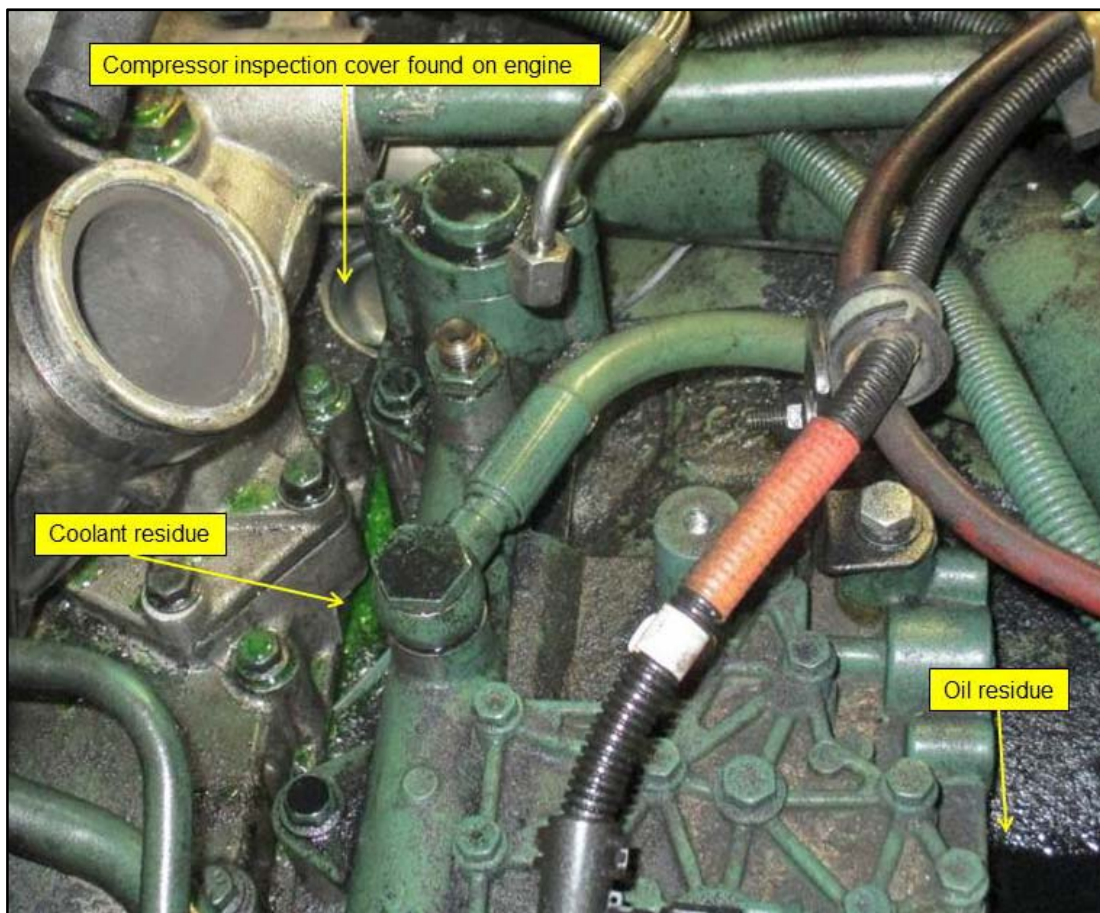
2.1 On 18 March 2016, OTSI investigators examined the bus at the STA Brookvale Depot. The investigation revealed that an inspection cover from the rear of the engine-mounted air compressor unit had dislodged and was lying on top of the engine. Oil and coolant from the engine were found in proximity to the dislodged inspection cover (see *Figure 2*).

Figure 2: Engine showing oil residue and inspection cover

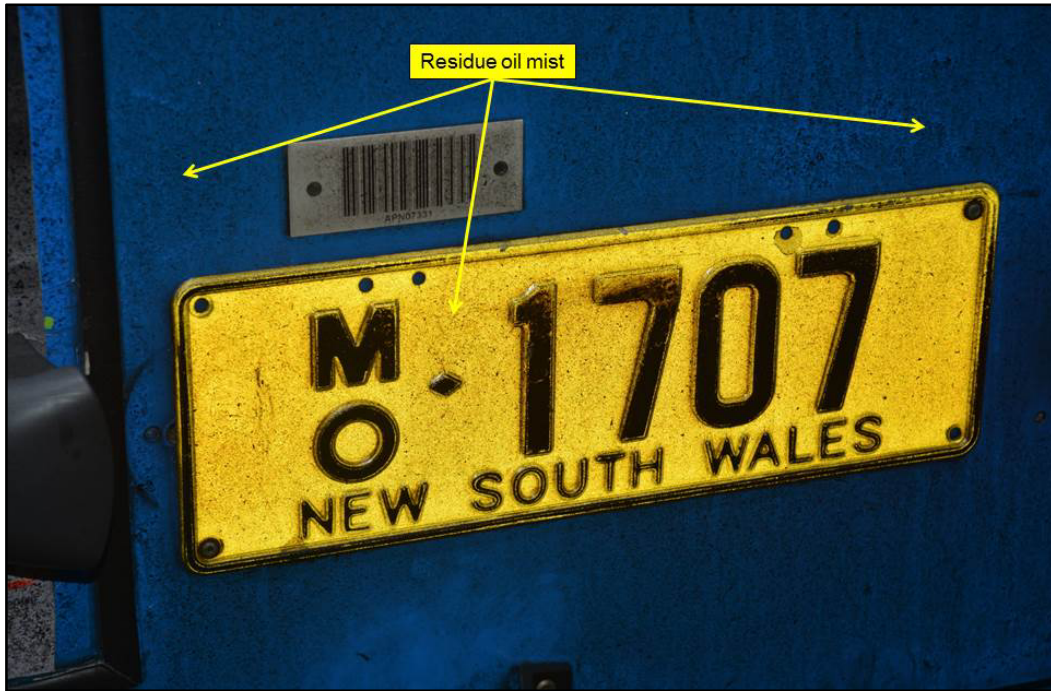
2.2 Residual oil was also found on the outside of the rear engine hatch. The pattern of the oil residue suggests the oil had been deposited on the hatch by the slipstream of the bus's movement (see *Figure 3*).

**Figure 3: Oil mist on exterior**

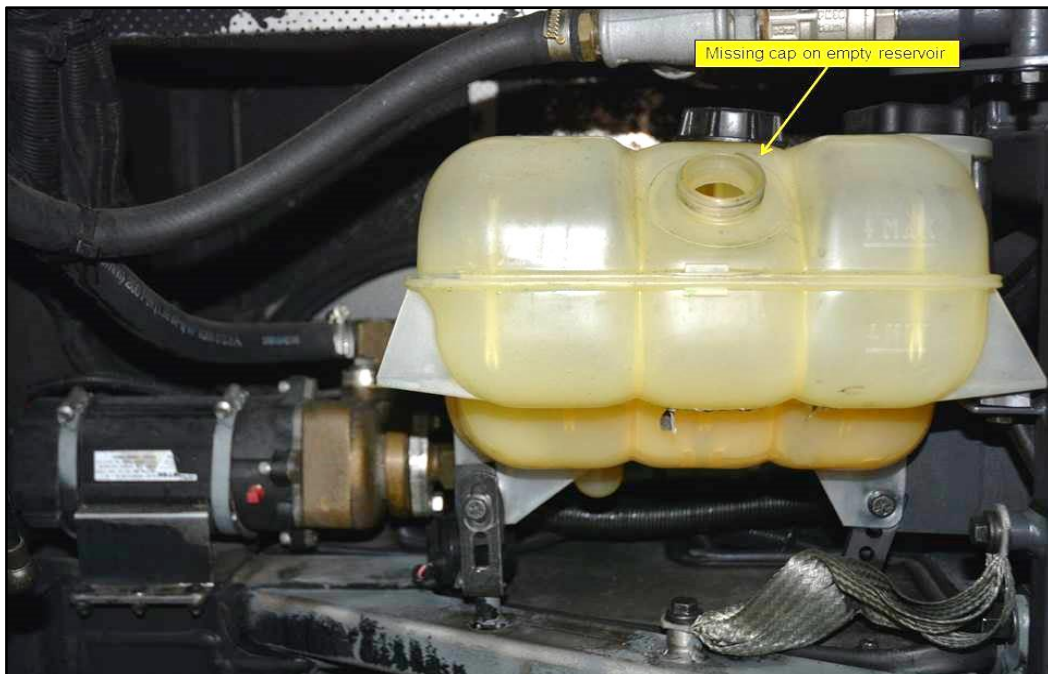
- 2.3 There was evidence of heat-affected oil deposits on the exhaust manifold.
- 2.4 The engine coolant reservoir was empty and the reservoir cap was missing. Coolant residue was deposited over the engine (see *Figure 4*).

**Figure 4: Empty coolant reservoir and missing cap**

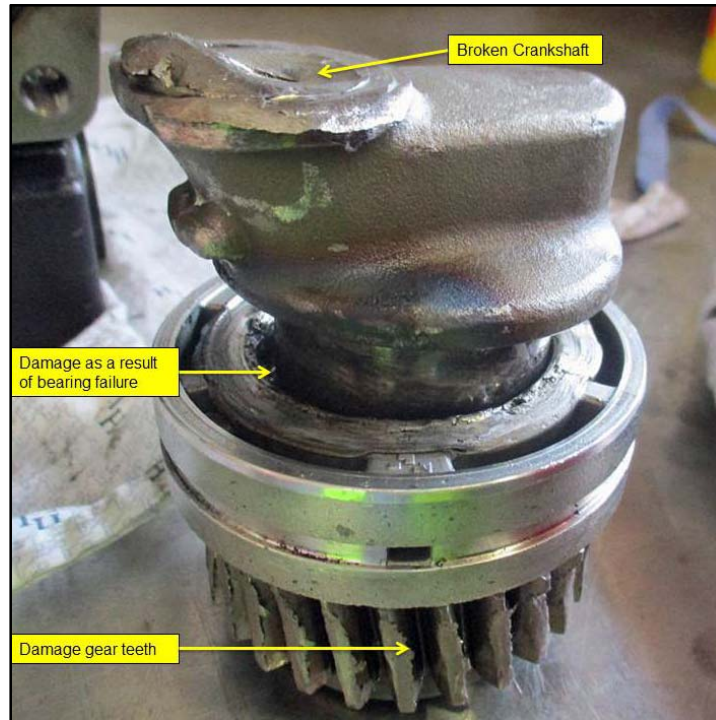
- 2.5 STA mechanics removed the air compressor from the bus for examination. The internal examination of the compressor revealed the air compressor's crankshaft and bearings had failed behind the front gear (see *Figure 5*). Both connecting rods were broken (see *Figure 6*). The compressor pinion was also cracked and the gear teeth damaged. The unsupported rotating pinion gear damaged the front of the housing. A compressor drive bearing retaining circlip was missing.

**Figure 5: Damaged crankshaft**

- The resulting forces created additional stresses in the crankshaft that led to its fracture.
- The fractured crankshaft led to a failure of the compressor connecting rods. The broken components dislodged the inspection cover from the compressor crank housing. This released oil to leak on to the road surface.

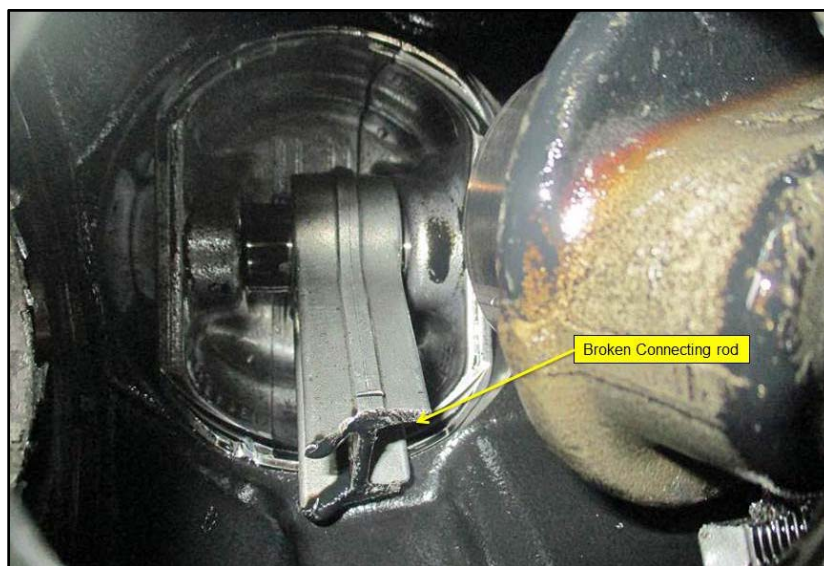
**Figure 6: Broken connecting rod**

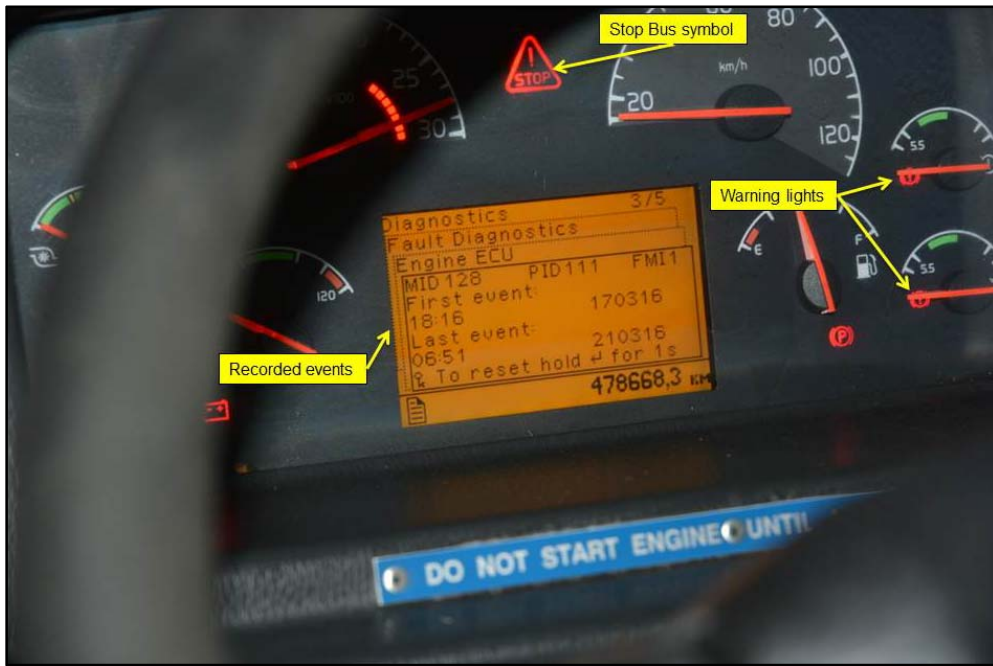
- 1645 a coolant temperature high alarm recorded
- 1651 low oil pressure at fault recorded
- 1651 a fault code for low coolant level recorded. (see *Figure 7*).

Figure 7: Driver's dashboard

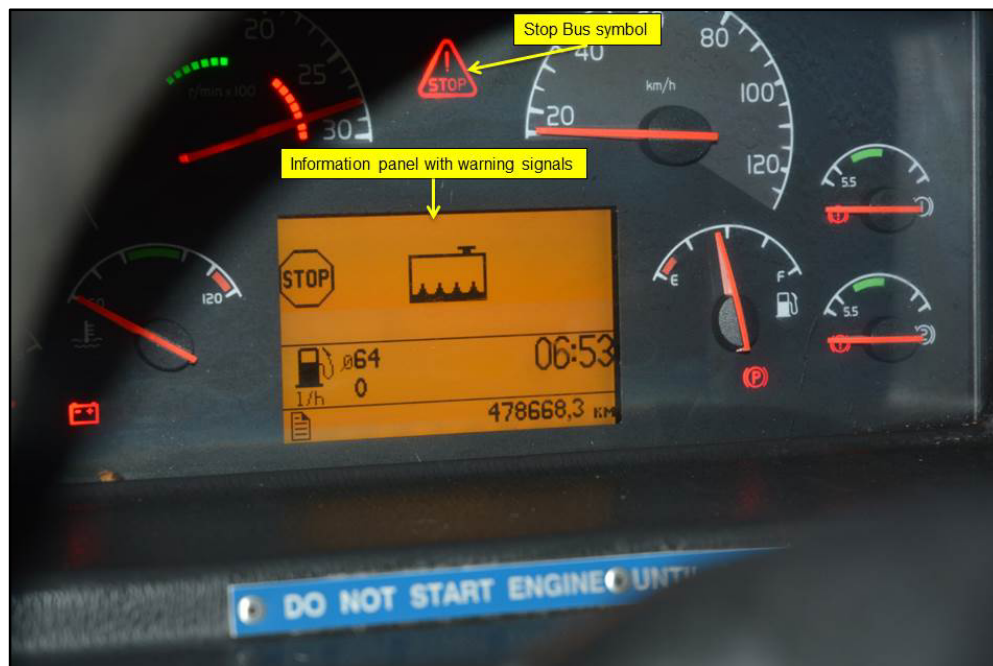
- 1.4 When the bus stopped at the traffic signals on the off ramp, the driver silenced the audible alarm which reset the high coolant temperature alarm. However, the stop bus symbol (see *Figure 8*) continued to be displayed on the driver's dashboard. The driver continued the journey to Spit Junction.

Figure 8: Driver's information panel

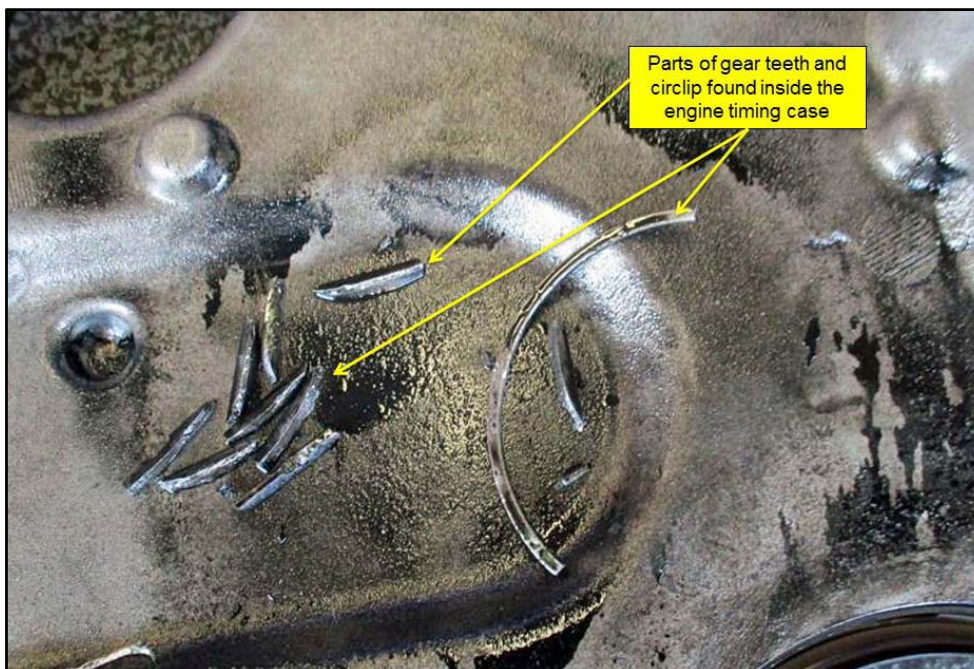
- remnants from the take-off gear and circlip from the compressor had entered the engine timing case (see *Figure 9*).
- the No 1 cylinder and liner showed evidence of a partial seizure caused by overheating (see *Figure 10*)
- the engine timing gear at the front of the engine, which drives the compressor, was severely damaged (see *Figures 11 & 12*)

**Figure 9: Metal parts found inside the engine**

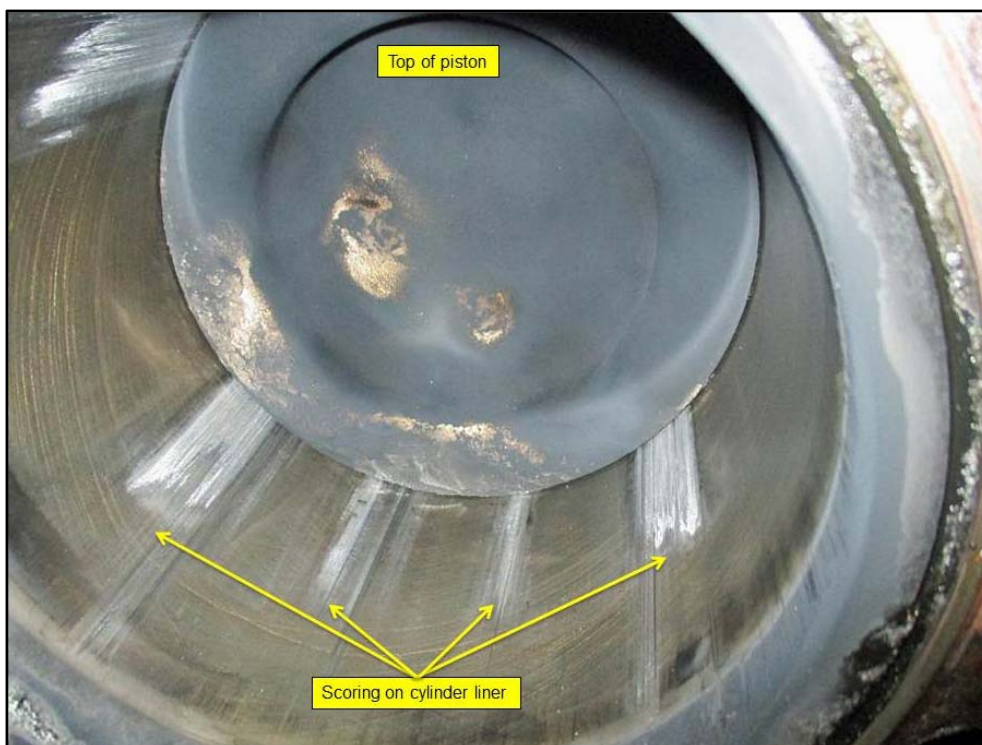
**Figure 10: Damaged cylinder liner**

- When the compressor failed, the drive gear dislodged and allowed the compressor to disconnect from the water pump drive shaft.
- With the water pump not functioning, engine coolant flow ceased and the engine became overheated. This caused the engine alarm to record a fault code at 1645.

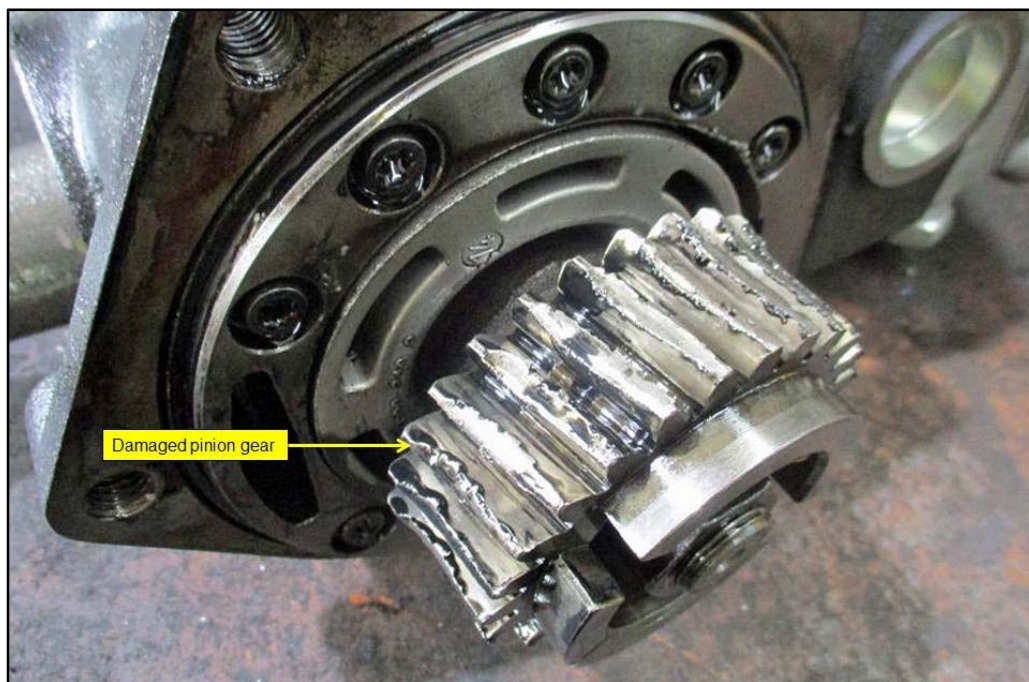
Figure 11: Damaged compressor pinion gear

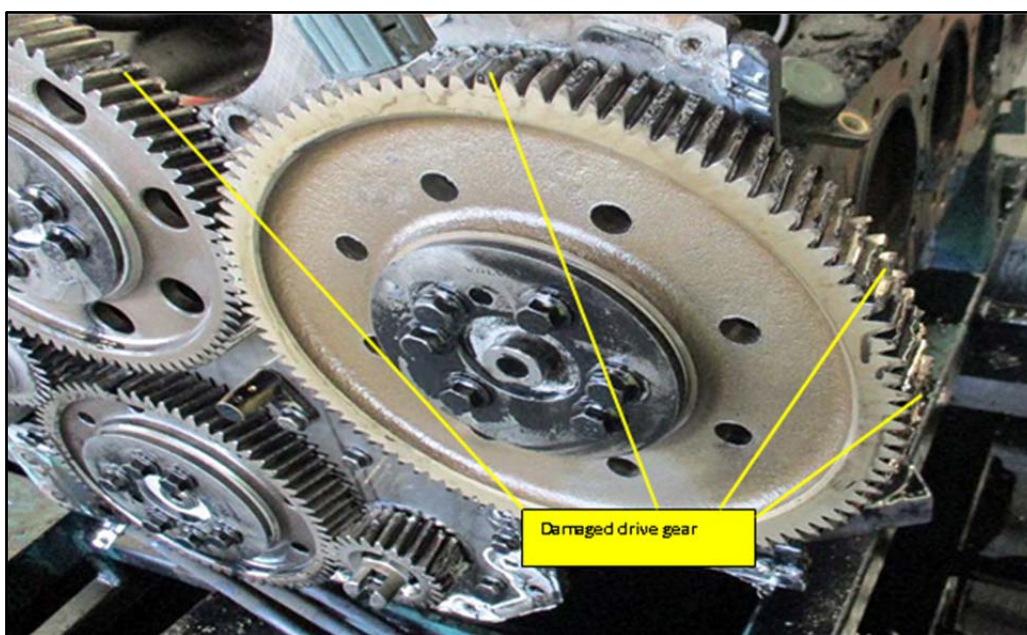
Figure 12: Damage to drive gears

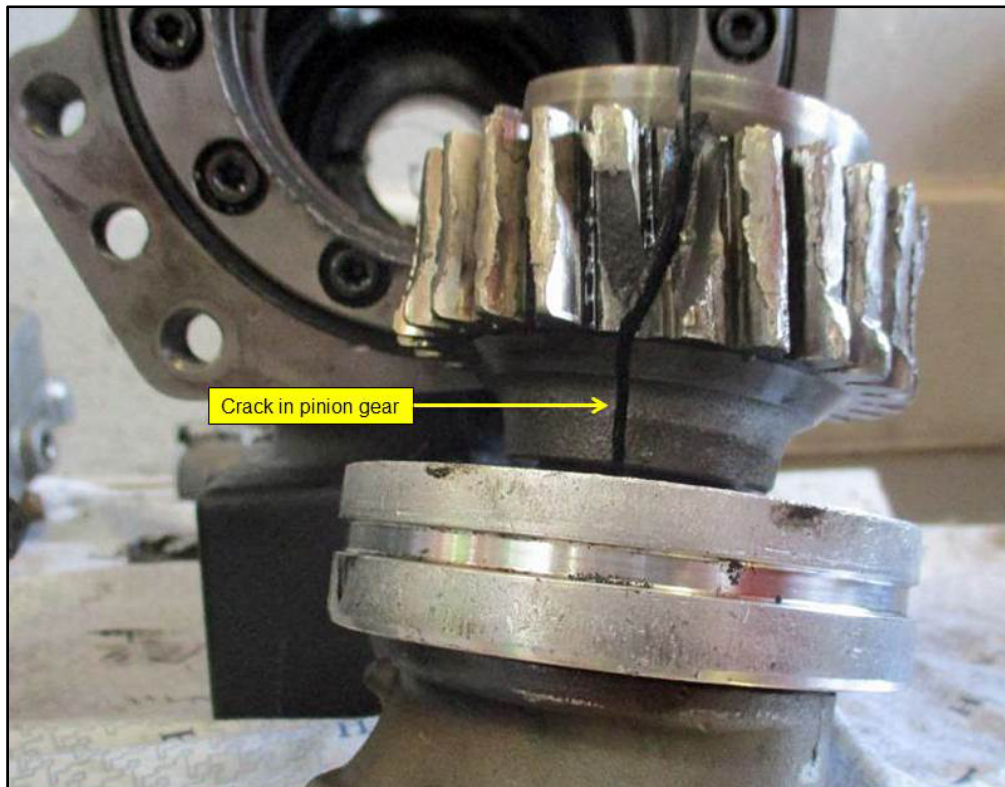
- The failure of the pinion gear from a pre-existing crack which created a misalignment of the pinion.

**Figure 13: Damaged pinion gear**

**Figure 14: Adjacent end of failed crank shaft**

- 3.2 The compressor crankshaft failure was most likely attributed to an undetected fracture in the compressor pinion.
- 3.3 There was vapour emitting from the engine bay however, there was no evidence of fire. There was a potential risk of an ignition source for fire from the expelled engine oil and coolant.

- 4.1 Improve procedures and practices to identify pinion gear fracture.
- 4.2 Ensure bus drivers are proficient to respond to alarms and emergency procedures.
- 4.3 Implement ongoing refresher training to reinforce driver response to emergency scenarios. Training scenarios to include a range of fault code responses to improve driver familiarity with associated failures.

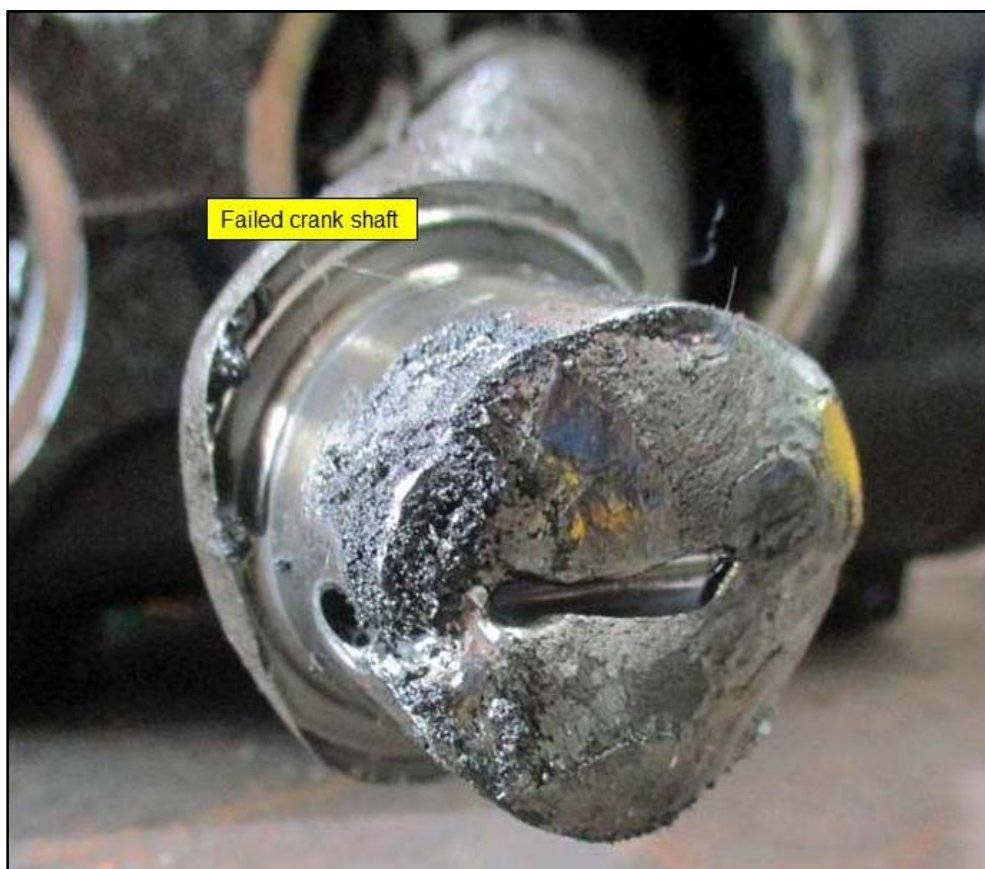
- 2.16 The STA commissioned an independent metallurgist to carry out a macro examination of the failed pinion gear.
- 2.17 The source of the failure was determined as a pre-existing crack in the pinion (see *Figures 13 - 15*).

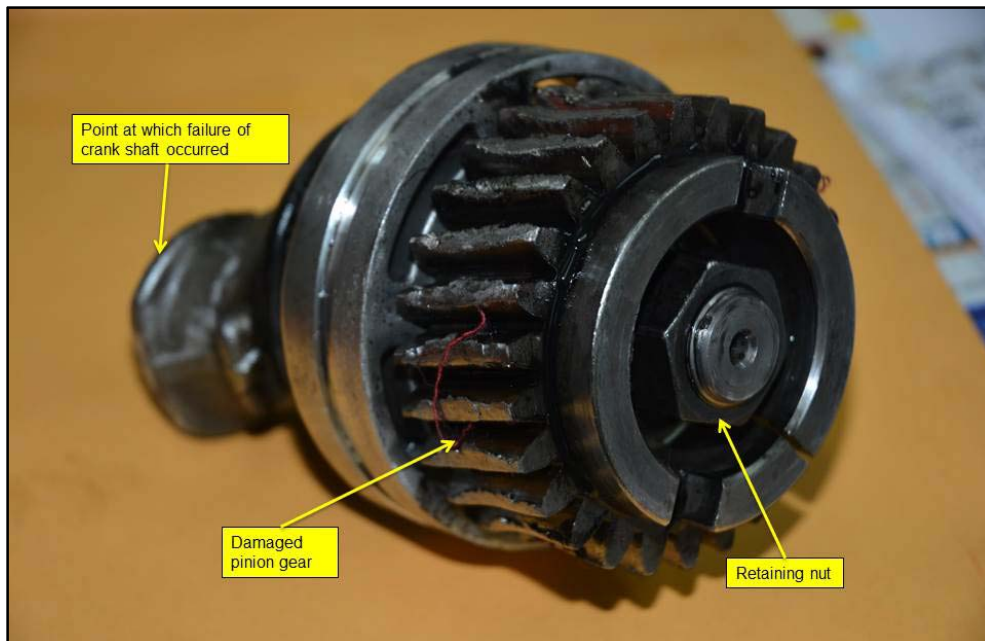
**Figure 15: Pinion and nut**
