Office of Transport Safety Investigations

BUS SAFETY INVESTIGATION REPORT

UNINTENTIONAL OPENING OF BUS REAR DOOR

19 MAY 2016

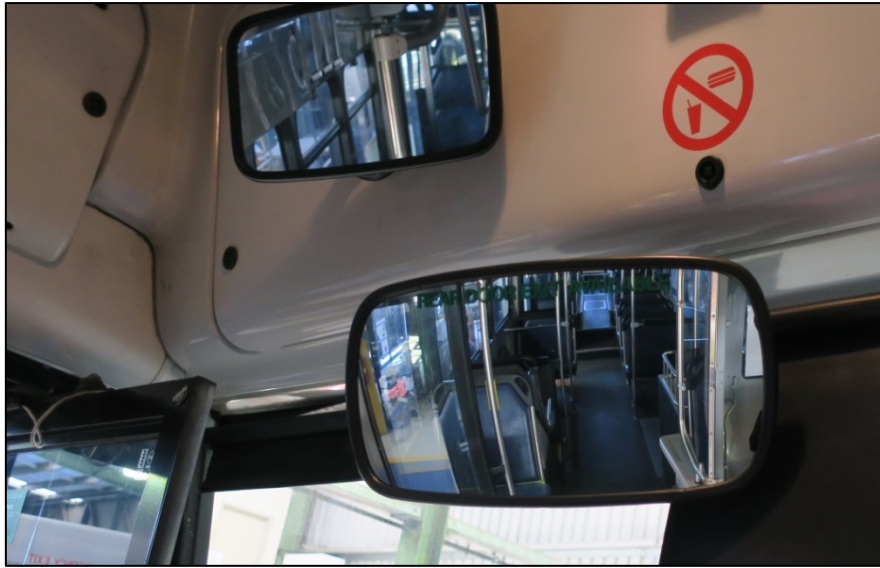
Figure 4: Driver's internal rear view mirrors

- 1.9 The investigation found that the driver did not conduct an adequate check utilising the internal rear view mirrors (see *Figure 4*); and did not notice the student standing in the area next to the rear door. The middle interior saloon mirror showed the view down the aisle and provided a limited view of the area adjacent to the rear door. It is possible that there were students standing in the aisle between the driver and the rear door. However, the mirror to the top left, the centre door spotter saloon mirror, provided a clear view to the mirror above the centre door.

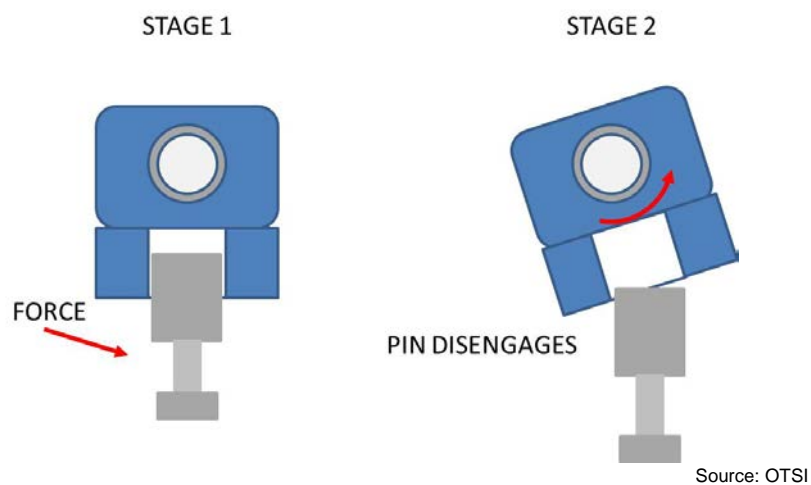
Figure 6: Bearing block disengaging from pivot pin

2.3 The investigation found that the door opened unexpectedly when the pivot pin disengaged from the bearing block (see *Figure 6*). The force of a student leaning or falling against the door was sufficient to open the door (see *Figure 7*). It was likely the door was not correctly adjusted. The pivot pin was positioned lower in the bearing block than specified, which meant that less force was required to disengage the mechanism and hence, open the door.

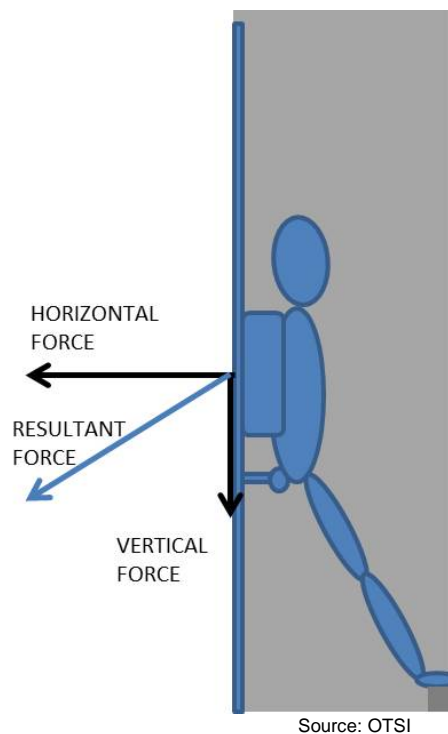
Figure 7: Forces applied by student

- 2.5 Further testing conducted found that the door could be opened if both a moderate horizontal and vertical force was applied to a door with the pivot pin situated lower in the bearing block. It is likely that this is the type of force applied by the student.

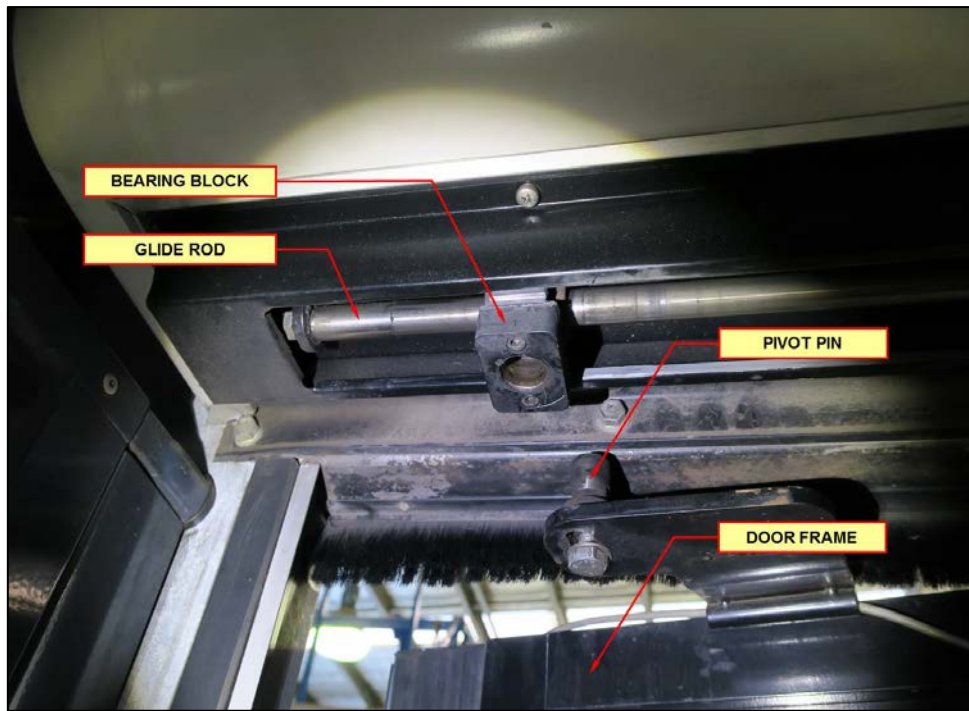
Figure 8: Rear door bearing assembly with pivot pin disengaged from bearing block

- 2.7 All doors on this bus were designed and manufactured by SMC, an Australian company. The door is a bus single gliding door (model BDK276-XAK5038). The design of the door mechanism, particularly the upper linear glide assembly features, as the connection between the door leaf and the sliding linear glide, a pivot pin engaging in a bearing block (see *Figure 8 and 9*).

- 2.8 The part number for the bearing block is XAL5011D and the pivot pin is D19055. Many other parts make up the assembly, but these two parts are the critical interface, and in this instance separated, allowing the door to swing open.

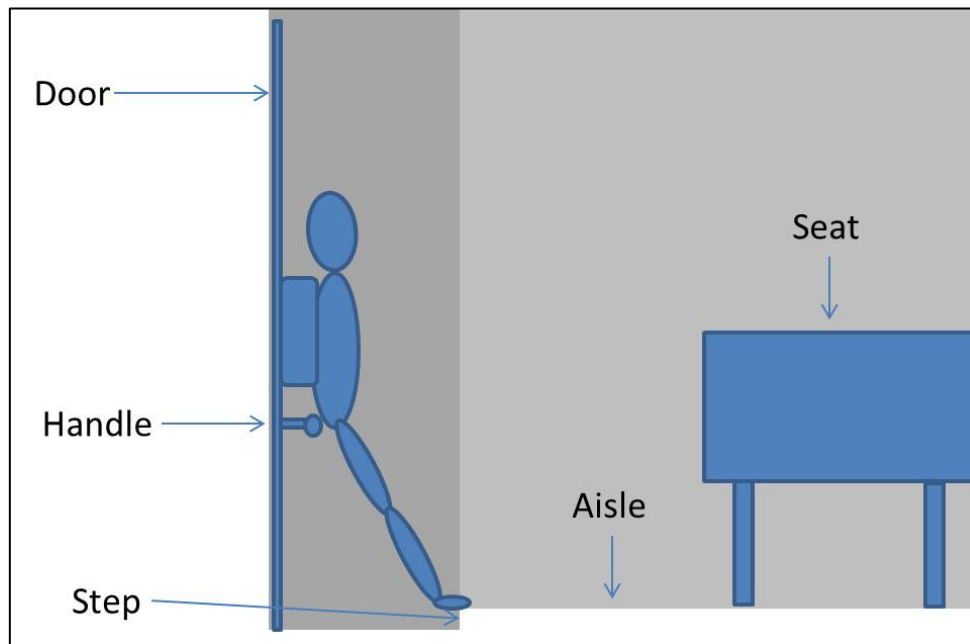
Figure 12: Position of student leaning against bus door

- 1.12 The student was standing with their back leaning against the rear door. There is a handrail also attached to the door. It is possible that the student was resting on the handrail, which is positioned across the lower half of the door.

- 1.13 The in-motion forces and the load applied on the door and (possibly) the handrail by the leaning student were sufficient to disengage the door mechanism. Once this occurred there was nothing to stop the door opening outward. The student said that there was no warning when the door opened. The driver received no notification or alarm. The driver estimated the speed at the time of the incident as 25 km/h.

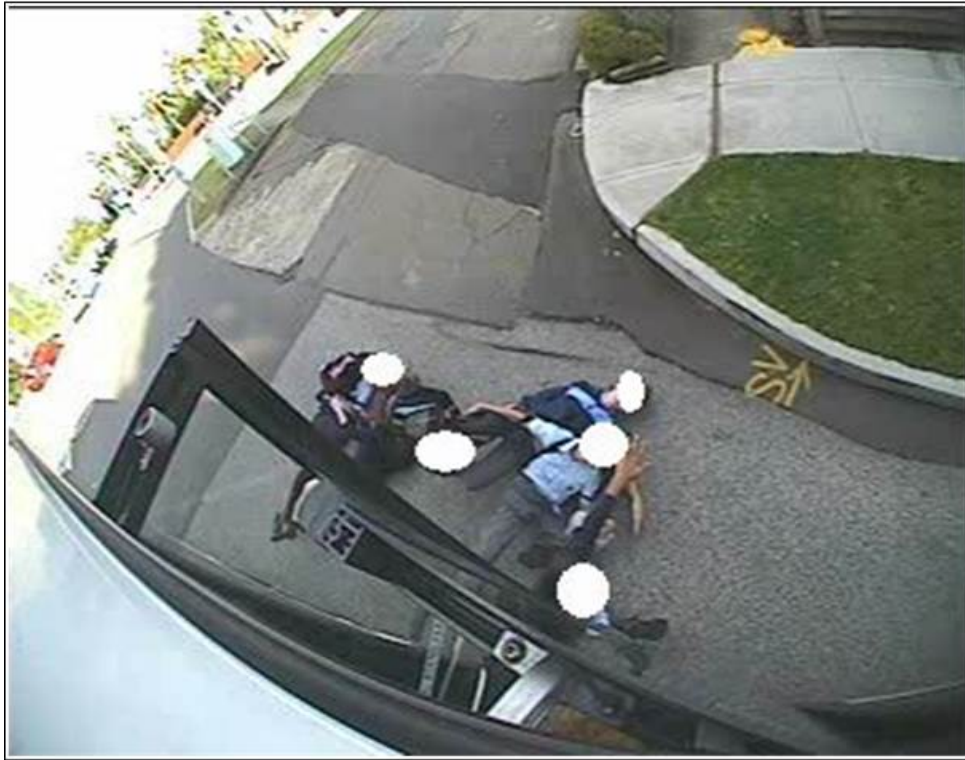
Figure 13: Students fall out of bus (2012)

- 2.28 Two previous incidents of this type occurred in June 2012 and April 2014. The model bus in both incidents was an articulated Volvo B12BLEA model, both operated by the State Transit Authority. The first incident occurred on 14 June 2012 when five students fell from the double rear doors of the bus. The combined force of five students falling against the doors caused the upper door bracket to separate from the pivot pin on door leaf six. The first two students fell out of the bus facing forwards, the next two students fell out of the bus facing backwards, and the last student fell forward onto the road (see *Figure 13*). The students sustained minor injuries.

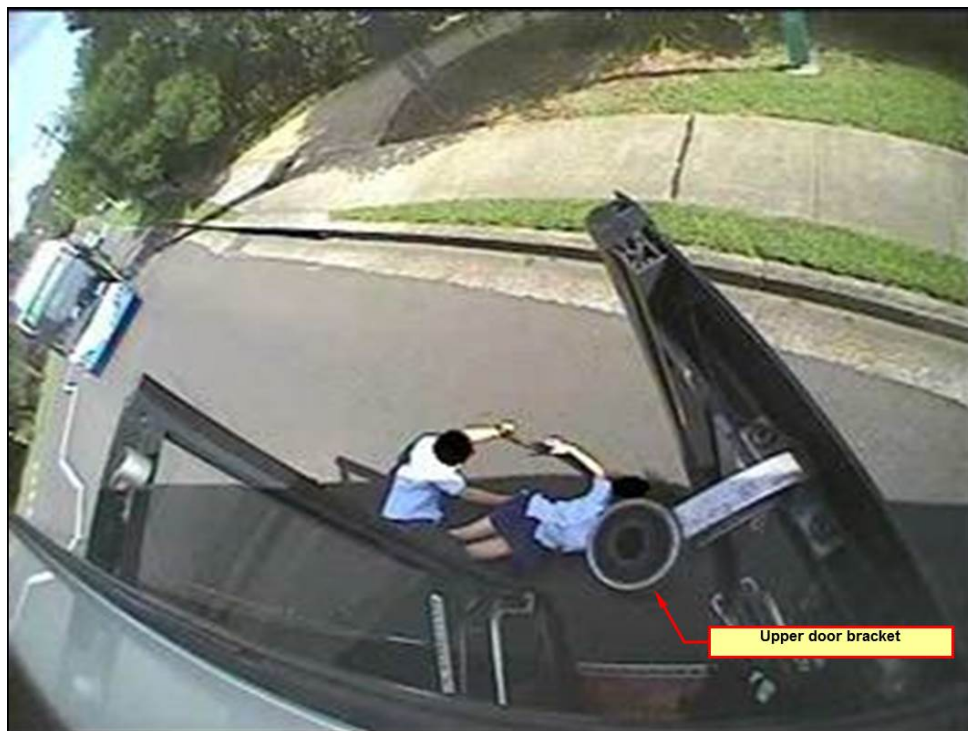
Figure 15: Students fall out of bus (2014)

- 2.29 A second incident occurred on 3 April 2014, when, two students standing in the rear vestibule area fell against the rear doors of the bus. As the bus was making the turn, a student, standing in the vestibule area, stumbled and fell against a another student (see *Figure 14*). The student was standing unsupported facing away from the doors and talking on a mobile phone. The force of the students falling against the doors again caused the upper door bracket to separate from the pivot pin of the door. The students fell onto the road sustaining minor injuries (see *Figure 15*).

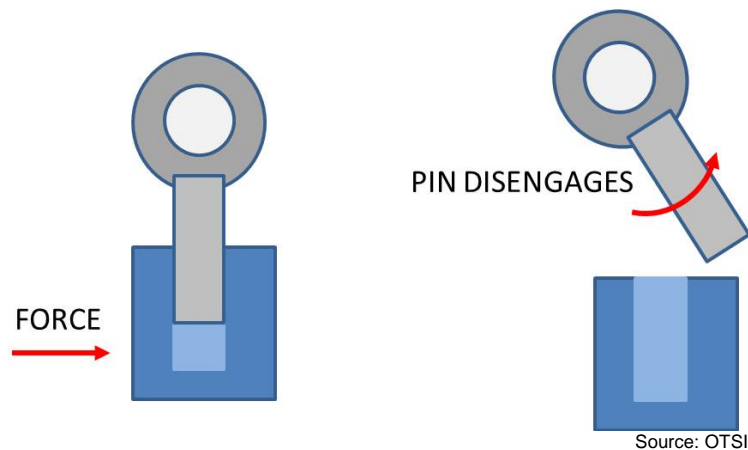
Figure 16: Pivot block pin disengaging from upper door bracket (2012 & 2014 incidents)

- 2.30 These previous occurrences involved door mechanisms from a different company (FBT Fahrzeugbau) than for this incident. The OTSI investigation found that with the application of sufficient force, the pin disengaged from the block allowing the door to open (see *Figure 16*).
