# **BUS SAFETY INVESTIGATION INTERIM FACTUAL STATEMENT**

**BUS FIRE**

**SYDNEY HARBOUR BRIDGE**

**15 SEPTEMBER 2016**

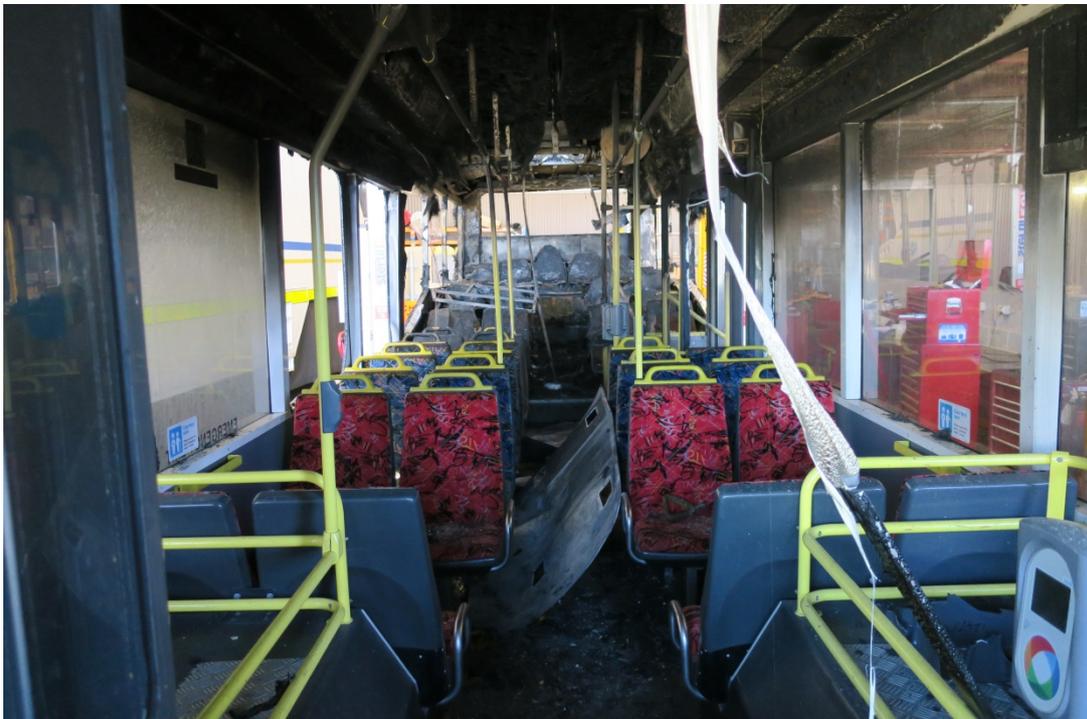
Figure 2: Interior of the bus

The fire intensified and progressed from the engine bay to the interior of the bus. Fire and Rescue NSW attended and extinguished the fire.
