BUS SAFETY INVESTIGATION REPORT

BUS FIRE

SYDNEY HARBOUR BRIDGE

15 SEPTEMBER 2016

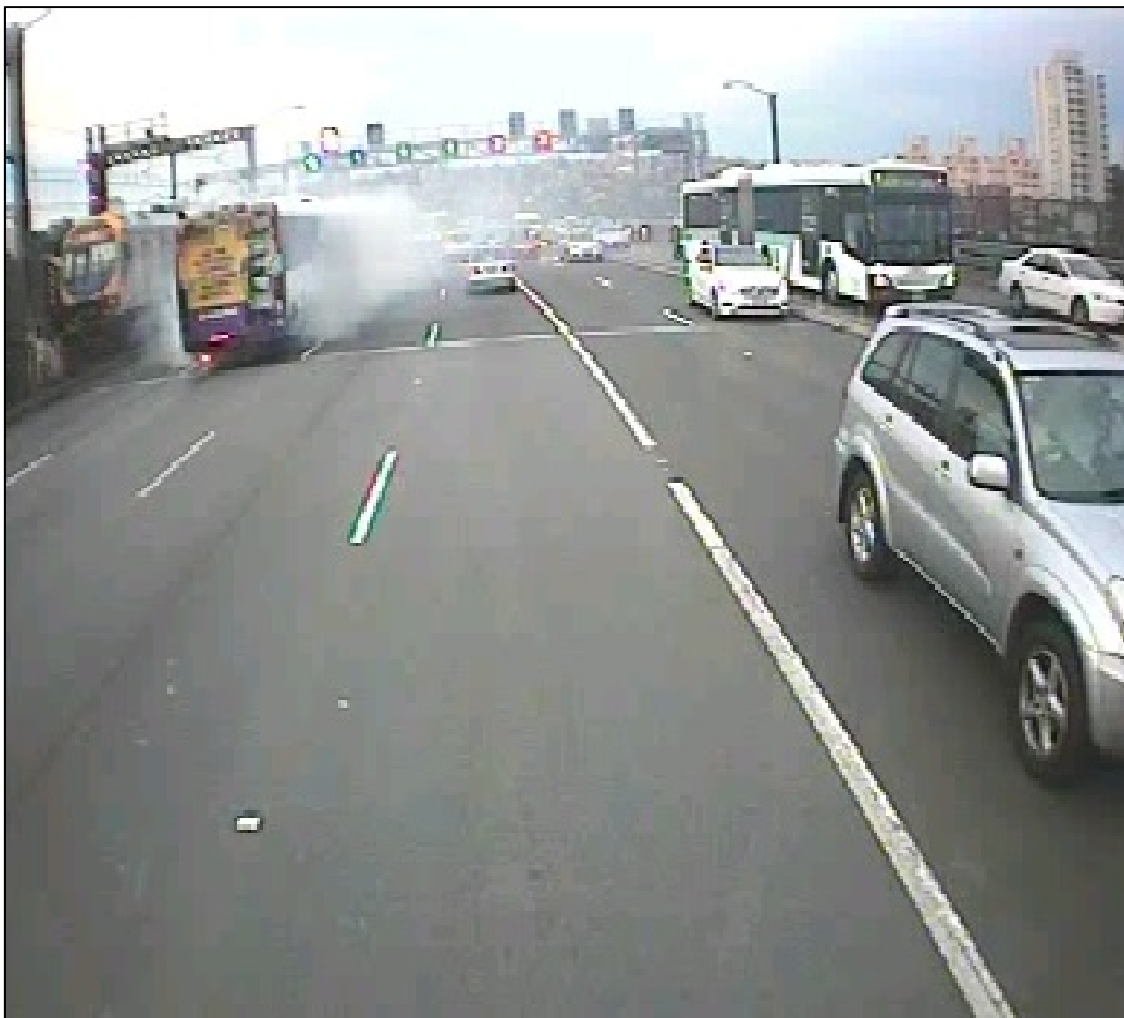
Figure 2: Bus on bridge shortly after stopping, looking north

- 1.14 The driver said the fire alarm activated as the passengers were evacuating. The passengers disembarked from the bus using both the rear and front double doors. They all stepped off the bus into lane 1. Ten passengers left by the rear door while another 12 passengers and the driver disembarked by the front door. Due to the smoke coming from the rear the driver could not see the traffic behind the bus. The driver was worried about passengers being struck by traffic as they stepped off the bus into a live traffic lane. The overhead gantry lane markings were still displaying a green arrow for lanes 1 to 4 (see *Figure 2*).

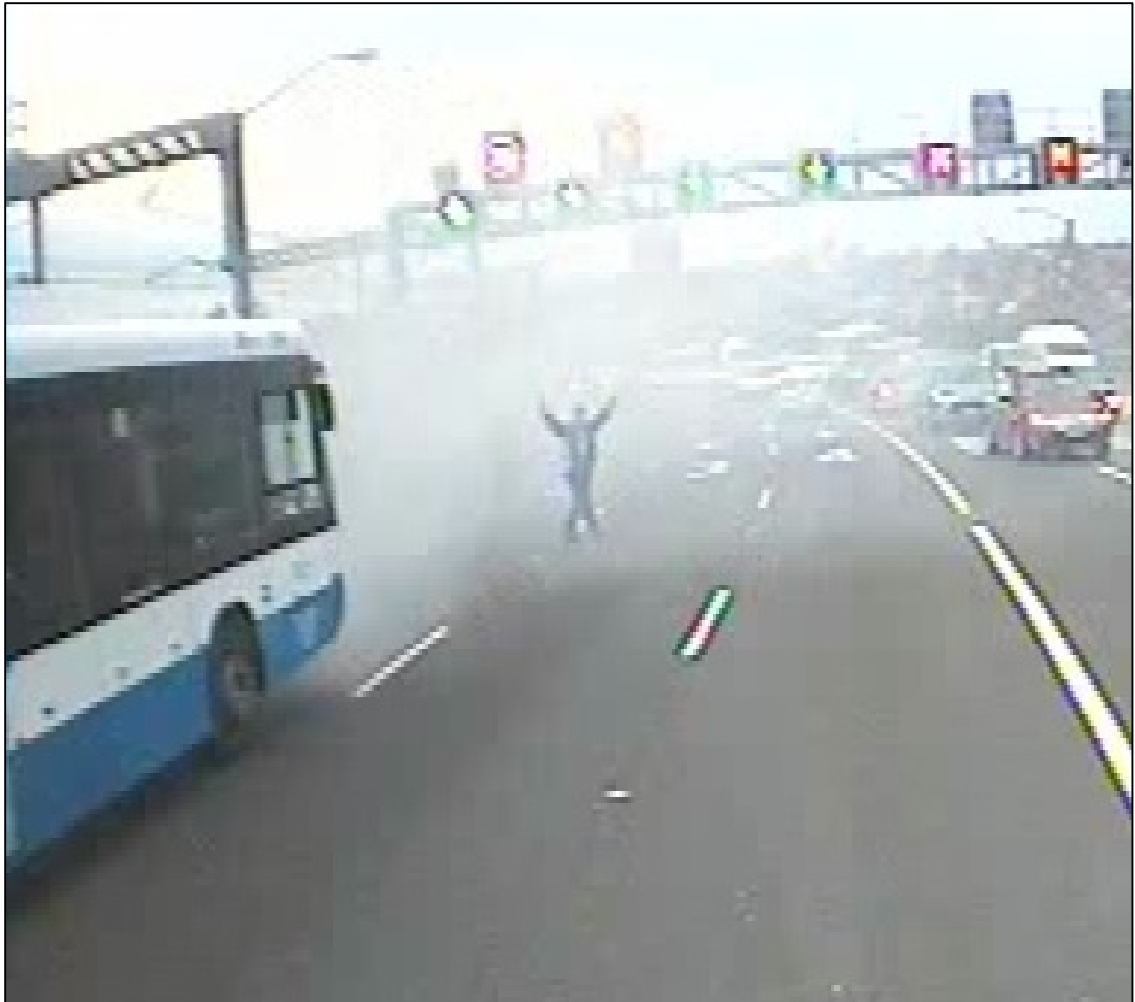
Figure 3: Driver attempted to wave down another STA bus

- 1.16 The driver left the bus for a second time and went to the front of the bus. Standing in lane 3 the driver tried to wave down another STA bus (see *Figure 3*). The other bus initially stopped but then kept going. Traffic was still coming past in lane 4. The driver was not wearing a hi-visibility safety vest and it was

left behind on the back of the driver's seat. The driver then went to the open driver's window and reached into the bus in an attempt to retrieve the safety vest. The vest was out of reach. The driver walked around the front of the bus then re-entered the bus at 1723:06. The driver took the safety vest from the back of the seat and left the bus for the third and final time.

- 2.51 The driver was not wearing a vest when first on the roadway (see *Figure 3*). The vest remained on the bus draped over the back of the seat where it was placed at the start of the trip. It is STA policy that high-visibility clothing is to be worn where appropriate. *'All staff must wear high-visibility authorised clothing and personal protective equipment when and where appropriate'*¹⁸ and *'where there is a risk of personal injury due to working in the vicinity of moving traffic.'*¹⁹
- 2.52 The driver said that it would be easier if high-visibility clothing could be worn during driving. It is STA policy that high-visibility clothing is not to be worn whilst performing operational driving duties. *'Glare and reflection from high-*

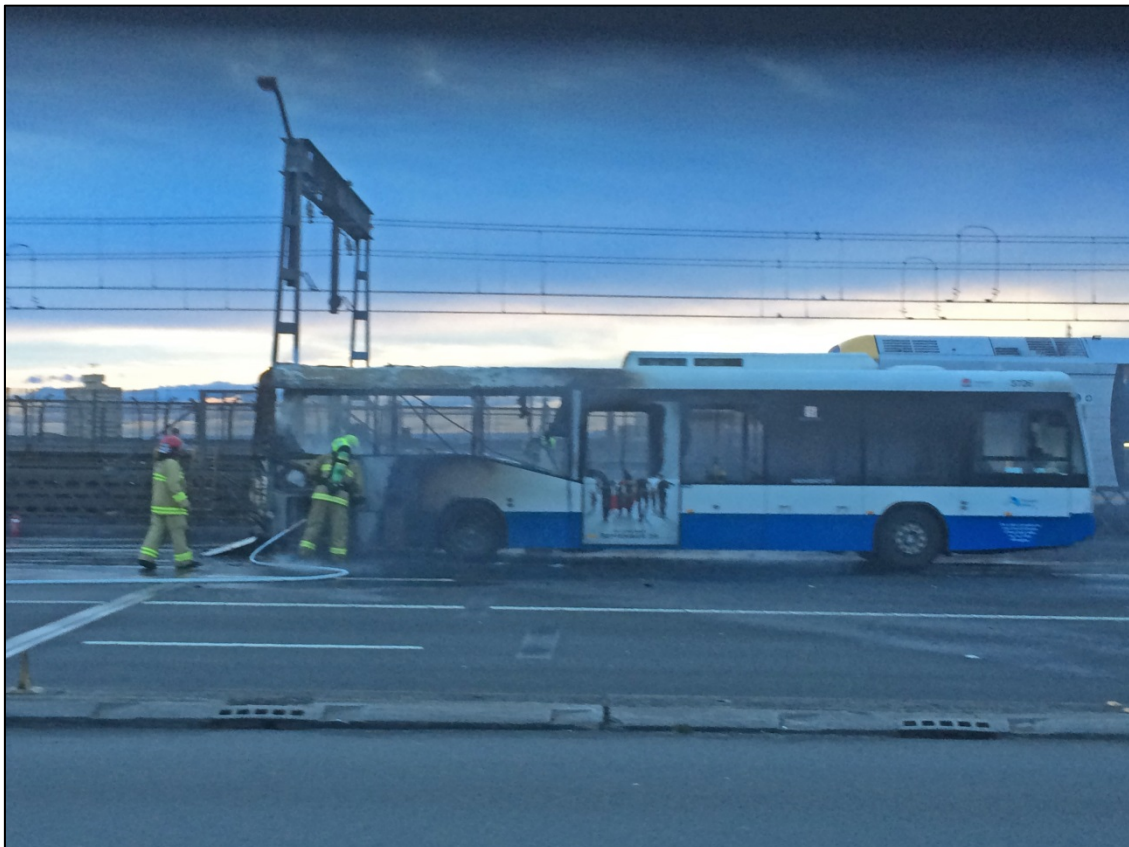
Figure 4: Bus on bridge, fire extinguished

- 1.22 The RMS emergency response crew attempted to extinguish the fire applying four portable fire extinguishers into the engine bay. Their attempts were unsuccessful as the bus fire reignited and continued to burn.

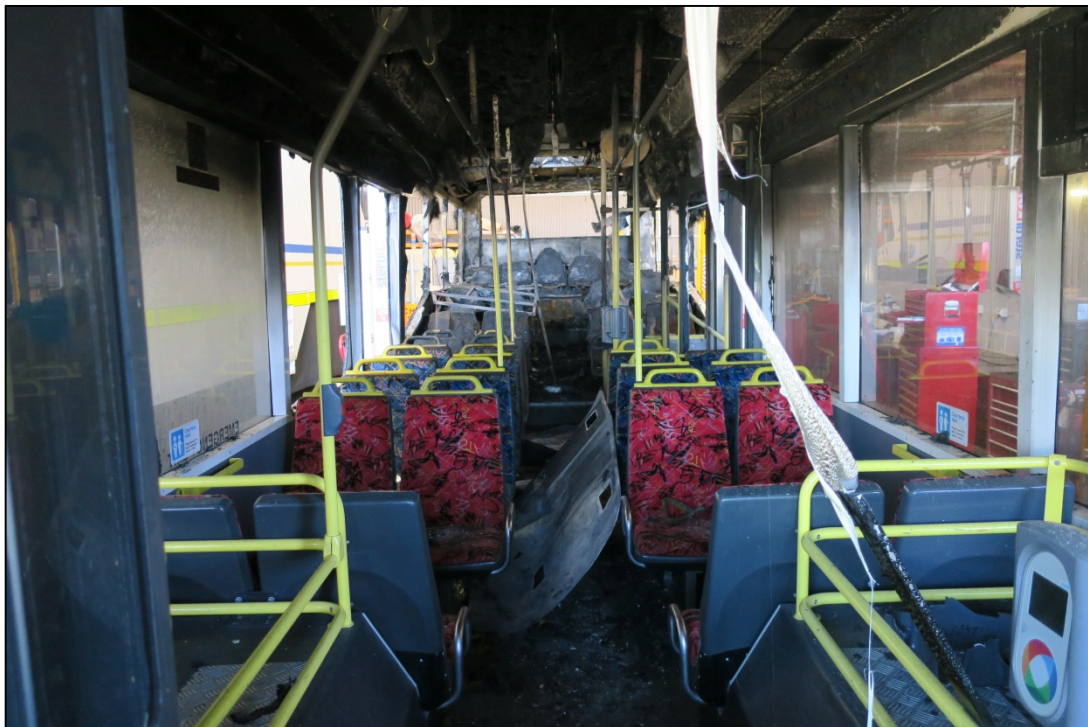
Figure 7: Interior of the bus

- 2.2 The bus sustained substantial damage particularly to the rear of the bus. The fire commenced in the engine bay, spread into the interior of the bus through the rear floor hatch, and then moved forward through the passenger saloon (see *Figure 7*). The passenger seating was destroyed up to the rear door. The interior ceiling was significantly damaged throughout the bus. The bus was not completely destroyed due to the efforts of Fire and Rescue NSW.

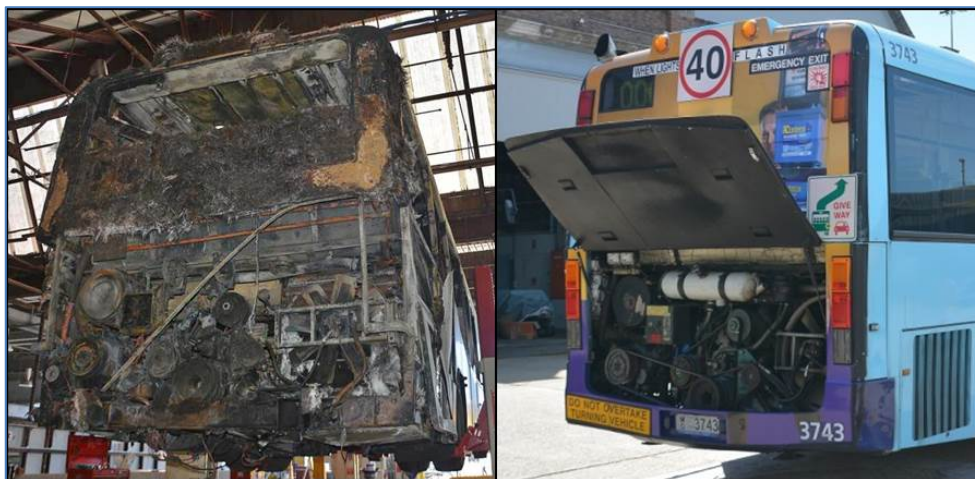
Figure 8: Left: Rear MO3726 Right: Rear of similar model bus - MO3743

- 2.3 The entire engine bay sustained considerable fire and heat damage (see *Figure 8*). Many components were melted or destroyed. This included: plastic engine bay tanks, insulation on wiring, polymer coolant hoses and some metal alloy components. Some of the liquids from these tanks and hoses added to

the fuel loading. These liquids included: diesel fuel, power steering fluid and air-conditioning coolant (ethylene glycol). According to the driver, the fuel tank was half full, containing approximately 120 litres of diesel. Also, a significant quantity of engine oil was released from the engine sump during the fire as the alloy sump melted.

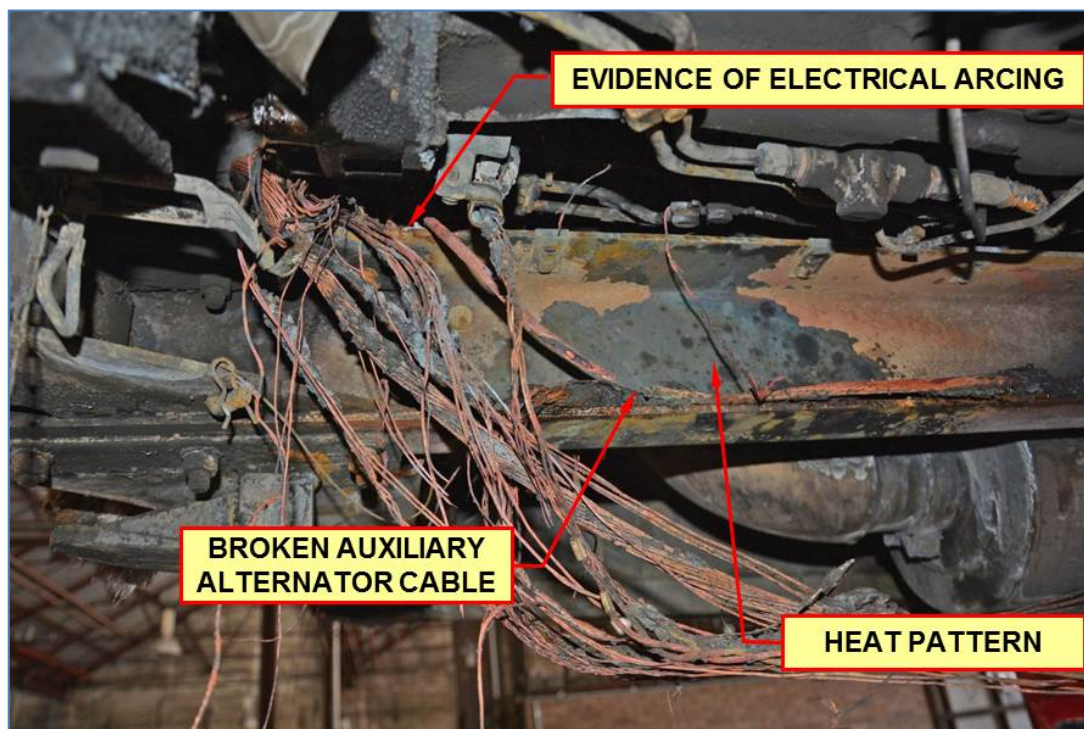
Figure 9: Chassis rail and cabling

- 2.5 The fire was initiated in the engine bay at the rear of the bus. It is likely that an electrical short circuit⁴ occurred in the area where the auxiliary alternator cables crossed the near side chassis rail. There was evidence of electrical arcing on the edge of the chassis rail and one of the cables was severed at the point where it crossed the rail (see *Figure 9*).
- 2.6 The cables from the primary alternator also showed evidence of a short circuit. The heat effect was less in this area compared to the auxiliary alternator cables. The STA technical investigation found:

*'The main B positive and B negative cables from the auxiliary alternator that connect to the main B positive terminal of the starter motor and B negative to the near side rear (NSR) main chassis rail had both been severed by a major short circuit from contacting the upper edge of the NSR chassis rail. The evidence indicates that this high amperage short circuit caused ignition of flammable materials in close proximity of this area and was the source of the fire. On inspection the auxiliary alternator was found to be seized: the damage consistent to a high level current passing through.'*⁵

- 3.2 It is likely that the initiation of the fire was caused by a short circuit of the auxiliary alternator cables where they crossed the edge of the near side rear chassis rail. There was evidence of the B positive cable being severed and electrical arcing marks on the chassis rail in this vicinity.

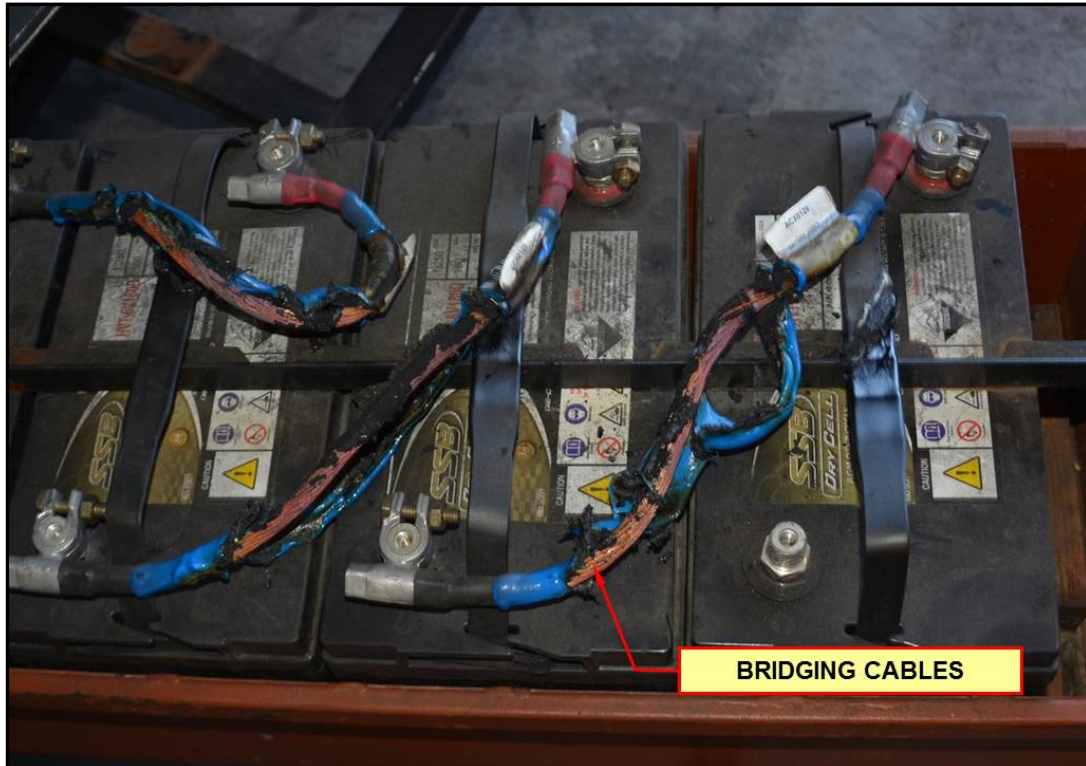
Figure 10: Batteries and melted insulation on bridging cables

from the batteries at the front of the bus to the engine bay. This may have caused the fire to intensify due to the continuous supply of thermal energy.

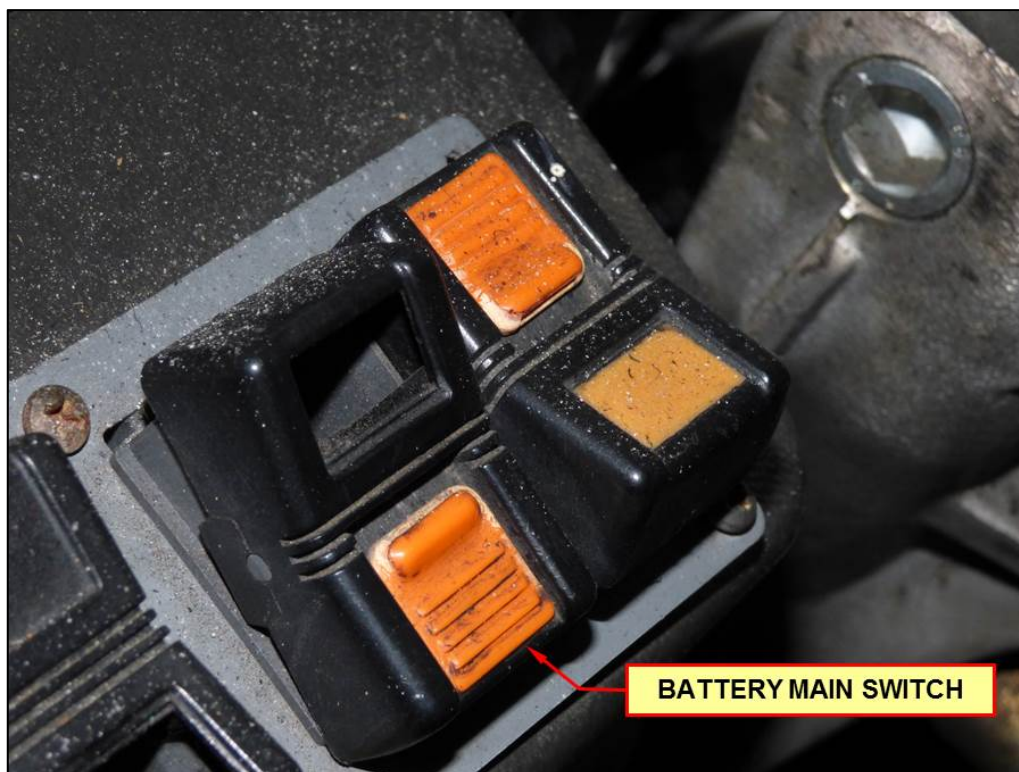
Figure 11: Battery main switch in 'on' position

- 2.9 The battery main isolation toggle switch was located on the dashboard of the bus (see *Figure 11*). Like many switches on the dashboard, there was no label to indicate its purpose. The switch was not equipped with a mode indicator light. The driver was familiar with the location and operation of the switch. As a trained mechanic, the driver would also be aware of the importance of switching the power off. It was likely that the driver overlooked this step in the rush to evacuate the bus.
- 2.10 On this model bus there was no other battery isolation switch. On some other model buses manual battery isolation switches are found in the battery compartment or in the engine compartment. The dash mounted battery isolation switch on this bus was identical in functionality to a manually operated battery isolation switch.

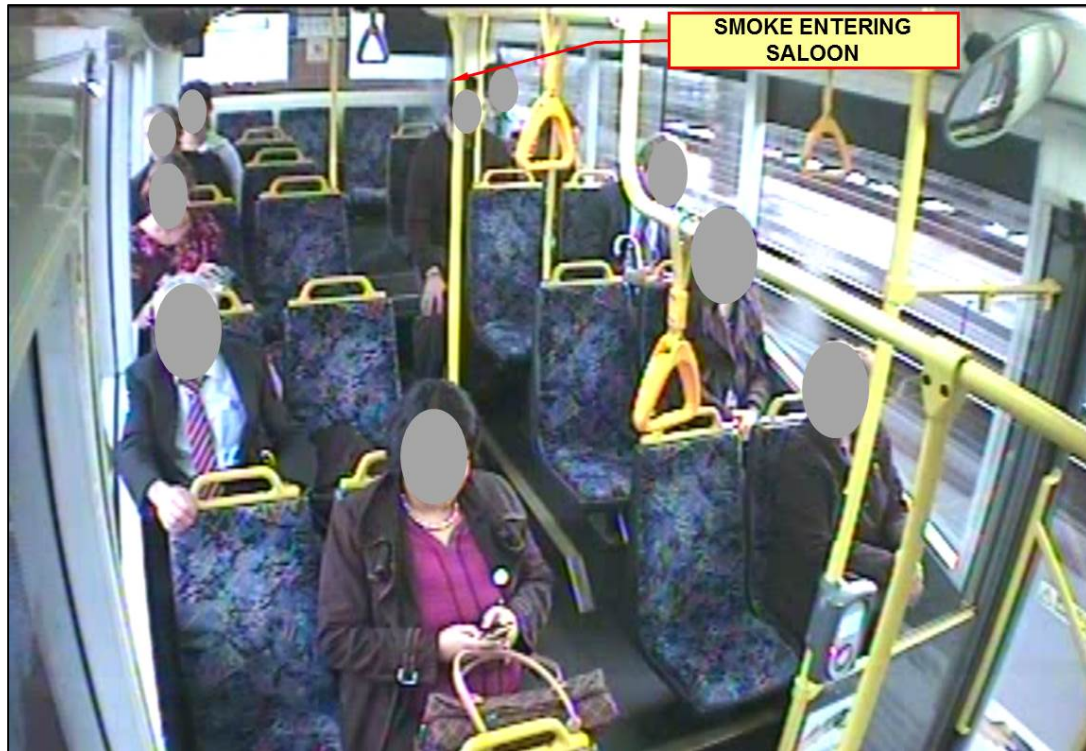
Figure 12: Passengers seated at rear of bus as smoke enters saloon

- 2.12 CCTV shows that smoke started entering the passenger saloon at 1722:06 in the vicinity of the nearside rear corner (see *Figure 12*). It is possible that a heat seal failed when subjected to intense heat or flames from the engine bay. Joints are sealed to ensure that gases from the engine bay do not enter the passenger saloon during normal operation. The sealant will eventually fail if exposed to fire or intense heat.

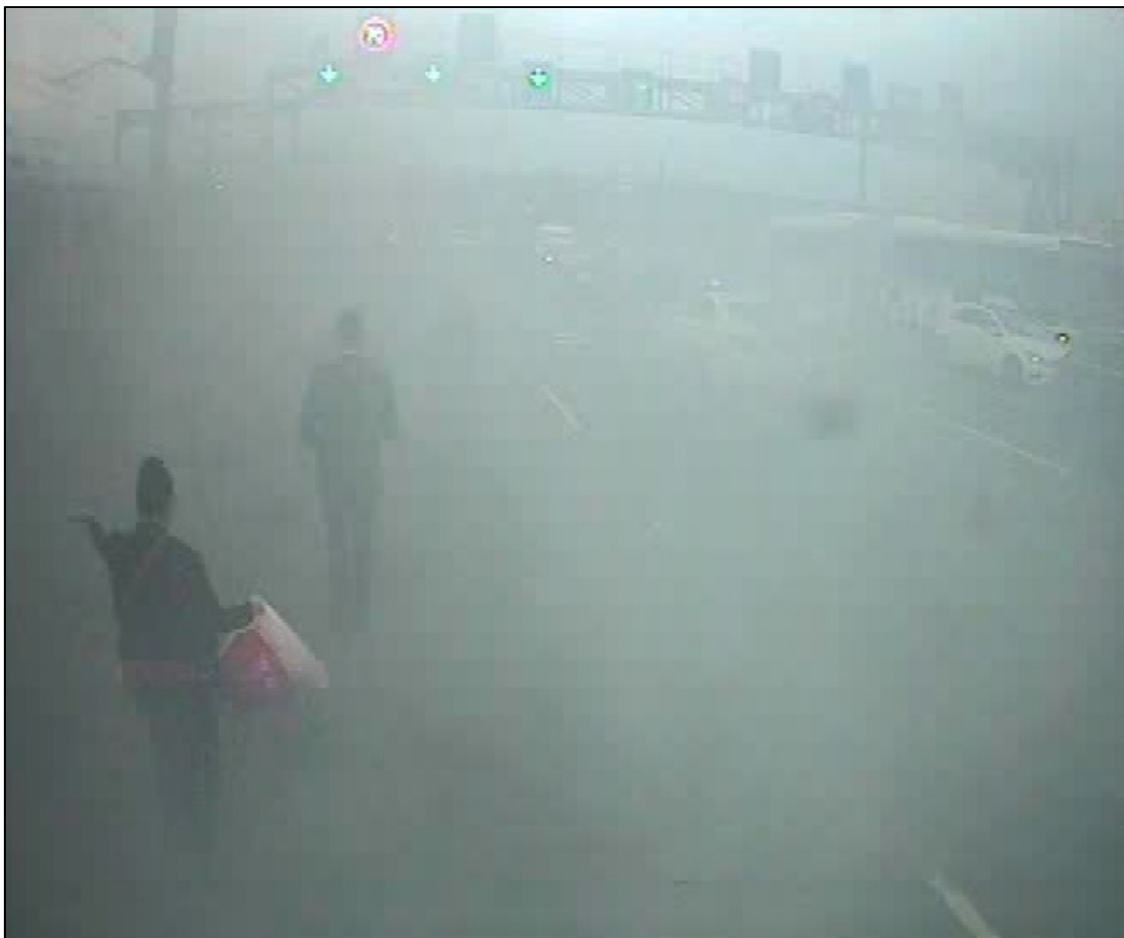
Figure 13: Looking north: passengers evacuating from bus

- 2.15 The passengers moved quickly from their seats when alerted by the driver. They all stood and waited by their nearest door for the bus to stop. After the bus was brought to a halt, the driver applied the handbrake, opened the doors and told the passengers to evacuate. All persons were off the bus within ten seconds (see *Figure 13*).
- 2.16 The driver stepped off the bus just before the last passenger stepped off the bus. About 90 seconds later the driver approached the bus and looked inside the bus through the front windscreen. Although being fairly certain that all the passengers were off, the driver said it was a final check to see if anyone was still on board.
