## **BUS SAFETY INVESTIGATION REPORT**

**MULTIPLE BUS FIRES**

**SYDNEY AIRPORT, MASCOT, NSW**

**4 DECEMBER 2016**

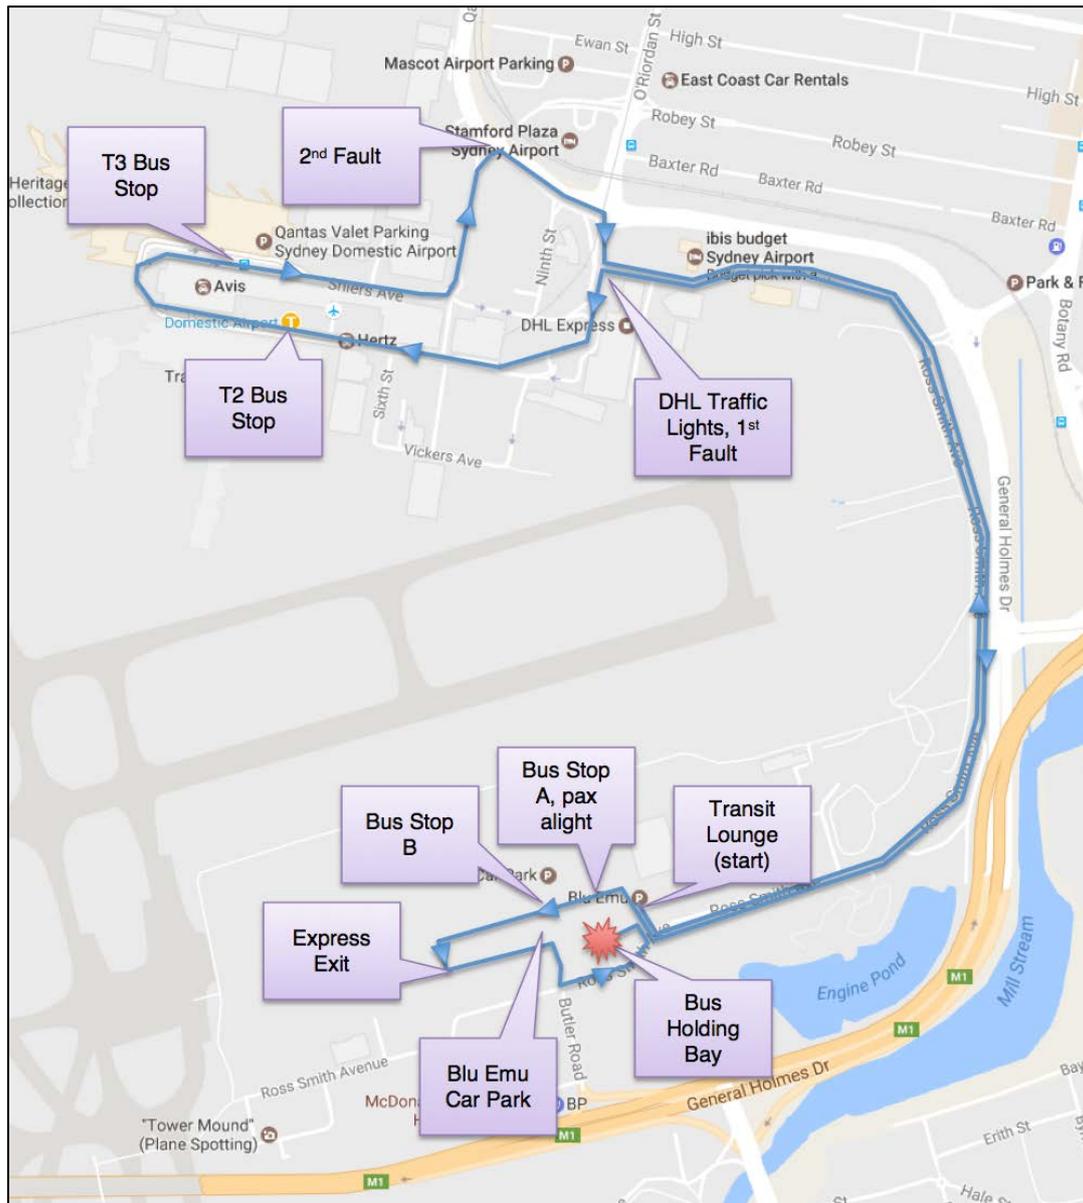
Figure 1: A map depicting the path of TV5179.

- 1.3 The driver operating roster BD1 departed with TV5179 from the Blu Emu Car Park (BECP) Transit Lounge at 1424. As the driver approached the DHL traffic lights (see *Figure 1, 'DHL Traffic Lights 1<sup>st</sup> Fault'*) the driver noted an audible alarm and a red warning light illuminated on the driver's dashboard. While stationary at the traffic lights, the driver performed a reset<sup>2</sup> of the system by turning the bus off and then restarting it. As a result of this reset process, the audible alarm and red warning light deactivated. The driver then continued.

- 1.5 After departing Terminal 3, the bus was still operating correctly however, after stopping at a set of traffic lights on the corner of Robey Street and Qantas Drive (see *Figure 1, '2<sup>nd</sup> Fault'*), the audible alarm and the red warning light reactivated.

- 1.9 The driver was instructed by the DM to return to the BECP and to disembark all passengers at stop "A" (see *Figure 1, 'Bus Stop A, pax alight'*), move the bus to the holding bay and wait for further instructions.

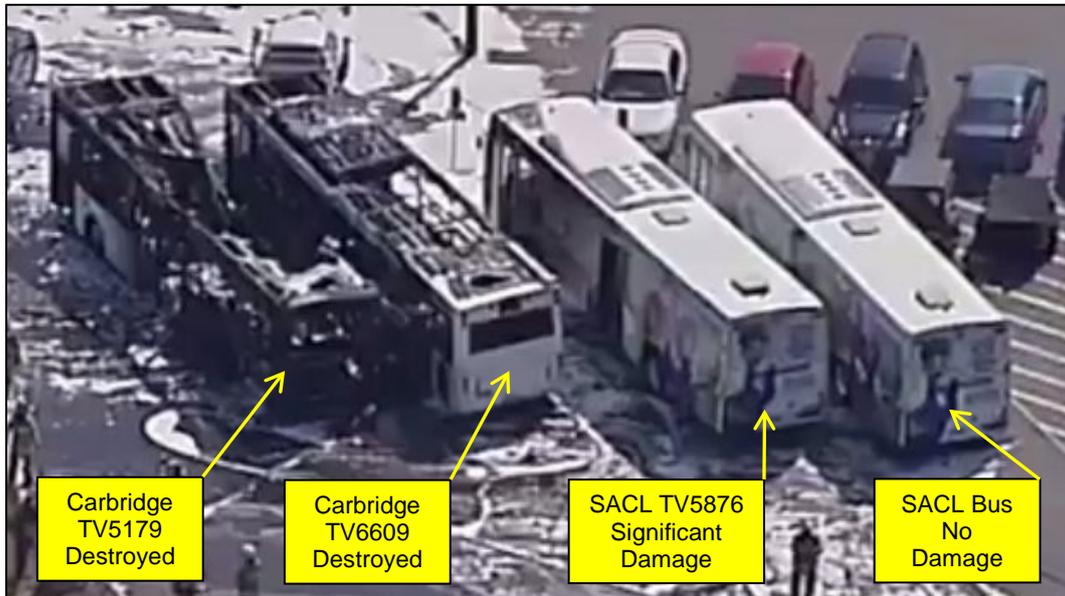
Photograph 1: Positioning of the two Carbridge buses and the two SACL buses

1.12 According to a passenger's statement, several passengers at the rear of the bus had requested the driver to open the door whilst others attempted to open the doors using the emergency exit door release button. The smell of smoke in the rear of the passenger cabin was evident. Once all the passengers had disembarked the bus, the driver walked through the bus to verify all passengers had evacuated.

- 1.14 The CCTV<sup>4</sup> system on board TV5179 was damaged by fire and the recorded footage was not retrievable. OTSI was able to review footage of the incident from other Carbridge buses that were parked within the holding yard.
- 1.15 The investigation report supplied by Carbridge said that SACL CCTV footage from carpark cameras indicated a small amount of smoke emanating from TV5179 at 1451 as it passed the BECP express gates.
- 1.16 Review of the available footage indicated that at 1453 TV5179 arrived at the bus holding bay within the BECP and the driver then parked the bus. The driver exited TV5179 and walked down the length of the bus. At this point, TV5179 was parked next to Carbridge bus TV6609. A SACL bus (TV5876) was parked next to TV6609 with another, SACL bus parked alongside.

- 1.17 At 1459 the driver reversed TV5177 and positioned the bus ready for the relieving driver to arrive. The reversing camera from this bus indicated that there was no visible fire activity on TV5179 at this point.
- 1.18 At 1459:52, the CCTV footage on TV5177 showed smoke emanating from the rear of TV5179.
- 1.19 The driver then ran towards TV5177 and obtained a fire extinguisher located in the cabin of the bus. The driver then ran towards the burning TV5179; however the DM instructed him that this was too dangerous as the rear of TV5179 was now fully ablaze.
- 1.20 The fire on TV5179 spread to the adjacent bus TV6609. The DM and the driver contacted emergency services and stood clear, away from the flames.
- 1.21 TV5179 and Carbridge bus TV6609 were both destroyed in the fire. A SCAL bus was also extensively damaged as a consequence of the fire.

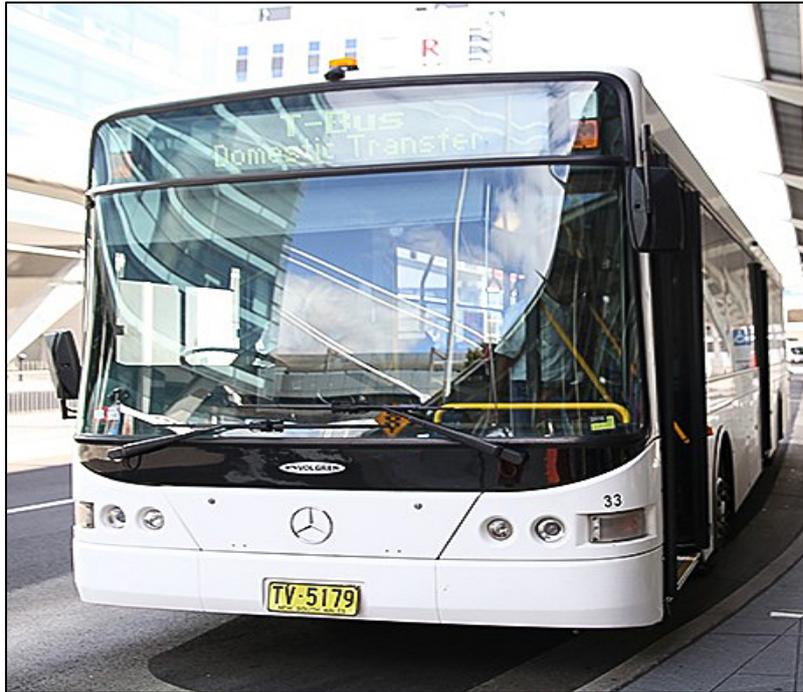
Photograph 2: Carbridge Bus TV 5179 prior to the fire.

- 1.29 The bus was a diesel fuelled 2004 model Mercedes OC500LE. The body was built by Volgren and was registered in NSW as TV5179 (*see Photograph 2*).

- 1.30 The odometer reading at the time of the incident was 774,158 km. Maintenance records indicate that the bus had a routine service on 31 October 2016. There were no defects detected in the engine bay area during this check. A Roads and Maritime Services (RMS) Heavy Vehicle Inspection Scheme (HVIS) inspection was carried out on the 29 July 2016. No defects were recorded as a result of this inspection.
