BUS SAFETY INVESTIGATION REPORT

**CHARTER BUS FIRE
HOMEBUSH, NSW
8 FEBRUARY 2017**

Investigation Reference 04765

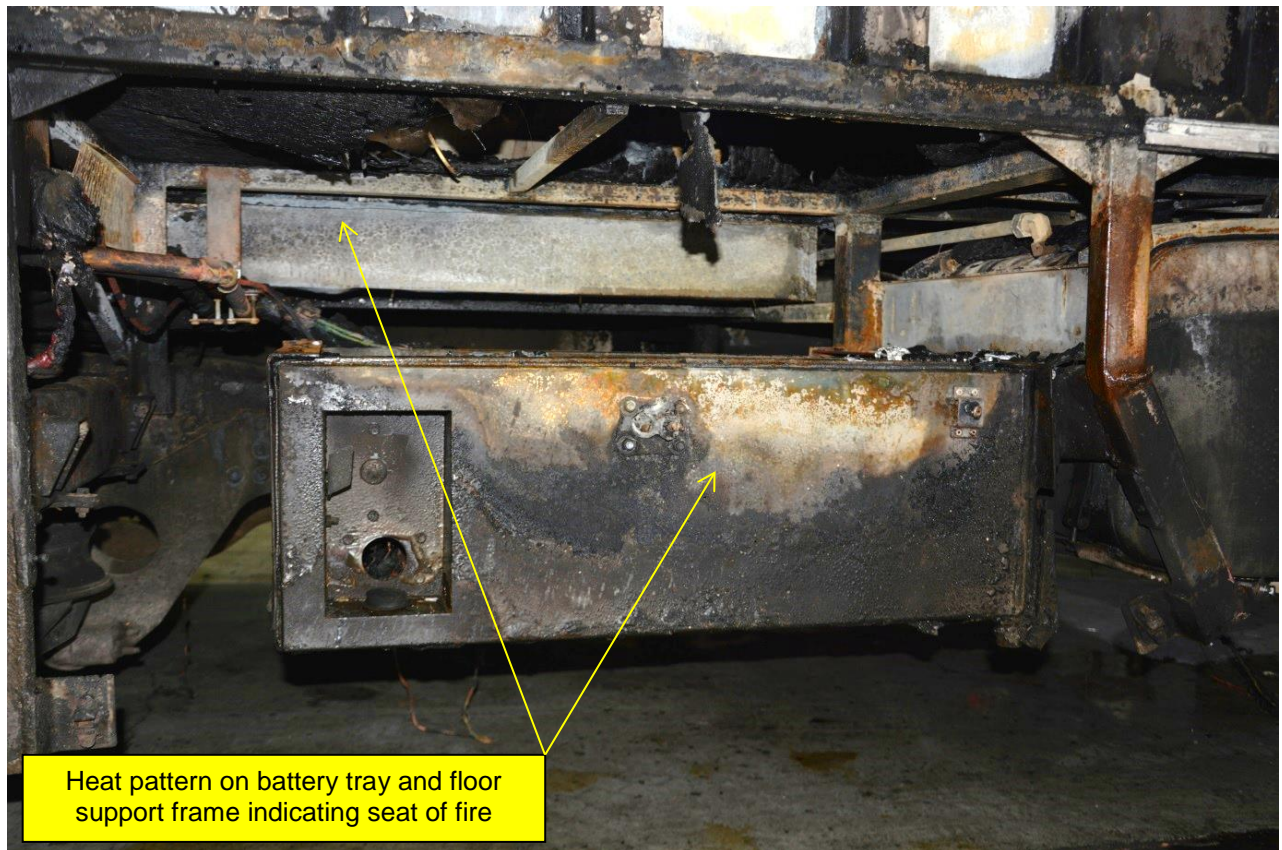
Figure 3: Heat pattern on battery tray assembly

- 2.8 The positive battery cable terminal exhibited evidence of an electrical short circuit between the terminal and the metal battery retainer attached to the battery storage tray (see *Figure 5*).
- 2.9 Heat patterns observed on the side of the battery storage tray and floor support frame indicated that the fire initiated from the two 12V DC batteries (see *Figure 3*).

2.10 The fire then consumed flammable materials in the vicinity of the battery tray and penetrated into the passenger saloon area through the timber flooring directly above the battery storage area.

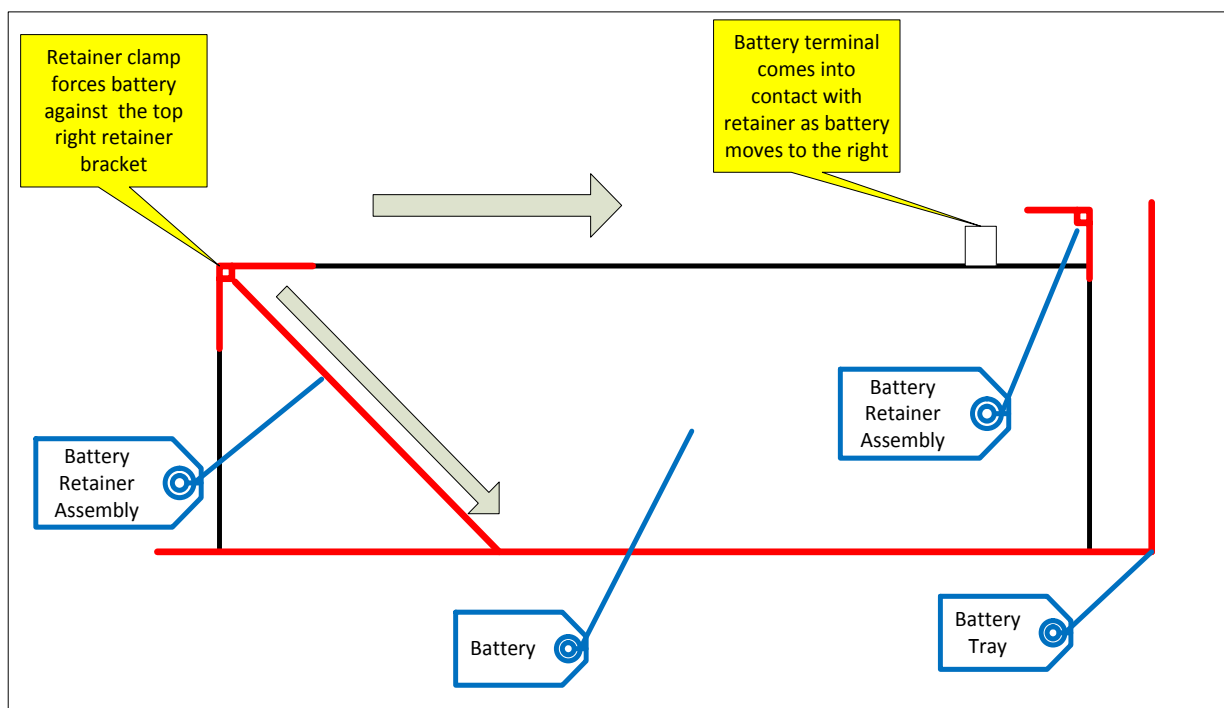
Figure 4: Schematic (profile) of battery tray assembly and retainers

- 2.19 The batteries are located under the floor at the NSR of the bus behind the rear axle (*see Figure 2*). A "swing out" tray provides accessibility during maintenance.
- 2.20 The batteries are secured to the tray by two right-angled metal retainers. The metal retainers run across the upper corners of each end of the two 12V DC batteries and are secured to the battery tray assembly.
- 2.21 Inspection of a similar model bus indicated that a gap of approximately 15mm between the rearward retainer and the battery that could allow the terminal end of the battery to move under the retainer allowing the positive terminals to contact the metal retainer causing an electrical short circuit³ of the battery (*see Figure 6 and 4*).

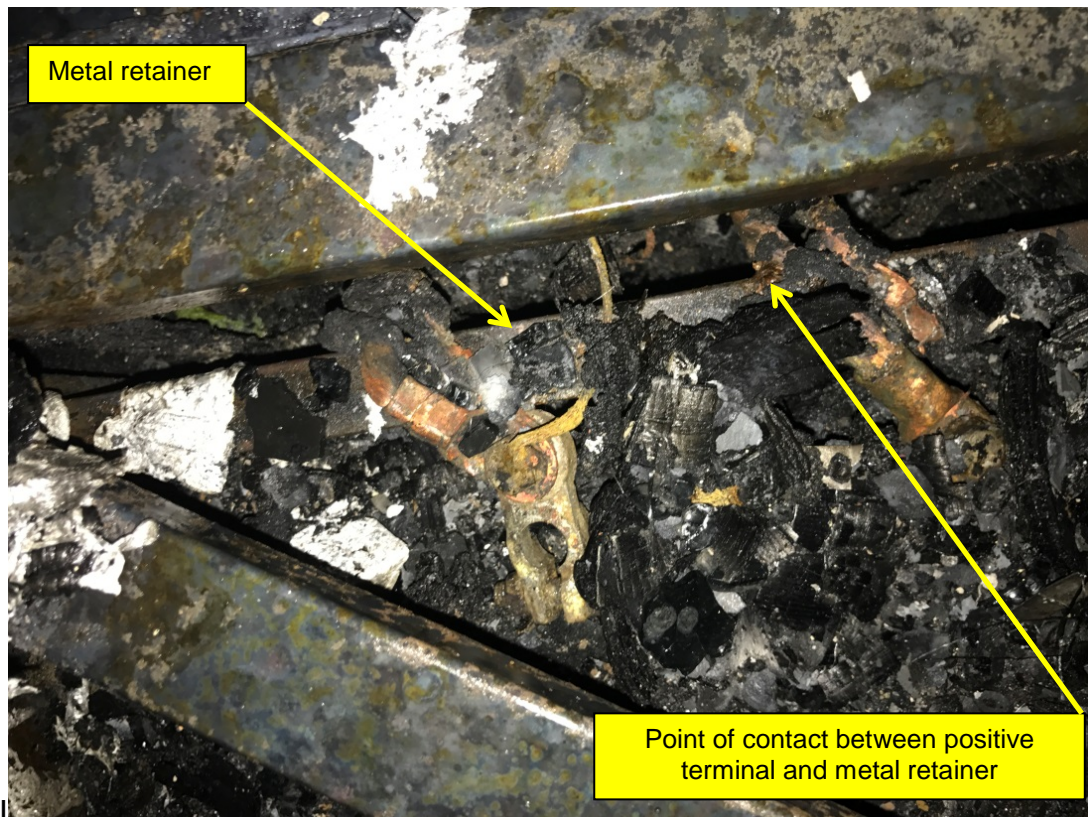
Figure 5: Demonstrates the short-circuited terminals on TV8308

- 2.23 An inspection of the bus revealed that the positive terminal had come into contact with the rearmost metal retainer causing the terminal to short circuit (see *Figure 5*).

- 2.24 It was determined the heat generated by the short circuit initiated the fire and the fire propagated through the timber flooring and into the rear of the bus.

- 4.1. OTSI determined that the battery positive terminal made contact with the battery retainer and created a short circuit.
- 4.2. The load on the battery from the short circuit has caused the battery to overheat and catch fire.

- 5.3. To include the specific instruction for the inspection of battery retainers and in particular, the integrity of cabling and protective covers on the terminal posts of batteries fitted to their fleet.
- 5.4. Include operational controls, in specific, the emergency door operation functions and evacuation procedures, in their induction and training resources.

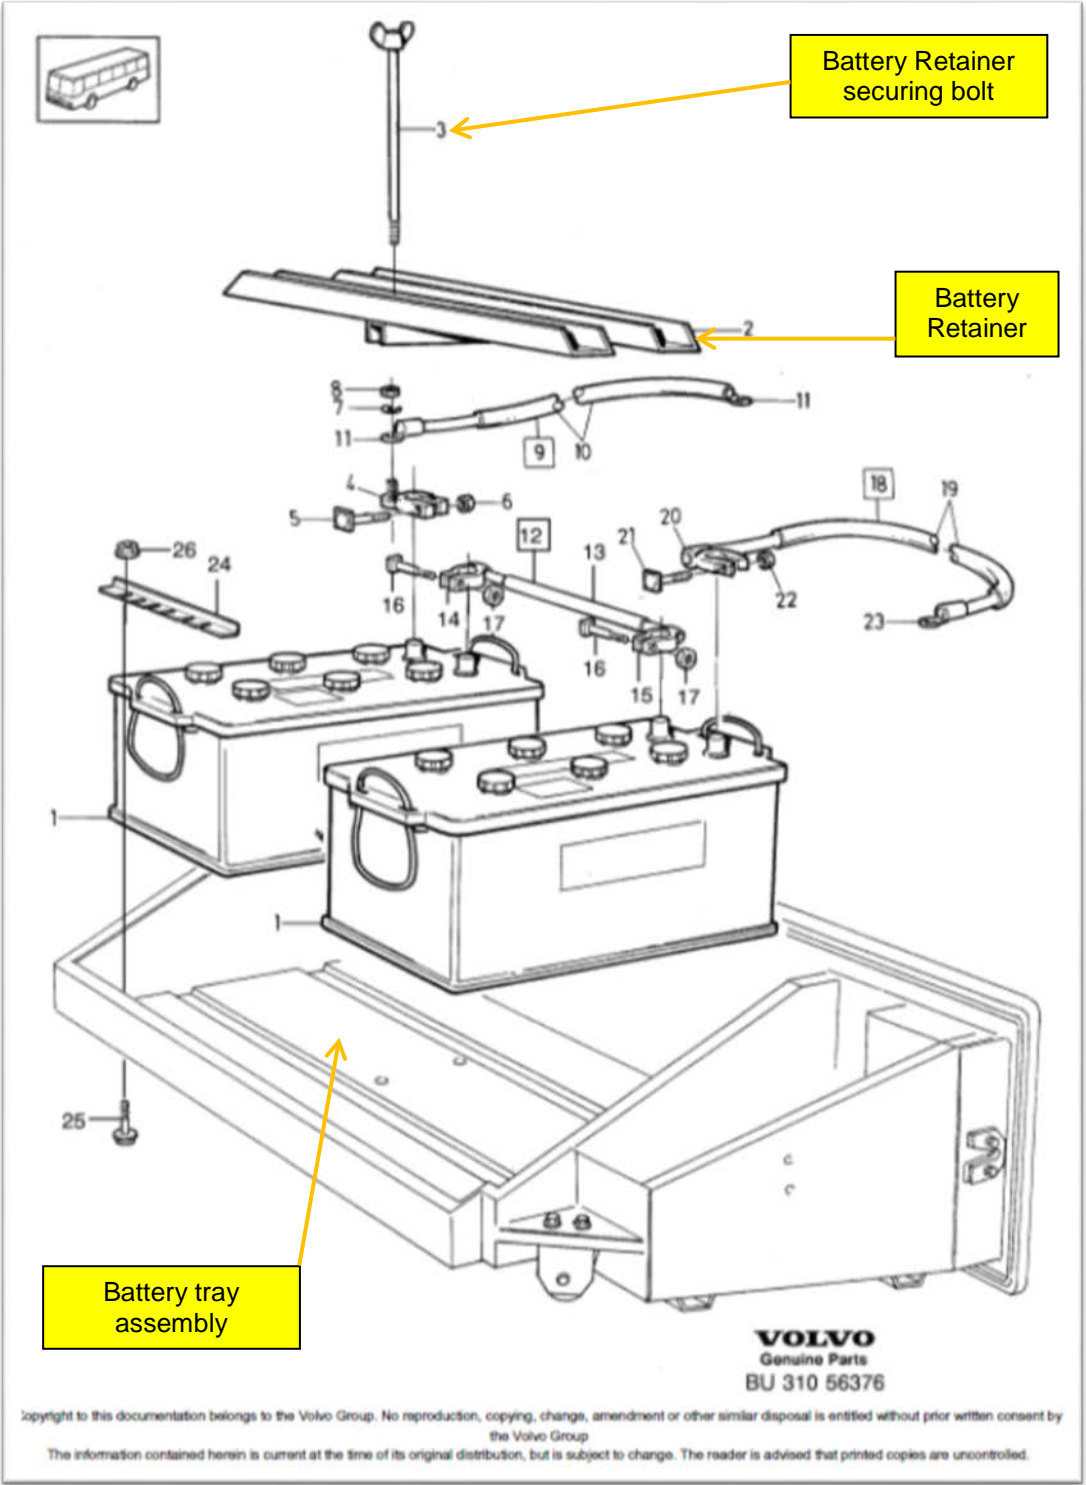
Figure 8: Schematic of OEM battery compartment

- 2.22 The configuration of the battery tray on the damaged bus and other similar model Volvo B10M's had been unaltered since they were introduced into in the Telfords fleet, however information supplied by the Original Equipment Manufacturer (OEM) (*Volvo Bus Australia*) indicated that the battery retainer fitted to the bus at the time of the incident was not as originally designed (see *Figure 8*).

- 4.3. The battery retainer design was different to that originally fitted by the OEM.
- 4.4. The safety inspections scheduled by Telfords maintenance department, identified as Activity ID S 1637, specify in step 97 “*Check / top up battery level & check terminals*”. However, there is no specific instruction to check the security of the batteries or battery mountings as required by the NHVIS.
