Office of Transport Safety Investigations

BUS SAFETY INVESTIGATION REPORT

SCHOOL BUS FIRE

6 MARCH 2017

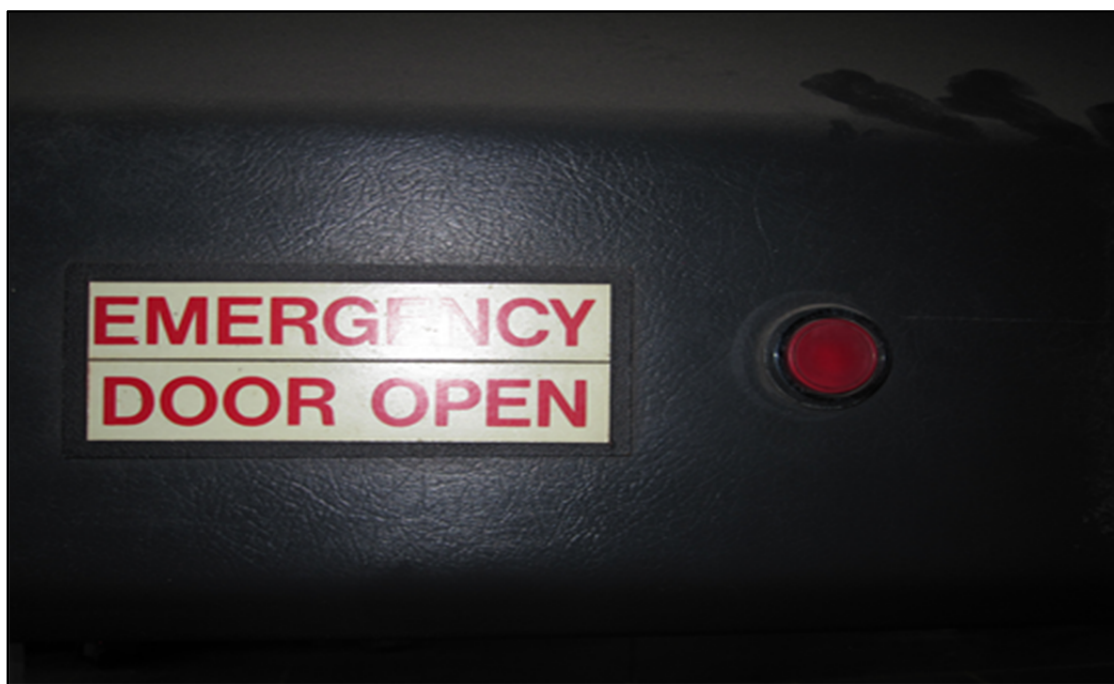
Figure 2: Emergency door release button

- 1.3 The driver pulled to the side of the road just as the bus lost all power. The driver turned the ignition off. With the cabin filling with smoke, the driver decided to evacuate the bus by opening the front door. The door failed to open so the driver attempted to open the door with the emergency release button located above the door (see *Figure 2*).

- 1.4 The driver pressed the button and then pulled at the folding type door, which resisted any attempt at moving. The driver, never having operated this emergency button previously, struggled against the door then pressed the button again and noted the door moved slightly. The driver realised that by holding the button while applying force to the door, air was released from the system and allowed the door to open.
- 1.5 The driver instructed the children to slowly leave the bus and directed them to an open space away from the bus and traffic. The driver instructed one of the older children to take charge of keeping the group of exiting passengers together and to count how many were present.

- 2.16 Research (Leach 2004), has shown that not everyone reacts well in emergency situations. During this incident there was a delay in evacuation due to the driver's unfamiliarity with the door release.

- 4.1 Examine the design and placement of electrical cabling on all buses to reduce the likelihood of short circuit events occurring.
- 4.2 Conduct driver training at regular intervals to maintain drivers' familiarity with current emergency procedures, emergency door operation and use of fire extinguishers.
- 4.3 Review training for maintenance personnel to increase their awareness of likely fire initiation points.
- 4.4 Ensure maintenance procedures encapsulate techniques to identify fire initiators and recommended practices to prevent fire events.

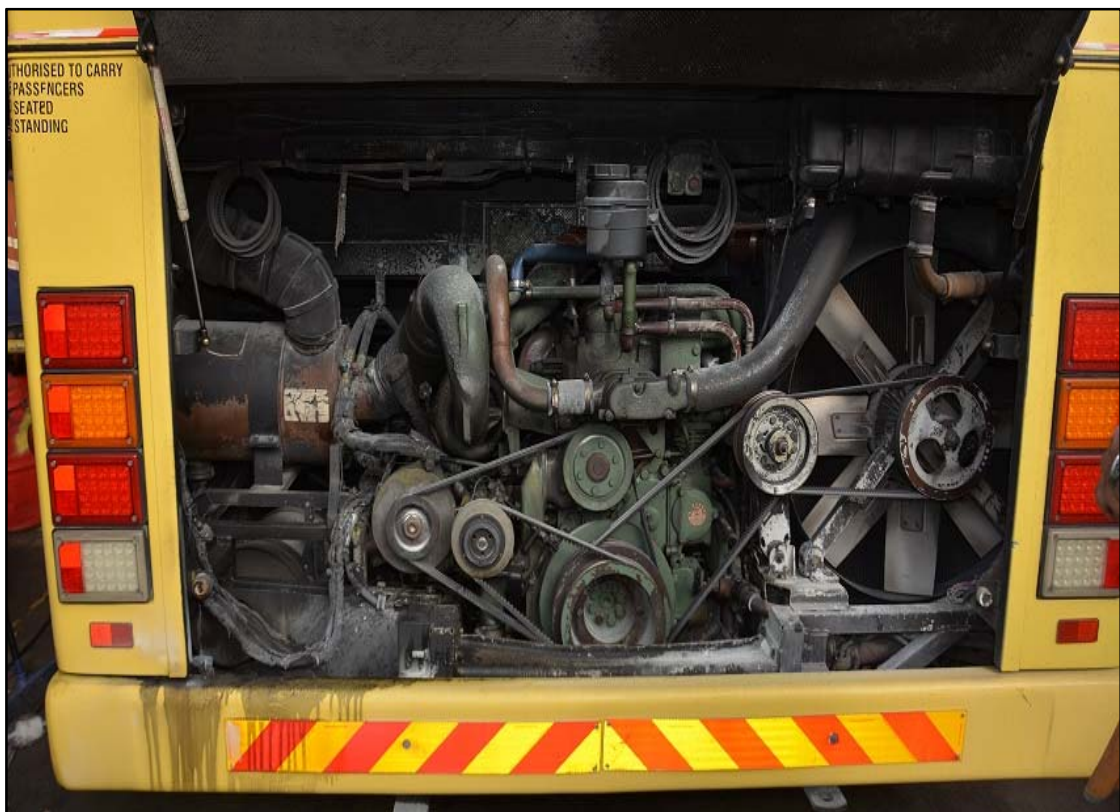
Figure 6: Fire damage restricted to left side of engine bay

- 2.2 The fire damage was limited to the engine bay area. There was wiring damage inside the engine bay and smoke stains near engine bay openings. The damage was restricted to the left hand side of the engine bay (see *Figure 6*).

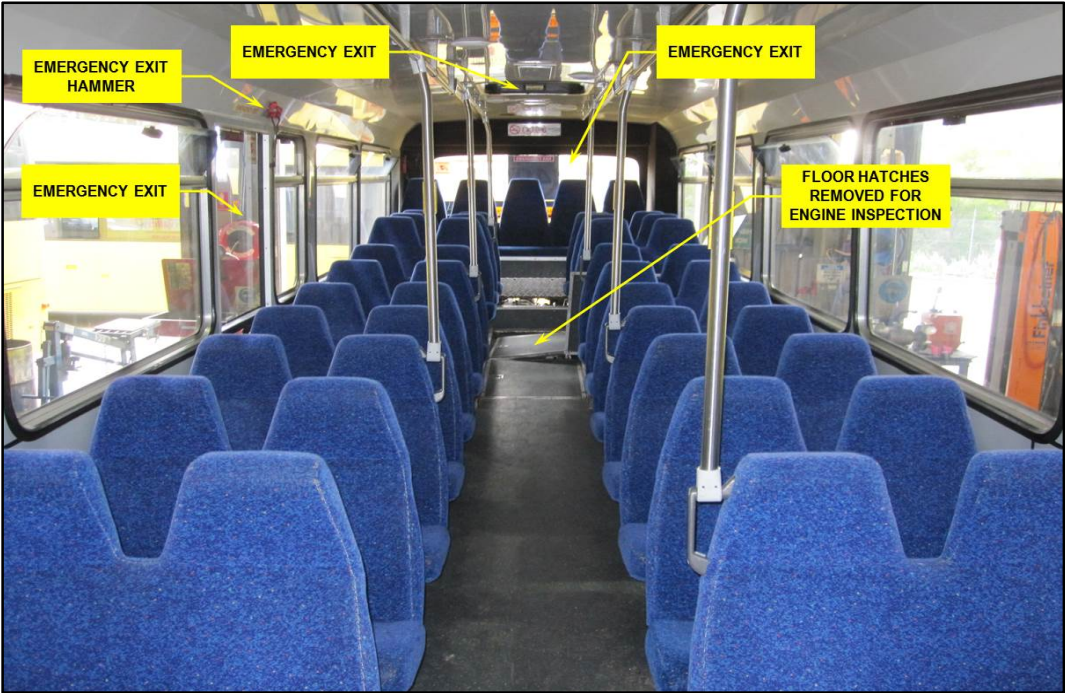
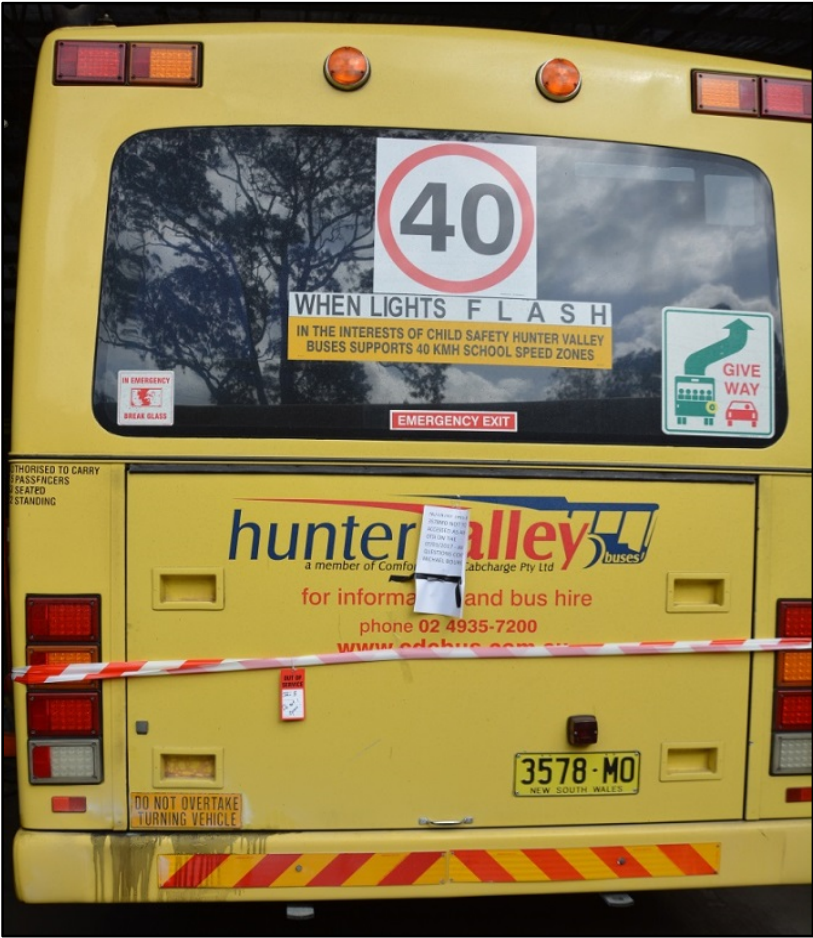
- 2.3 The exterior and passenger area of the bus suffered no discernible damage (see *Figure 7 and 8*).

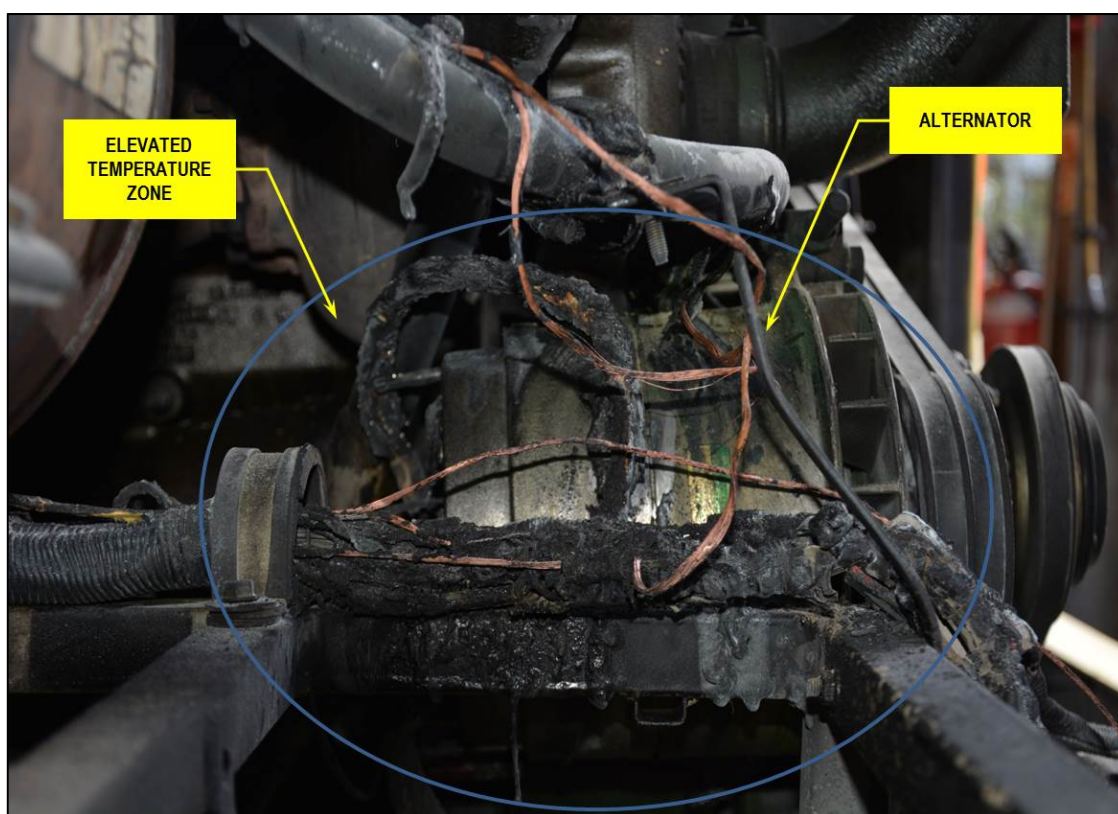
Figure 9: Heat damage around alternator

- 2.4 The investigation found that it was likely that the fire started due to an electrical malfunction in the engine bay at the rear of the bus. The area of the left hand side of the engine bay exhibited high levels of carbonisation and exposure to elevated temperatures (see *Figure 9*).
- 2.5 Two areas were identified as possible initiation points, both were in the lower left hand area of the engine bay: the cabling from the rear of the alternator; and the wiring loom on the left hand side of the engine bay.
- 2.6 Around the alternator the plastic insulation on the cables on the left hand side was significantly destroyed by the fire (see *Figure 9*).

- 3.1 The fire started due to an electrical short circuit in the wiring on the lower left hand side of the engine bay at the rear of the bus. Two areas were identified as possible initiation points: the cabling from the rear of the alternator; and the wiring loom on the left hand side of the engine bay.
- 3.2 From the short circuit, flammable materials ignited. This lead to the air conditioning refrigerant pipe rupturing which released flammable vapour and accelerated the engine bay fire.
- 3.3 Routine maintenance carried out at the depot did not detect any cable chafing problems before the fire.
- 3.4 An engine bay fire suppression system was not fitted to the bus.

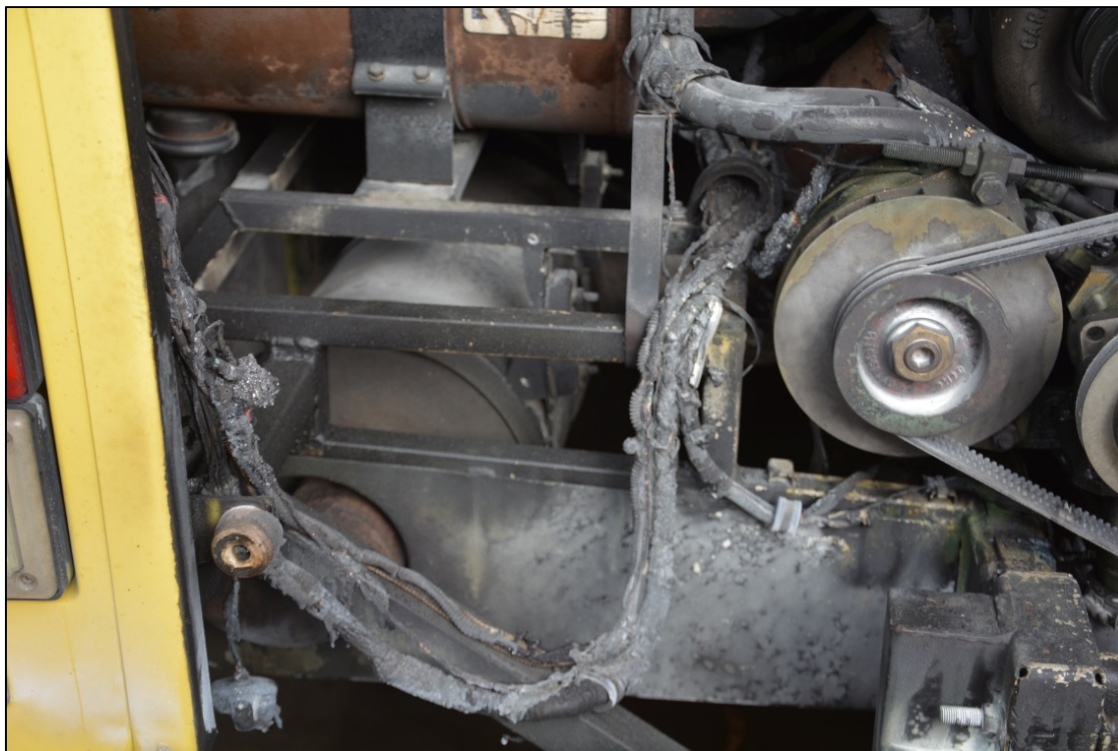
Figure 10: Damaged and melted insulation on left hand side of engine bay

- 2.7 Another area of high thermal activity was the wiring installed on the left hand side of the engine bay. (see *Figure 10*). There was evidence of damaged and melted insulation.

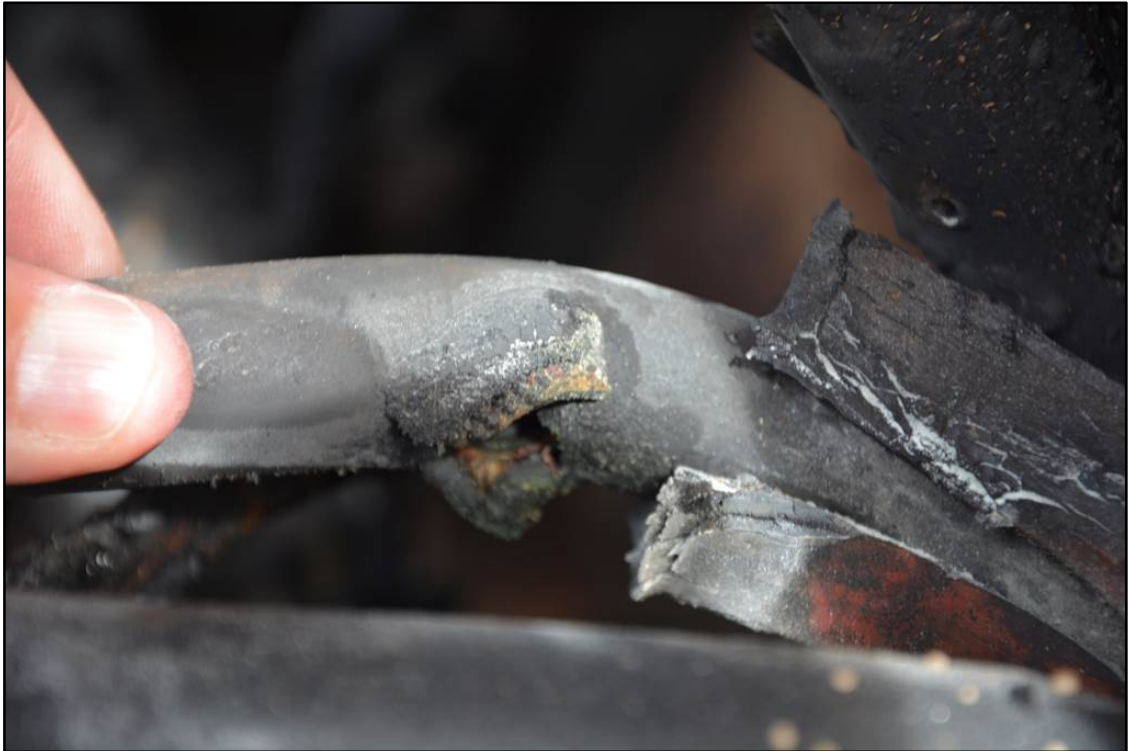
Figure 11: Damaged air-condition refrigerant hose

- 2.8 Once the cabling insulation was alight it would have spread to other plastic combustibles. Consequently, flames would have contacted the air-conditioning refrigerant pipe. This pipe ruptured and has likely released a mixture of combustible vapour and refrigerant oil (see *Figure 11*). The air-conditioning gas combusts at around 650°C and it is likely that this assisted in spreading the flames observed by the driver.

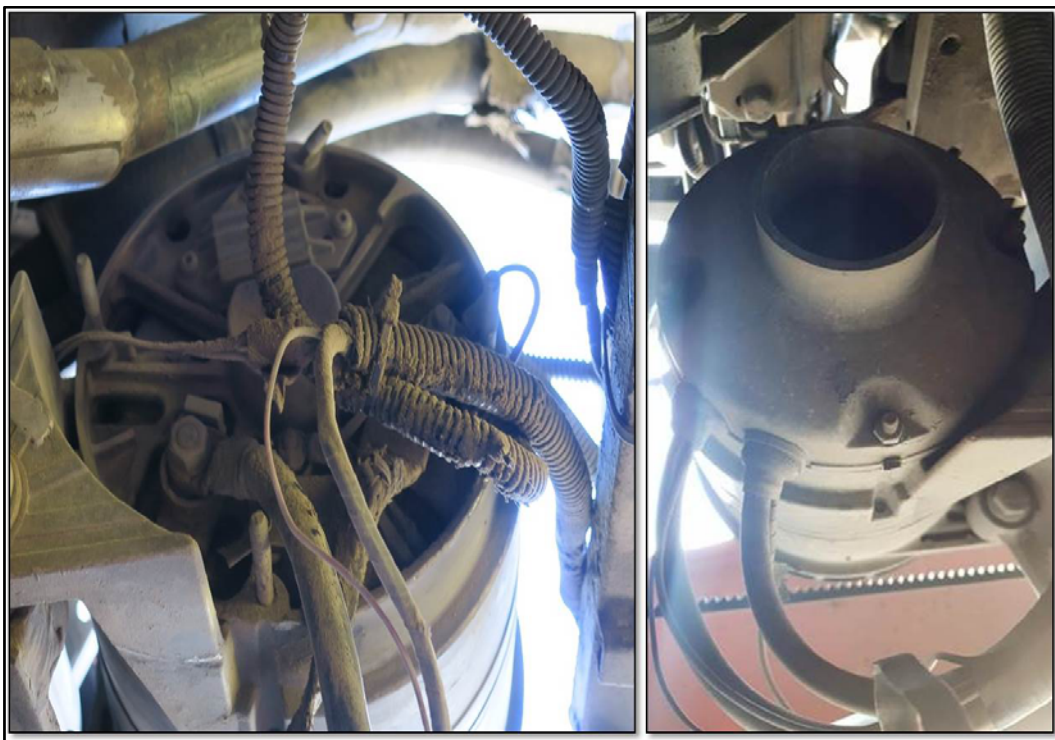
Figure 12: Alternator rear cover missing (left) and in cover place on similar model bus (right)

- 2.12 It was found that the alternator originally had a rear aluminium cover as standard fitment from the OEM (see *Figure 12*). The alternator rear cover had not been replaced. It is not known when this occurred. It is possible that the alternator was repaired or replaced at some time since new and the rear cover was not replaced. This cover is usually fitted with a flexible hose which routes clean air to cool the alternator. It is good practice to ensure that all covers and hoses are replaced after maintenance or inspection.
