**Office of Transport Safety Investigations**

# **BUS SAFETY INVESTIGATION REPORT**

**UNCONTROLLED MOVEMENT OF BUS**

**28 JUNE 2017**

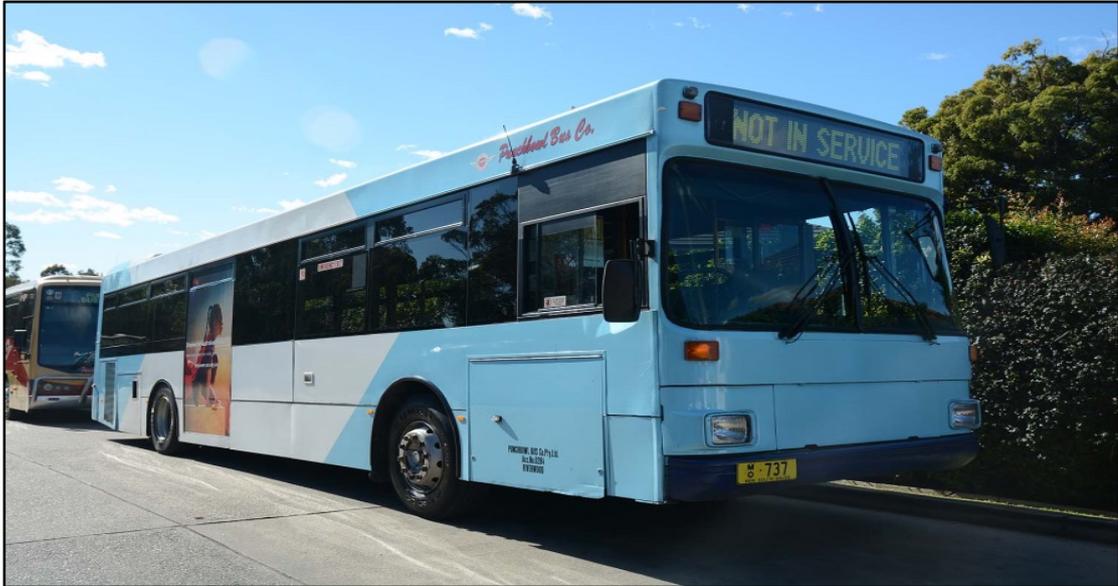
Figure 2: PBC MO737 - 1997 Scania bus

- 1.11 The bus was a diesel powered, 05/1997 K112 model Scania single door route bus registered in NSW as MO737. It was fitted with a Pressed Metal Corp (PMC) body manufactured by Jaguar-Rover Australia Limited (JRA). The bus was operated by PBC from their Riverwood depot. (See Figure 2)

2.6 OTSI examined the bus maintenance records and found no outstanding issues or defects relating to the incident. It was noted that the bus build date was prior to the implementation of TS 146.

<sup>5</sup> Type II door systems (door systems manufactured to comply with TS146) are fitted with throttle deactivation and apply air pressure to the rear service brakes to secure the bus when the passenger doors are open. The incident bus was a Type I door system that does not have either of these features.

- 3.4 OTSI’s investigation into this incident has found that PBC’s defences to uncontrolled bus movements were compliant to industry standards.
- 3.5 An additional factor is that the bus involved was not fitted with any safety systems that would have arrested the movement of the bus, or alerted the driver to the fact that the park brake was not applied whilst the driving position was unattended.

2.12 MO737 was part of 10 buses scheduled for replacement in August 2017 as part of the TfNSW replacement program. This reduced the number of pre 1997 buses in the route fleet.

- 4.5 Issue a general bulletin for operators/owners of the risks associated with buses manufactured prior to the implementation of TS146, specifically the different operating characteristics of Type I and Type II door systems.
