**Office of Transport Safety Investigations**

## **BUS SAFETY INVESTIGATION REPORT**

**COACH FIRE**

**26 SEPTEMBER 2011**

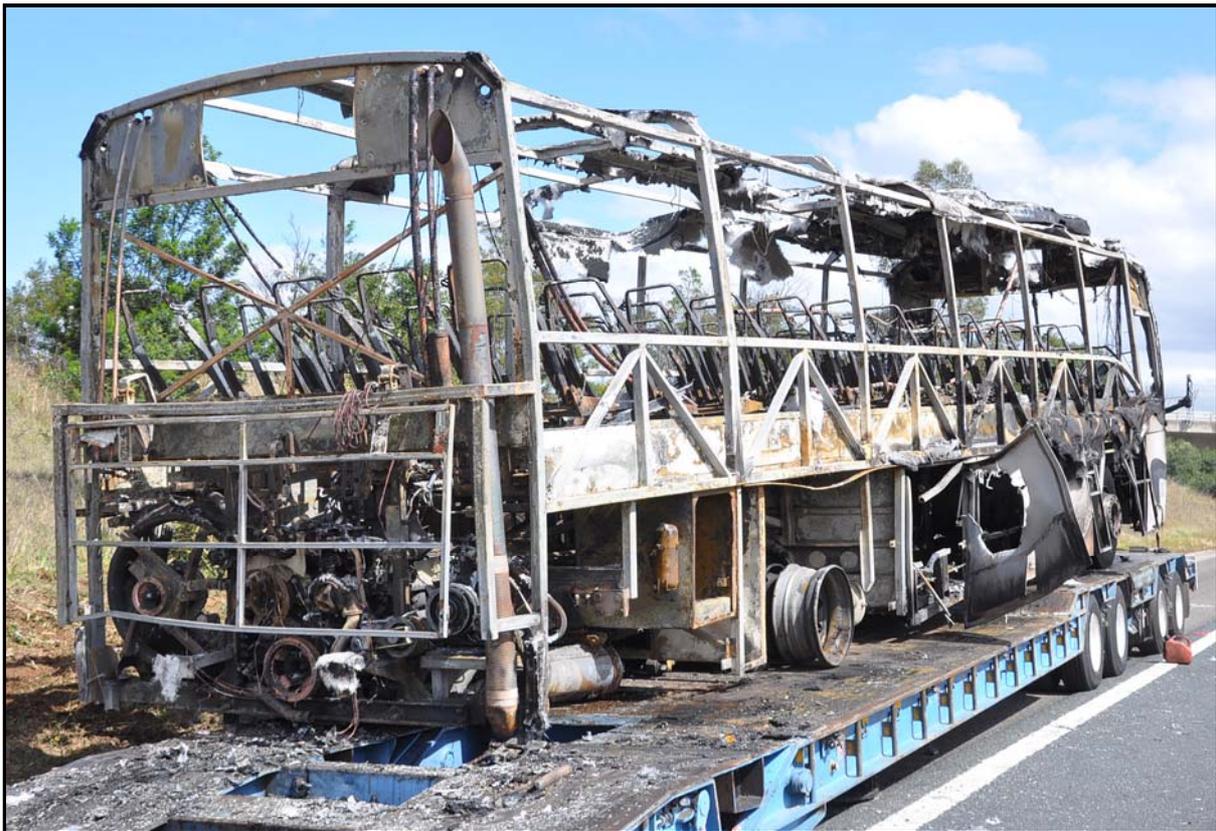
1.1 At approximately 9.11am on Monday 26 September 2011,<sup>1</sup> a coach owned and operated by CYC Tours Pty Ltd (CYC) caught fire while travelling from Sydney to Canberra. On observing smoke coming from the rear of the coach, the driver immediately pulled over and stopped in the emergency lane. While the driver evacuated the passengers, the tour guide inspected the engine bay and found the entire top of the engine was engulfed in flames. The coach crew, assisted by a passing truck driver and a Police officer using their own portable fire extinguishers, then attempted to extinguish the fire. However, they were unsuccessful and the coach was completely destroyed by the fire (see *Photograph 1*).

**Photograph 1: Wreckage of the Coach**

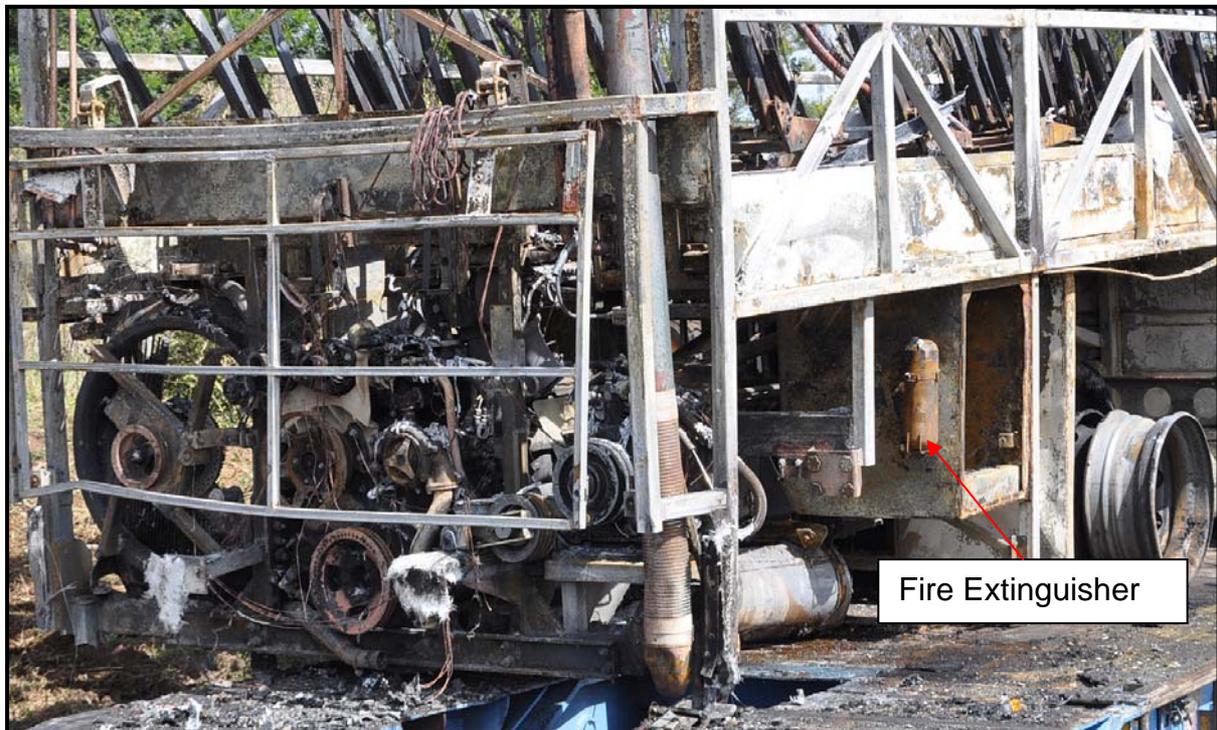
- 1.7 The tour guide tried to access the fire extinguisher mounted in a compartment on the right hand side at the rear of the coach (see *Photograph 2*). However, when he opened the compartment door, he was not able to reach the fire extinguisher because of the flames and extreme heat. He then went and reported back to the driver.

**Photograph 2: Fire extinguisher in close proximity to the engine bay**

- 3.2 The fire extinguisher positioned to the rear of the coach and not protected from fire could not be accessed due to the heat and flames from the fire. By the time further portable extinguishers could be applied, the spread and intensity of the fire was beyond their capability.
- 3.3 The coach was not fitted with an automatic fire suppression system.
- 3.4 Volvo service literature specifies the torque to be applied in tensioning various coach component fastenings but does not stipulate subsequent periodic checking to verify tensions are being maintained. However, the coach was being well maintained and serviced regularly which included checks of seals, pipes and hoses, and for oil and coolant leaks.

- 4.1 Evaluate the feasibility of installing an automatic fire suppression system on all company coaches.

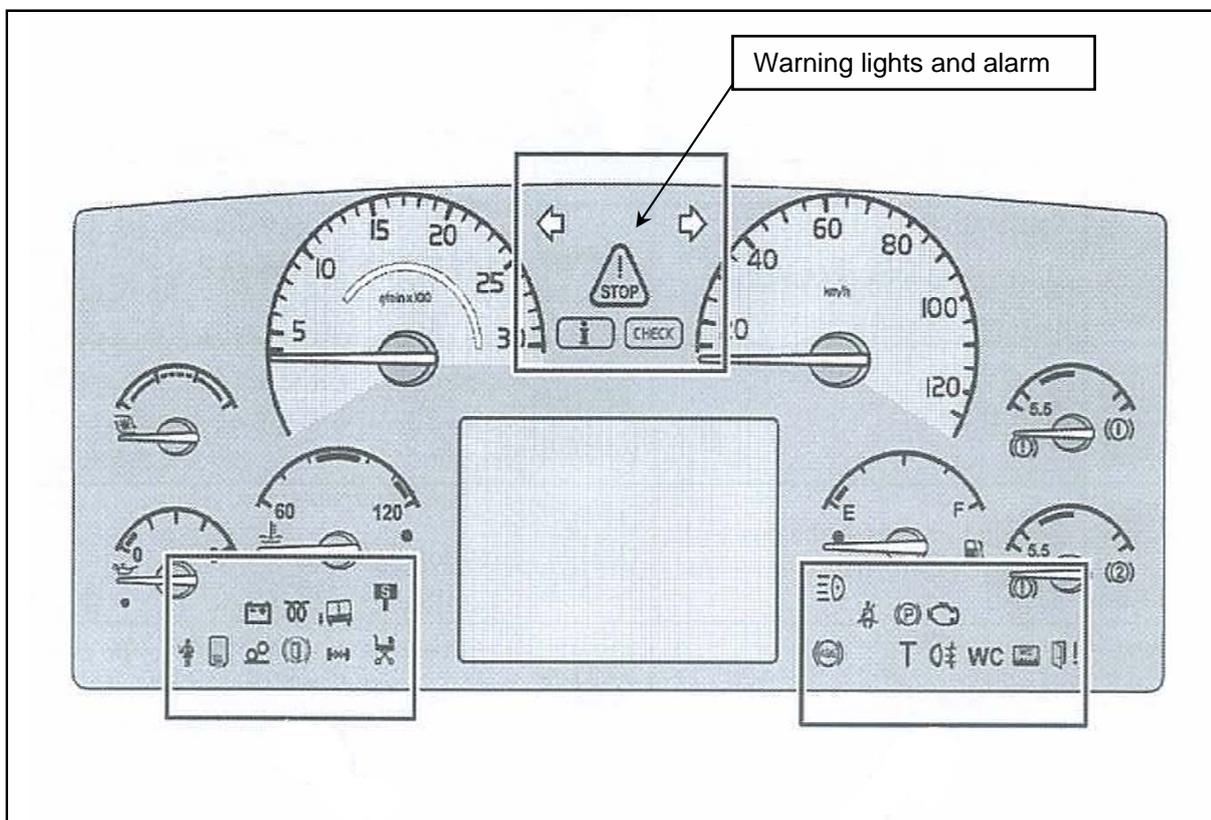
**Figure 2: Driver's dashboard layout with Stop, Information and Check lights**

2.1 On this model coach, there are three lights at the centre top of the driver's console which alert the driver to faults on the coach. They are designed and located so as to readily attract the driver's attention (see *Figure 2*). One delivers a 'Stop' message that signifies to the driver that they must stop immediately, turn the engine off and determine the nature of the fault. It is accompanied by an audible alarm. A second alert provides a 'Check' (warning) message which signifies that the coach must be driven to the nearest service centre as soon as possible. The third delivers an 'Information' (advisory) message which, when illuminated, does not necessarily mean there is something wrong with the coach, but that it should be checked for faults. The driver was adamant that none of these alerts were activated prior to the incident and his stopping in the emergency lane.

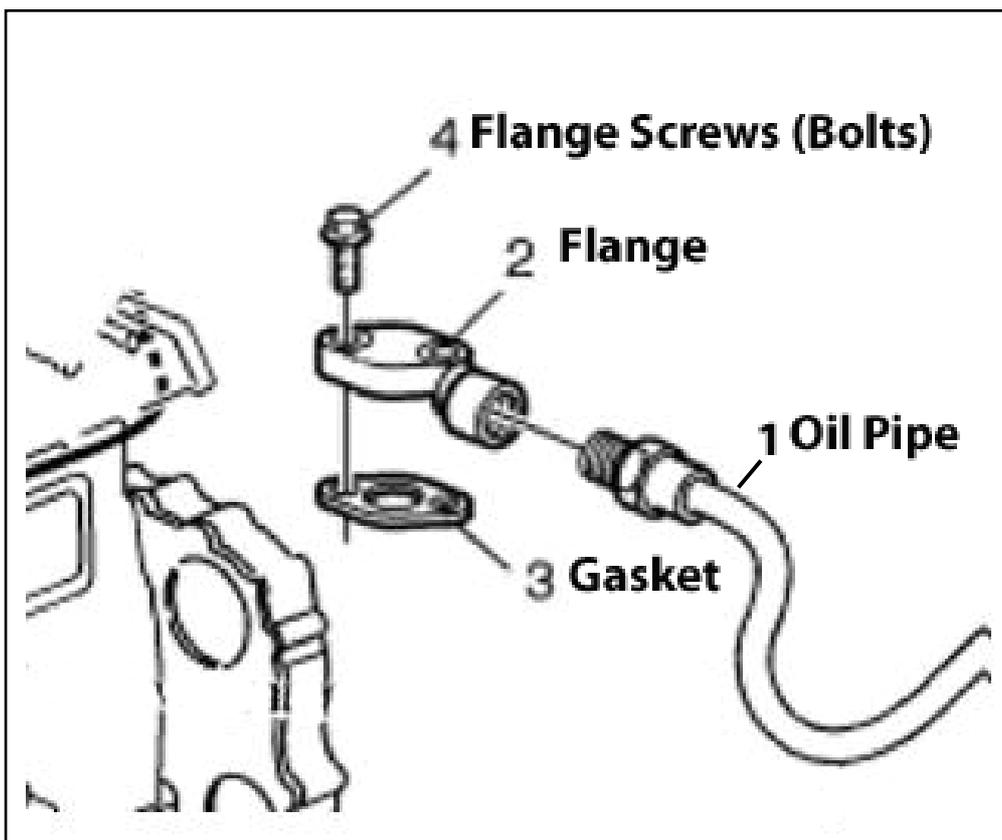
**Figure 3: Items 1,2,3,4 all belong to the oil system function group**

- 2.10 When the turbocharger was inspected, it was found that both flange screws were loose to such an extent that the flange unit could be physically shaken by hand. The gasket sitting under the flange was intact and still functional. The oil pipe leading from the engine to the flange was intact and secured. A complete inspection of all other fasteners throughout the engine bay area, including injectors, injector piping, exhaust system, electrical units and other auxiliaries, found all items to be firmly fastened.

- 3.1 The investigation found that the flange unit that secures the oil supply pipe mounted on the top of the turbocharger was loose. This allowed engine oil under pressure (of approximately 600kPa) to escape between the flange unit and turbocharger housing then spray over the extremely hot turbocharger and associated exhaust components and ignite. The fire then spread quickly throughout the engine bay and thence into and through the interior of the coach destroying it completely.

- 4.3 Develop and incorporate in technical maintenance servicing documentation recommended parameters for the periodic checking of the tension on fasteners securing key engine and chassis components.

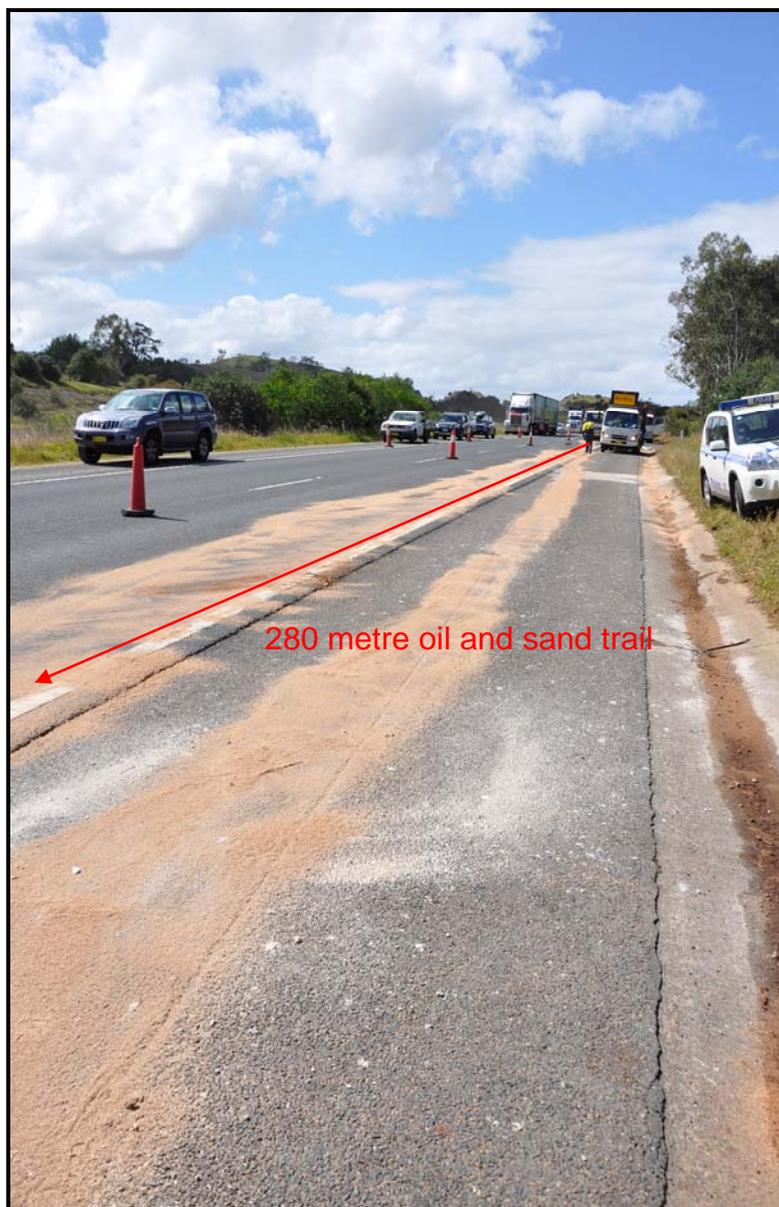
**Photograph 3: Oil residue and sand trail extending 280 metres**

- 2.11 The oil sump of the D7C290 engine has a capacity of 28 litres. When the sump plug was removed to take a measurement of how much oil remained, no oil discharged from the sump. A hole was then made through the side of the sump and approximately one litre of burnt oil was found to be remaining. This supported a conclusion that the oil had probably discharged at the loose flange on the turbocharger.

- 2.12 A trail of a liquid residue some 280 metres long followed the path of the coach from the freeway to where it was stopped (see *Photograph 3*). Although RTA emergency crews had already dispersed sand on the residue trail by the time OTSI investigators arrived on site, it was evident that the residue was oil based and not a water or coolant based substance. This further supported the conclusion that oil, pumped under high pressure from the engine to the turbocharger, could have discharged from around the loose flange and sprayed over the extremely hot turbocharger and associated hot exhaust components, and then ignited.
