Office of Transport Safety Investigations

BUS SAFETY REPORT

BUS FIRES IN NEW SOUTH WALES IN 2015

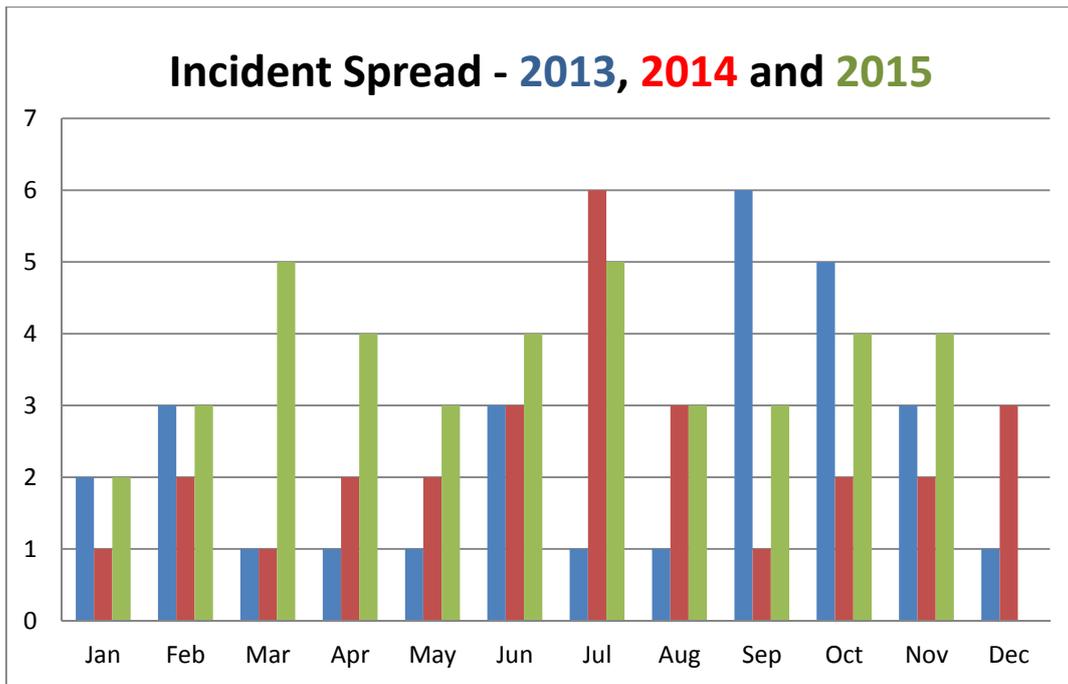
Figure 1

Forty fires were reported in 2015, and were distributed through the year as shown in *Figure 1*. Brief details of each incident are recorded at *Appendix A*.

The total represents a significant increase over prior years; 29 in 2014 and 28 in 2013.

Unlike the previous two years where there was a discernible peak in incidents, in 2015 the distribution was comparatively even, averaging 3 to 4 incidents a month. For the first time in the three years there was a month during which no incident was reported – December.

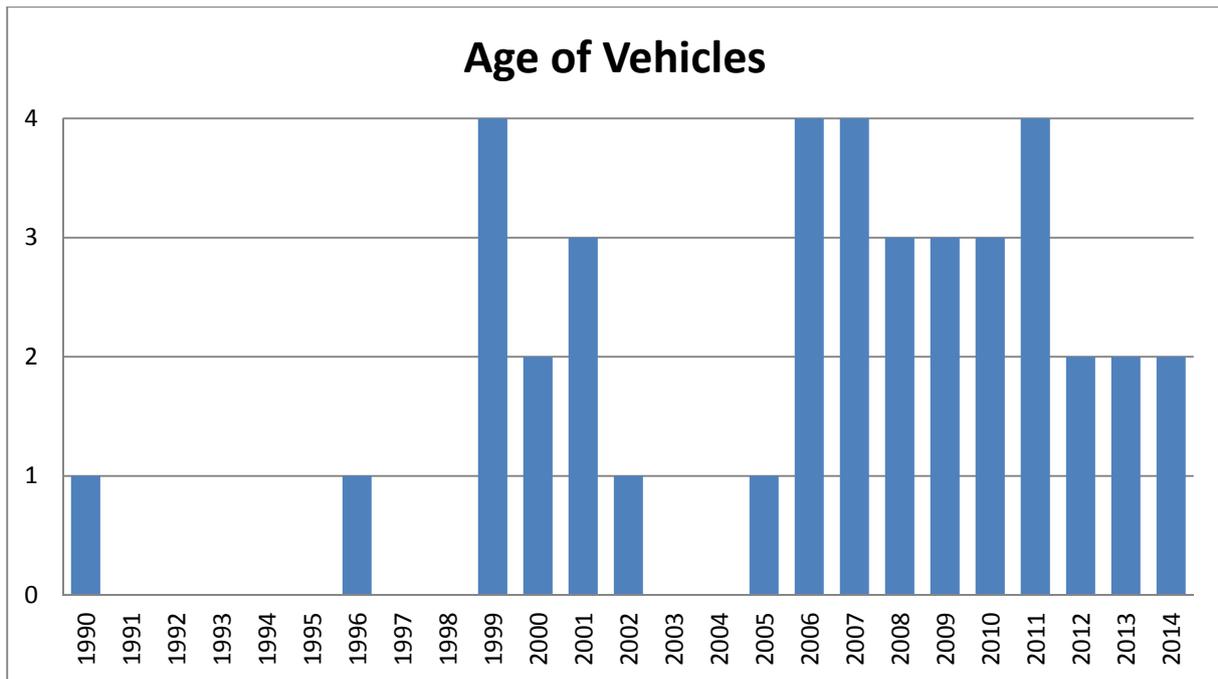
Figure 2

As was also the case in 2014, the ages of the buses involved, with two exceptions, ranged between one and 16 years (see *Figure 2*). Seven different makes of vehicle were involved and no make or model trends were identified. Only two of the buses were CNG-fuelled, one experienced a fault in the air conditioning compressor solenoid and the other a coolant leak from a split pipe.

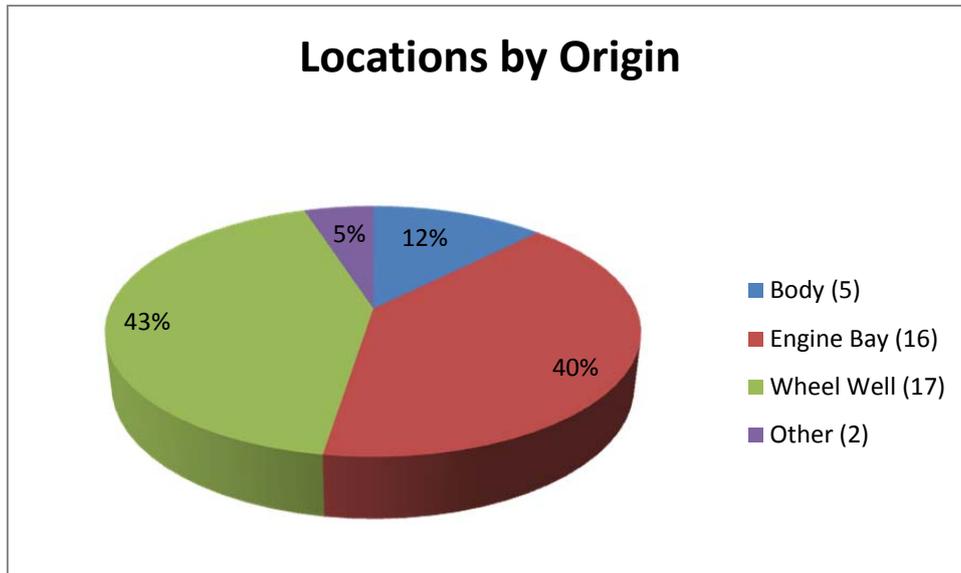
Figure 3

Sixteen fires (40%) originated in the engine bay (see *Figure 3*). This is a similar number to, but a lower percentage than, the prior two years. In 2013, 16 engine bay fires represented 59 % of the total number of fires. In 2014, the 14 engine bay fires represented 48% of the total.

In 2015, 17 (43%) incidents were confined to the wheel well. In 2013, there were 6 (22%) and, in 2014, there were 11 (38%). Fortunately none resulted in damage of any significance. No detailed investigation to explore possible underlying causes or contributing factors was undertaken in the period.

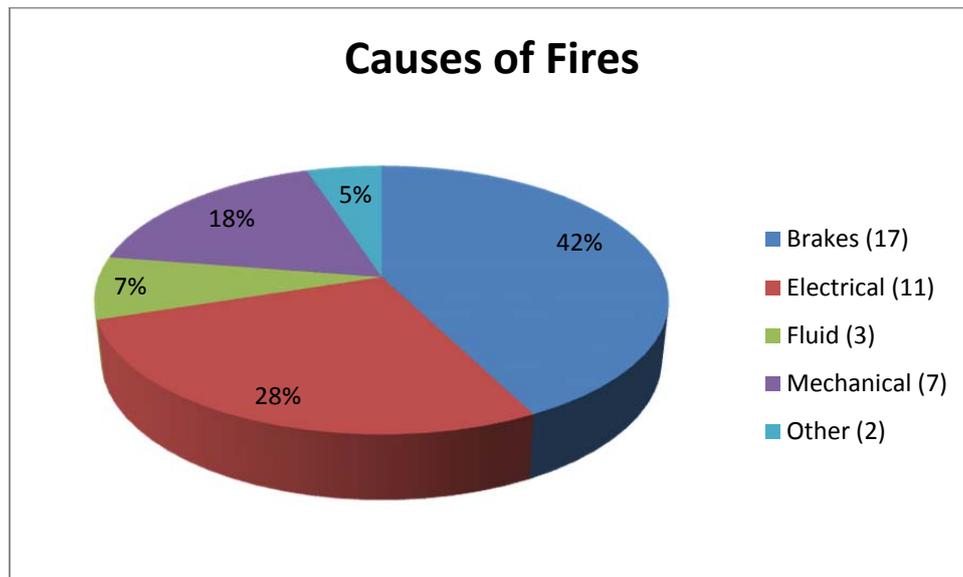
Figure 4

The data for the causes of fires in 2015 are shown in *Figure 4*.

Brake-related incidents have increased markedly over the three years from 6 (23%) in 2013, through 10 (34%) in 2014, to 17 (42%) in 2015. In part the increase may be attributable to increased reporting of brakes-related ‘thermal incidents’ which were often not reported in the past as they did not involve fire. However, there appears to be grounds for concern with brake adjustment cited as the reason for all but one of the 2015 incidents. The exception was attributed to low air pressure causing the park brake to activate momentarily resulting in the brake linings overheating.

Though the number of electrical fires has varied over time, the percentage has not varied significantly. The results have been 11 (28%) in 2015, 6 (21%) in 2014, 8 (29%) in 2013 and 4 (27%) in the 2½ years to 30 June 2012. The majority of the incidents were caused by short circuits, which highlights the need for extra vigilance in checking the condition and securing of electrical wiring. Of the 11 in 2015, 8 occurred in the engine bay.

There was a significant reduction in the number of incidents attributed to fluid leaks in 2015 – three (7%) compared with 10 (34%) in 2014 and 11 (39%) in 2013. All three in 2015 were caused by coolant leaking onto the manifold but causing only negligible or minor damage. One of the incidents was detected in its very early stage when passengers mistook steam for smoke. On this occasion the low coolant alarm also activated.
