## **TECHNICAL INSPECTION FINDINGS**

**FIRE INVOLVING STATE TRANSIT BUS MO 3422**

**DARLINGHURST, NSW**

**16 OCTOBER 2012**

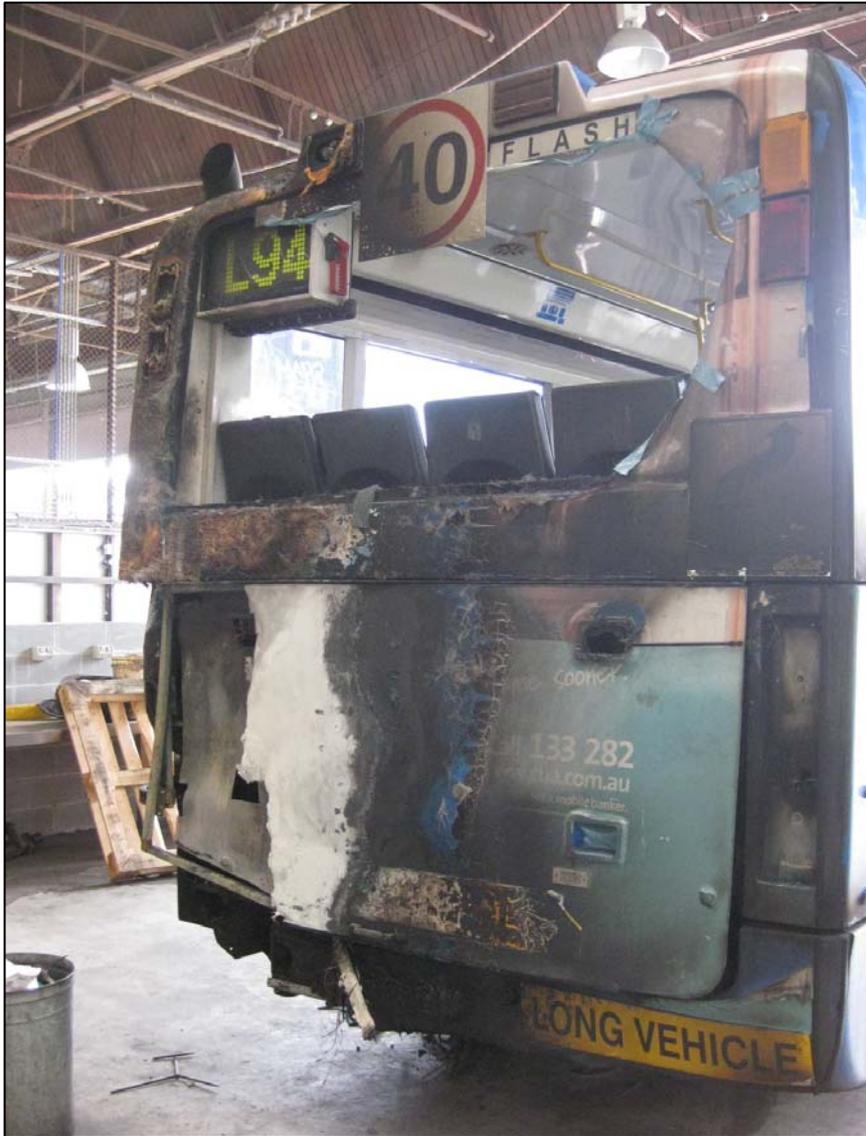
All components in the engine compartment, particularly in the vicinity of the near side of the engine, were damaged, as was the engine compartment hatch and the body panels above and to the sides of the hatch. The rear window shattered from the effects of heat.

Examination of the bus established that there was a concentrated pattern of fire damage around a particular area within the engine compartment on the near side between the turbocharger, exhaust manifold and auxiliary alternator. Damage to the exterior of the bus was confined to the aluminium engine compartment hatch, the fibreglass body panels to the side and above the hatch, the rear window, the reversing camera housing and centre 'wig wag' lights (visible in *Photograph 1*). There were signs of minor heat and fire damage within the rear interior of the bus.

**Photograph 1: Overview of fire damage to the rear of the bus**

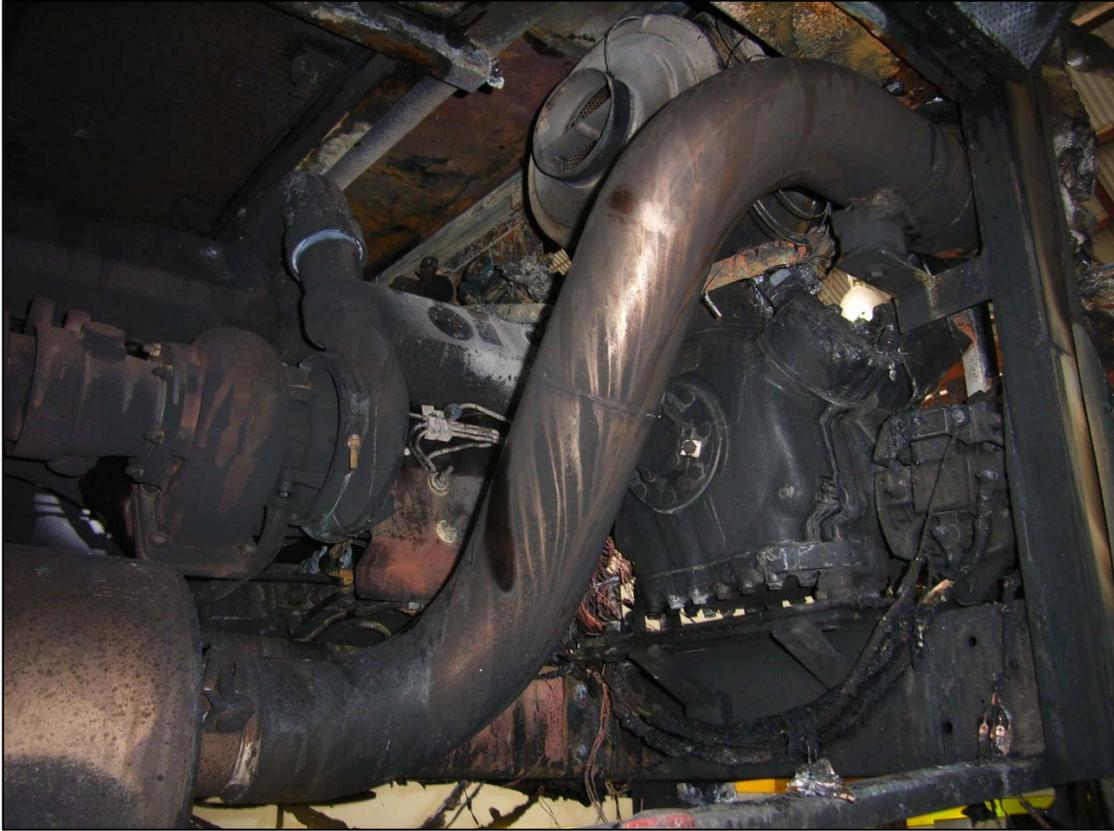
Witness observations, corroborated by the location of the greatest concentration of fire damage, indicated the likely source of the fire was on the near side of the engine (see *Photographs 1 to 3*). The turbocharger, air filter, auxiliary alternator and some nearby engine components were removed to allow for more detailed examination of those components, and to allow better access to that general area of the engine compartment. Other components in that area of the engine compartment included the exhaust manifold and several fuel injector delivery lines ('delivery pipes') which ran from the fuel pump to the fuel injector near the top of the engine. Amongst these delivery pipes was a low pressure fuel injector return line ('return line'). All components were checked for irregularities.

**Photograph 2: Damage within engine compartment (near side)**

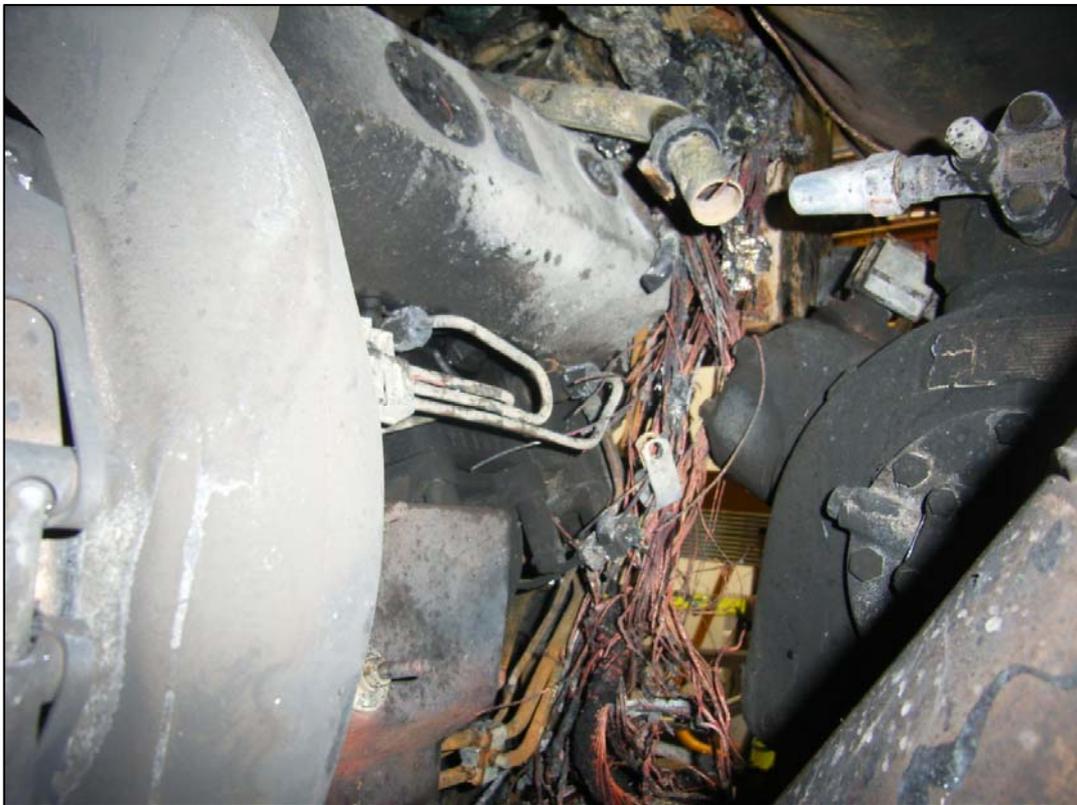
**Photograph 3: Component damage adjacent to fuel return line**

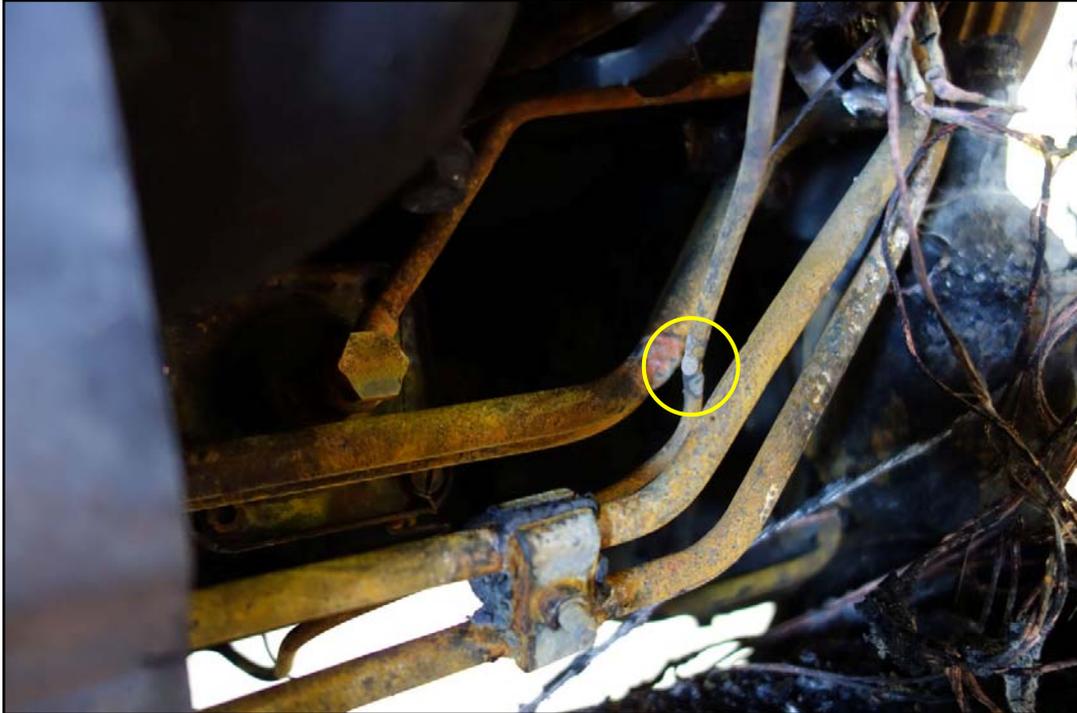
The delivery pipes appeared intact and properly clamped, however the return line was bent, unclamped, loose at one connection point and showed evidence of a previous repair (see *Photographs 4 and 5*). When removed for closer examination, the movement at the connection point was found to be due to a crack near a junction in the return line (see *Photograph 6*).

**Photograph 4: Fuel return line in situ, showing previous repair**

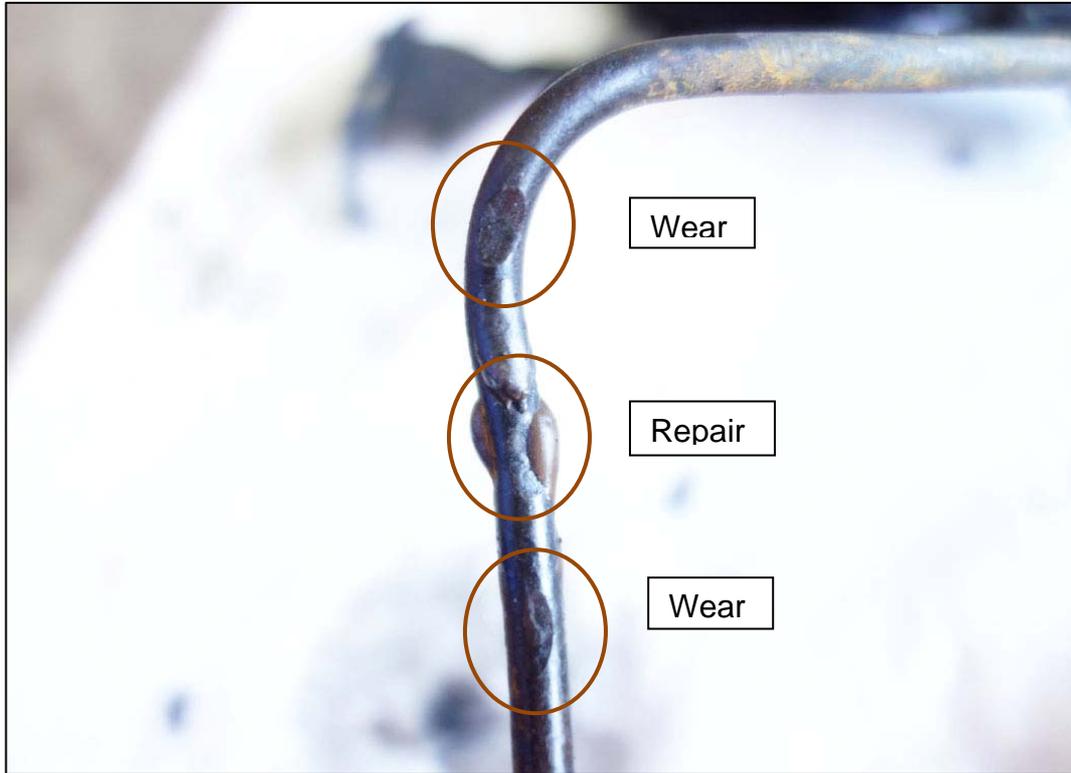
The return line was bent from its normal alignment, had evidence of a previous repair and showed wear marks from rubbing against adjacent pipes (see *Photograph 5*). This damage was unlikely to have been caused by the fire. It was more likely to

have occurred from a combination of normal operation/vibration, maintenance intervention and/or reinstallation activity. In this condition, the return line was more susceptible to failure from vibration and stresses under normal operating conditions.

**Photograph 5: Wear damage and previous repair on the return line**

- *“There were two visible areas of mechanical or wear type damage adjacent to the repair.”* (See Photograph 5) *“This type of damage is probably the type of damage that had previously been repaired.”*

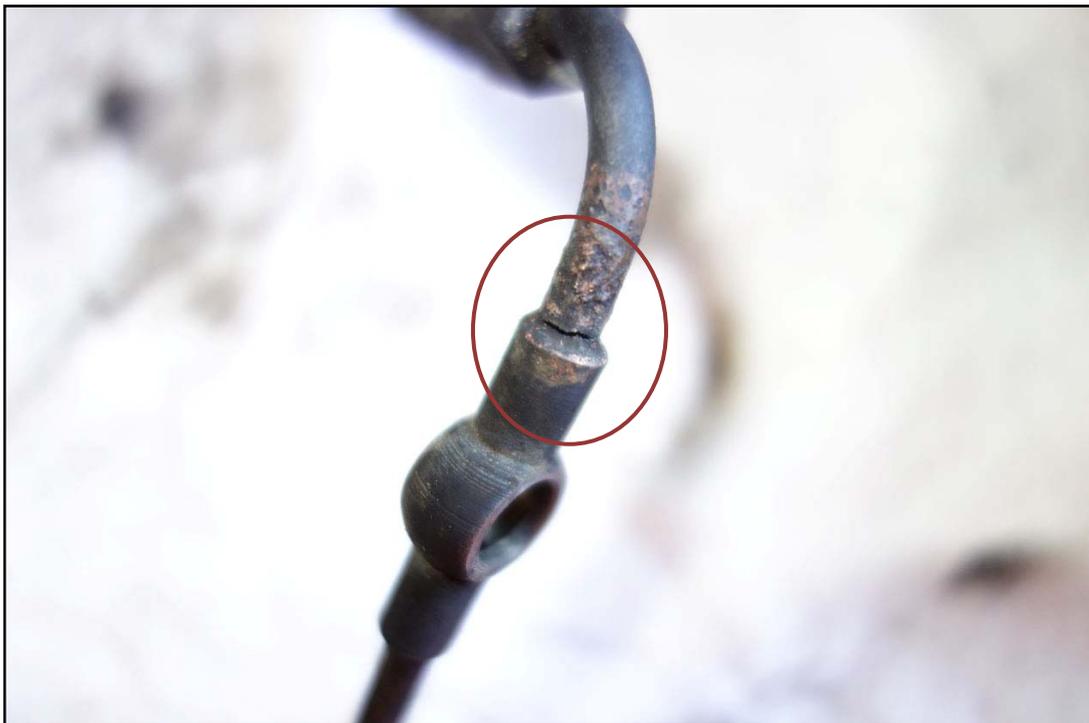
**Photograph 6: The crack in the return line**

- A fatigue crack had initiated at one end of the return line and grown in size over a period of time prior to the fire. The metallurgical investigation report states: *“A pre-existing crack of this size will have acted as a significant stress concentrator such that further crack propagation would have been likely to develop over a relatively short period of time, even under nominally normal operating conditions”*. Further: *“The presence of a crack at one end of the return line ... indicate that the return line provided the fuel source for the initiation of the fire in question”*.

- There were no witness marks along the length of the return line to indicate the presence of any supporting rubber sleeved “P” clamps. These clamps have an important role in improving rigidity against vibration, preventing chaffing against adjacent pipes and minimising the likelihood of undue stresses at the connection points. Importantly: *“The absence of a supporting “P” clamp will have greatly increased any movement of the return line associated with engine vibration etc. and therefore greatly increased the bending movement on the end of the return line where it fractured”*.

As a result of this incident, State Transit immediately inspected the remaining 48 buses of the same model in the fleet. They subsequently issued a maintenance alert covering vehicles of a similar configuration in the fleet (totalling 204 Scania buses). The alert focuses on the correct removal, repair and installation procedures relating to fuel lines.
