**Office of Transport Safety Investigations**

## **BUS SAFETY INVESTIGATION**

**FIRE INVOLVING STATE TRANSIT BUS MO 1414**

**28 APRIL 2016**

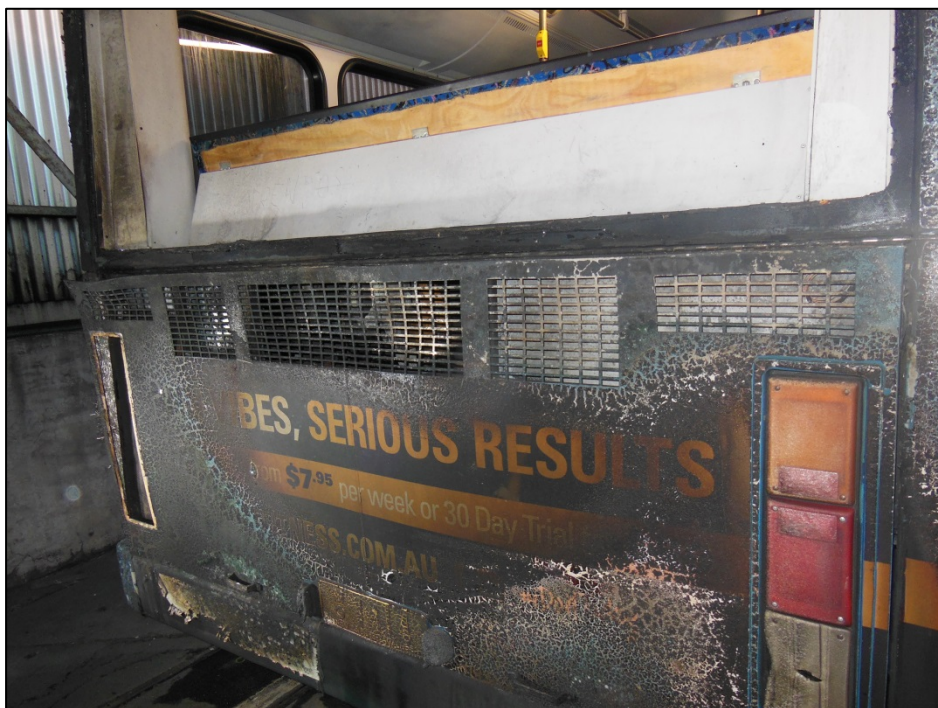
- 2.2 The fire damage was confined to the bus' rear exterior, engine bay including electrical wiring loom and associated combustible materials.
- 2.3 Examination of the bus established that there was a concentrated pattern of fire damage on the rear side towards the rear of the engine compartment (see *Photographs 1-4*). Damage to the exterior of the bus was confined to the engine compartment hatch, the side fibreglass body panels and destroyed the rear window. There were signs of minor heat and smoke damage within the rear interior of the bus.

Photograph 1: Fire damage to the rear of the bus

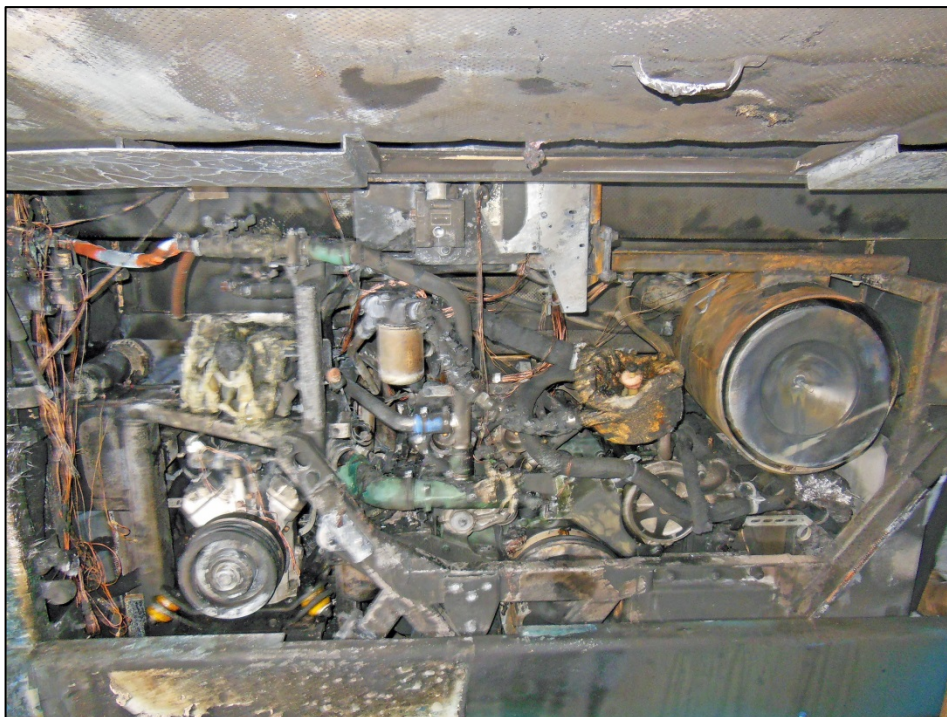
Photograph 2: View of damaged engine bay from rear of bus

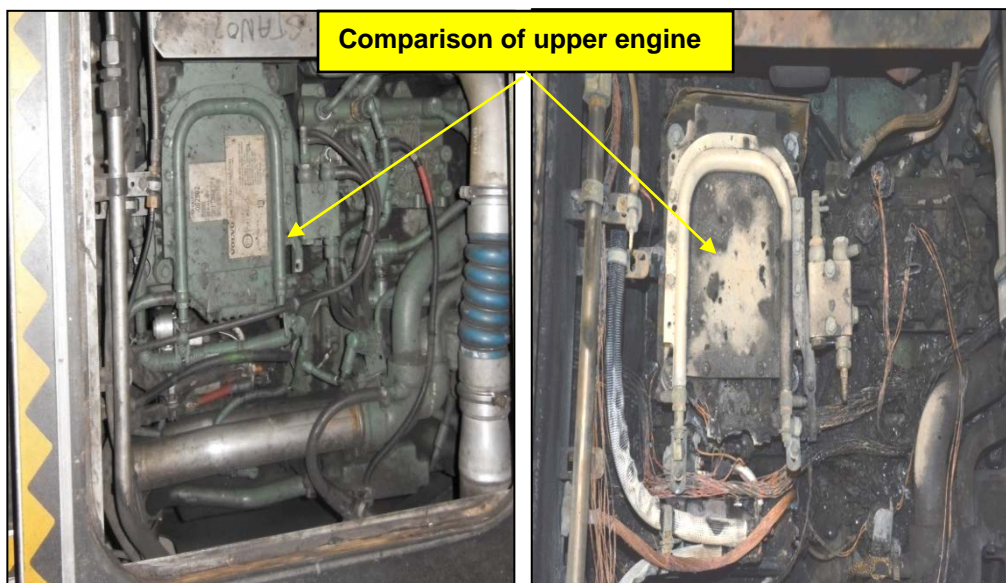
Photograph 3: Undamaged top of engine bay (from same model bus). The view looking down through a floor hatch inside the rear passenger area of the bus.

Photograph 4: Destroyed fuel return lines and damage to top of engine. The view looking down through a floor hatch inside the rear passenger area of the bus.

- 2.6 The heat from either the first or second short-circuits (or a combination of both) ignited surrounding combustible material, such as the insulation of the wiring loom, which ignited the fire. As a result, the fire destroyed the nearby hydraulic and low-pressure fuel return lines, enabling the release of combustible fluids onto the hot engine surface. The continued operation of the engine maintained a supply of fuel, electrical energy and a flow of air (from the radiator fans), which intensified the fire. This created the ideal environment for the fire to spread throughout the engine bay.

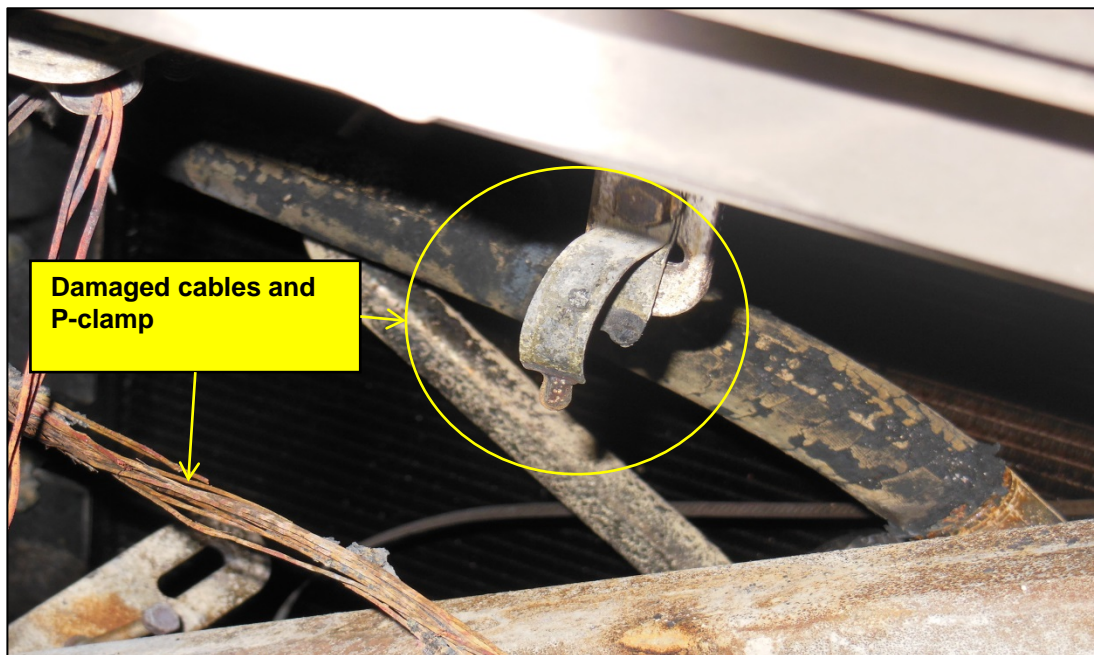
- 2.4 Examination of the upper side of the engine bay revealed a severed electrical cable. This cable, known as the 'B+' runs from the alternator to the starter motor, showed evidence of having short circuited the electrical system on both a holding bracket or 'P-clamp' and an engine-cooling pipe. The location of the break in the cable corresponds with the location of a broken securing P-clamp (see *Photographs 5-7*).

Photograph 5: Melted P-clamp

- 2.5 The investigation established that the B+ cable short circuited on the metal of the P-clamp. As a result, the heat caused by this short-circuit destroyed the P-clamp and severed the B+ cable. Consequently, one part of the cable then fell onto the engine cooling pipe, creating another short-circuit.

- 3.2 It is likely that the destruction of the supporting P-clamp or its associated rubber boot damaged the B+ cables insulating cover. Once this insulation failed, the cable short-circuited onto the metal of the P-clamp. The resulting heat melted the P-clamp and parted the cable. The live parted B+ cable then came into contact with the engine cooling pipe causing another short-circuit. The heat generated from one or both short-circuits ignited surrounding combustible materials. The resulting fire destroyed fuel and hydraulic lines releasing combustibles onto hot engine components, which spread the fire.

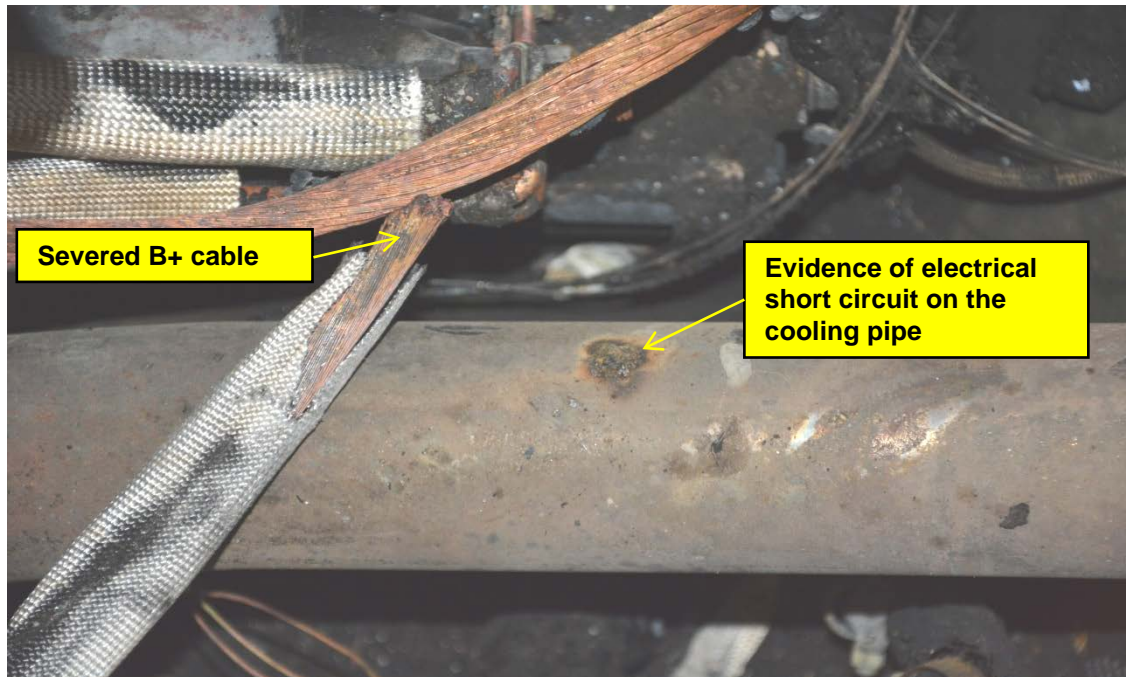
Photograph 7: Severed cable & evidence of short circuit on the cooling pipe

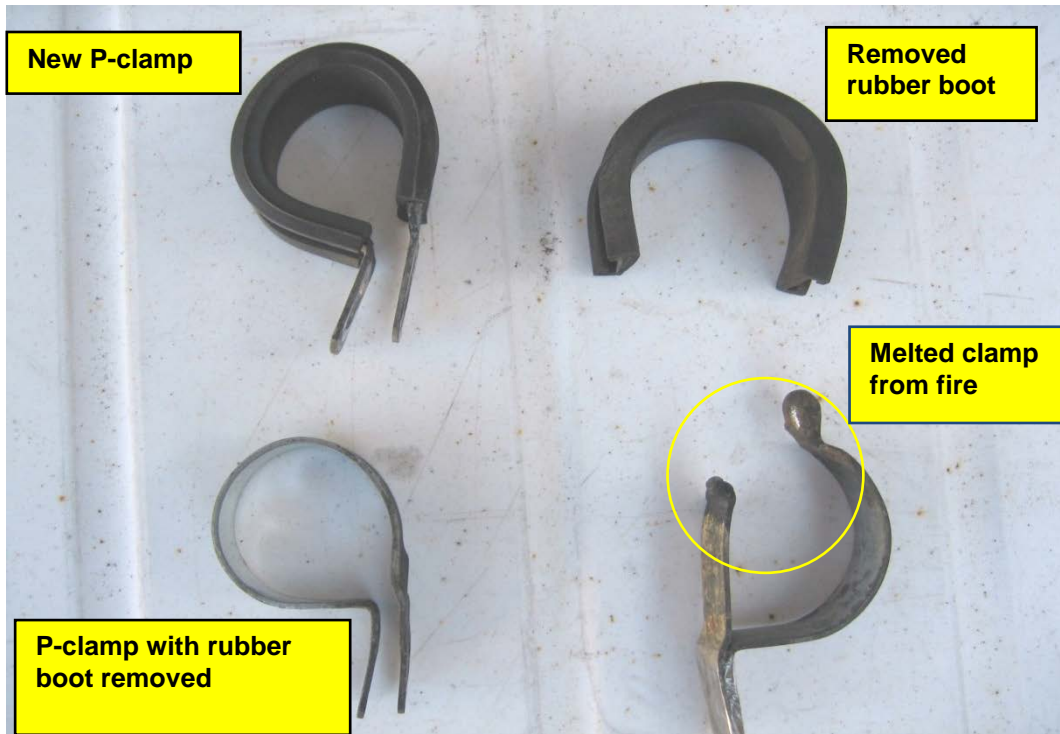
2.7 P-clamps, consist of a metal loop; with a protective rubber jacket (see *Photographs 8-9*). This rubber jacket protects any surfaces that the clamp holds from direct metal contact. The clamps are utilised to secure components like cables and hoses.

Photograph 8: P-clamps new, unassembled, and melted P-clamp from fire

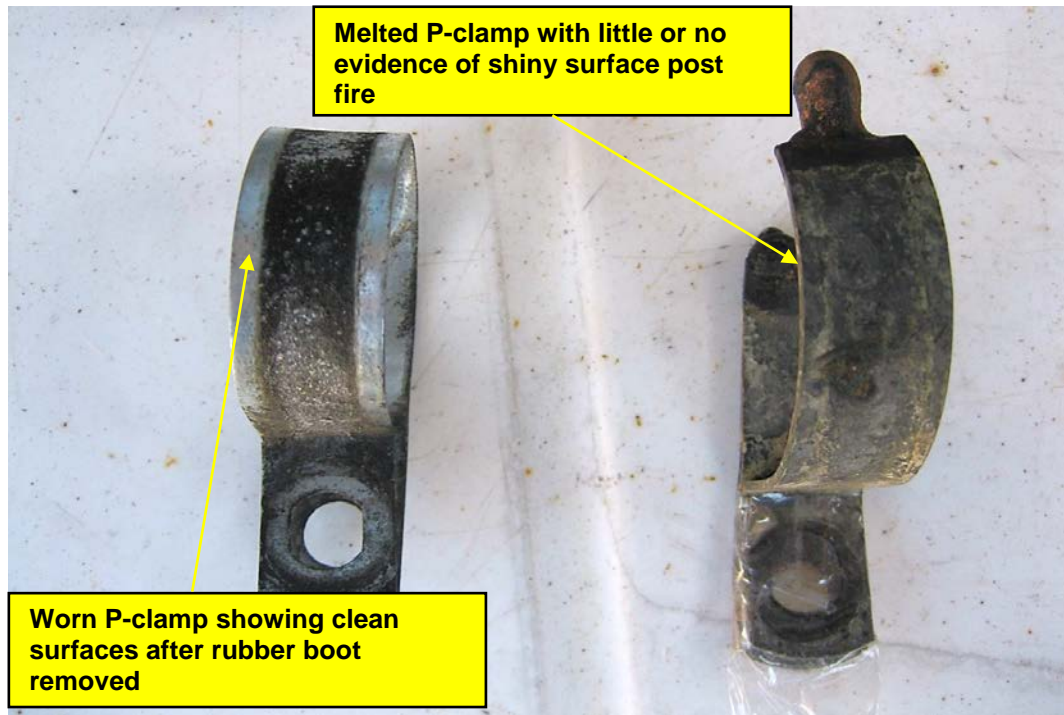
- 2.8 Examination of the damaged P-clamp post incident indicates that the rubber protective boot had possibly been missing or damaged prior to the fire (see *Photograph 10*).

Photograph 10: Comparison of P-clamps
