Office of Transport Safety Investigations

FACTUAL STATEMENT

BURRUM SCHOOL BUS MO 7509 ROLL OVER

18 March 2016

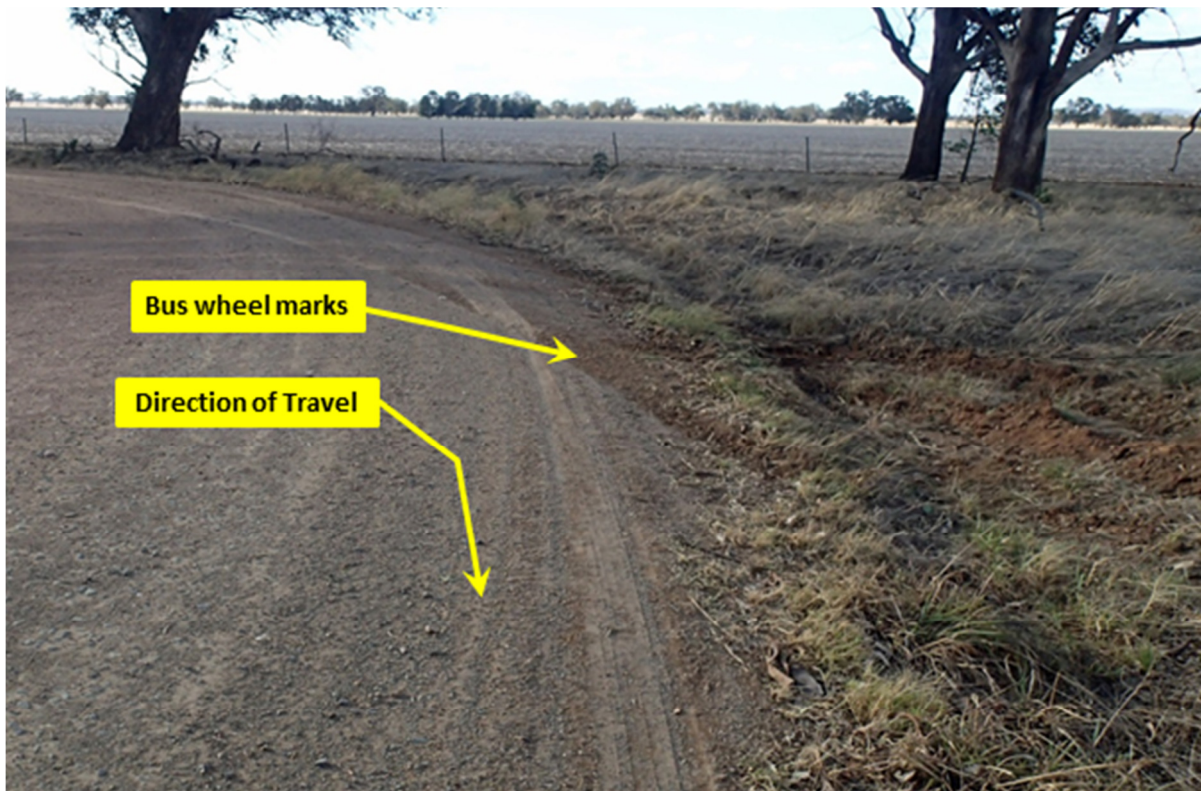
Photograph 1: Wheel marks at corner (Source: South Albury Truck Repairs)

The speed of the bus negotiating a 90⁰ right-angle bend on a dirt road and in windy conditions resulted in the bus rolling on its near side.

1. Where buses are seat belt equipped, bus operators are to remind their drivers to ensure all bus occupants wear seat belts at all times.
2. Bus drivers to drive cautiously when operating on unsealed roads and select a speed that will enable the driver to maintain safe control of the bus in any situation, regardless of the road's default speed limit.
3. Drivers to undergo route knowledge training which identifies road locations where extra caution is required, and additionally, include recommended driving and braking techniques to apply when entering corners.

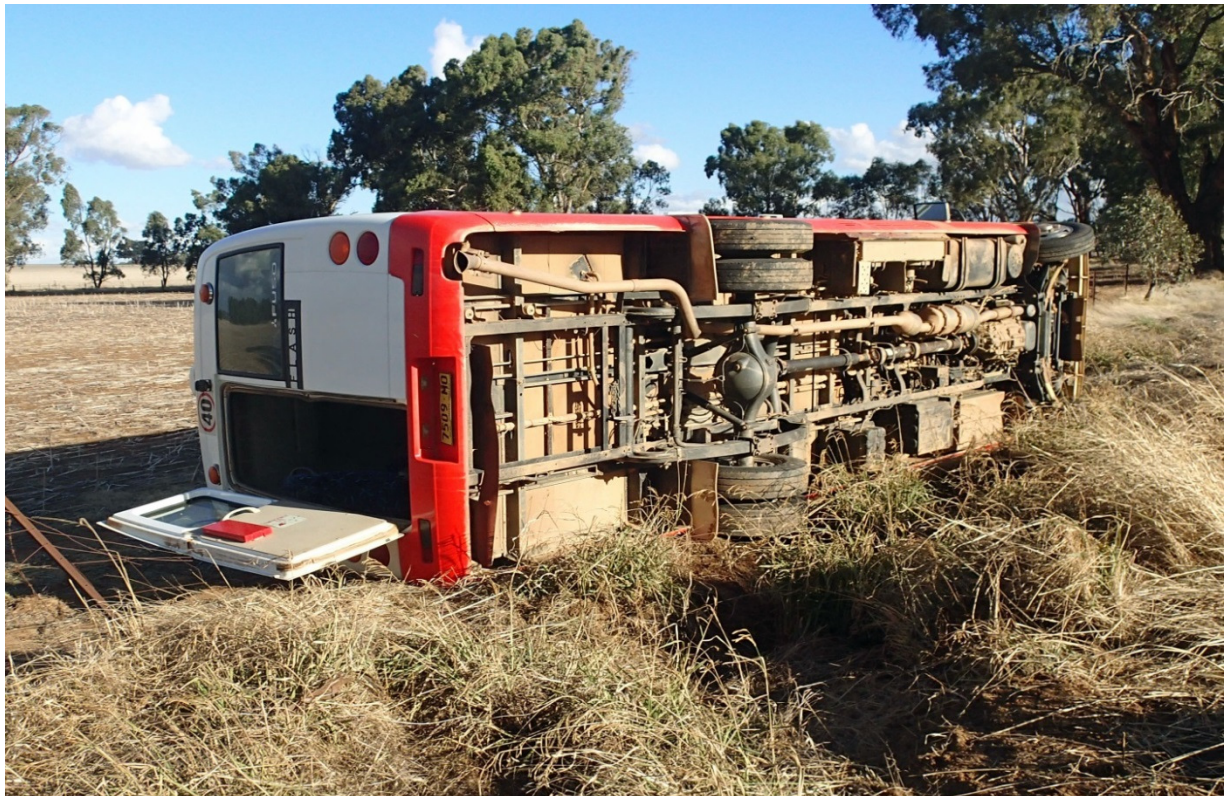
The actions of the eleven-year-old school boy deserve recognition. After the rollover, the boy assisted the eleven-year-old girl from her seat belt, then assisted to free the driver who was hanging in his seat belt. He then went to the rear of the overturned bus, opened the rear emergency escape door and assisted the girl and driver exit to a safe place away from the bus. The boy then started to walk to a nearby farm property to get assistance; however, a farmer passing the incident site stopped and rendered assistance.

Photograph 2: Rear escape door (Source: South Albury Truck Repairs)
