## **TECHNICAL INSPECTION FINDINGS**

**FIRE INVOLVING CYC TOURS BUS TV 4153**

**HUME HIGHWAY, HOLBROOK**

**8 FEBRUARY 2010**

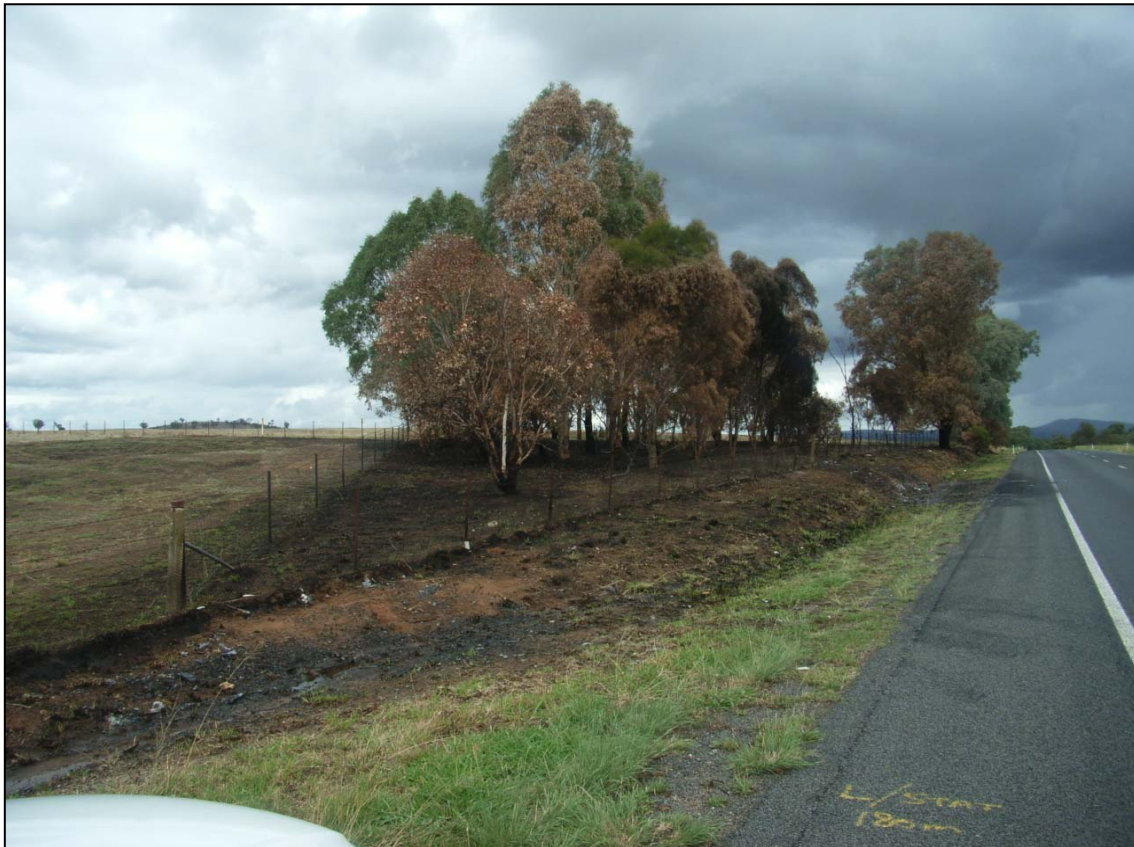
The CYC tour guide exited the bus and saw what appeared to be smoke emanating from the nearside rear wheel arch area. He described the smoke as being initially white in colour, and then becoming black. The guide attempted unsuccessfully to extinguish the fire using a fire extinguisher from the cabin of the bus, whilst the bus driver safely evacuated the 23 passengers and contacted emergency services. However, by the time the NSW Fire Brigade arrived on scene the bus was beyond saving, and they turned their attention to the nearby grass and trees which were well alight. The extent of the fire damage to the bus and surrounding property can be seen in *Photographs 1 and 2*.

**Photograph 1: Incident site showing area affected by the spread of fire**

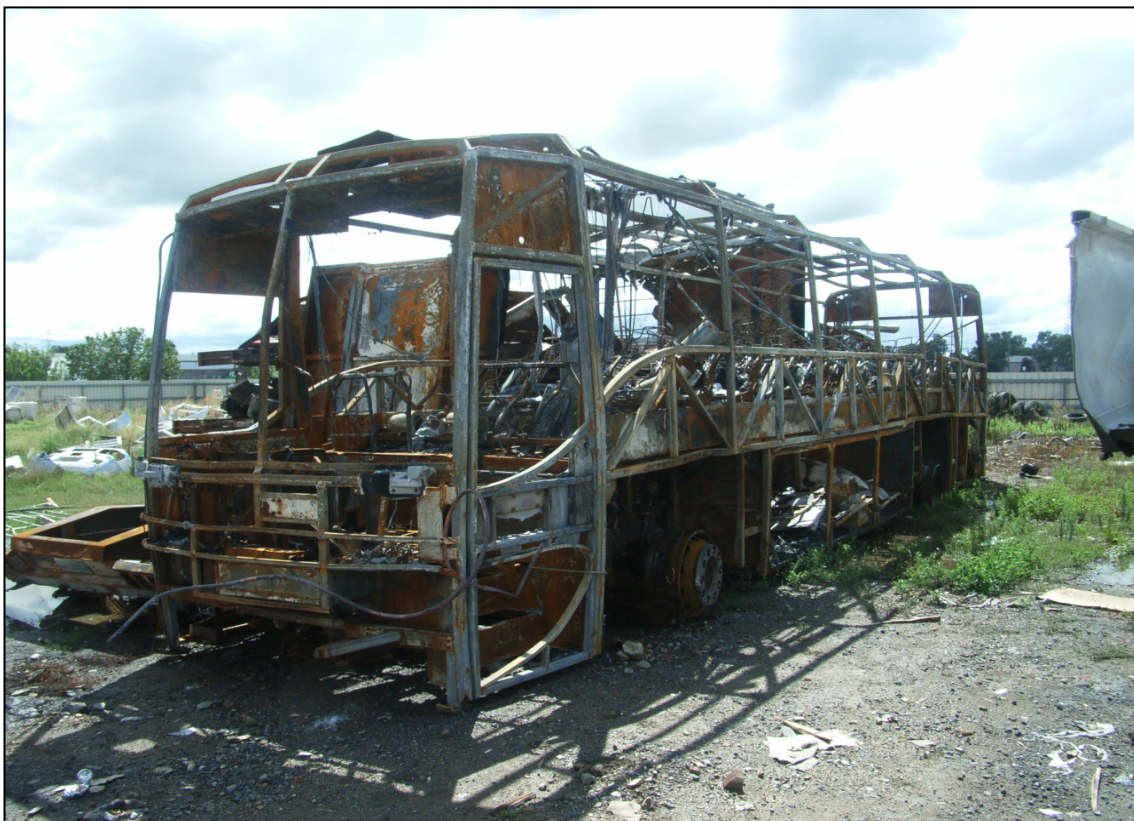
During February and March 2010, the wreckage of the bus was examined by various parties including the insurer (Zurich), Volvo and OTSI investigators, at a holding yard at Wagga Wagga (*Photograph 2*).

**Photograph 2: Wreckage of the bus**

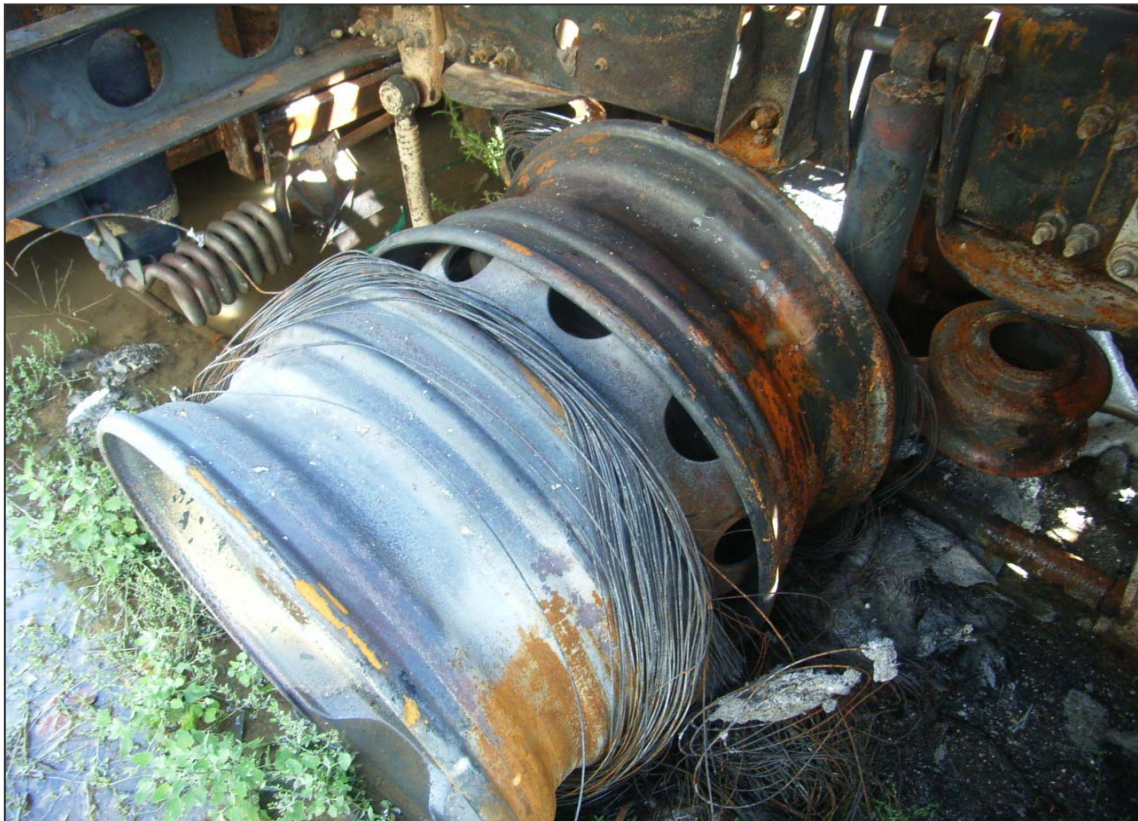
The rubber of the left side rear tyres had been consumed by the fire, leaving the steel reinforcing cord exposed. *Photograph 3* shows steel bead<sup>2</sup> cord from the outer tyre still largely contained within the rim's profile. Bead cord from the inner tyre can also be seen, located inboard of the rim. There was also cord, not visible in the photographs, between the rims.

**Photograph 3: Rear wheel rims showing location of steel tyre cord**

The presence of the steel cord from the beads of both left side tyres in a relatively tidy and untangled condition in or adjacent to the wheel rims is an indication that it is unlikely that the tyres burned away or disintegrated while the bus was travelling at speed.

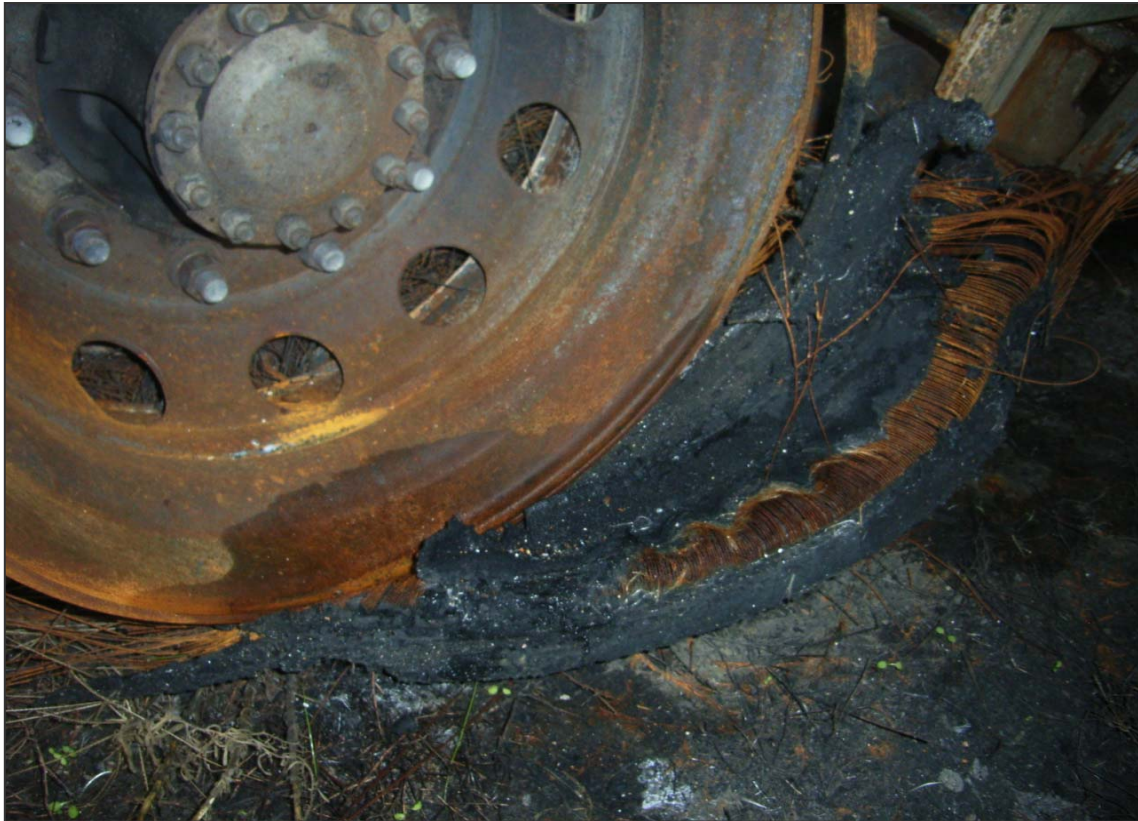
There were remnants of rubber remaining from the right side rear tyres, and much of the steel reinforcing cord remained in place (*Photograph 4*).

**Photograph 4: Remaining rubber from right outer rear tyre**

The absence of any tyre rubber remaining in the vicinity of the left side wheels, unlike the right side wheels where some rubber remained, supports the premise that the fire started on the left side of the bus.

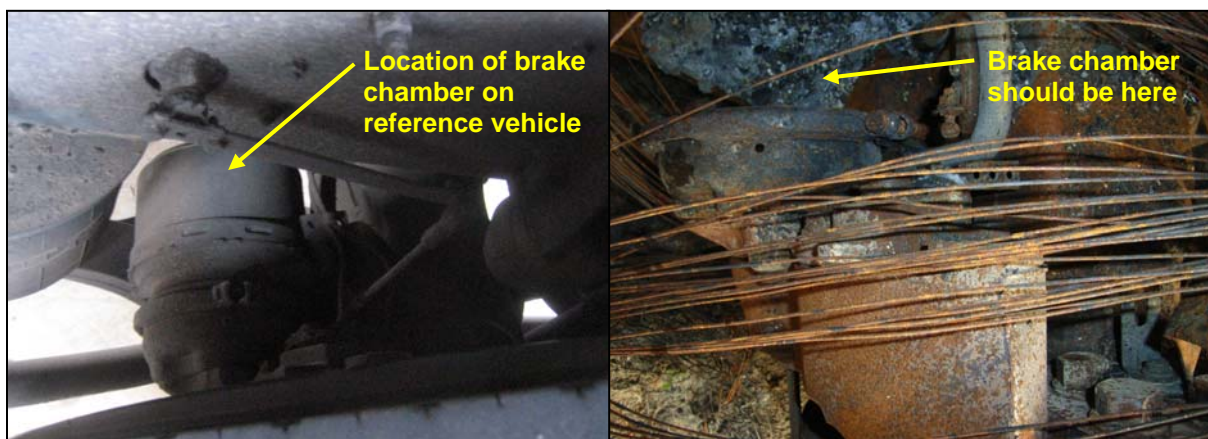
Components inboard of the hub were severely fire affected, and it was noted in particular that the spring brake chamber was missing, having separated from its mounting flange, as can be seen in *Photograph 5*. As a consequence there was no need to release the brakes to check movement of the hub, which was found to rotate freely.

**Photograph 5: Missing spring brake chamber**

The bus was equipped with air operated disc brakes, with the rear brakes incorporating a spring brake chamber to provide a parking brake function. As noted earlier, the spring brake chamber on the left hand rear wheels was missing, having separated from its mounting flange, rendering the spring brake inoperative. The report by the driver that the brakes operated normally when he brought the bus to a stop indicates that the spring brake chamber was present at this stage, and became separated as the fire intensified.

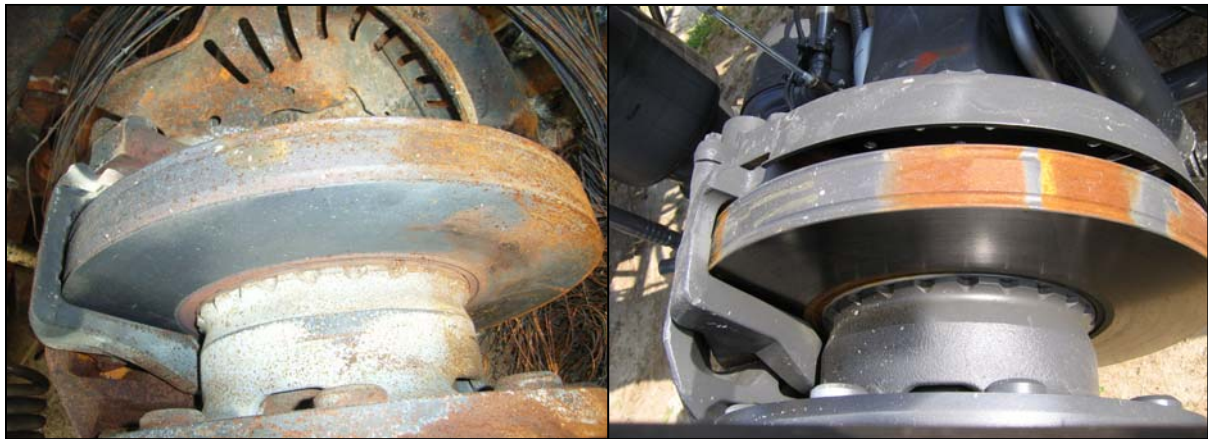
The brake shield located inboard of the brake disc was severely deformed, as can be seen in *Photograph 6* where it is compared with a similar undamaged shield. There was an impact mark, evidenced by visible burring, on the edge of the shield (*Photograph 7*) and, although the shield remained secured to the brake calliper mounting bracket by a bolt at each end, it had separated from a third bolt approximately mid-way between the other two.

**Photograph 6: Comparison of the damaged shield (left) with an undamaged shield (right)**

The damaged brake shield was examined and compared with an undamaged shield on another bus of the same model. It was considered that the damage to the shield was unlikely to have been caused by the tyre cord after the tyre disintegrated, as the cord was found to be lying loosely around the shield rather than caught and tangled on it.

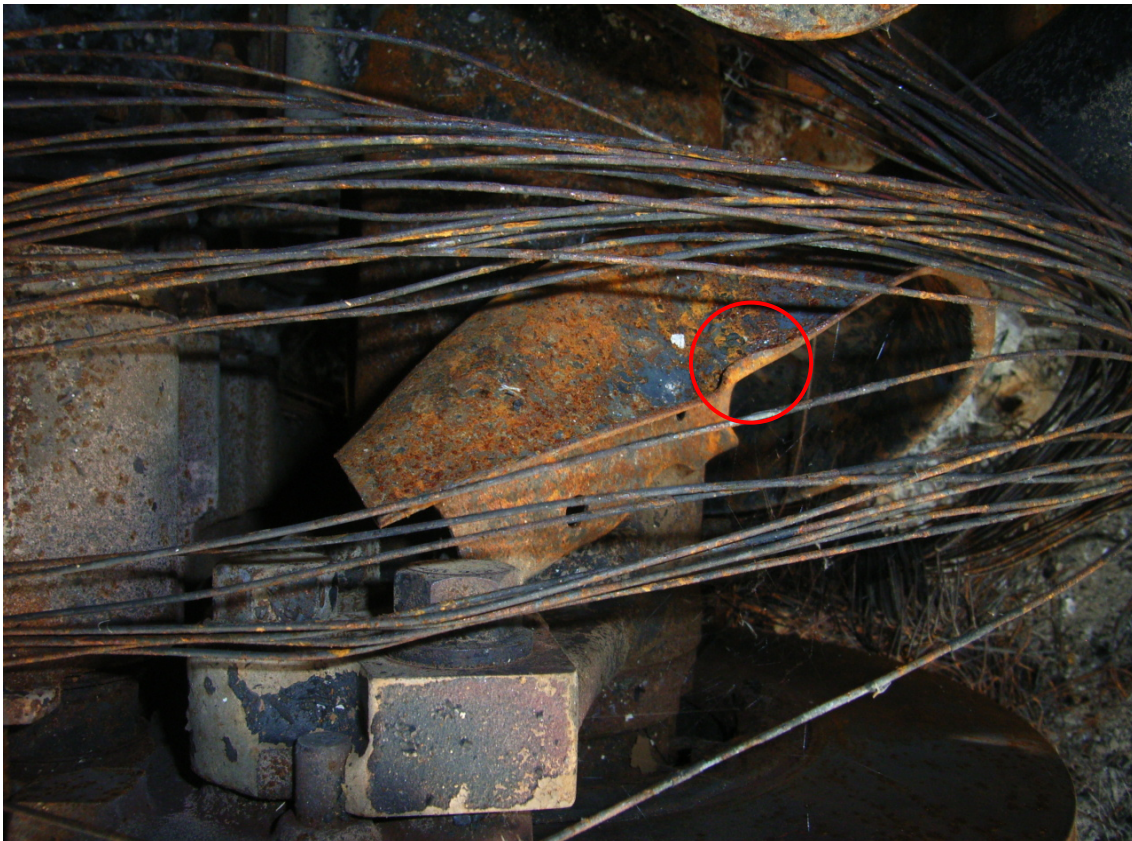
**Photograph 7: Evidence of impact damage on edge of deformed brake shield**

The burring to the edge of the shield had the appearance of having been due to impact by a hard object, rather than by rubber from a disintegrating tyre. This, and the location of the undamaged shield within the profile of the rim and with a relatively small clearance from the rim, suggests that the damage to the shield may have been caused by some hard object being trapped between the rotating wheel and the bus body and suspension components, and being forced into the gap between the rim and the shield. This raises the possibility of the damage to both the tyre and the shield being caused by some object thrown up from the roadway.

The most likely cause of the fire was ignition of rubber residue from a failed right inner rear tyre due to friction. The tyre failure was probably due to a foreign object being thrown up from the roadway and being forced into the gap between the brake shield and wheel rim, in such a way as to damage both the brake shield and the tyre. The white smoke initially seen by the tour guide is characteristic of rubber heated by friction before it ignites, while the black smoke seen shortly after the bus came to a stop is characteristic of burning rubber or fuel, due to the tyre igniting from the concentration of heat once the bus came to a stop.

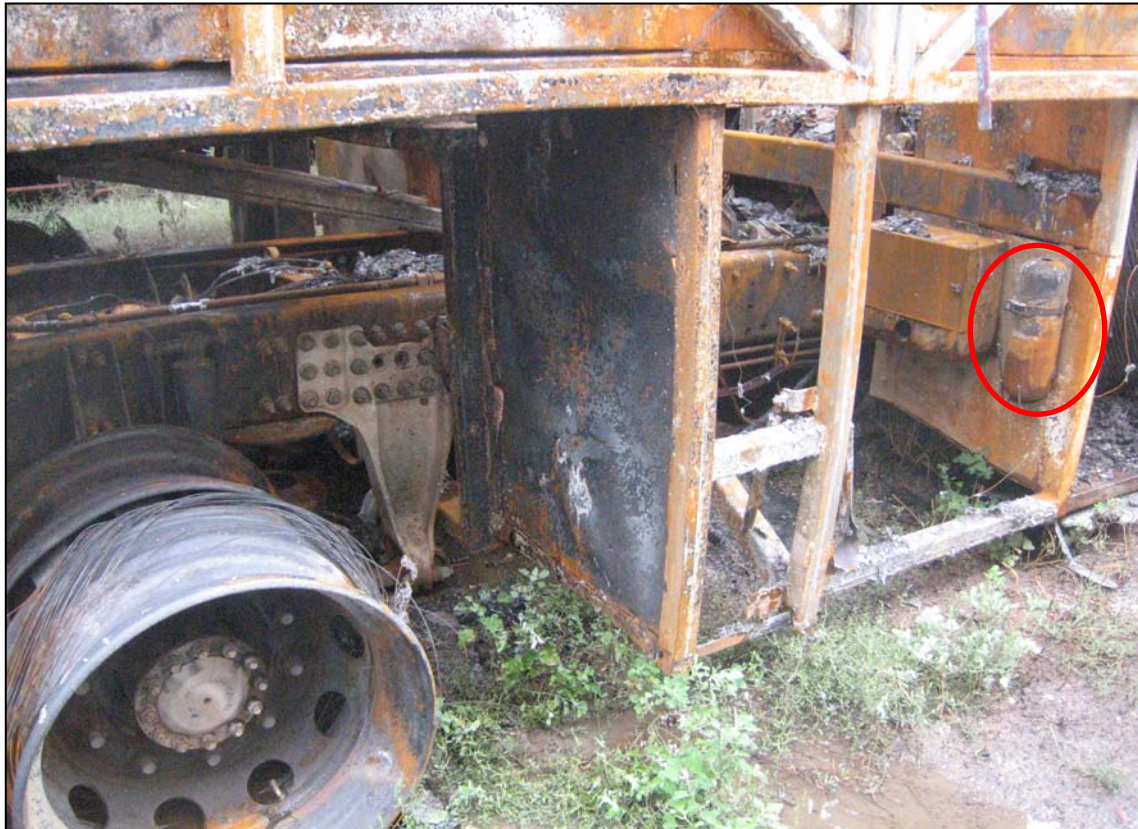
The bus was fitted with two powder type fire extinguishers, one (the one used by the guide) located behind the driver's seat and the other located in a compartment on the driver's off-side, behind a panel between the engine bay and wheel well (visible in *Photograph 8*). On the bus examined at the Zetland holding yard, the second fire extinguisher was located on the opposite side. Neither the driver nor the guide was aware of this difference, their assumption being that for buses of the same model it would always be found on the same side.

**Photograph 8: Position of second (rear) fire extinguisher in relation to rear wheels**

When the guide became aware of the fire, he attempted unsuccessfully to extinguish it using the extinguisher that was mounted behind the driver's seat. Once the fire was established, the second extinguisher, located behind a side panel behind the left hand rear wheel, would no longer have been accessible due to the spread of the fire. However, as the fire had become more firmly established despite use of the first extinguisher, inability to access the second extinguisher is not considered to have had any significant bearing on the events that followed.
