**OTSI Technical Inspection Findings  
Fire Involving AAT Kings Mercedes Tour Bus  
Gore Hill Freeway, Artarmon  
6 July 2010**

FIRE INVOLVING AAT KINGS MERCEDES TOUR BUS  
GORE HILL FREEWAY, ARTARMON

6 JULY 2010

*Investigation Reference: 04486*

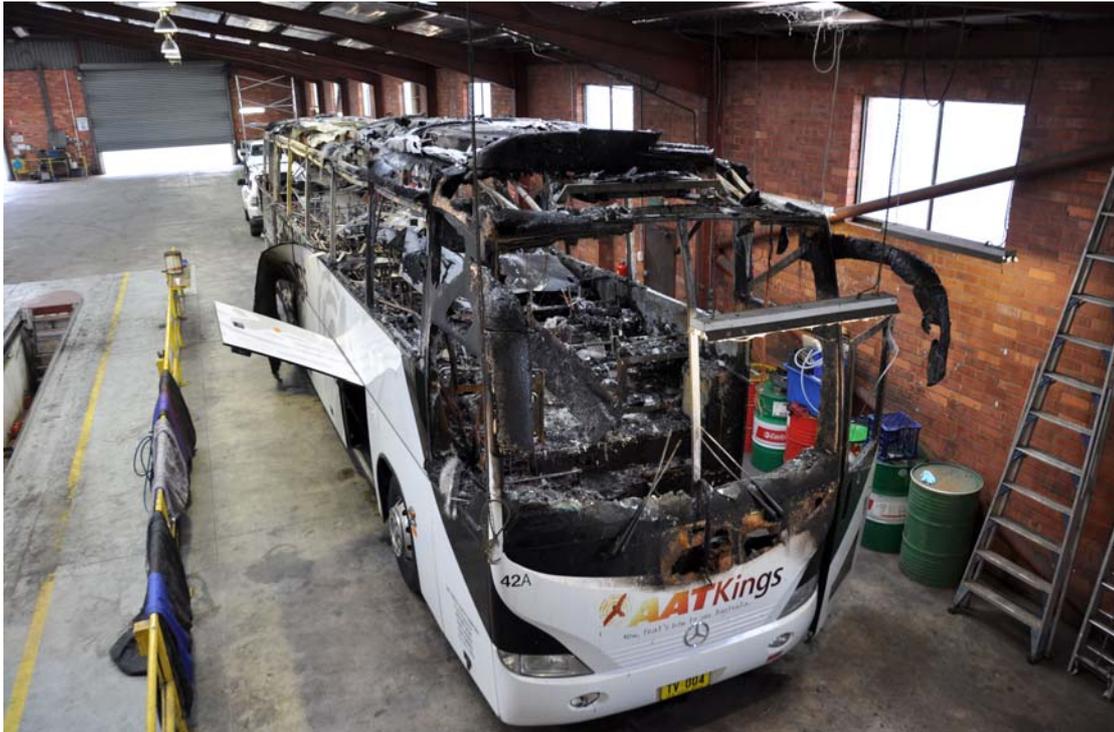
The bus was destroyed by fire, with only the front driver's side escaping complete incineration. Photographs 1, 2 and 3 depict the level of fire damage to the bus.

**Photograph 1: Top down view of bus from front.**

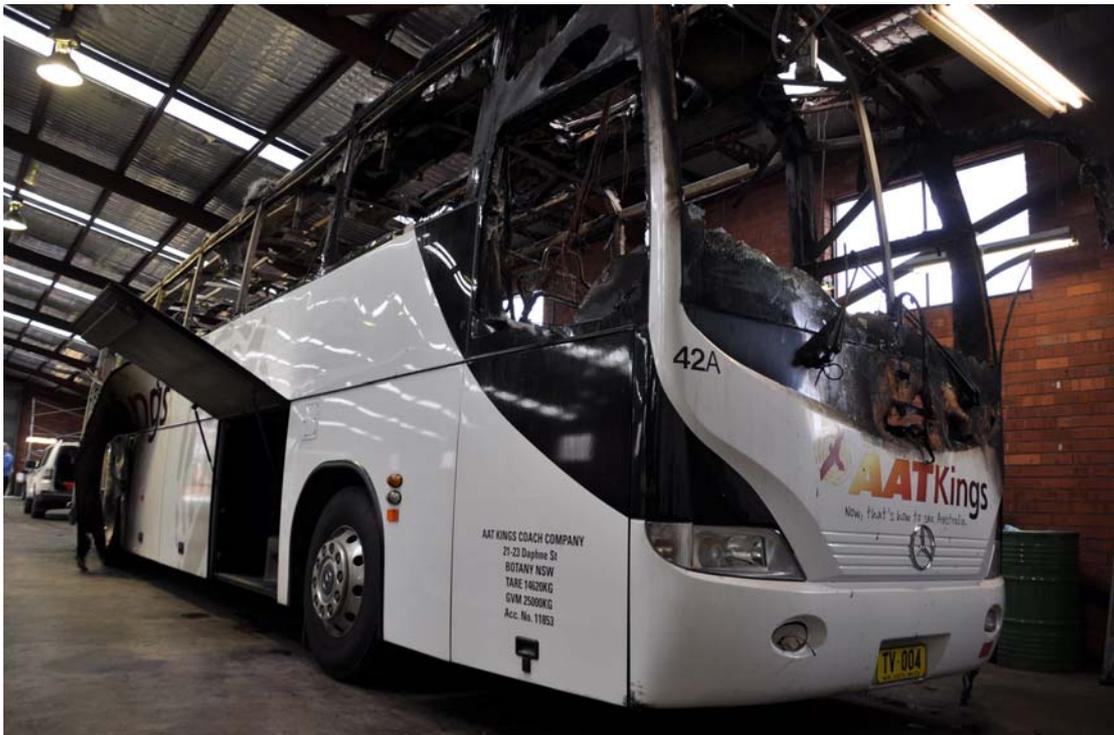
**Photograph 2: Side view of bus showing least damaged area.**

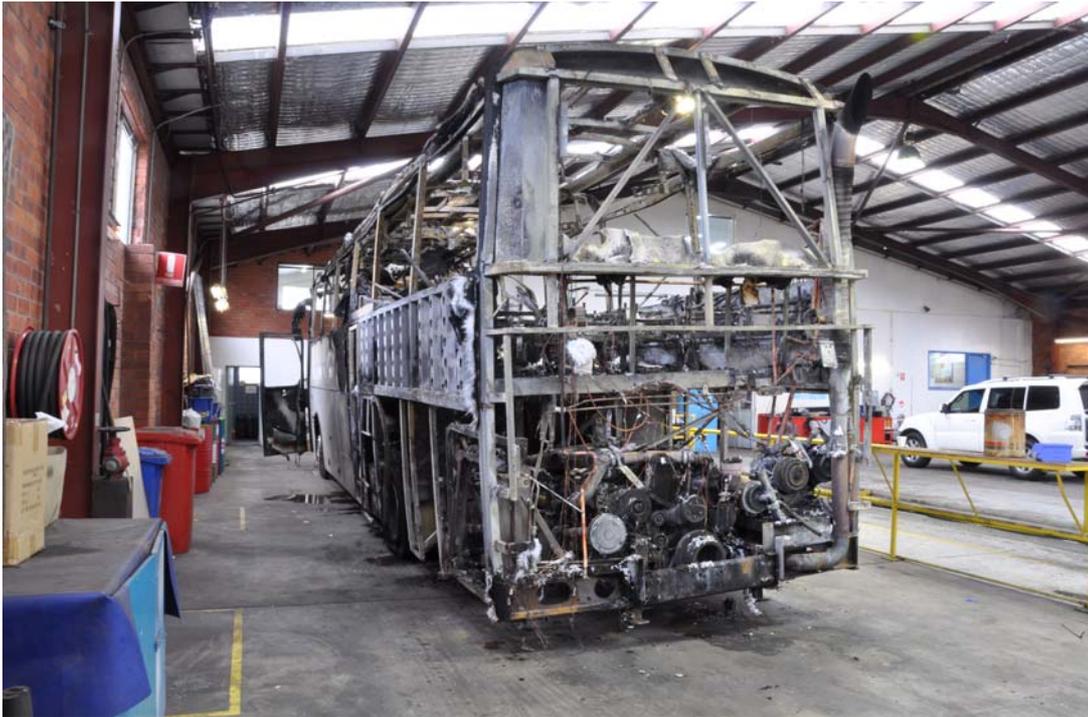
**Photograph 3: Rear view of bus showing fire damage to engine bay.**

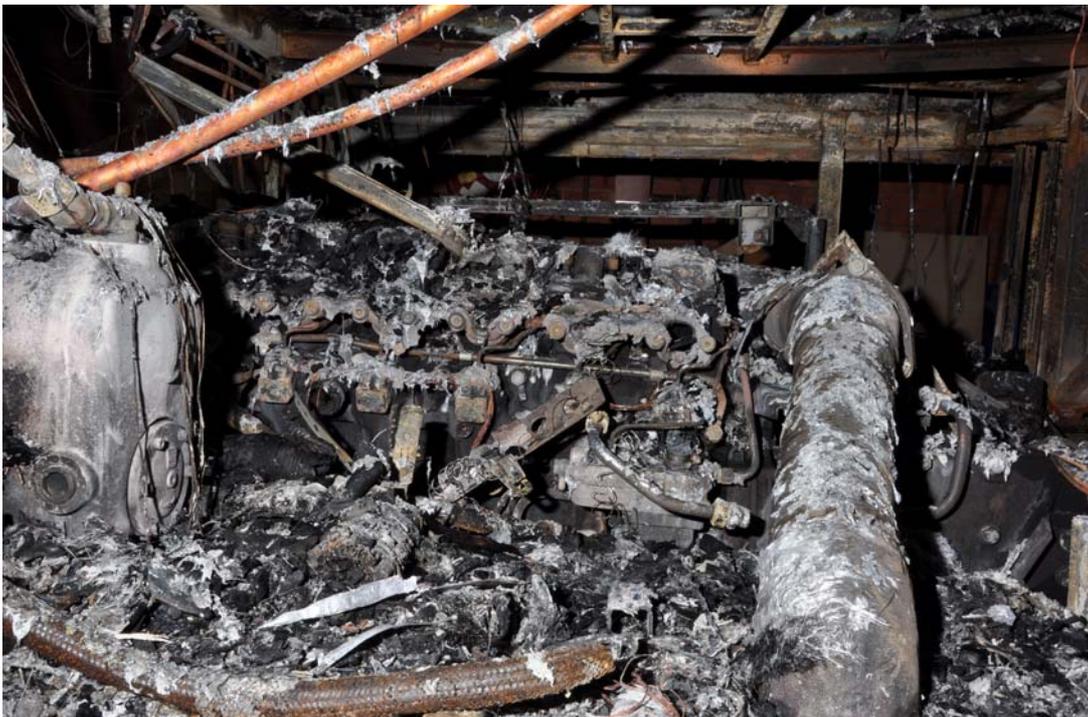
Based on the driver's account of seeing excessive exhaust smoke leading up to the incident, the examination concentrated on the fuel system of the bus. Due to the fire damage, all soft metal components and rubber fuel hoses were destroyed. Photograph 4 is taken from the driver's side of the engine bay, showing the level of fire damage sustained to the engine.

**Photograph 4. Engine damage caused by fire.**

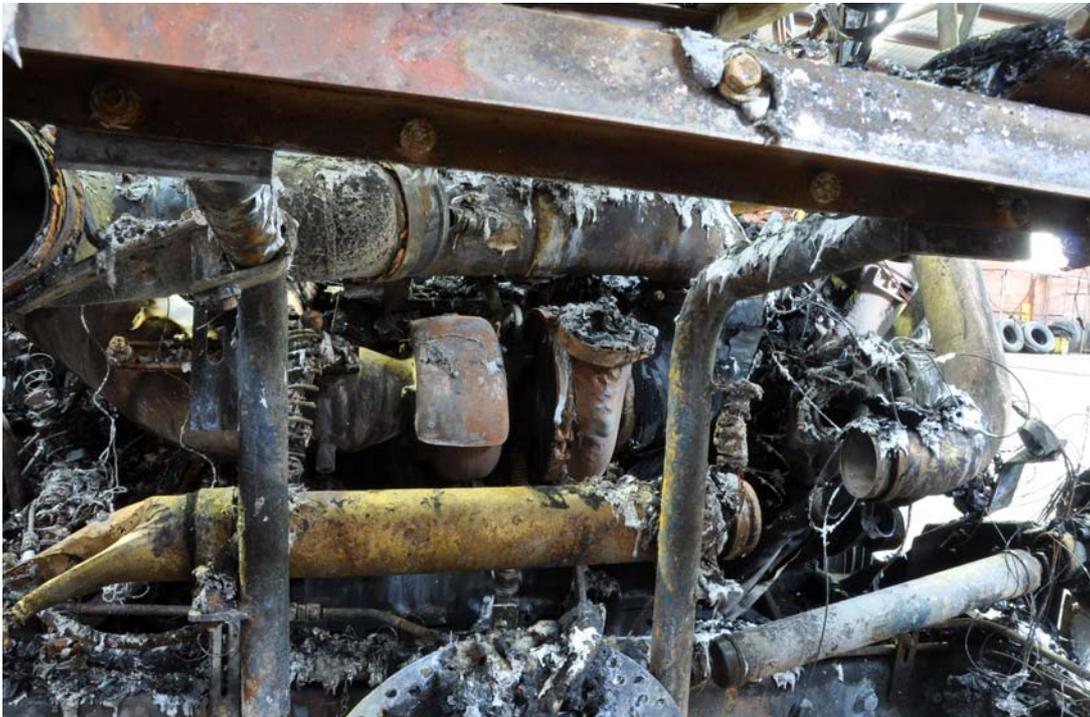
One component of the fuel system that can lead to excessive smoke emissions is the turbocharger. On inspection of the turbocharger, it was found that the compressor housing had partially melted away. This indicated that extreme and unusual temperatures were encountered by that component of the turbocharger. Photograph 5 is a general shot of the turbocharger, while Photograph 6 shows a close up view of the compressor housing.

**Photograph 5. Turbocharger viewed from left of engine compartment.**

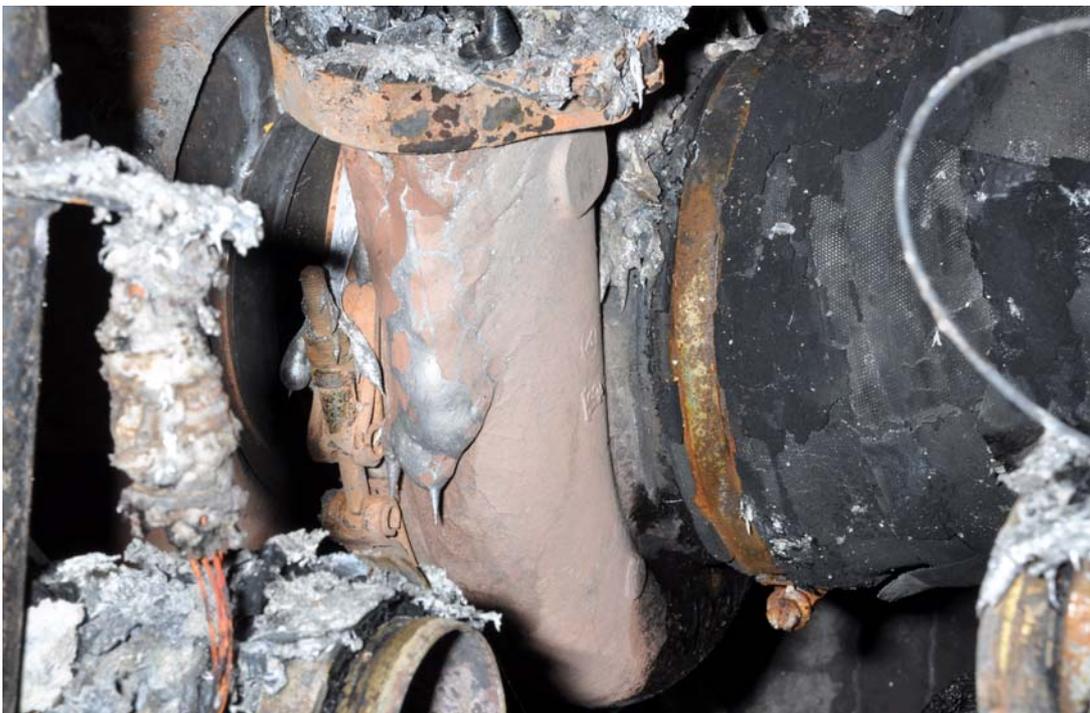
**Photograph 6. Close up of compressor housing, showing molten metal.**

The only way that the compressor housing could have suffered such damaged was through extreme temperatures generated inside the turbocharger. This was clearly the origin of the fire, as no other iron components of the bus had encountered that much heat; in effect, nothing could melt the turbocharger from the outside, and so the fire necessarily originated from a failure within the turbocharger.

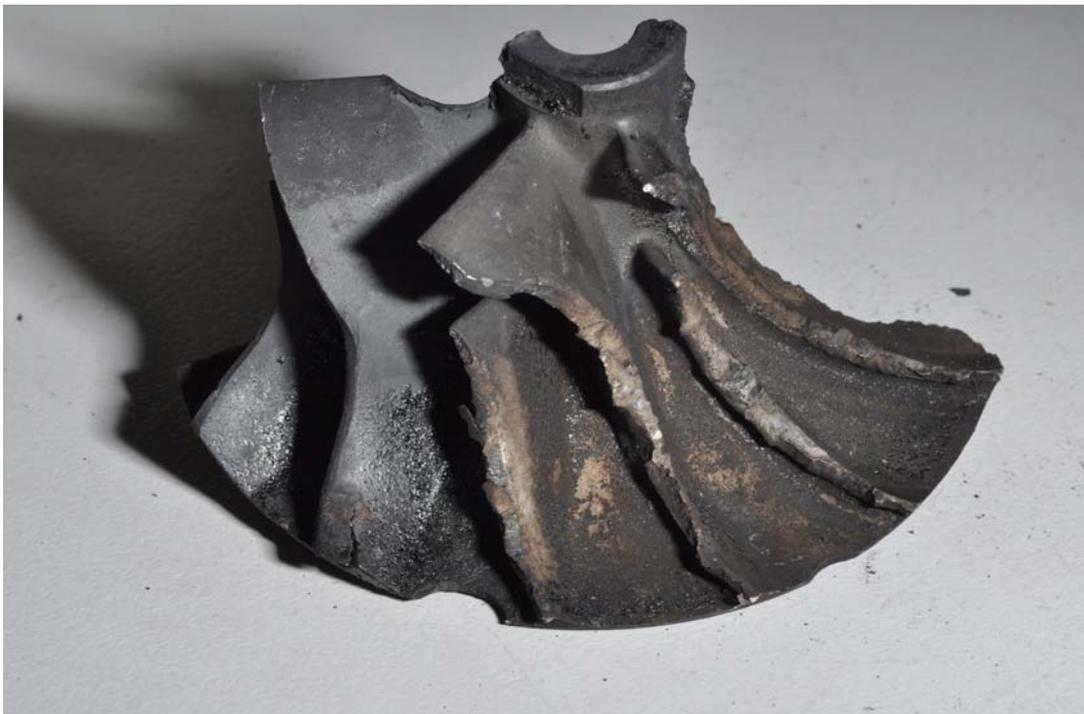
**Photograph 7: Close up of one half of the shattered compressor wheel**

The insurer of the bus secured the services of a fire investigator who removed the turbocharger from the bus and dismantled it for inspection. It was found that the compressor wheel had shattered (Photograph 7) which confirmed a catastrophic failure of the turbocharger.

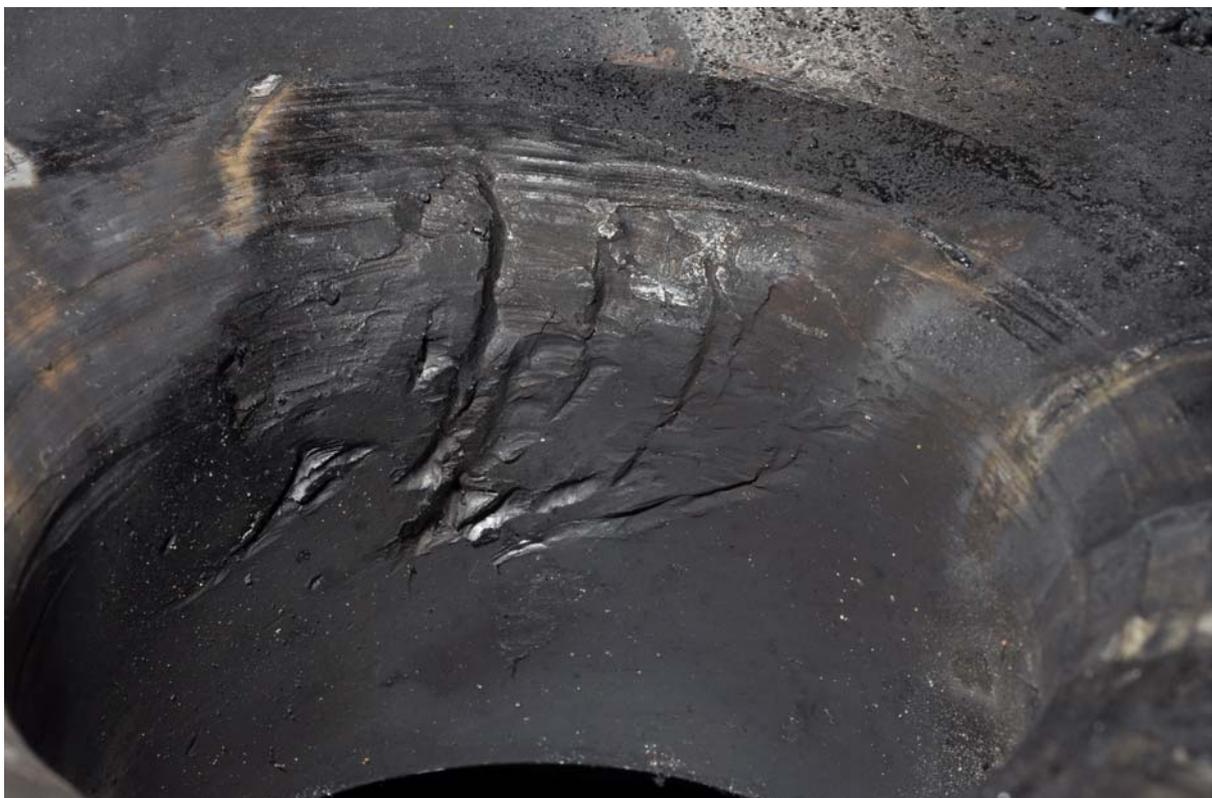
On 12 July 2010, an OTSI investigator examined the dismantled turbocharger unit and found that there was excessive movement in the bearings on the compressor side of the unit. This movement would have allowed lubricating oil to enter the turbocharger compressor housing, where the fire originated. Impact damage evident on the inside surface of the compressor housing showed that the compressor wheel had come into contact due to excessive shaft movement (Photograph 8). This would have generated excessive heat, setting fire to the oil entering the compressor side and leading to the eventual destruction of the compressor wheel.

**Photograph 8: Close up of damage to inside of compressor housing.**
