**Office of Transport Safety Investigations**

**BUS INCIDENT FACTUAL FINDINGS  
FIRE INVOLVING BCI 29 SEAT COACH  
BELLIMBOPINNI, NSW**

**19 June 2013**

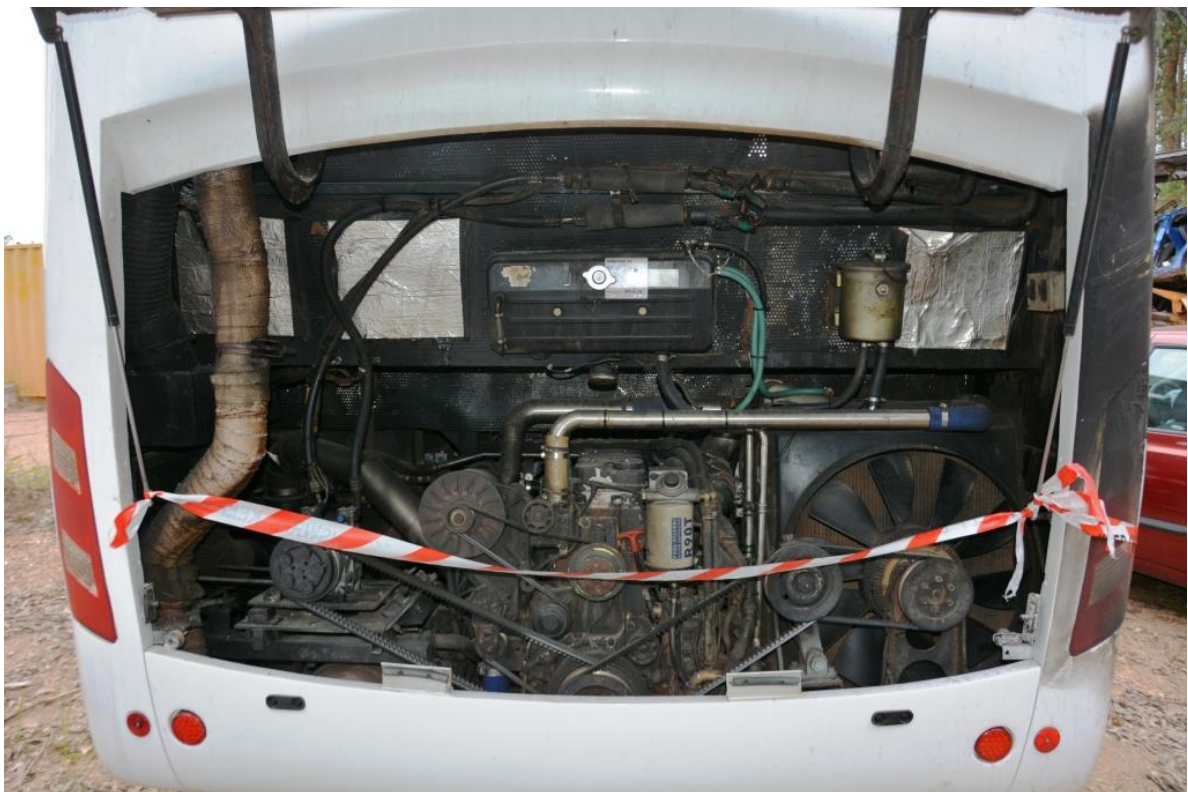
- The driver switched off the engine and opened the electrically operated plug door at the front near side of the coach.
- The driver left his seat and exited the vehicle, collecting the fire extinguisher and kicking his bag out of the coach as it had got in the way. He ran straight to the rear of the coach where he cautiously opened the engine access hatch; there was no sign of fire with everything appearing to be normal (see Photograph 1).

**Photograph 1:** Rear of coach and engine compartment untouched by fire

The external rear portion of the coach showed little sign of the fire with the engine compartment being untouched. Likewise, the fuel system including the underfloor tank was intact and had not suffered any fire damage.

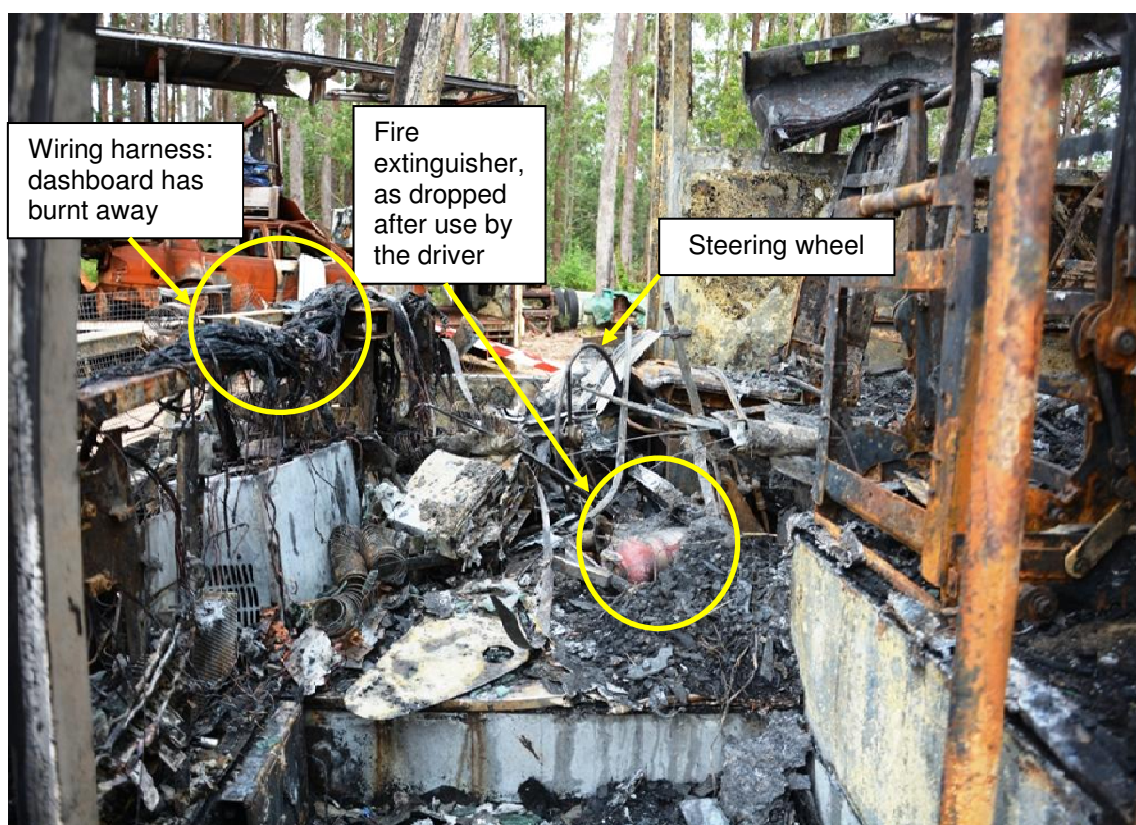
- The driver then looked around the side of the coach back to where he had come. 'Plumes of black smoke where pouring out the door.'
- The driver returned to the door and stood on the bottom step and 'half onto the second'. The driver could feel 'intense heat' and could see flames to his right at seat height.
- The driver discharged the hand-held fire extinguisher into the interior of the coach. (Photograph 2 shows the location of the fire extinguisher after the fire).

**Photograph 2:** View through the door of the coach

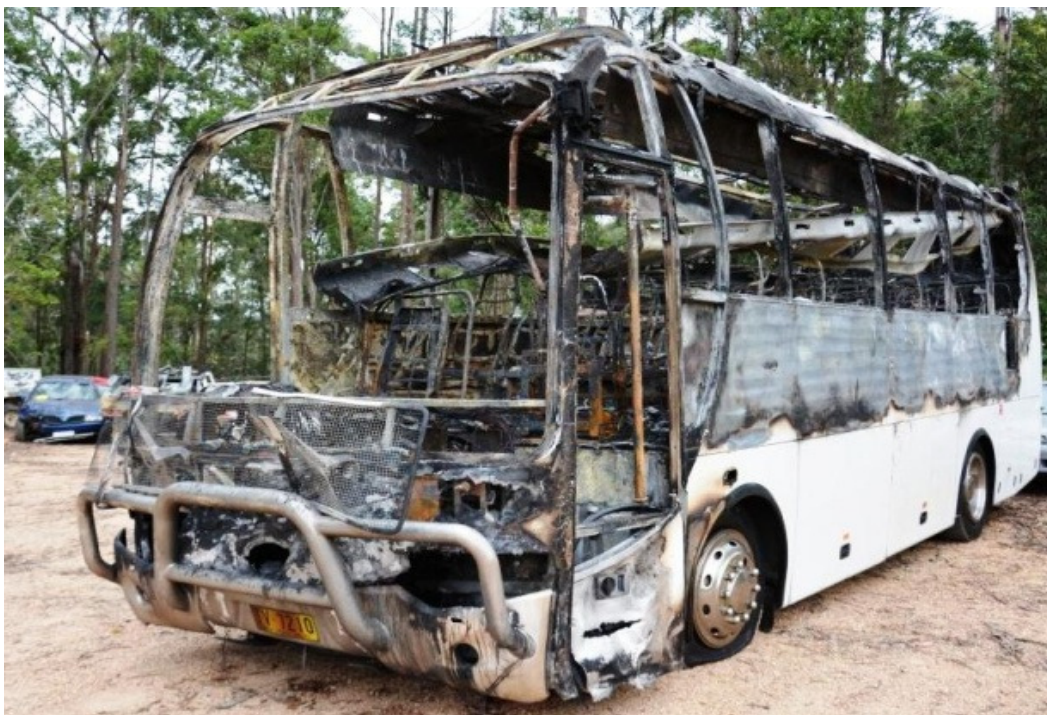
An OTSI investigator inspected the bus at a holding yard at Woolgoolga, to which the coach had been transported post incident (see Photograph 3). The investigator also inspected the incident site at Bellimbopinni.

**Photograph 3:** Burnt out coach at the holding yard in Woolgoolga

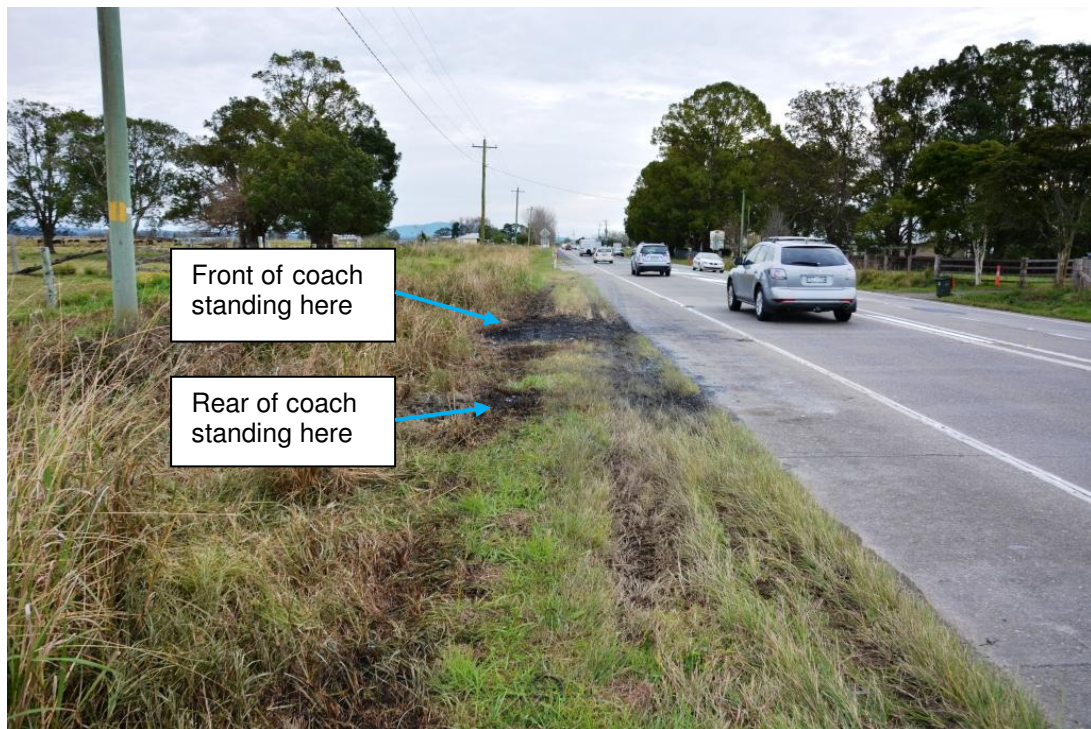
The site inspection revealed that the grass area where the front part of the coach had been located had been severely burnt (Photograph 4). In contrast, there was less evidence of fire in the remainder of the area where the coach had stood while it burnt.

**Photograph 4:** Incident location

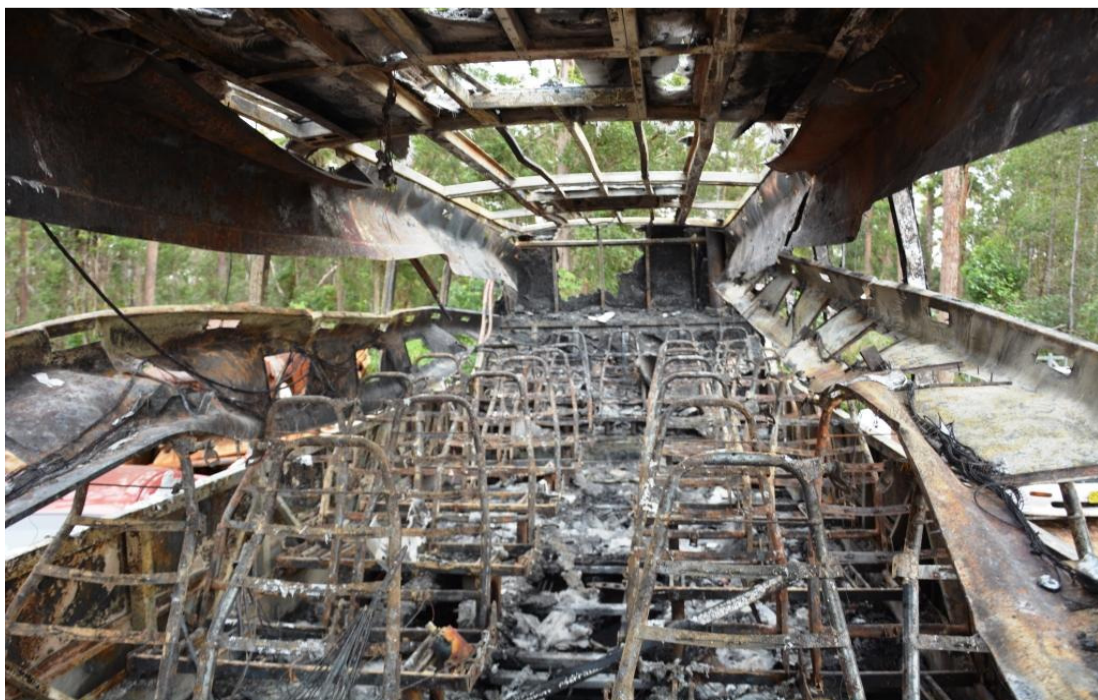
The coach had suffered extensive fire damage with the interior having been totally burnt out (see Photograph 5). The glass from the windows was missing and, excepting where it was shielded by the air conditioning equipment, the fire had consumed the fibreglass roof. The underfloor luggage areas were not touched by fire except for debris that had fallen through as the plywood floor burnt away.

**Photograph 5:** Coach interior

The examination of the circumstances of this incident indicates that the fire was likely to have been initiated by an electrical fault in the front of the coach, probably in the dashboard or the wiring harness under the floor.

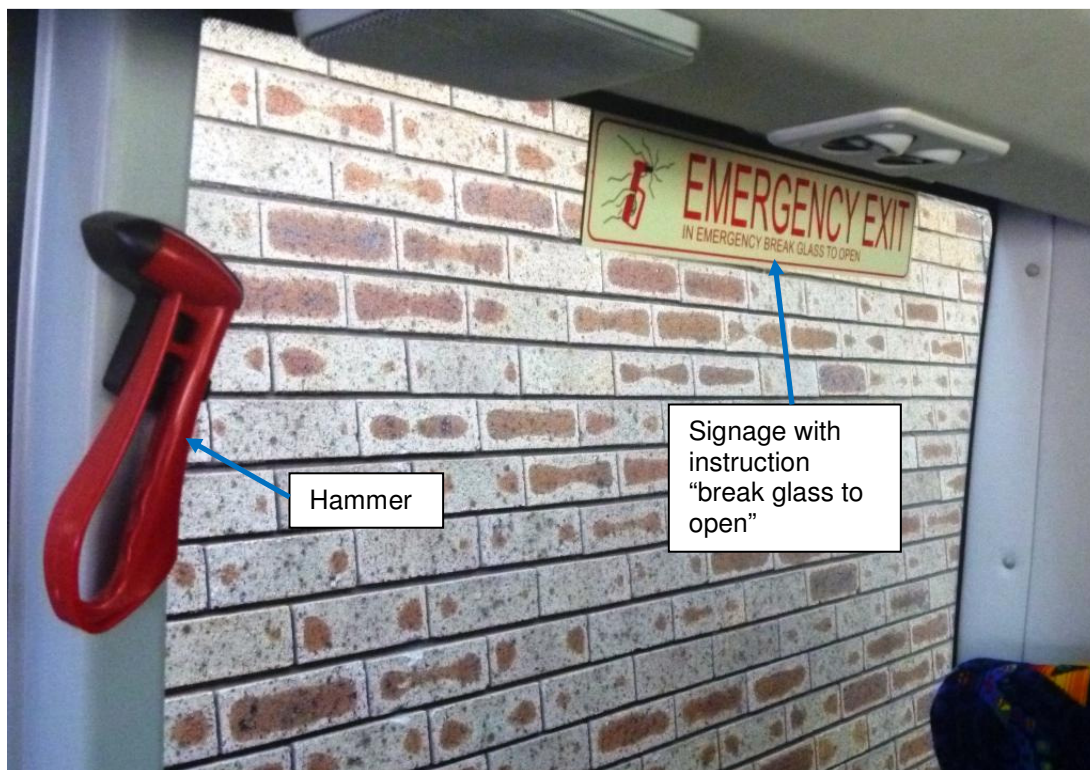
In addition to a manual override operable from both inside and outside the vehicle to allow the plug door to be opened in the event of a power failure, four emergency escape exits were provided. Three hammers located by windows, one on the near side and two on the off side, were available for passengers to break the glass to create an escape route (see Photograph 6).

**Photograph 6:** Emergency exit window

- Passengers may not be familiar with the procedure of using a hammer to break windows. Any passengers with mobility difficulties would find evacuating through a window far from straightforward, even the one with the sliding panel that provided an easier exit route.

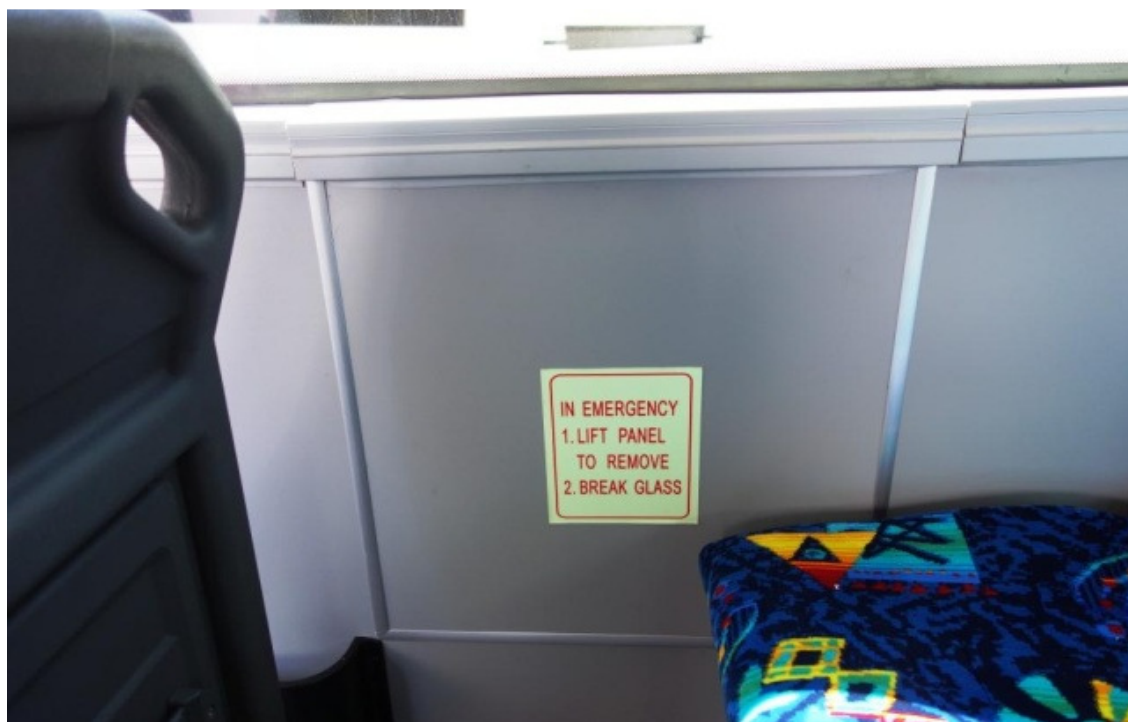
Additionally, there was an escape hatch on the roof centreline towards the rear of the vehicle. The nearside emergency exit window extended down towards floor level with a sliding panel that could be lifted out (see Photograph 7). Once the glass was broken and removed, this provided an easier escape route from the interior of the coach.

**Photograph 7:** Removable sliding panel
