BUS SAFETY INVESTIGATION REPORT

SYSTEMIC INVESTIGATION INTO AN ALLEGED 'BLIND SPOT' ON MARK II AND MARK III MERCEDES-BADGED BUSES OPERATED BY THE STATE TRANSIT AUTHORITY.

OTSI File Ref: 03004

OTSI File Ref: 03004	Office of Transport Safety Investigations
	Level 21, 201 Elizabeth Street
27 September 2005	Sydney NSW 2000

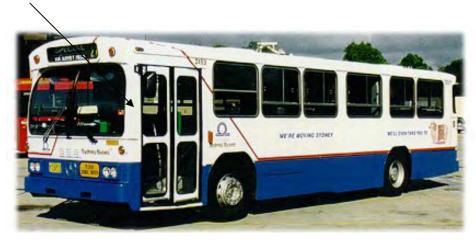
Photograph 1 - Mk II "Mercedes"

- 4.3 **Design**. STA introduced the Mk II Mercedes bus into service between 1978 and 1980 to satisfy an increasing demand for public transport at the time and to replace its aging fleet of Leyland Leopard buses. A Mk III was subsequently commissioned into service in the period 1981-1983. With the exception of subtle changes in step and ceiling heights, the two bus types are very similar in appearance. In respect of those matters that might affect the driver's visibility, STA's Mk II and Mk III Mercedes buses are, as can be seen in Photographs 1 and 2 below, almost identical. It is important to note that many buses are 'hybrids', with one manufacturer supplying the chassis, engine, transmission and other mechanical components, whilst another provides the coachwork. The Mk II Mercedes bus operated by STA is in fact a Mercedes chassis fitted with coachwork supplied by the Pressed Metal Corporation⁴. Accordingly, OTSI's investigation has more properly focused on establishing the presence, or otherwise, of a blind spot on Mk II and Mk III 'Mercedes-badged' buses operated by STA.

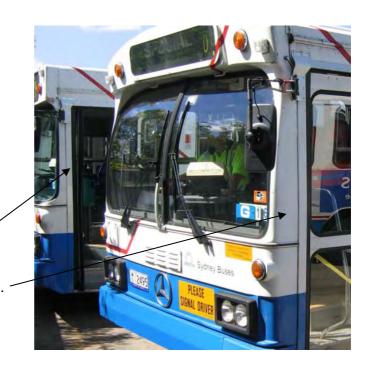
4.5 Notwithstanding improvements in design, all vehicles have, under certain circumstances, a 'blind spot'. The 'A' pillar on a truck or bus is vertically positioned to provide additional structural integrity. The pillar on buses typically also provides part of the housing for the front door frame. In contrast, the 'A' pillar on a standard family vehicle is oriented at approximately 45 degrees and is therefore less likely to obstruct a driver's view of a standing pedestrian in close proximity. OTSI noted that whilst the integrity of the 'A' pillar on the Mk II and Mk III Mercedes-badged buses operated by STA is not in question, 50% of the pillar is comprised of moulded fibreglass and contributes to design aesthetics, rather than structural integrity, i.e., the 'A' pillar on these models is 50% wider than need be. Indeed, much of this fibreglass was removed and replaced with glass in the Mk IV.

The difference in 'A' pillar width between STA's Mk IV and Mk II Mercedes-badged buses.

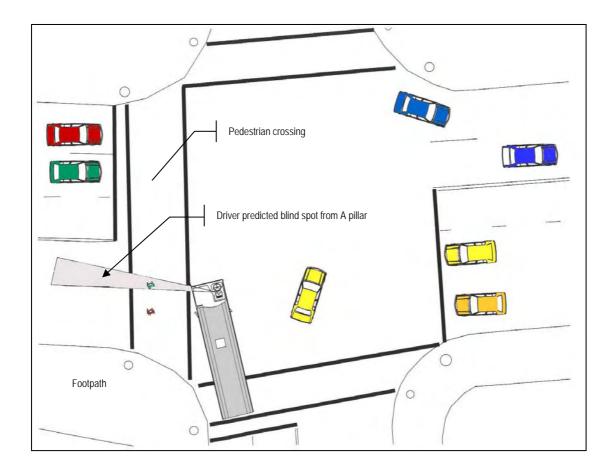
4.6 To define the magnitude of the blind spot effect, OTSI utilised a commercially available computer-aided design program and measurements taken from the driver's seat in a Mk II Mercedes-badged bus to produce the representative diagram below. OTSI calculated that the width of the 'A' pillar on STA's Mk II and Mk III Mercedes-badged buses produces a blind spot which, if the driver remains in his/her normal driving position, increases in width by approximately one metre in every four metres from the left hand front corner of the bus.

Driver's predicted blind spot for a Mercedes Mark II & III bus when turning left at an intersection

- 4.7 To overcome the blind spot on STA's Mk II and Mk III Mercedesbadged buses, a driver must either lean forward or backwards to see around the 'A' pillar.

- 4.16 OTSI considers that there may be further scope to improve visibility, by a combination of mirror positioning and mirror type, on STA's Mk II and Mk III Mercedes-badged buses. STA has advised OTSI that it will be engaging a consultant to complete a comparative study on the physical blind spots that exist on all of its bus types and that the results will be used to develop appropriate strategies to manage the risks associated with any identified blind spots⁹. This provides STA with an opportunity to examine the positioning and type of mirrors fitted to its Mk II and Mk III Mercedes-badged buses.

c. STA examines the fitting and placement of alternative side

mirror types to its Mk II and Mk III Mercedes-badged buses.
