## BUS SAFETY INVESTIGATION REPORT

# COLLISION BETWEEN TWO STA BUSES IN THE EASTERN DISTRIBUTOR TUNNEL, SYDNEY 25 FEBRUARY 2005

**OTSI File Ref: 03531**

**28 October 2005**

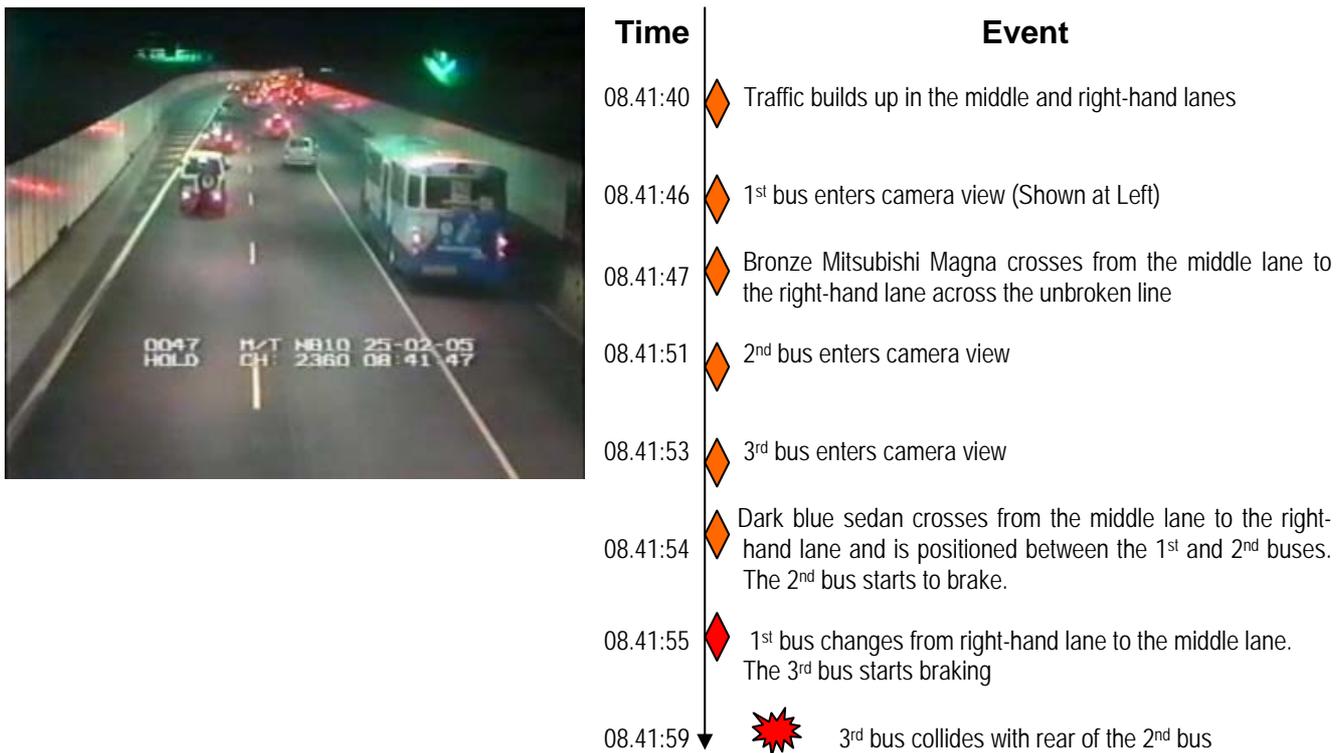
Figure 2 Sequence of Events

3.1 Figure 2 provides an indication of the sequence of events leading up to the collision, as recorded on CCTV footage provided by the tunnel operator. Camera No. 47, oriented North, captured, albeit at almost the limits of its range, the following sequence of events.

3.2.1 Traffic was building-up as the first of the three buses entered the tunnel. A bronze Mitsubishi Magna crossed over the unbroken separation line in front of this bus but had no effect on its progress.

3.2.2 The second and third buses entered the tunnel and a dark blue sedan crossed the unbroken separation line from the middle lane to the right-hand lane into the gap between the first and second buses. Almost immediately, the first bus crossed from the right-hand lane to the middle lane, increasing the size of the gap in which the dark blue sedan was travelling. The second bus commenced braking in response to the built-up traffic.

3.2.3 When the third bus entered the tunnel, its speed appeared to match the speed of the traffic in neighbouring lanes. The second bus braked as described above, and the third bus braked suddenly but impacted with the rear of the second bus.

3.2.4 The impact between the third and second bus appeared to be at low speed, but an accurate analysis of the closing speed could not be made because of the camera angle and its distance from the incident.

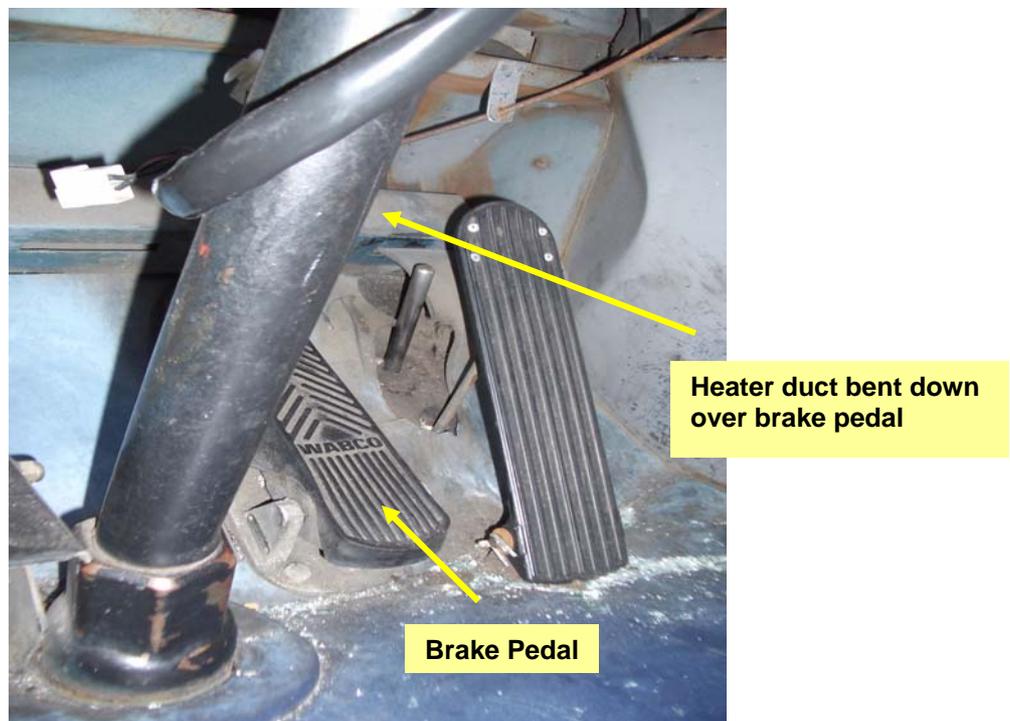
Figure 3 Brake Pedal Position

3.3 The buses involved in the collision were examined in situ by OTSI. The dash-mounted air pressure gauges on the third bus indicated that it had a full supply of compressed air for braking. Furthermore, the brake pedal was fully depressed, indicating that the brakes were fully applied at the time of impact, and was jammed in this position due to collision damage. See Figure 3.

3.4 This bus was later subjected to a dynamic braking test on a brake roller testing machine. The test confirmed that the braking system worked efficiently, with the braking levels exceeding the required standards in both force and balance.

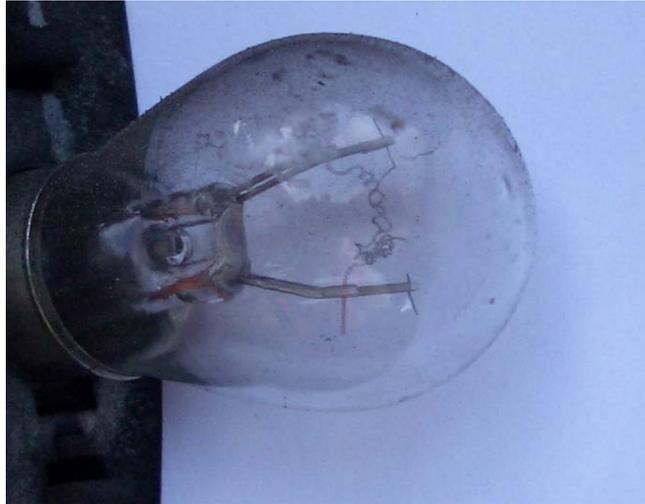
Figure 4 Stop light filament showing 'hot break' deformation

3.6 The brake lights on the second bus were examined. Those globes not destroyed in the collision were either functioning or had indications of 'hot breaks' (see Figure 4) consistent with the globe filament being illuminated at the time of the collision. CCTV footage confirmed this to be the case.

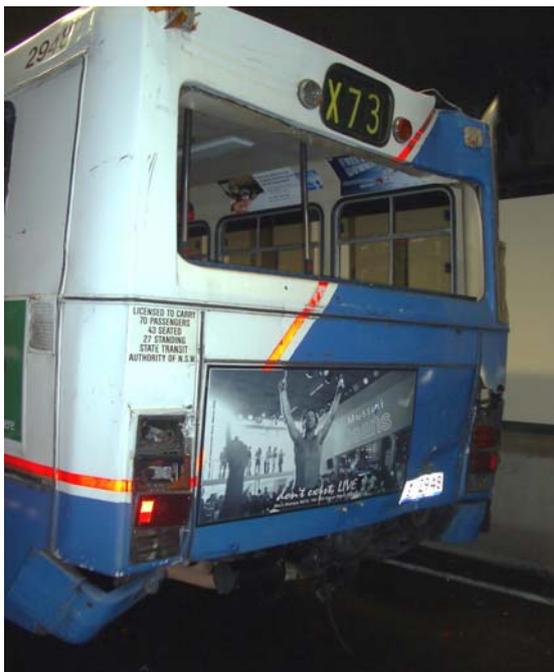
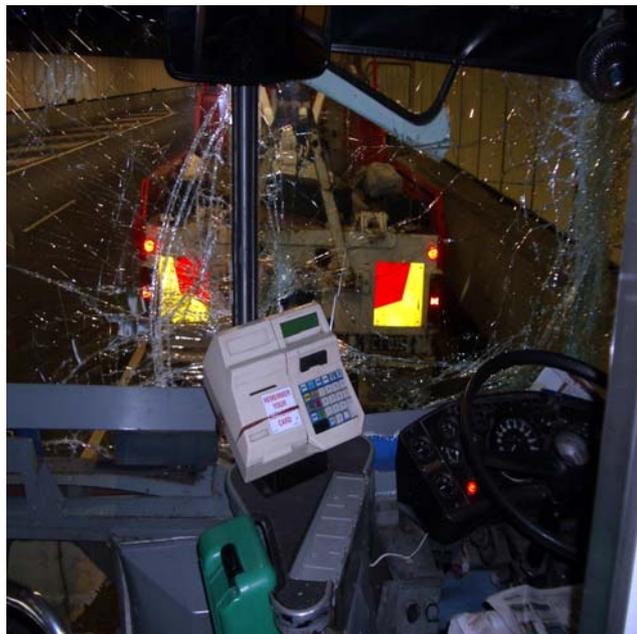
4. In a rear-end collision such as the subject of this report, the people in greatest danger are those seated closest to the impact zone, being the passengers at the rear of the bus that is struck from behind, and the driver of the bus which crashes into the vehicle in front of it.

5. The positions of vulnerability in rear-end collisions are depicted in the photographs below which are taken from the scene of the Eastern Distributor Tunnel collision.
