## Bus Safety Investigation

25 February 2005

**Collision between two State Transit Authority buses in the Eastern Distributor Tunnel, Sydney.**

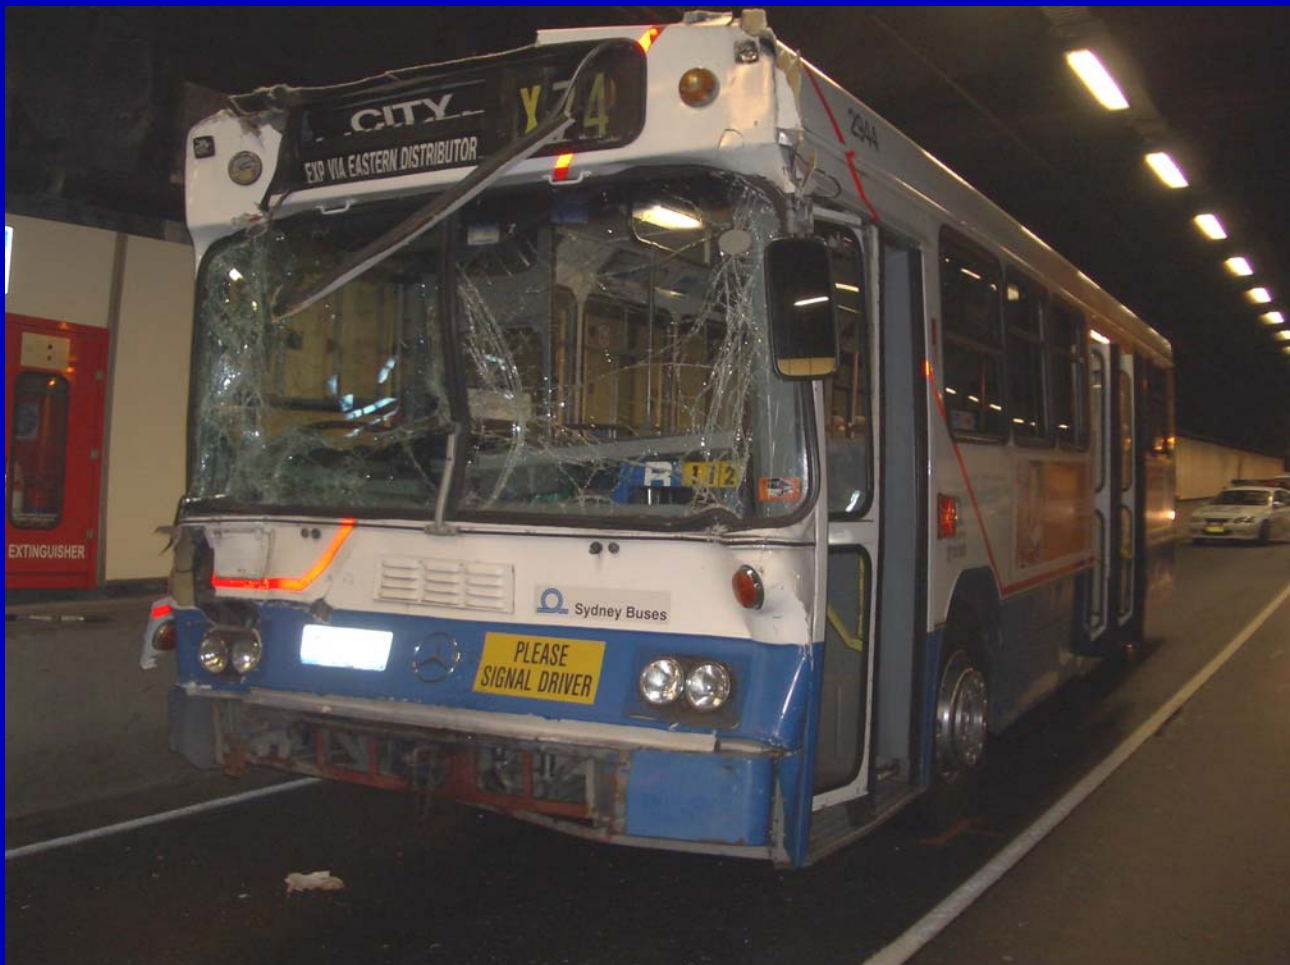
Whilst negotiating a right hand bend in the tunnel, the leading bus travelling route X73 was forced to apply brakes due to slowing traffic in front. The following bus travelling route X74 failed to reduce its speed adequately and collided with the rear of the leading bus. Both buses were travelling with a full standing load of passengers.

The braking system of both buses is of the full air brake type, with an engine driven compressor supplying air pressure to supply tanks which store pressure for brake applications. On inspection of the buses at the scene, it was observed that the following bus, X74, had full air pressure available in the braking system. Furthermore, accident damage to the front bulkhead of the bus had caused the brake pedal to be jammed in the apply position. To allow the bus to be towed for further examination, the brake linkage was removed under the supervision of investigators from the Office of Transport Safety Investigations.
