# Bus Safety Investigation Report

## Gosford

8 June 2004

**Sudden Brake Application Resulted In Multiple Injuries.**

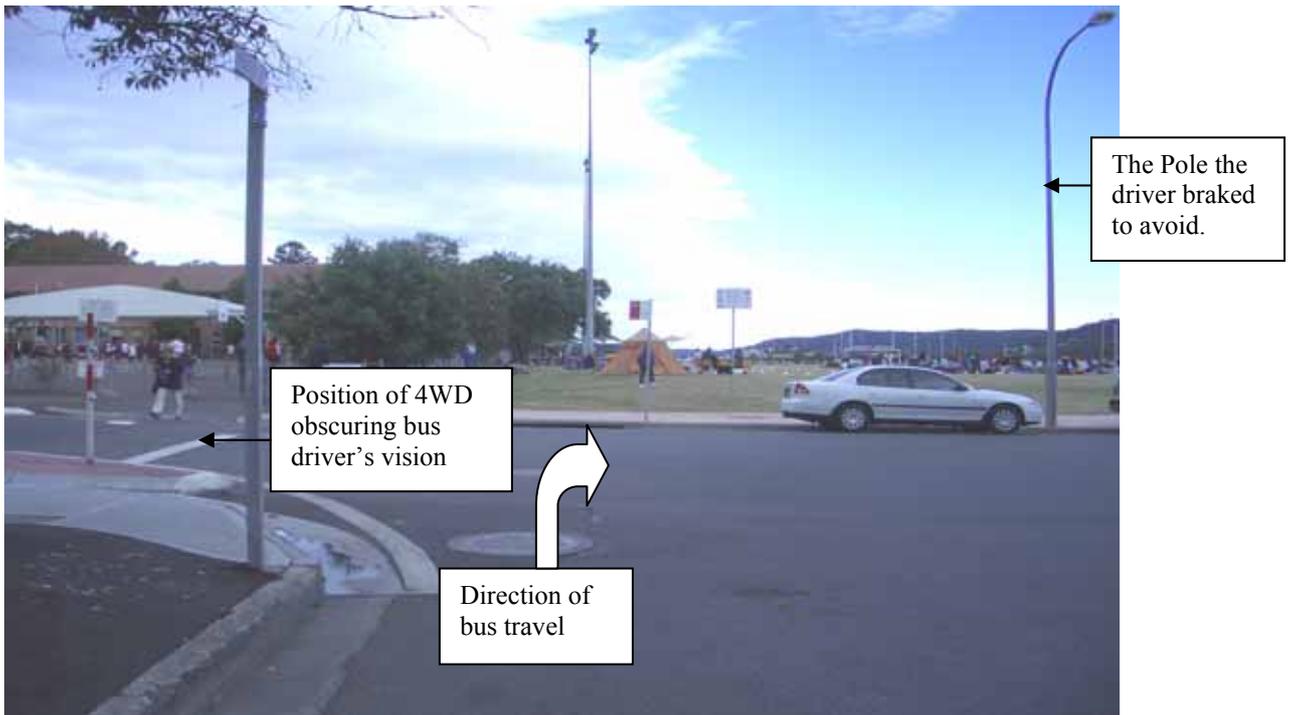
- 2.4 Having been waved-on, the bus driver proceeded with caution, conscious of the fact that other drivers might attempt to pass the 4WD on his left. At a point quite late in the turn however, the driver suddenly realised that there was an imminent prospect of a collision with the light pole adjacent to the drop-off zone and braked suddenly – see Figure 1.

*Figure 1.* "T junction" as viewed from the end of Baker Street. Gosford Public School can be seen across the road on the left-hand side. The school bus drop-off zone is located across the road in the vicinity and to the right of the white car. Nb that the white car was not in the vicinity at the time of incident, but that a 4WD, not shown, was in the vicinity of the pedestrian crossing.

- 3.8 The incident occurred in daylight, on a fine day and on a dry but busy road. The right turn being attempted by the driver was complicated by the presence of a vehicle to his left, which limited visibility of traffic that might be approaching from the left, and a light pole across the street in the direction of travel. The positioning of the pole provided a barrier protecting pedestrians using the footpath in that it prevented large vehicles from encroaching onto the footpath during such turns. However it also meant that drivers of large vehicles had a restricted turning arc and this required that any right turn from Baker Street into Georgina Terrace be commenced early. In this instance, the bus driver, who did not have the benefit of traffic lights or stop/give-way signs to assure him of his right-of-way, was most concerned about the prospect of the possibility of traffic approaching from his left. As a consequence, he momentarily lost awareness of the light pole. Upon shifting his focus to the right, he was required to brake suddenly to avoid colliding with the pole.

- (2) The turning manoeuvre being attempted by the driver was complicated by the limited visibility of traffic approaching from his left and the positioning of a light pole in the direction of travel.

- (2) develop, document, distribute and implement an Emergency Management Plan.
  - b. Gosford Council, in conjunction with the RTA, review traffic control measures at the intersection of Baker Street and Georgina Terrace.

- f. In relation to matters that might enhance the safety of bus operations, that there is scope for improved traffic flow and safety at the intersection of Baker Street and Georgina Terrace.
