## **BUS SAFETY INVESTIGATION REPORT**

**FATAL BUS ACCIDENT - JUBO TRAVEL  
JAMBEROO MOUNTAIN ROAD**

**5 SEPTEMBER 2005**

**Office of Transport Safety Investigations**

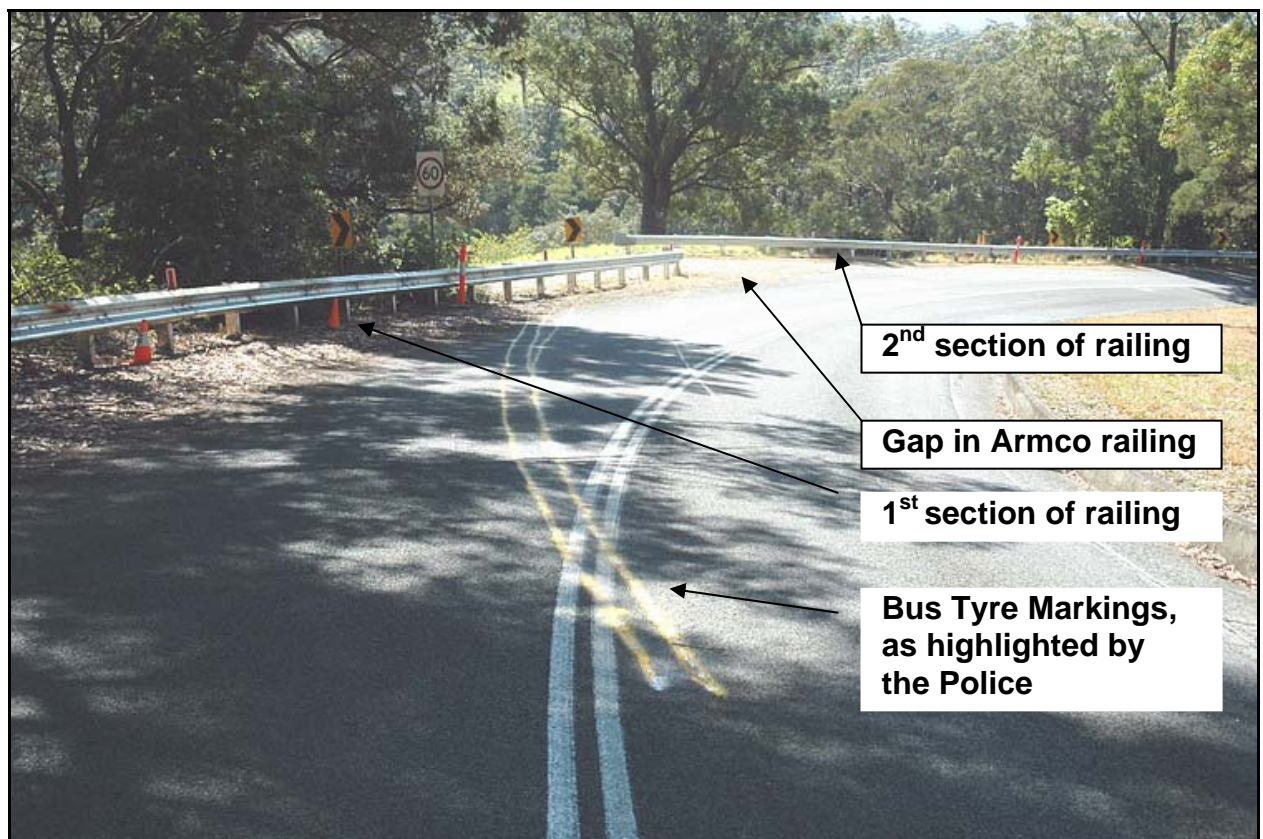
- 2.2 The Driver lost control of the bus as he approached a sharp right-hand bend at the end of a 7km section of steeply descending and winding road. The bus collided with a section of Armco guard railing and remained in contact with the railing for approximately 20m before rolling onto its left side and impacting with a second section of railing. It subsequently crushed the second portion of railing, slid over it and rolled onto its roof, coming to rest against a small tree. The immediate area of the accident is depicted in *Photograph 1*.

**Photograph 1: Immediate area of the accident**

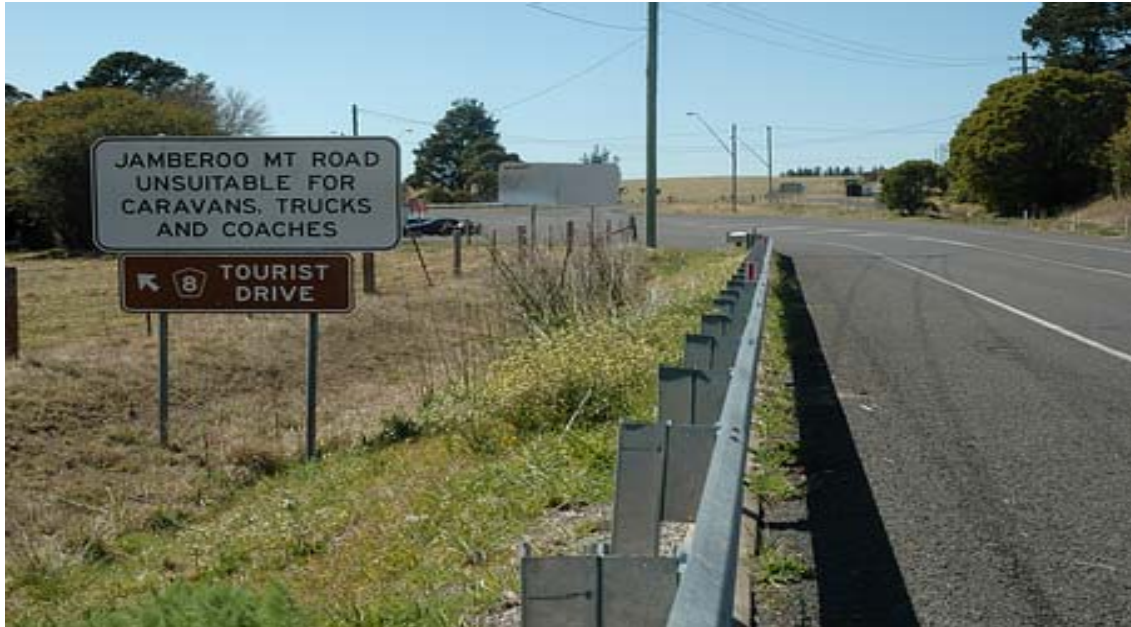
suitable for caravans, trucks and coaches, as shown in *Photographs 2* and 3. Although the signage on Jamberoo Mountain Road was partially obscured by foliage, the signage on the Highway was not.

**Photograph 2: Signage on the Illawarra Highway, approximately 100m before its intersection with Jamberoo Mountain Road**

- i. Undertake a safety audit of the Jamberoo Mountain Road to determine whether the road should be prohibited for use by passenger buses and other heavy vehicles; to ensure the adequacy of the signage in place and to examine the feasibility

of establishing one or more emergency 'run-offs' along the steeply descending and winding sections of the road.

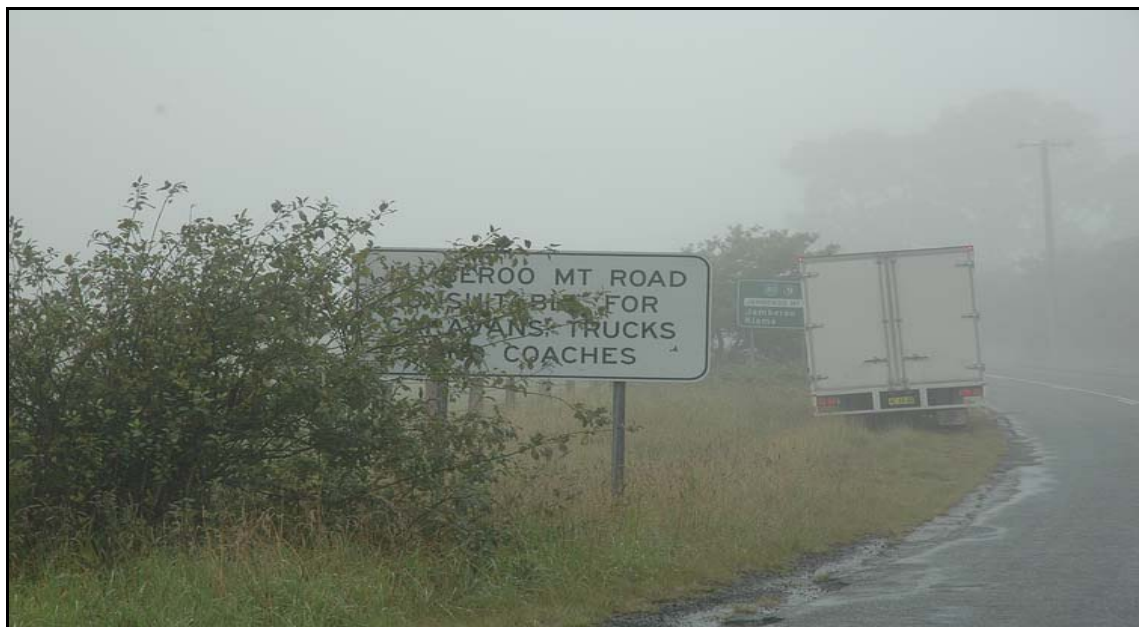
**Photograph 3: Signage on Jamberoo Mountain Road, approximately 100m after having turned onto the road from the Illawarra Highway.**

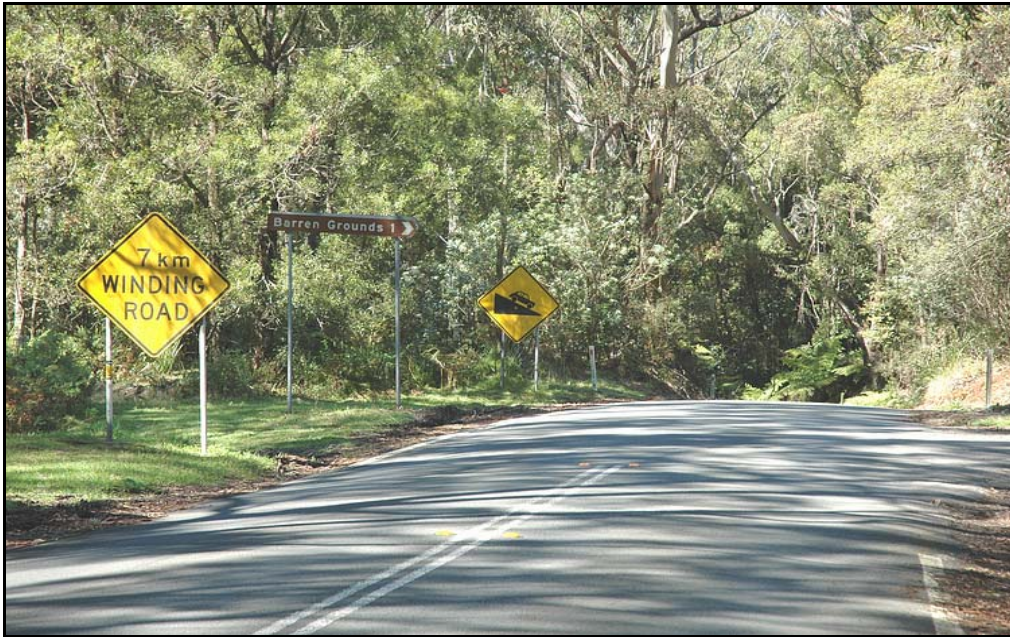
*Photograph 4* depicts road signage further along Jamberoo Mountain Road, approximately 8.5km from the accident site.

**Photograph 4: The “7km Winding Road” sign, including the sign depicting the steep grade ahead.**

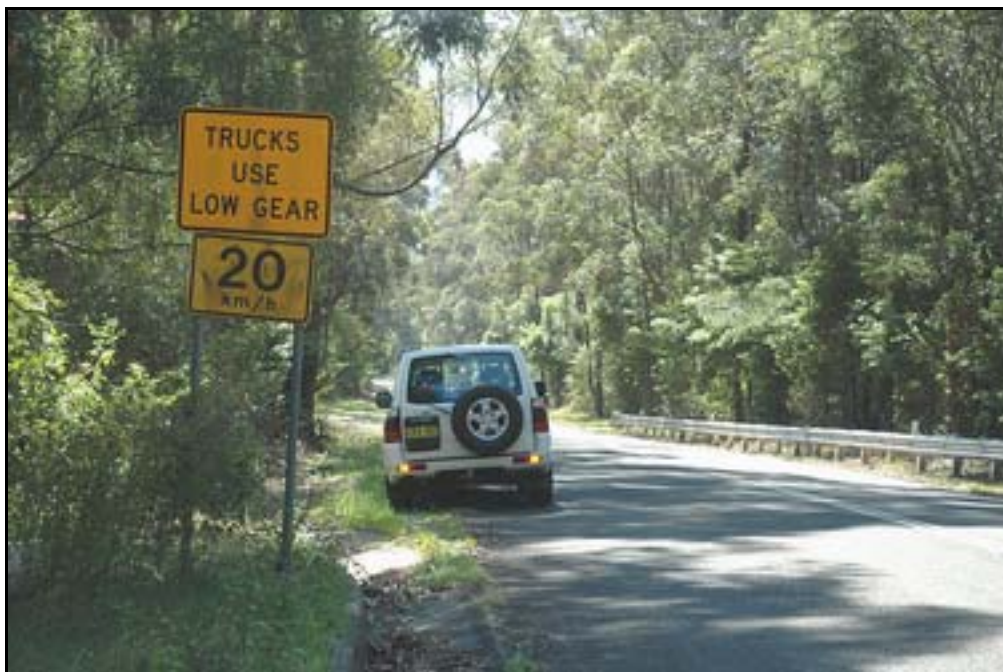
Further down the grade, there are other signs indicating difficult driving conditions and speed restrictions, as depicted in *Photograph 5*.

**Photograph 5: Jamberoo Mountain Road location approximately 800m before the accident site.**

3.4 Approximately 800m before the point of impact, there was a road sign advising "Trucks Use Low Gear", as previously indicated in *Photograph 5*. There were a number of other signs between this point and that of the accident indicating speed restrictions of 20km/h. Several days after the accident, OTSI observed buses and trucks travelling on this section and it was apparent from their engine noise that they were being driven in a low gear and with the benefit of exhaust brakes. However, as revealed by the tachograph, the bus was operated at speeds well in excess of 20km/h without the benefit of the exhaust brake and was found to be in 4<sup>th</sup> gear when examined immediately after the accident.

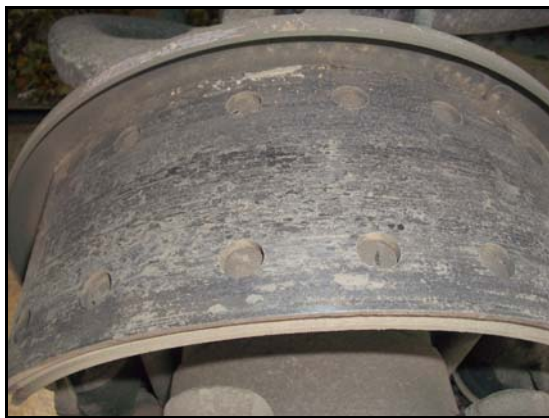
- 3.9 The operation of automotive brakes is dependent upon friction and the conversion of kinetic energy into heat energy in the process. Disc brakes, which are commonly fitted to modern passenger cars, dissipate generated heat efficiently; however, they require a high degree of force to operate. Drum brakes dissipate heat less efficiently but their stopping power and compact design make them more suitable for heavy vehicle applications. An examination of other elements of the bus's brake components established that the brake linings were within the required specifications. However, there was evidence of discolouration of the outer brake drum and brake dust residue at the bottom of the drum as shown in *Photographs 6 and 7*.

**Photograph 6: Glazed brake shoe**

- 3.10 The discolouration is consistent with the brake operating at higher than normal temperatures, induced by frequent and rapid applications of the brake at speed. Furthermore, there was evidence of severe glazing on the transmission park brake hub, indicating that it had been used as a dynamic, rather than a static or 'park', brake.

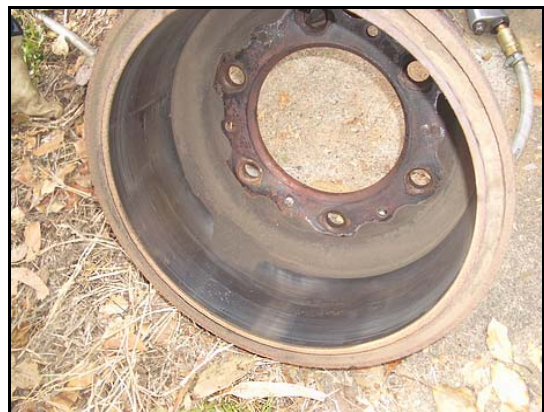
**Photograph 7: Discoloured outer brake drum**

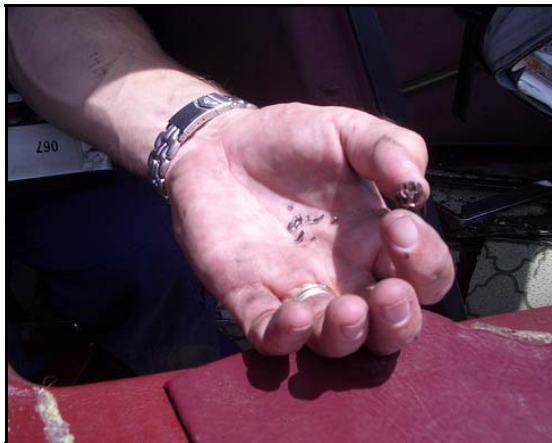
Photograph 8: Pieces of the broken light bulb.

- 3.16 During its examination of the bus, OTSI noted that the warning light and audible alarm on the dashboard, intended to alert a driver to low brake air pressure, was not functioning. *Photographs 8 and 9* depict what was revealed on closer inspection, that the light bulb for the

warning light was found to be inoperable and the circuit board within which it was located showed signs of discolouration and burnt circuitry.

3.17 Documentation revealed that this defect had been identified in Victoria by a coach repairer in 2004. Given that there was no record of the defect being rectified, OTSI could only conclude that this matter was not revealed during the certification and inspection processes that were required before the bus was first registered in NSW. This defect was not significant in the context of this accident as there was no indication that low brake pressure was at issue. However, the fact that Jubo Travel failed to detect this fault, or allowed the bus to operate with such an important safety device disabled, is indicative of poor defect identification.

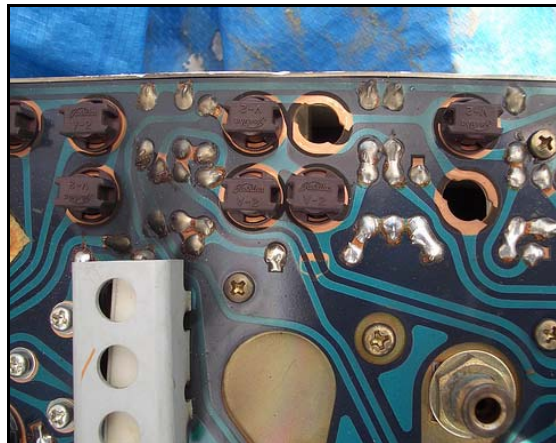
Photograph 9: Back of circuit board
