TECHNICAL INSPECTION FINDINGS

Fire Involving *Come' On Tours* Coach

Kosciuszko Road, Jindabyne

7 August 2010

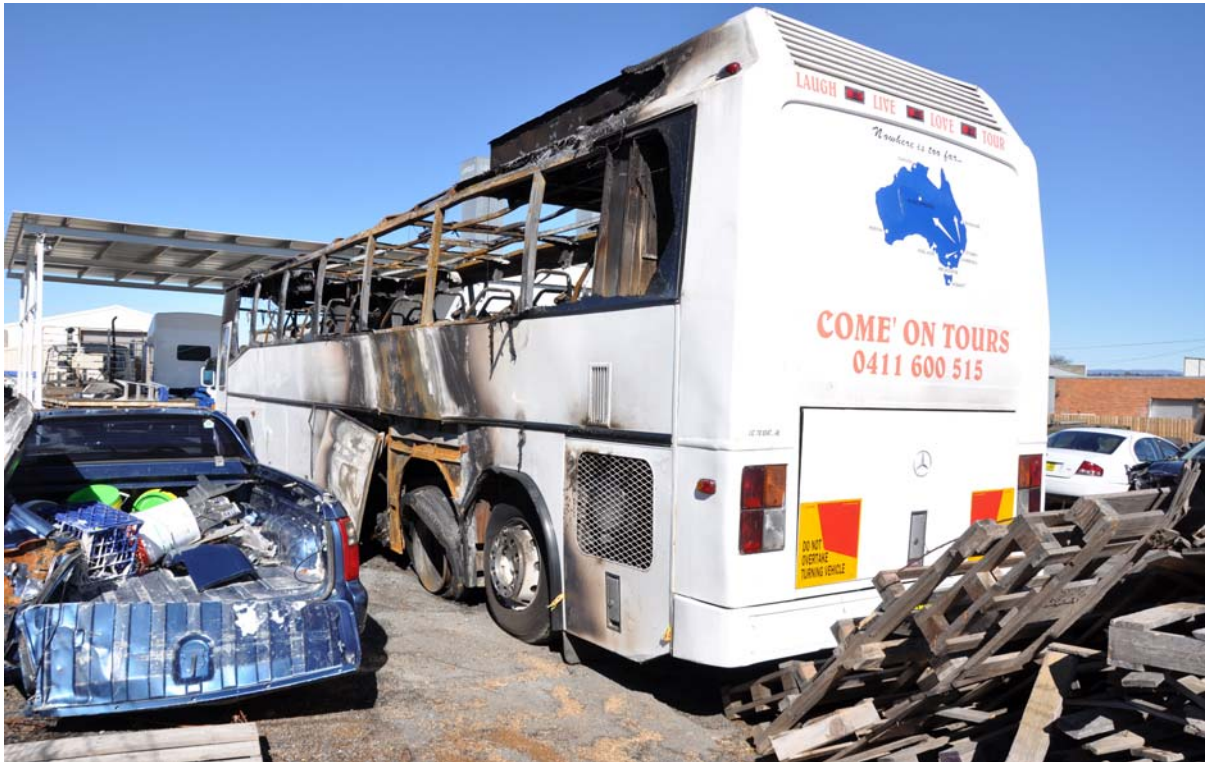
Photograph 1: View of passenger's side showing origin of fire

Corroborating the driver's version of smoke initially coming from the passenger's side rear wheels was a distinct burn pattern emanating from the rear drive wheel (forward rear axle), indicating the fire's origin.

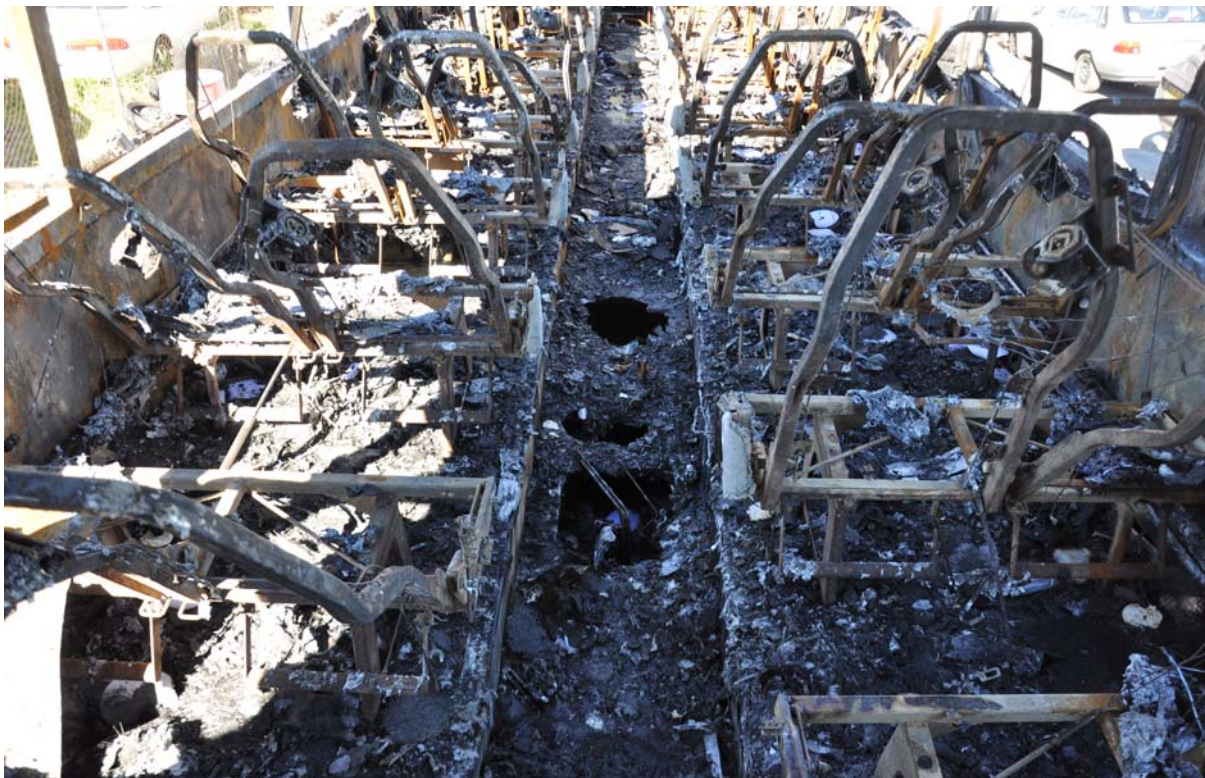
Photograph 2: Seating and flooring looking forward

The fire appeared to have spread from the wheel arch to the interior of the coach through the flooring in the adjacent luggage compartment. Once the fire had spread to the interior, the burn pattern appeared to indicate that the fuel load for the fire was concentrated in the materials used in the seating upholstery. *Photograph 10* shows the burn pattern around the rear bulkhead, consistent with intense heat coming from the combustion of the seating upholstery fabrics.

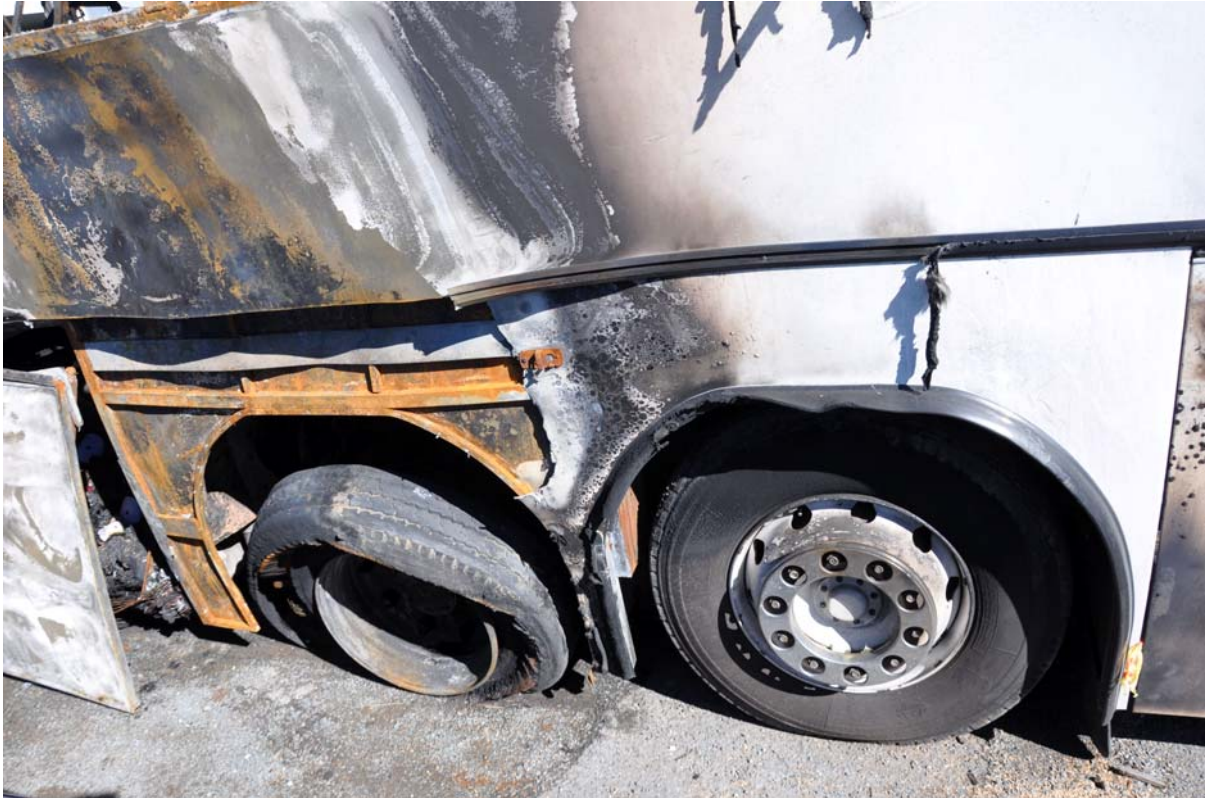
Photograph 3: Rear drive axle and fire damaged tyre

Both rear tyres on that axle had been extensively damaged by fire but it appeared unlikely that the fire had actually started in the tyres since there was no evidence of the tyres having run deflated. However, there was evidence present around the backing plate, brake drum, rims and hub to show that there was a concentration of excessive heat at the passenger's side rear brakes.

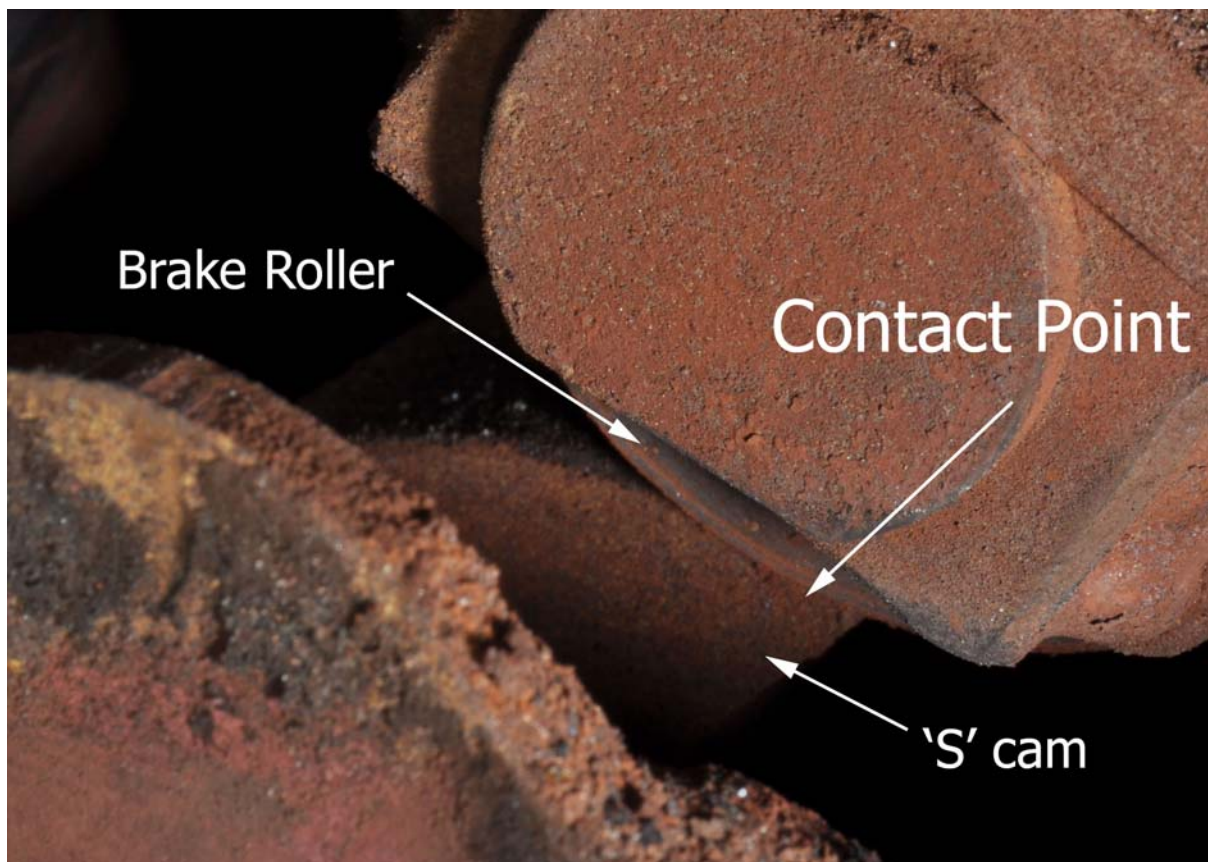
The remnants of both passenger's side rear drive axle tyres and the brake backing plate were removed. The 'S' cam, which transfers rotary motion from the 'S' cam shaft into the linear motion of the brake shoes for brake applications, could be seen in contact with both brake shoe rollers at the limit of its effective travel (see *Photograph 4*). The hub and drum assembly could not be rotated by hand, confirming that the brakes were locked in the applied position.

Photograph 4: 'S' cam in contact with brake roller at limit of travel

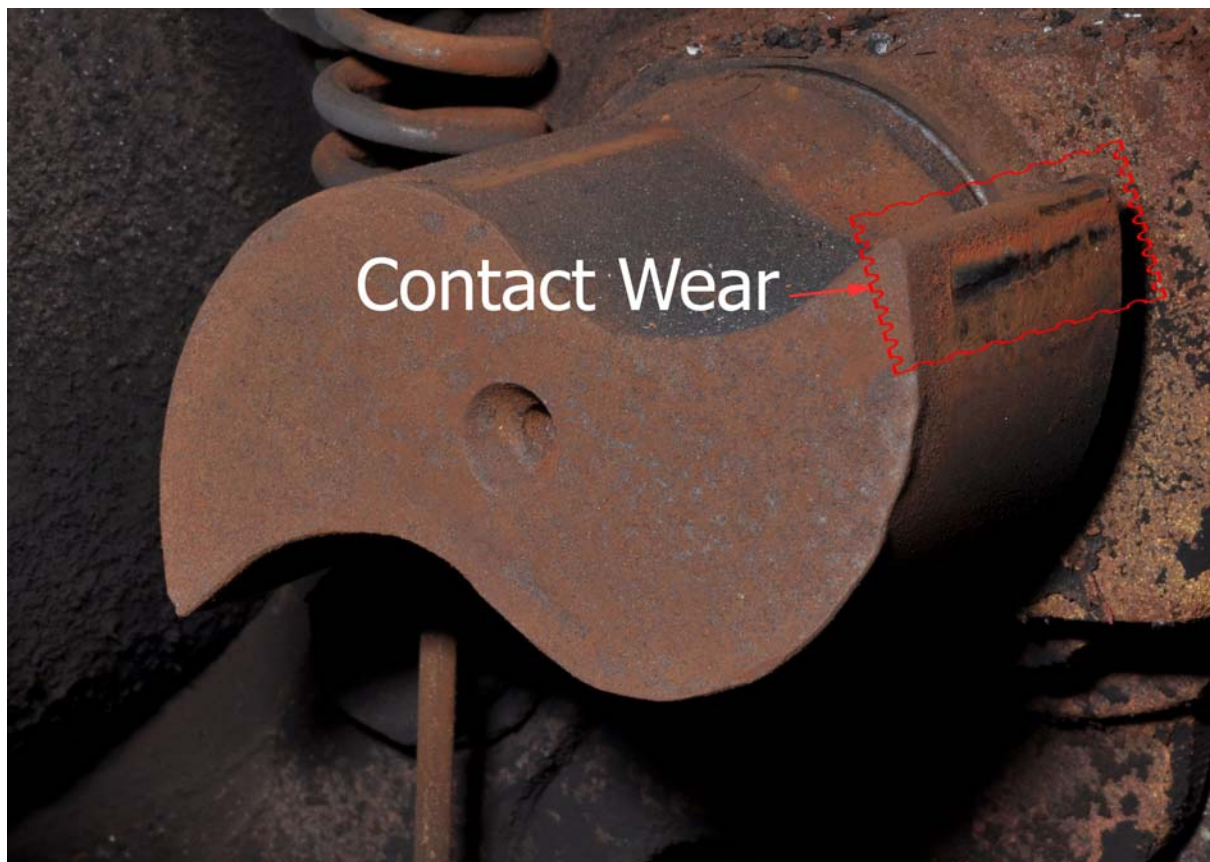
The brakes could only be released after repetitive tapping of the shaft and loosening of the slack adjuster. Once released, the drum was removed for inspection and it was found that both the drum and friction material were worn which explains the excessive travel of the 'S' cam. Witness marks on the 'S' cam surface showed wear points at the limit of its travel (see *Photograph 5*). Rotating any further would have allowed the 'S' cam to travel over-centre, resulting in the brakes not functioning at all on that side.

Photograph 5: Wear pattern on 'S' cam visible after disassembly

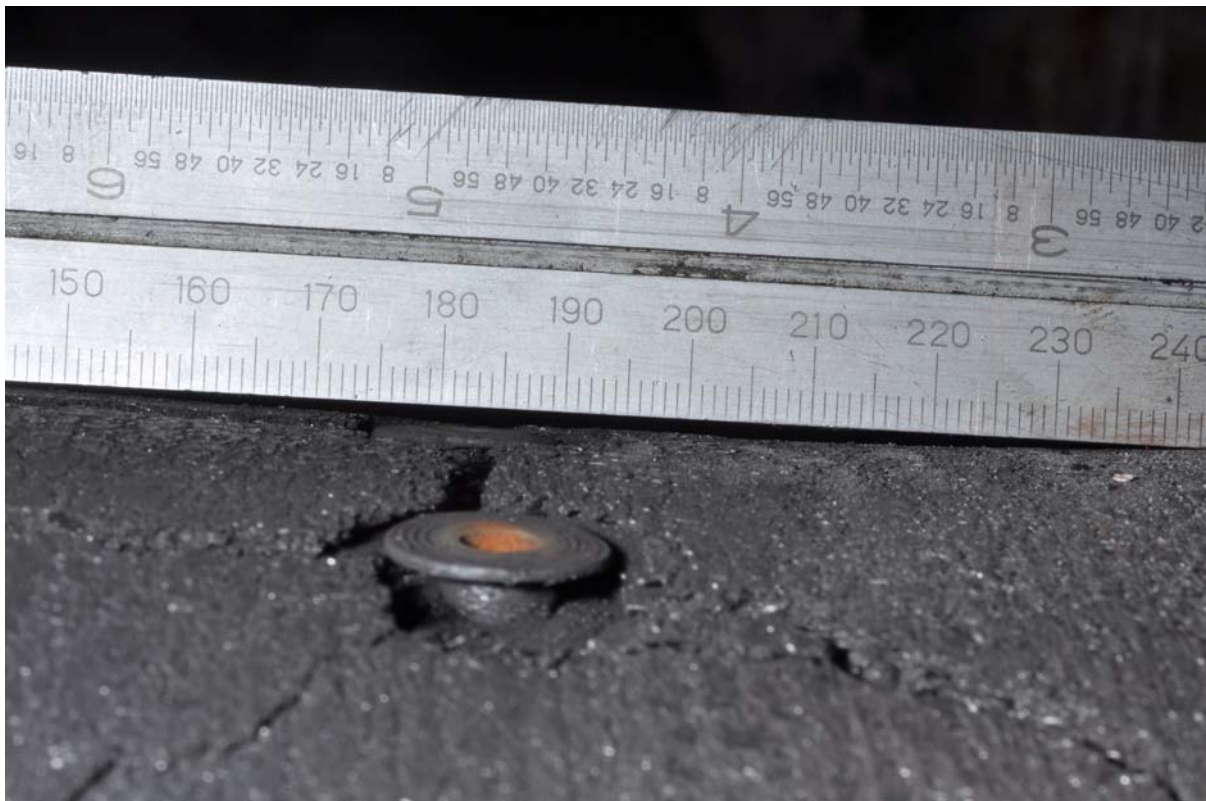
The friction material riveted to the brake shoes was worn unevenly (see *Photograph 6*), with a maximum thickness of 6.5 mm at the edges (see *Photograph 7*). The lining material may be up to 19 mm thick when new, and has an allowable maximum wear thickness down to 5 mm. This, combined with approximately 2.5 mm wear to the drum (see *Photograph 8*) would have been sufficient to allow for the excessive travel of the 'S' cam.

Photograph 6: Uneven wear across surface of the brake lining

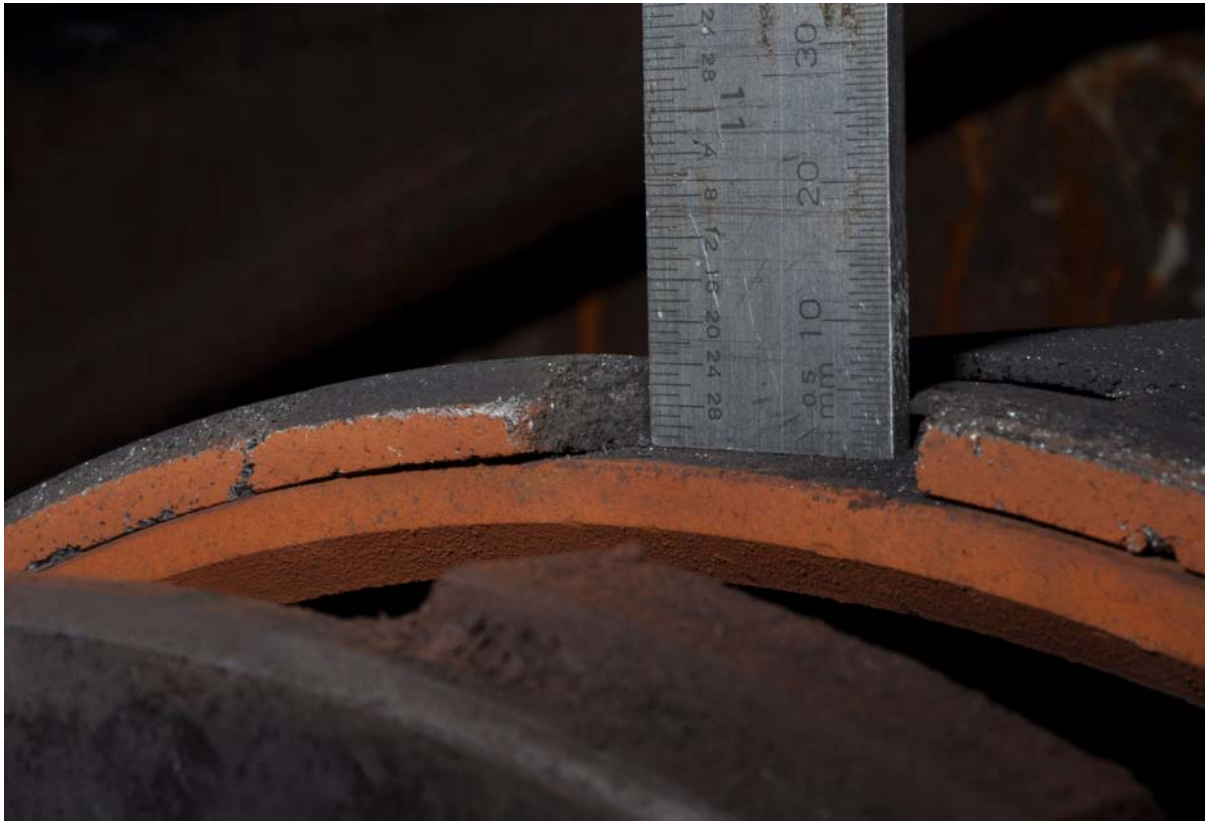
Photograph 7: Brake lining thickness at maximum point

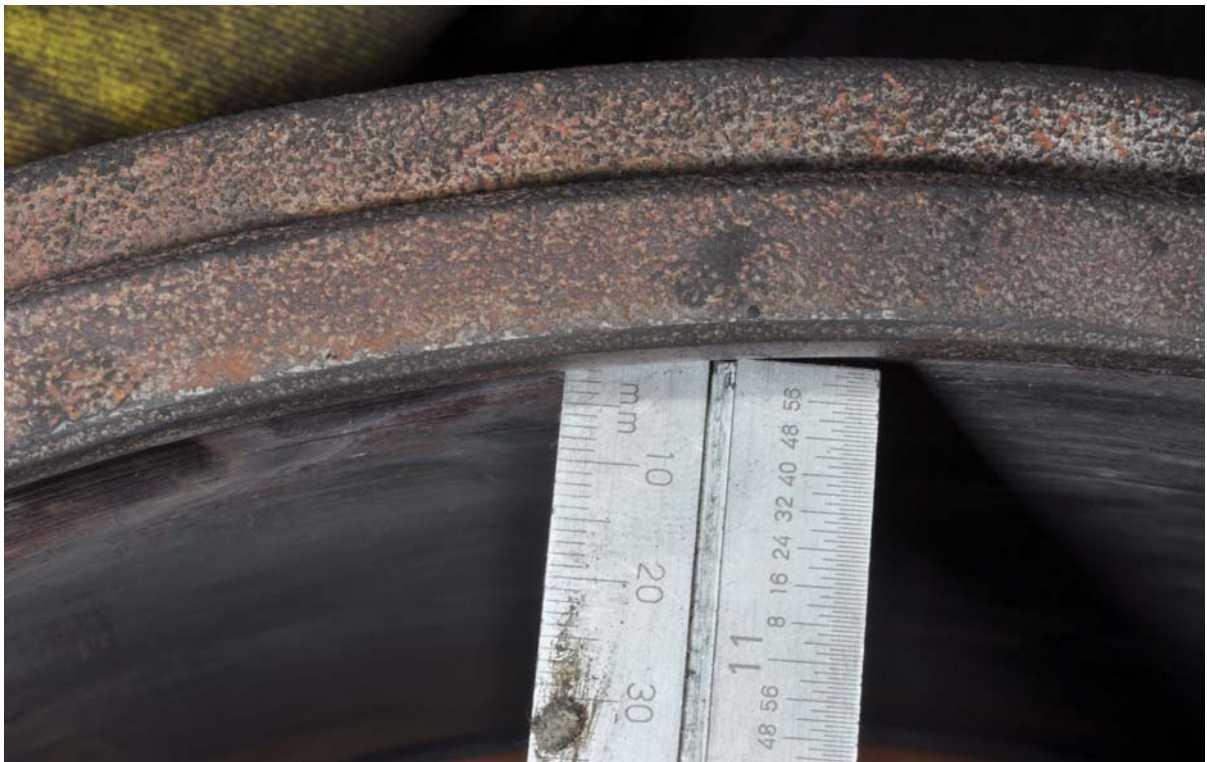
Photograph 8: Brake drum wear evident by 2.5 mm lip on drum

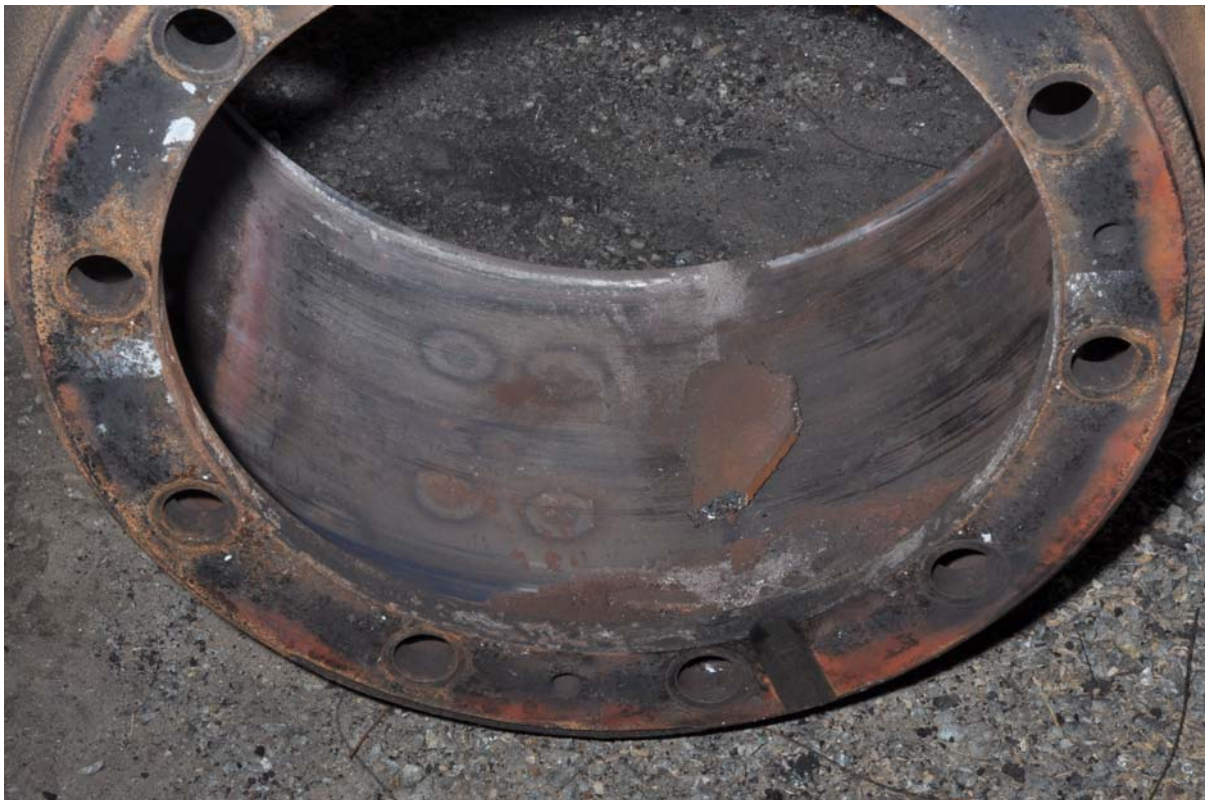
The brake drum displayed clear evidence of undergoing excessive heat loading, with bluing and surface cracking throughout the friction surface of the drum (see *Photograph 9*). Further evidence of overheating was that the friction material had decomposed and cracked away from the shoes, and the shoe return springs had lost their tension. The heat damage to the braking components greatly exceeded normal operating temperatures. This is most probably the origin of the fire, with the fuel for the fire being the rubber of the inner rear tyre.

Photograph 9: Heat damage to brake drum and remnants of friction material

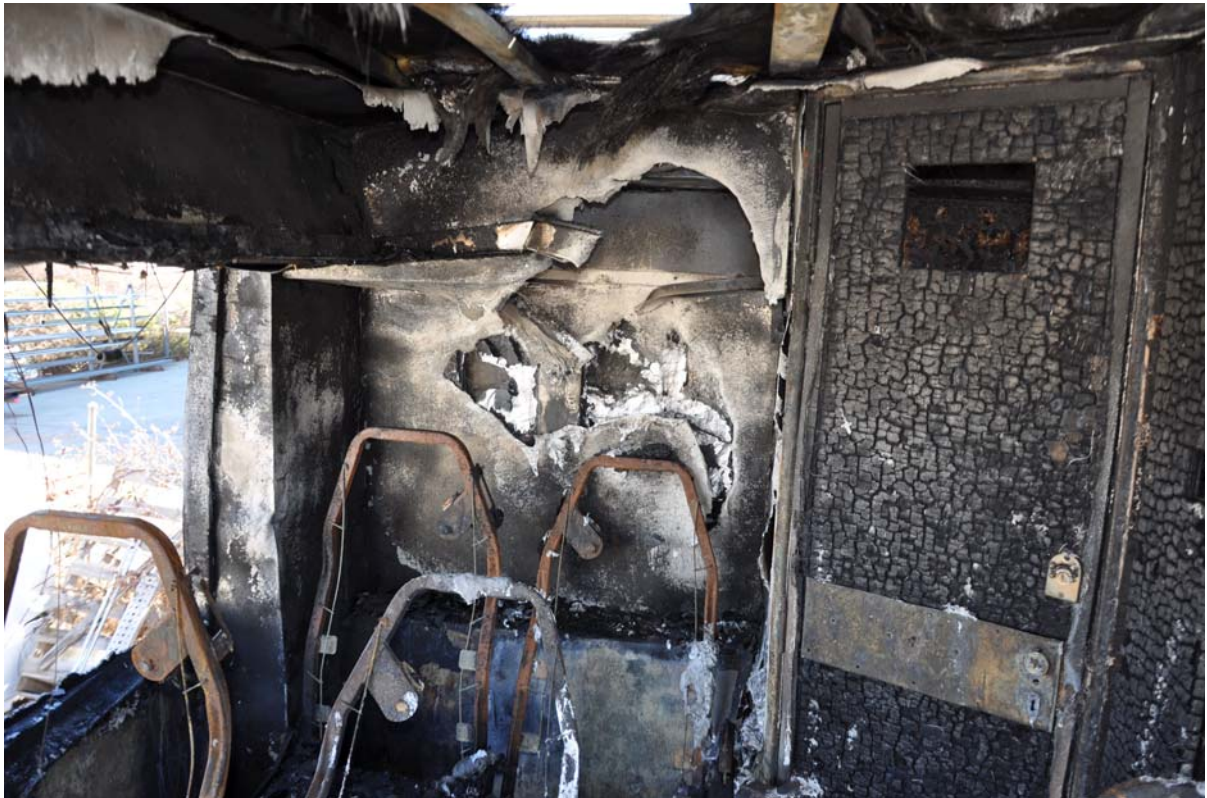
Photograph 10: Burn pattern on rear aluminium bulkhead

The coach displayed a burn pattern characteristic of a compartment fire with the sides, windows and roof of the coach replicating a compartment. Compartment fires grow rapidly due to reflected heat increasing internal temperatures exponentially as the fire grows. Flashover occurs when materials away from the initial point of the fire are subjected to gas temperatures above their auto ignition temperatures, effectively meaning that all surfaces burst into flames at approximately the same time. It was apparent from floor to ceiling charring, burning of the floor and destruction of all windows, that the fire was able to reach flashover within the coach. This also
