Office of Transport Safety Investigations

BUS SAFETY INVESTIGATION REPORT

**FATAL INJURIES SUSTAINED BY A PEDESTRIAN
STRUCK BY A VEOLIA BUS
KENSINGTON AND MONTGOMERY STREETS
KOGARAH**

2 MAY 2006

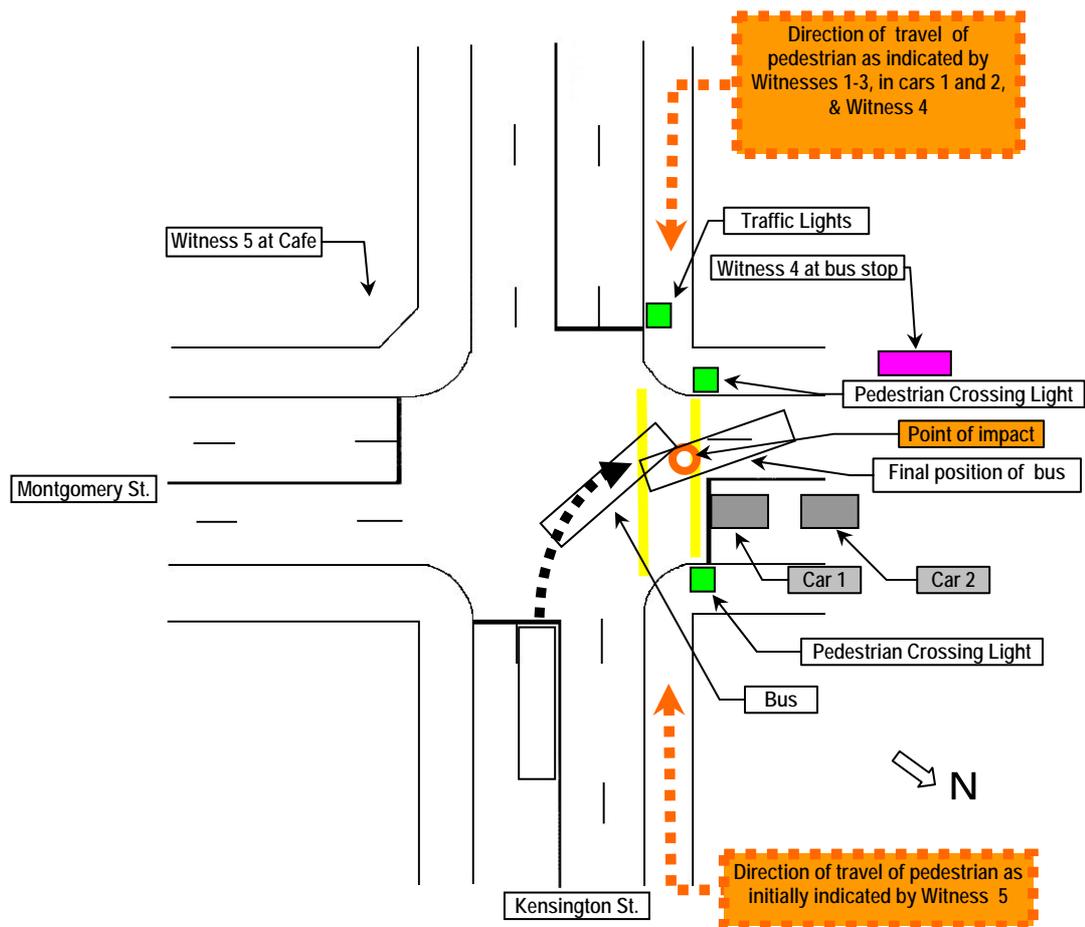
Figure 1: Accident Location

2.3 Three witnesses, who were occupants of cars 1 and 2 (see *Figure 1*) waiting in the outer lane of Montgomery Street and intending to turn Right into Kensington Street across the intersection, reported seeing the pedestrian at the crossing and then walking normally across Montgomery Street in a North-Easterly direction. They indicated that

she was the sole user of the pedestrian crossing at the time and that she had a green pedestrian light indication. They described the front right hand side of the bus as striking the pedestrian moments after the bus commenced its right turn and the pedestrian being pushed under the bus's front right wheel and then being dragged across the ground until the bus stopped. These witnesses were closest to the point of impact.

- 2.4 A person waiting at the bus stop in Montgomery Street (indicated as Witness 4 in *Figure 1*) also indicated that the pedestrian was moving, in a North-Easterly direction but described her as appearing to have delayed her crossing, then running. Another witness (Witness 5) who was looking across the intersection from the opposite side of Kensington Street, described the pedestrian as crossing from the opposite direction, i.e., moving in a South Westerly direction. The sole passenger on the

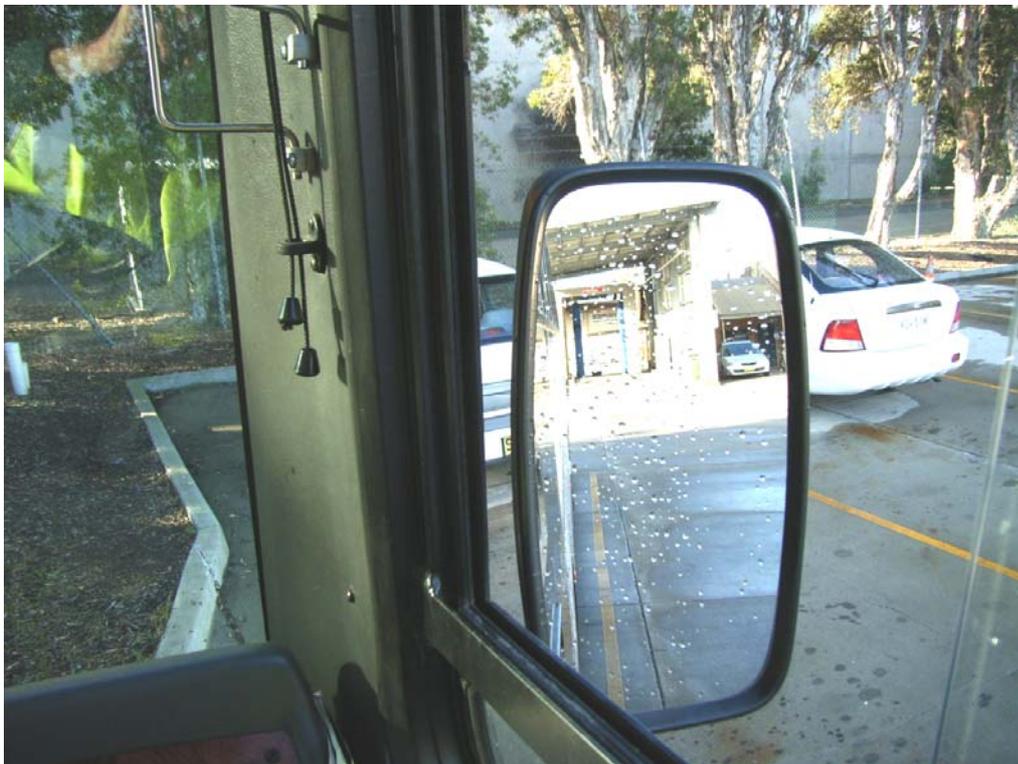
- 2.5 The driver recalled getting a ‘proceed’ indication/green light but having to wait for vehicles coming from the opposite direction to pass before he could commence the turn. He also remembered taking a wide arc as he started the tight right turn. He did not recall seeing a pedestrian as he turned. He became aware that he had been involved in some form of accident when he felt the impact of the collision with the pedestrian and immediately stopped the bus. Having done so, he observed the pedestrian lying beside the bus in the bus’s right rear vision side mirror. This side mirror can be seen in *Photo 1*.

Photo 1: Driver’s side rear vision mirror from which the bus driver detected the pedestrian after she was struck by the bus. Note also, the extent to which the screen pillar and mirror can obscure the driver’s forward vision

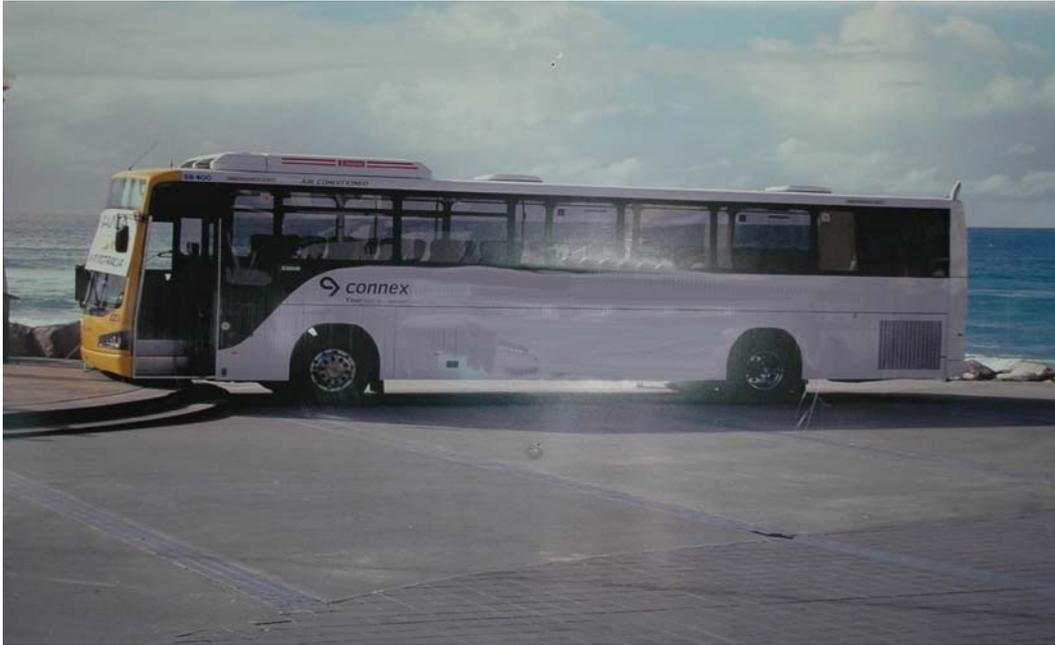
- 2.10 The Scania K94 bus, pictured in *Photo 2*², was first registered in 2004 and is one of six such buses operated by Veolia Transport. It is 12.5 metres long and 2.48 metres wide, with a wheelbase of 6.5 metres. The bus is licensed to accommodate 62 seated and 15 standing passengers. It is fitted with two backward-facing CCTV recording cameras, one above the driver's location and the other in the mid-section.

Photo 2: The bus involved in the accident

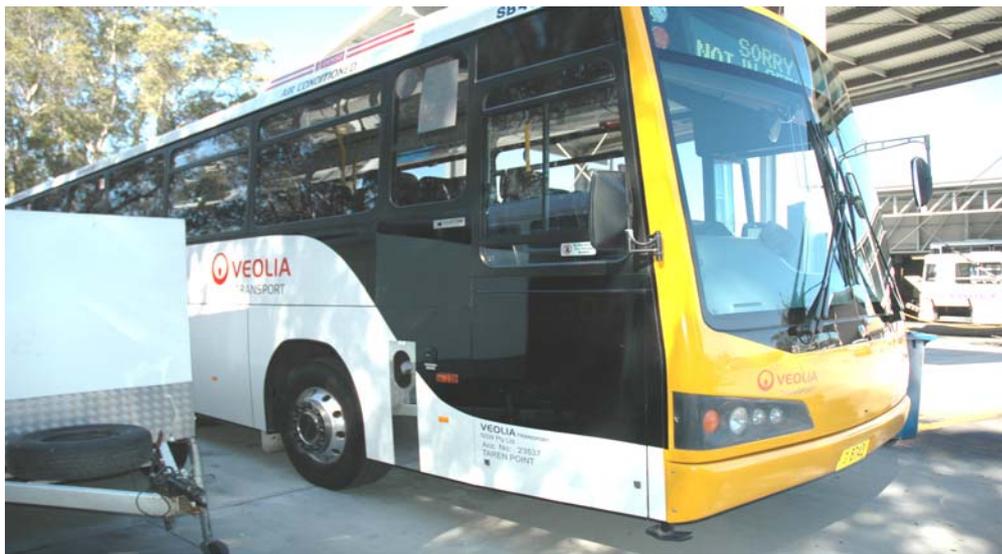
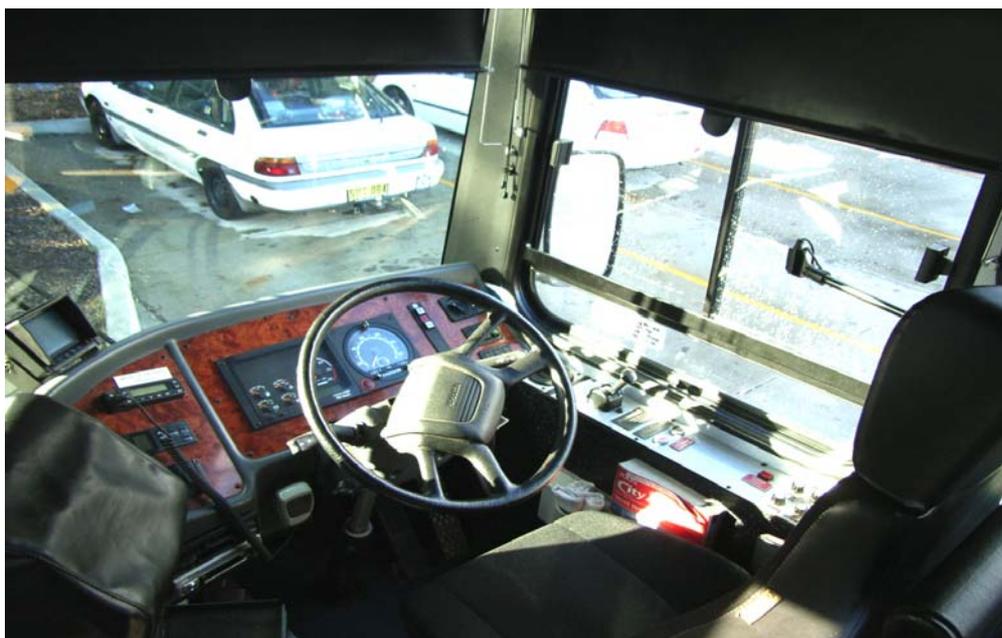
(1) The placement of the external rear vision mirror on the driver's side did not meet requirements identified in *Australian Design Rule 14/02 (Rear Vision Mirrors)* and, in combination with the Right forward windscreen pillar, might have limited or obstructed the bus driver's view of the pedestrian as she moved from the opposite side of the road towards the bus. However, the driver was conscious of this obstruction and the need to adjust his driving position to look around it.

bus and driver. It was apparent from video recordings taken during the reconstruction that the width of the supporting pillar on the front right side of the bus in combination with the positioning of the right side mirror obstructs a driver's view of objects in the middle distance if the driver remains static in the seat. In order to overcome this obstruction, drivers must alter their seating position to look around the pillar and mirror (see *Photos 3 and 4*).

Photo 3: The bus involved in the accident – note the pillar and position of the external rear vision mirror

Photo 4: Obscuration caused by the front screen pillar and external rear vision mirror

- 3.12 The extent of obscuration, which was partial rather than total, was calculated as being about 6 metres wide by 3 metres high at a range of 19 metres. This was also approximately the same distance from the point at which the driver commenced to make his turn and the point at which the pedestrian would have stepped onto the pedestrian crossing if she was crossing from the opposite side of the road. It was also apparent from the reconstruction that the driver's view of a pedestrian within this field would remain partially obstructed if the pedestrian was crossing in the opposite direction to that of the bus. Measurements also showed that the pedestrian would not have been visible to the driver if she was forward, and within half a metre, of the right side of the bus unless the driver altered his position.

- 3.13 The driver indicated that he was aware that the pillar and right external side mirror, under certain circumstances, obstructed his field of view and that he habitually moved his head to see around the obstruction, as he had been trained to do. He also described and demonstrated how he also included checks of his rear view mirrors whilst preparing to turn. He further described his approach to this intersection on the day. His first action was to monitor the opposing traffic ahead after which he checked the pedestrian crossing to his right. He indicated that he did not see anyone on the pedestrian crossing, but did observe a female waiting to board at the Montgomery Street bus stop beyond the crossing (indicated as Witness 4 in *Figure 1*). As he commenced to turn, he checked his left side mirror to ensure the left rear corner of the bus did not converge with any traffic in the inner lane of Kensington Street, as was his usual practice.

3.15 OTSI noted that the design and standards governing bus rear vision mirrors and driver visibility are contained in the *Commonwealth Motor Vehicle Standards Act*, as *Australian Design Rules 14/02* (Rear Vision Mirrors) and *42/04* (General Safety Requirements). These ADRs do not stipulate a specific minimum ‘arc’ of vision that must be achieved but do identify the requirement for side mirrors to be positioned in such a way that they do not obscure a driver’s view of traffic. Section 15.2.2.1 of *ADR 14/02* specifically states that “Mirrors must be so placed that the driver, when sitting on the driving seat in a normal driving position, has a clear view of the road to the rear, side(s) or front of the vehicle.” OTSI does not consider that the placement of the rear vision mirror on the driver’s side of the bus met the requirement of Section 15.2.2.1.

- i. Seek expert assistance to review the positioning of all external mirrors throughout its fleet to ensure that the requirements of *ADR 14/02* are met and to eliminate 'blind spots' to the extent that it is possible.
- ii. Alert its drivers to the presence of any known blind spots and the driving techniques necessary to overcome them.
- iii. Ensure that its drivers are reminded of the need for additional caution at tight intersections and are refreshed periodically in the required driving techniques.
- iv. Undertake periodic monitoring of its drivers' performance to ensure that appropriate driving techniques are being employed at such intersections.

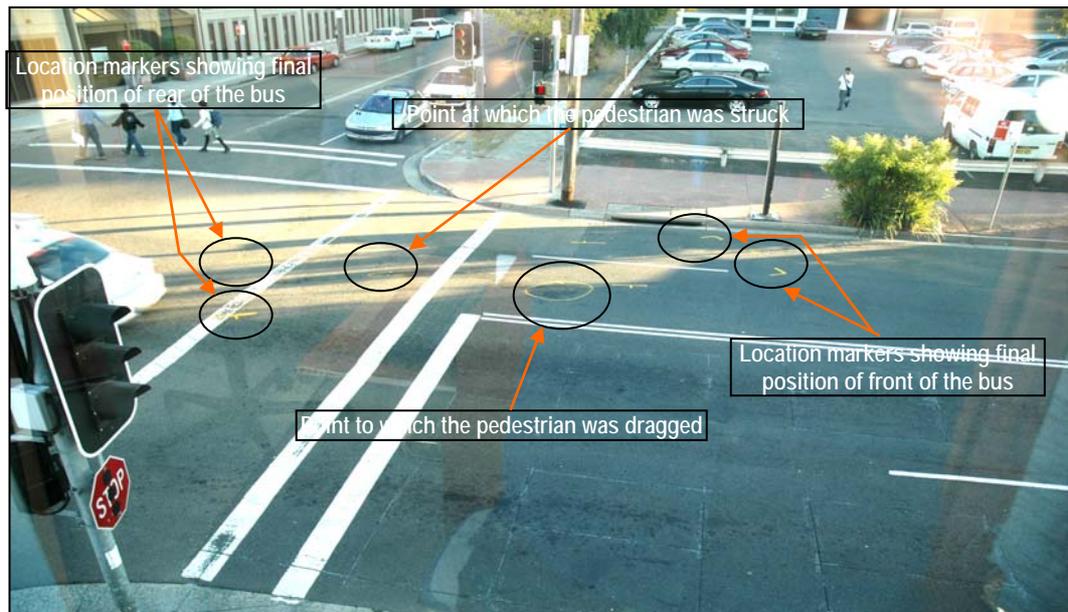
- 3.14 OTSI noted the presence of two poles on the footpath, about a metre apart, on the Kensington Street side of, and adjacent to, the pedestrian crossing (see *Photo 5*). One was the galvanised metal traffic light control post and the other was a timber power pole, measuring approximately 10 and 24 centimetres in diameter respectively. These poles might also have partially obscured the bus driver's line of sight if

the pedestrian had been waiting behind the poles. However, the position of the marks, later painted onto the road by the attending Police, indicate that this was not the case (see *Photo 5*). The point of impact is highly significant because it indicates that the pedestrian had been moving for some time, as opposed to having just stepped out from behind these poles.

Photo 5: Showing the pedestrian crossing and the accident location markings
