**Office of Transport Safety Investigations**

## **BUS SAFETY INVESTIGATION REPORT**

**STA BUS COLLISION  
SPIT ROAD MOSMAN**

**14 NOVEMBER 2005**

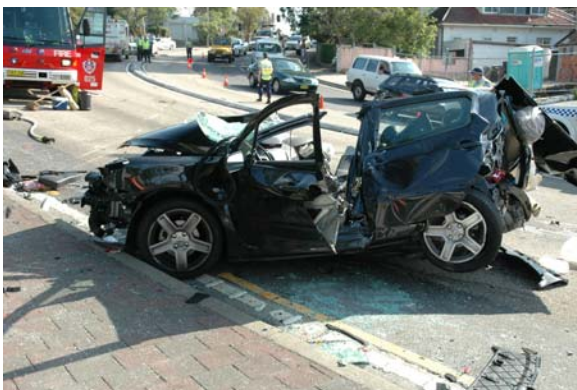
**Photo 1: Damage to Peugeot 307**

2.8 The damage to the Peugeot, Toyota Hi-Lux, Ford Falcon and Hino tip-truck are indicated in *Photographs 1-3* respectively.

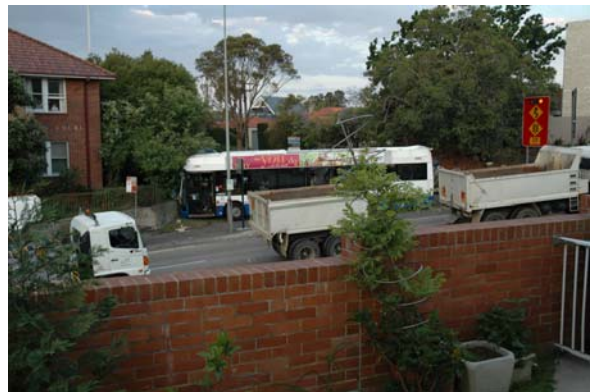
**Photo 4: Position of the bus, at rest**

2.9 The point at which the bus came to rest is indicated in *Photographs 4* and *5* and the limited extent of damage to the fence in *Photograph 6*.

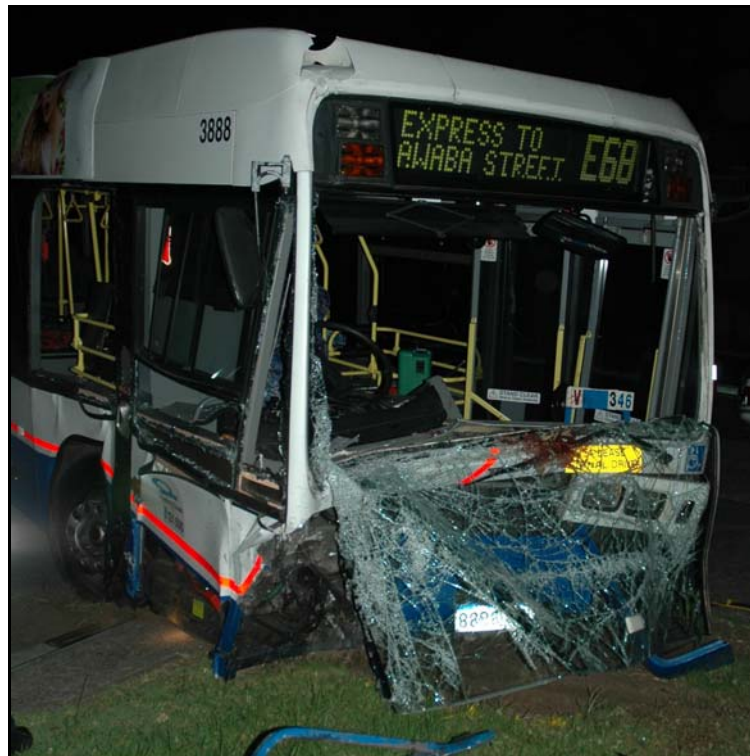
**Photo 8: Damage to front of bus**

- 3.3 The front of the bus was crushed when it impacted with the masonry wall. The corner of the masonry wall penetrated into the steering

assembly of the bus which resulted in damage through the drive train to the transmission at the rear of the bus. The front laminated-glass windscreen shattered and was projected outwards. The damage to the windscreen and the driver's injuries are consistent with the driver being thrown against the windscreen. OTSI noted that the driver was not wearing the fitted seatbelt at the time of the collision. The damage to the front of the bus can be seen in *Photograph 8*.

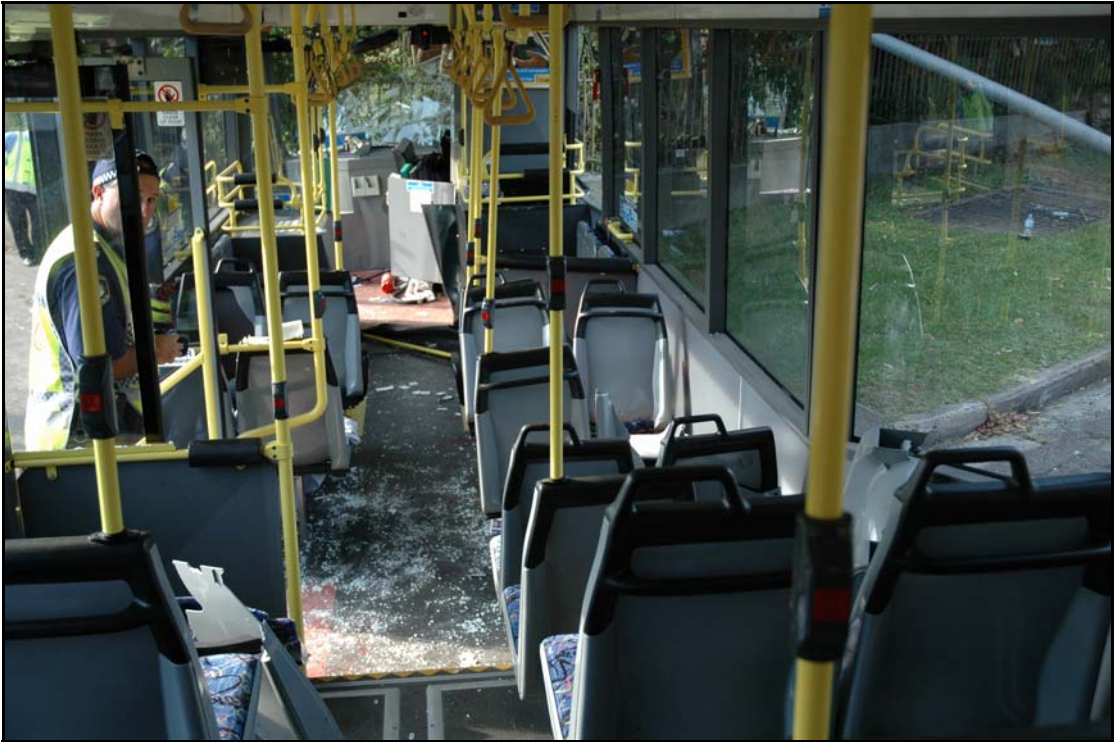
**Photo 9: Inside of the bus, looking forward**

- 3.5 *Photograph 9* shows some of the interior damage to the bus. Two toughened-glass side windows, on the driver's side, also shattered upon impact with the wall. The remainder of the bus's bodywork and windows were relatively undamaged. OTSI noted that one passenger was projected from his seat and through safety screens placed on either side of the rear inward opening door. All passengers were seated in forward-facing double seats at the time of the collision. The seats were subjected to considerable load, either by passengers being projected into the rear of the seats in front of them, or by the act of passengers gripping the handgrips on top of the seats to brace themselves. As a consequence, 10 seats were broken. The bending of some steel brackets bolting seats to the floor was indicative of the forces involved. OTSI also noted that the points at which some seats fractured presented some sharp edges.

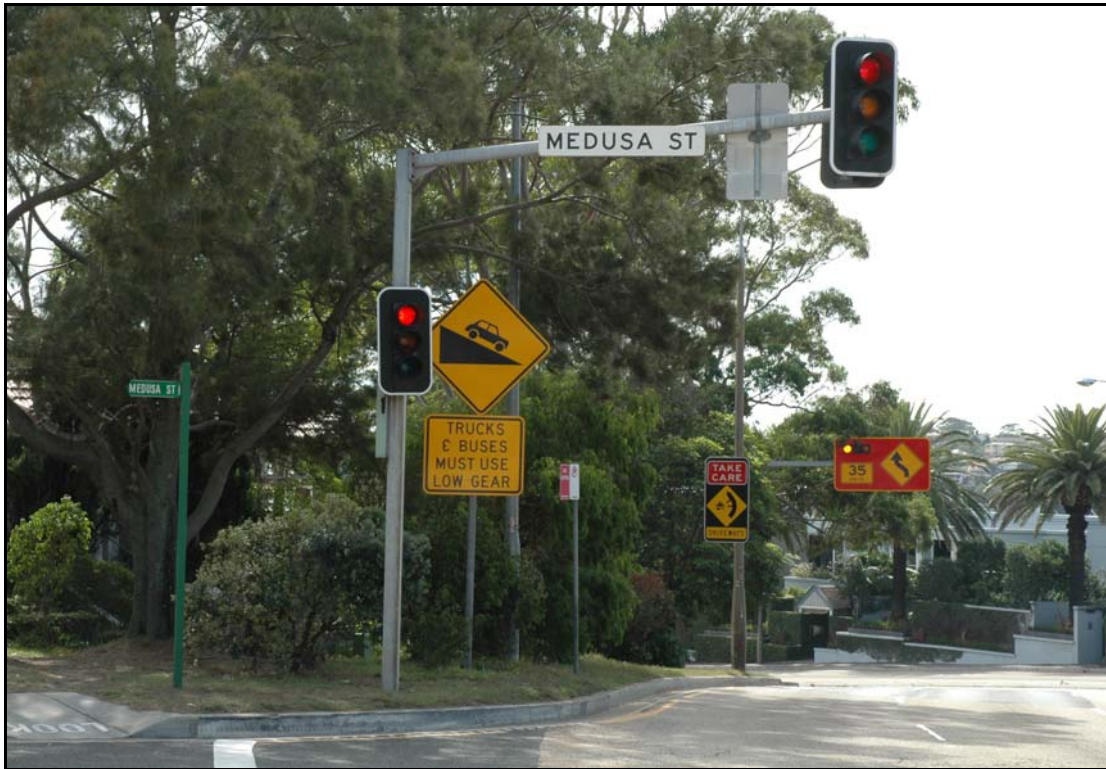
**Photo 10: Approaching Spit Hill at Medusa Street traffic lights, looking North**

- 3.9 As previously stated, the bus's gear selector was found to be in "D" after the accident. OTSI noted that just after the Medusa Street lights there is

a warning sign indicating that 'Trucks & Buses Must Use Low Gear'. This sign, indicated in *Photograph 10*, is visible from a distance of 150m.

- 3.10 Australian Road Rule 108 states that “If the driver of a truck or bus is driving on a length of road to which a trucks and buses low gear sign applies, the driver must drive the truck or bus in a gear that is low enough to limit the speed of the truck or bus without the use of a primary brake.” There is also a 35km/h advisory speed sign 46m North of the Medusa Street traffic lights which is visible from a distance of 150m. Had the Driver engaged a low gear, an action that would have been consistent with the low gear warning sign, the 35 km/h advisory speed sign and good driving practice on such a section of road, the bus would have been operated at a safer speed. Given the curvature and gradient of Spit Road North of Medusa Street, a severe braking application would have been necessary to counter any control or traffic problems a bus driver might encounter while negotiating the descent.

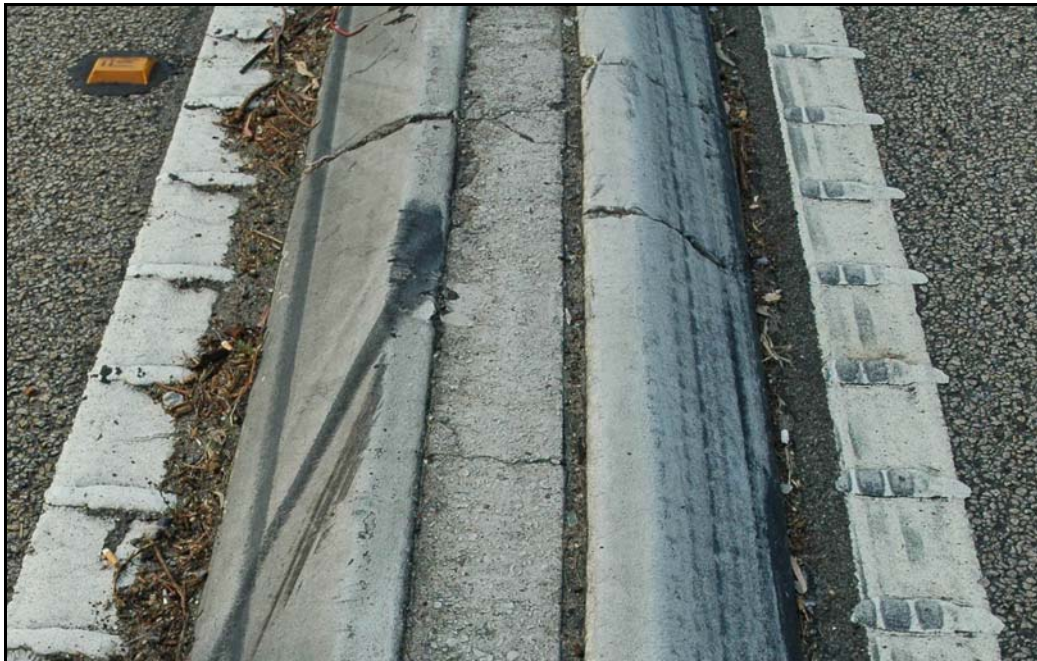
**Photo 12: Median Strip on Spit Road**

3.30 The median strip separating the Northbound and Southbound lanes on Spit Road can not be considered a ‘barrier’, as is obvious in the illustration at *Photograph 12*.

The RTA commissioned a number of reports which, in succession, considered the appropriateness of a different type of median barrier after each previous option considered had been found to be unsuitable for the location. The barrier types considered over time included a rigid concrete barrier, a movable barrier which could be altered to accommodate or facilitate increased traffic flow at different times and non-rigid barriers such as steel guard rails or wire rope barriers.

- a. A report, completed in May 2000, examined the feasibility of replacing the median strip with a 600mm vertical concrete barrier. It proposed that the existing lanes remained at a minimum of 3.0m with an additional 300mm width added to the median lane to improve “driveability” and safety against the vertical concrete barrier. The report predicted that the installation of a vertical concrete barrier would reduce the number of cross-carriageway accidents but noted that it might increase the rate of rear-end and side-on accidents. It also noted that the distance at which drivers might see brake lights around a curve would also be diminished and expressed concerns relating to the narrowness of footpaths either side of the road.

- b. Another report, completed in July 2001, examined the feasibility of installing a moveable lane barrier to eliminate or reduce head-on collisions. This solution would have reduced the number of lanes from six to five and increased the width of the lanes. It was envisaged that the moveable barrier would be adjusted at varying times of the day to regulate traffic flows and that this would more than offset the loss of a lane. It was observed in the report that vehicles were generally travelling at inappropriate speeds given the presence of concealed driveways, restricted sight lines, congestion and tight curves. The report also observed that advisory signs were generally disregarded and that it was difficult for enforcement action to occur given that drivers could travel within the mandated speed limit and still fail to drive at an

appropriate speed for the conditions. OTSI noted that the current 35km/h RTA speed signs in the vicinity of Medusa Street are advisory only and formed the view that if such signs are unenforceable, they are less likely to have the desired effect and as such, should be replaced by mandatory speed limits in critical areas, such as between Medusa and Ida Streets.
