## Bus Safety Investigation Report

### Woodpark

**Air brake failure on bus resulting in a collision.**

# Road Safety Investigation - Woodpark

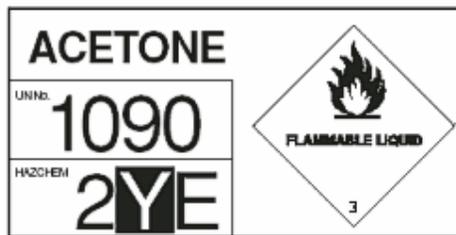
**Figure 3: Acetone Warning Sign**

- 3.19 In addition to the one drum that was dislodged, four drums were embedded into the side of the bus. Had any of these drums ruptured, the consequences might have been catastrophic. The RTA's Load Restraint Guide requires individual drums to be secured by lashings<sup>5</sup>. The rope webbing found at the rear of the truck may have allowed for easy access to the drums but it did not meet the RTA requirements designed to ensure that dangerous loads are isolated in the event of rear-end collisions. The restraining arrangements also failed to meet the requirements of the Dangerous Goods Code which requires that such loads be isolated by a secure gate on all sides.<sup>6</sup> Again, these are matters for further consideration by the RTA and EPA.

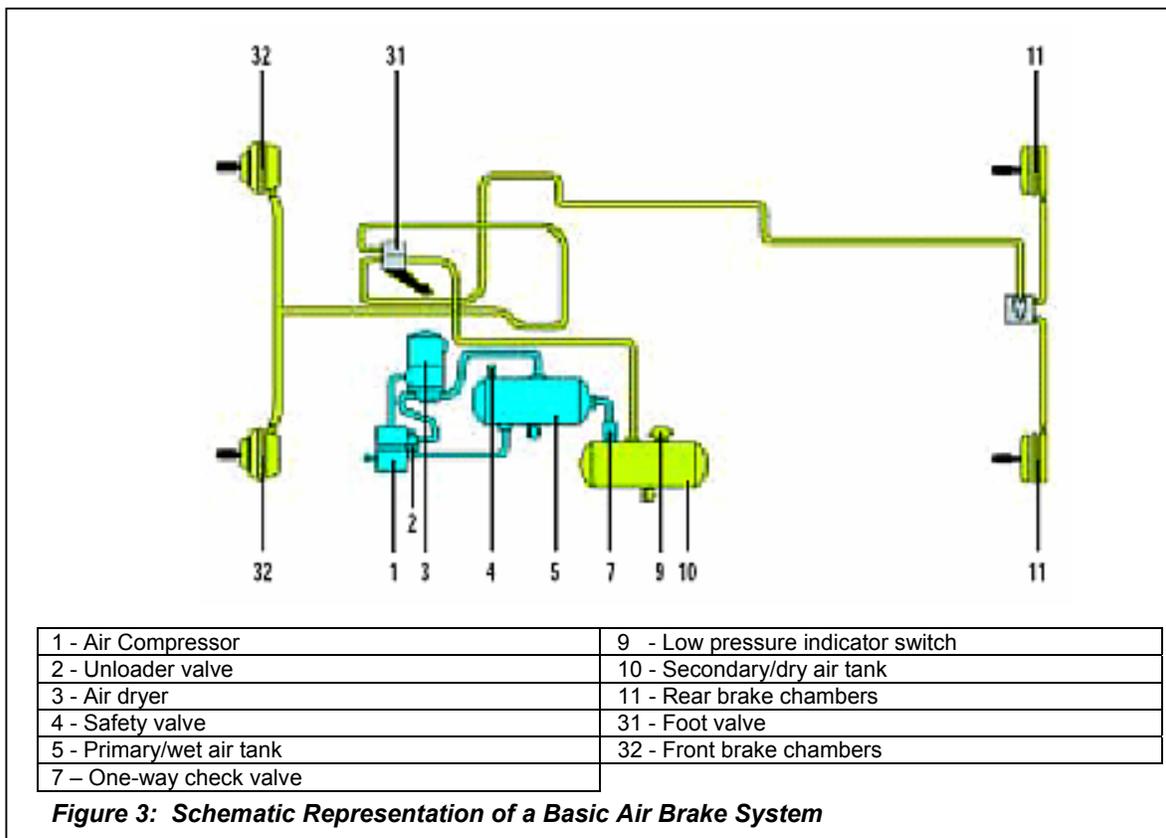
4.1 **Bus Braking System & Function.** *Figure 3* illustrates a braking configuration typical of that fitted to MO8053. It should be noted that such a system, whilst allowed, predates the requirement of Australian Design Rule 35 which requires a level of redundancy with respect to compressed air (braking) systems. The braking system of MO8053 requires a regulated flow of compressed air passing through an air compressor (indicated as 1) to brake chambers (11 & 32) which allow for the activation of brakes when applied. Enroute, air pressure is regulated by an unloader valve (2) and moisture is removed via an air dryer (3) and 'stored' in air tanks (5 & 10). These components make up the critical elements which need to be functioning correctly for proper brake function to occur.

- 4.2 Testing of MO8053's braking system at the RTA Heavy Vehicle Inspection Station immediately following the accident established that the vehicle's secondary air tank (10) and the air compressor (1) failed to supply air, but that the damage was a consequence, rather than the cause, of the accident. When the system was supplied with pressurised air from another vehicle, the air-brake test results were satisfactory. Each wheel brake (11, 32) and the park/emergency brake (a separate system not depicted) functioned satisfactorily when tested on a brake roller.

- 4.3 Examination of the air compressor (1) established that it was pumping a sufficient amount of air through the air line to the unloader valve.
- 4.4 During an inspection of the primary air tank (5), a considerable amount of oil and debris drained from the tank when the drain cock was opened.

- 4.6 Inspection of the air line and a one-way check valve (7) connected between the unloader valve (2) and the primary air tank (5) found that the air line and a one-way valve connected between the unloader valve and the primary air tank were also contaminated with engine oil and sludge.<sup>9</sup> This contamination effectively blocked the flow of compressed air, preventing the activation of the brakes.

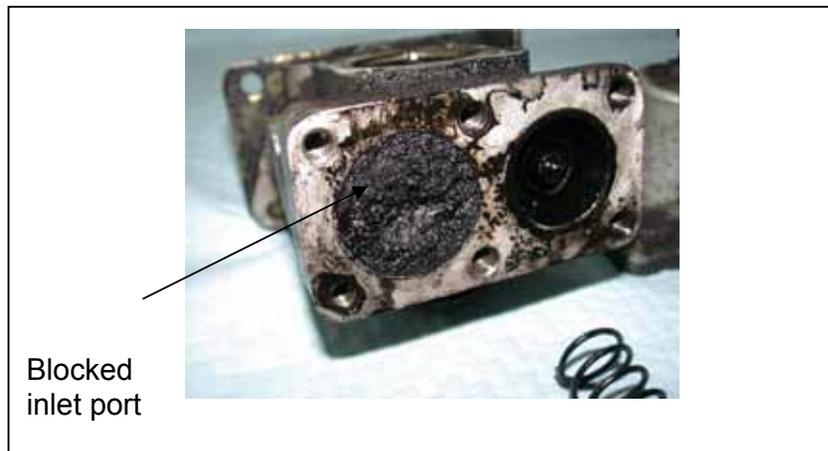
**Figure 4: Photograph of Unloader Valve Removed From MO8053 on 17/03/2004**

- 4.5 Shortly after the accident, testing of the unloader valve (2), which is designed to maintain constant air pressure in the braking system, found that a large amount of oil had dispersed from around the inlet side of the unloader valve and sprayed rearward onto the surrounding chassis rail and body. It was further established that with the engine idling, no air was detected coming out of the valve. The Police subsequently removed the unloader valve and in their report stated that "the entire inlet port was blocked with a build up of carbon and other debris, which had hardened."<sup>8</sup> Further examination found that the inside of the valve assembly was coated with "sludge" and engine oil (refer Figure 4).

- 4.10 Police testing has established that MO8053's air system, upon which the brake system depended, was contaminated by water, grease and oil. This contamination was a consequence of poor maintenance.

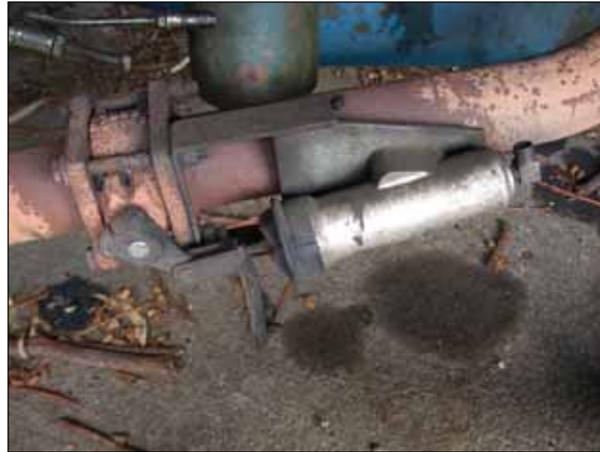
**Figure 5: Photograph of Disconnected Exhaust Brake from MO8053 on 17/03/2004**

- 4.7 The exhaust brake, an engine brake, is designed to slow rather than stop a vehicle. There is no legislative requirement to have an exhaust brake fitted on a passenger bus in NSW, however it is worth noting that in this instance the brake was disconnected. The NSW Police investigating officer is of the view that disconnection was not a consequence of the collision, i.e., disconnection had occurred before the collision.<sup>10</sup>
