BUS SAFETY INVESTIGATION REPORT

COACH OVERTURNED

JINDABYNE

11 JUNE 2011

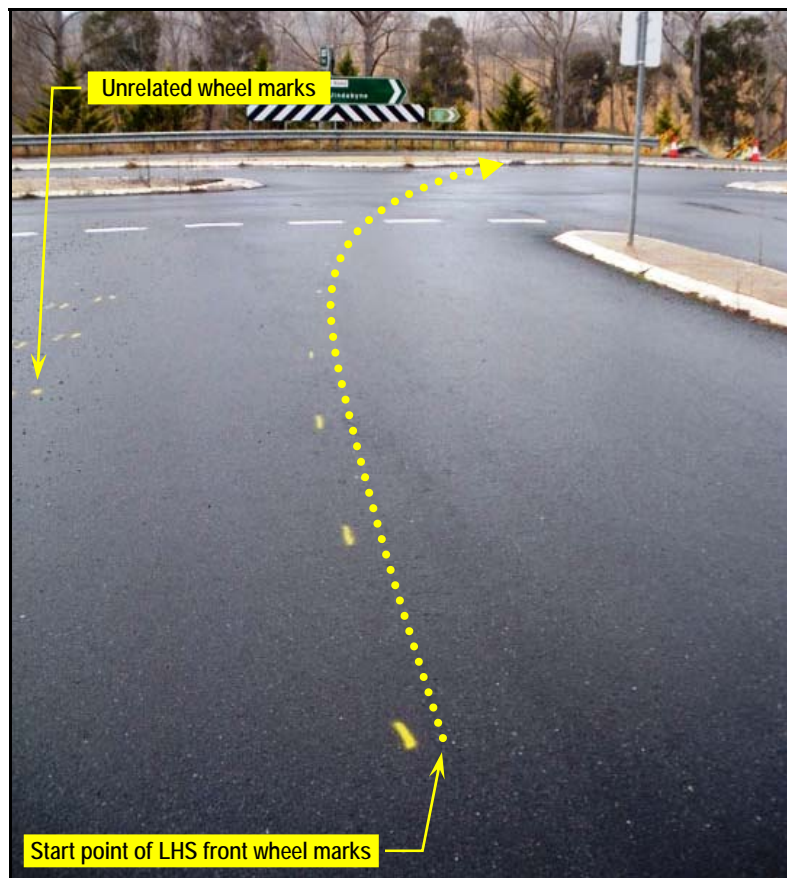
Photograph 3: Start of tyre markings from LHS front wheel

- 1.34 Driver 2 stated that the Director yelled at him to turn as TV 3777 reached the raised median strip dividing the carriageways of Alpine Way. He recalled that he was still trying to slow TV 3777 using the brakes at the time.
- 1.35 Driver 2 recalled that, at near full right hand lock, the front wheels lost adhesion with the road surface and he was unable to steer TV 3777. Tyre scuff marks on the carriageway confirmed that the front wheels had lost adhesion at the beginning of the median strip dividing the Alpine Way. The scuff marks also indicated that the driver had not gone as wide as possible for the turn (see *Photograph 3*).

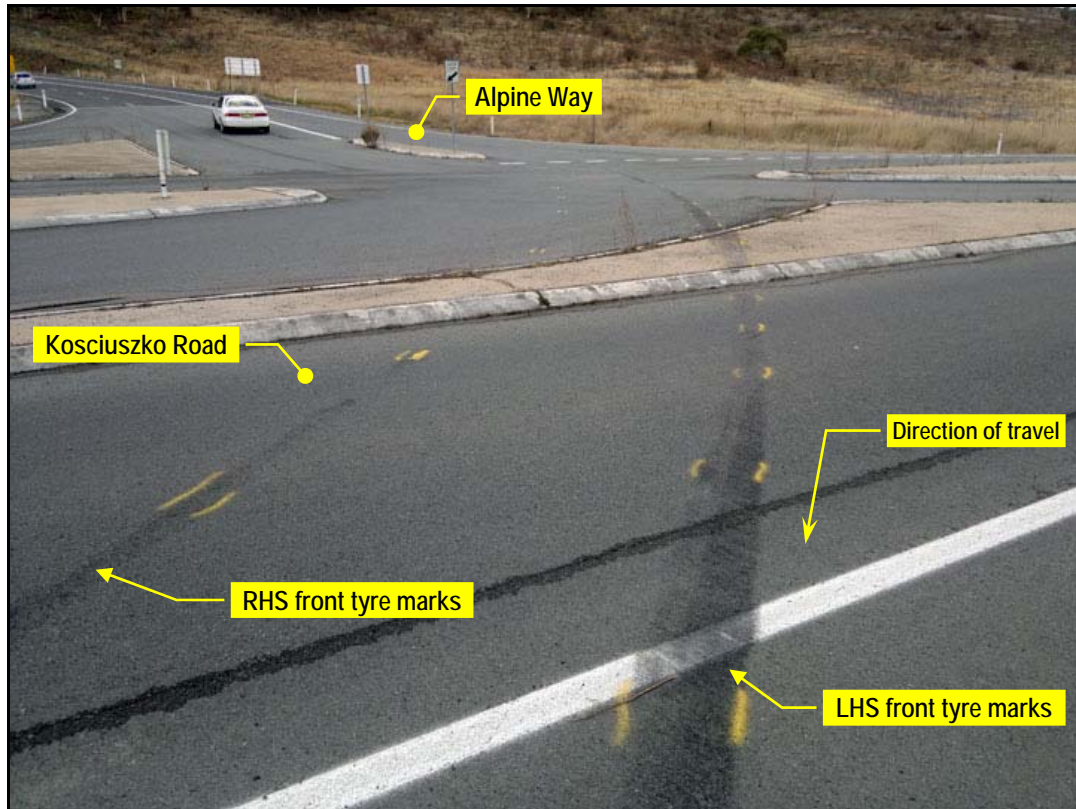
Photograph 4: Path of front wheels over median strip

- 1.36 With the steering still turned to the right, TV 3777 then travelled across the raised median strip dividing the Kosciuszko Road carriageway (see *Photograph 4*). Continuing, TV 3777 travelled across the East-bound carriageway of Kosciuszko Road before colliding with a guard rail positioned on the road shoulder.

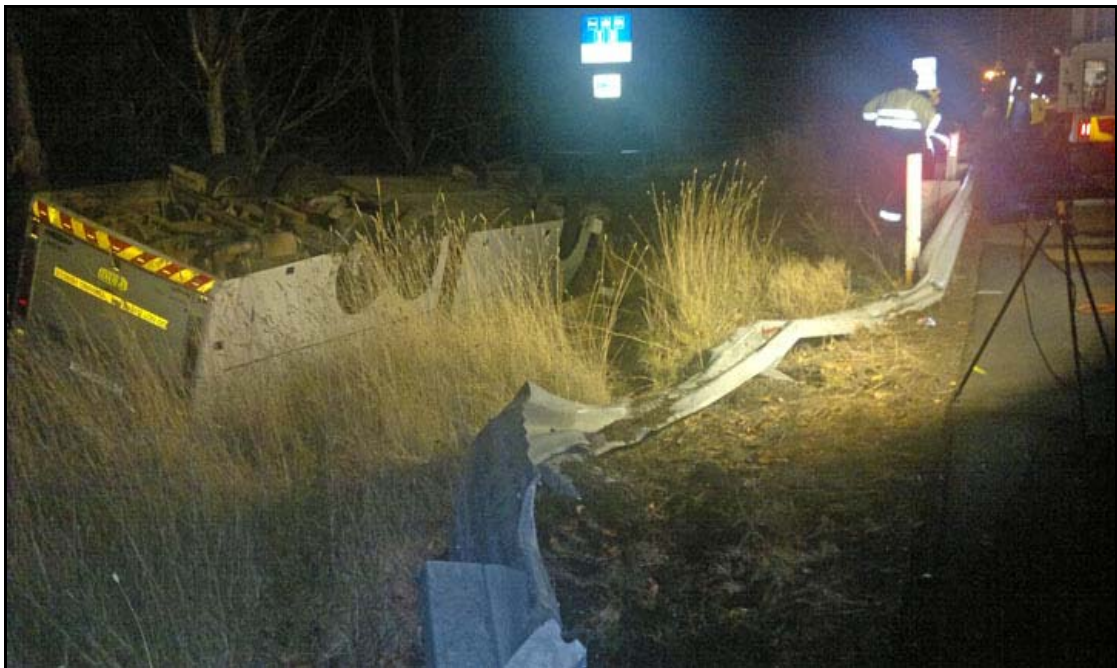
Photograph 6: TV 3777 overturned in drainage ditch

- 1.37 TV 3777 then demolished the guard rail and veered part-way down the embankment of a four metre deep drainage ditch separating Kosciuszko Road from a caravan and cabin park. Here, still upright, it crossed the top of a concrete culvert which emptied into the drainage ditch (see *Photograph 5*).
- 1.38 Now at a virtual standstill, the combination of a high centre of gravity and a steep embankment then caused TV 3777 to roll and land on its roof in the ditch (see *Photograph 6*).

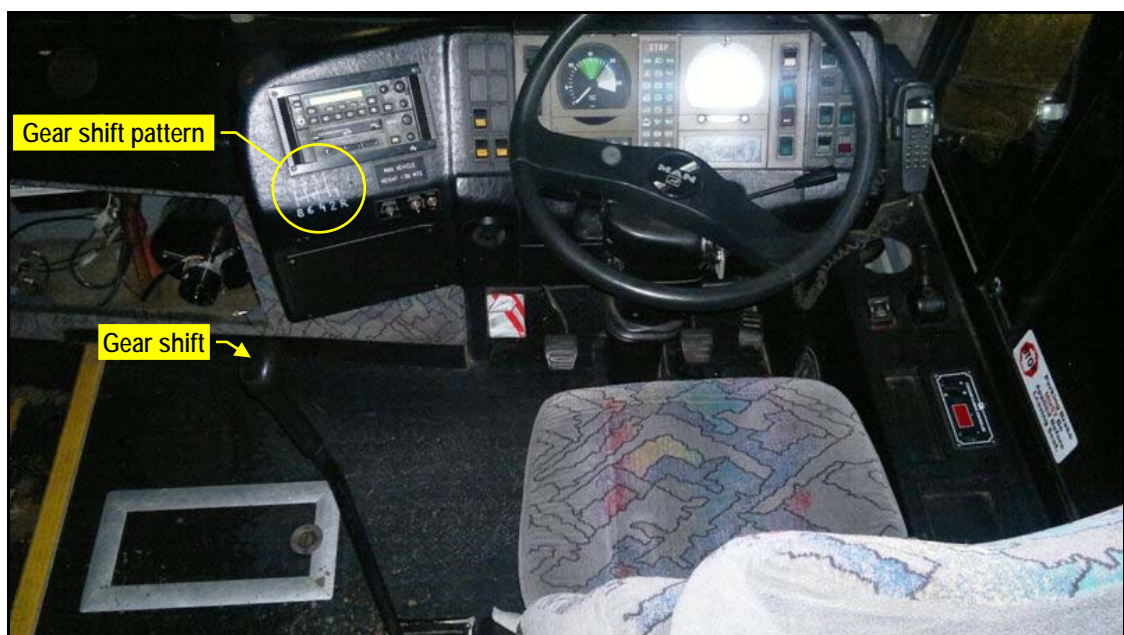
Photograph 8: Position of gear shift after TV 3777 was righted at Jindabyne

- all passenger effects, barring litter, had been removed;
- the park brake was in the release position;
- the transmission, an eight speed split arrangement, appeared to be in 6th or 8th gear (see *Photograph 8*);

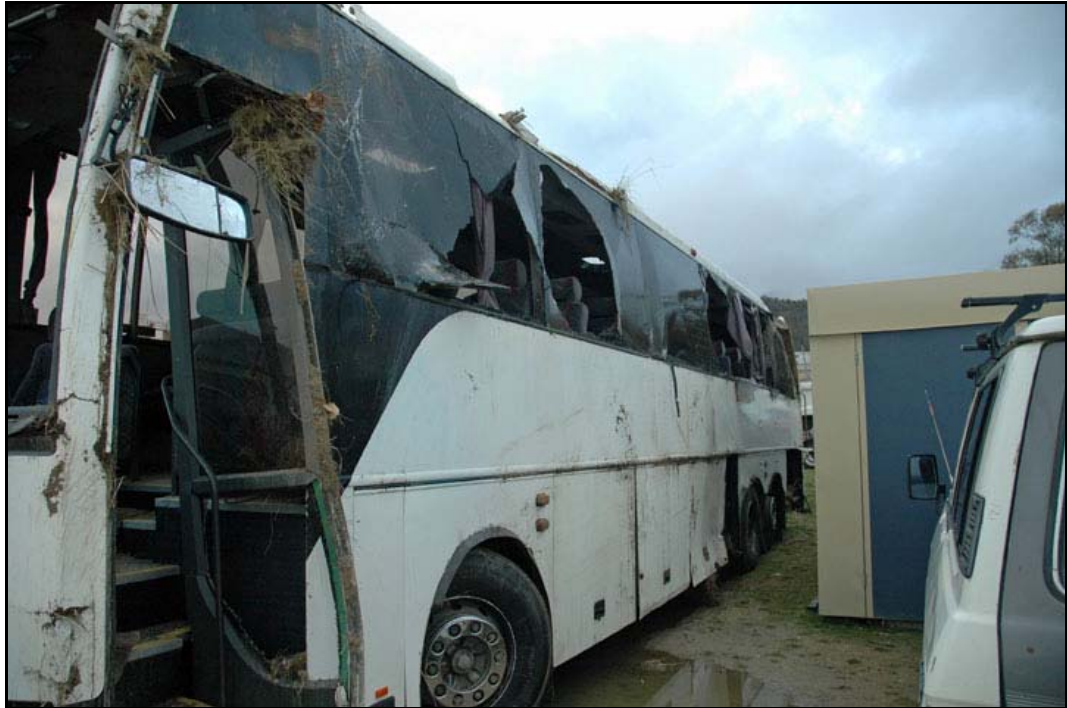
Photograph 9: External damage to TV 3777

- the damage to the bodywork, including broken passenger windows, was consistent with the low speed overturn into the ditch (see *Photograph 9*);

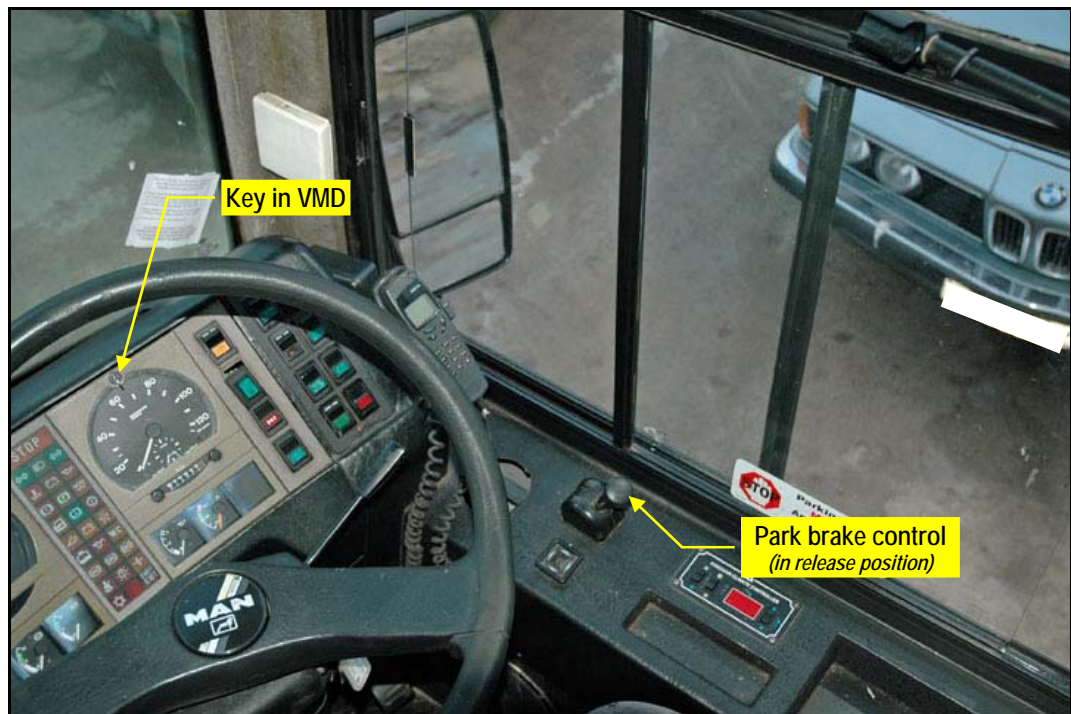
Photograph 10: Vehicle monitoring device not secured, with key still in lock

- all tyres appeared to be in a serviceable condition with tread thicknesses within specified wear limits;
- there was no evidence of flat spotting on any tyres that would indicate wheels had locked up under brakes and skidded;
- the brake chamber on the right hand side (RHS) drive axle had recently been renewed but its piston was fully extended; and
- the VMD was not secured, with a key was still in its lock (see *Photograph 10*).

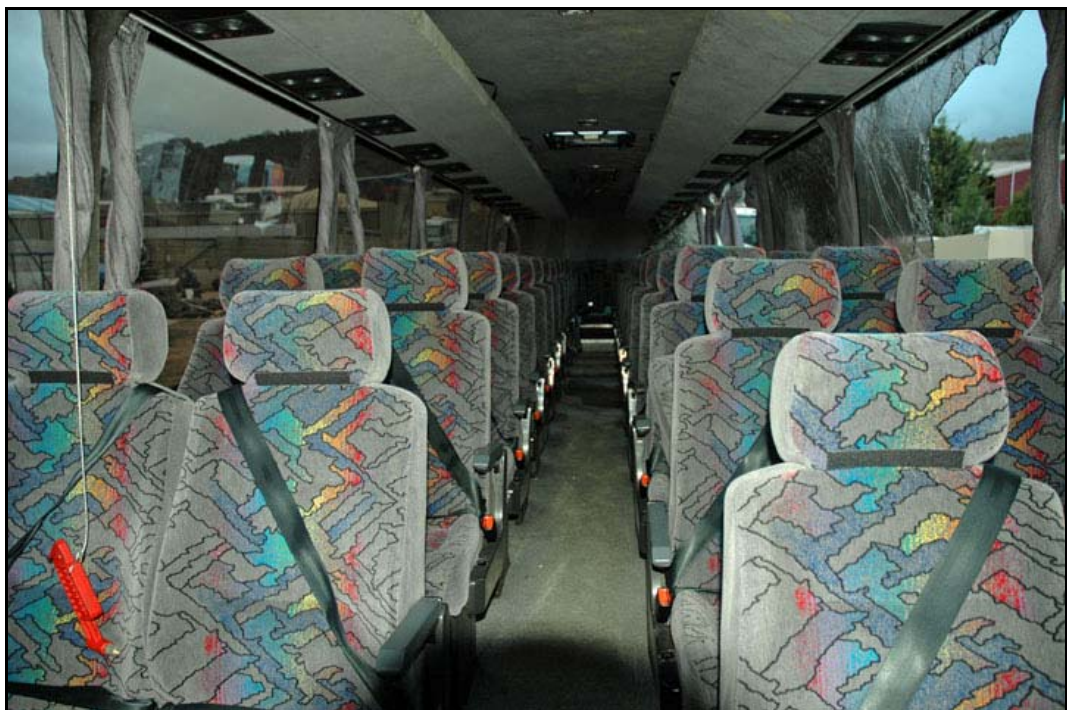
Photograph 11: Interior view of TV 3777 with seatbelts engaged

2.35 The majority of seatbelts were found to be engaged and clipped. It was later established that this had been done by a RTA Heavy Vehicle Inspector who, with the assistance of the TNSW Traffic Commander, tested the seatbelt operation prior to the arrival of OTSI investigators. They had found only two belts defective due to their being tight to clip (see *Photograph 11*).

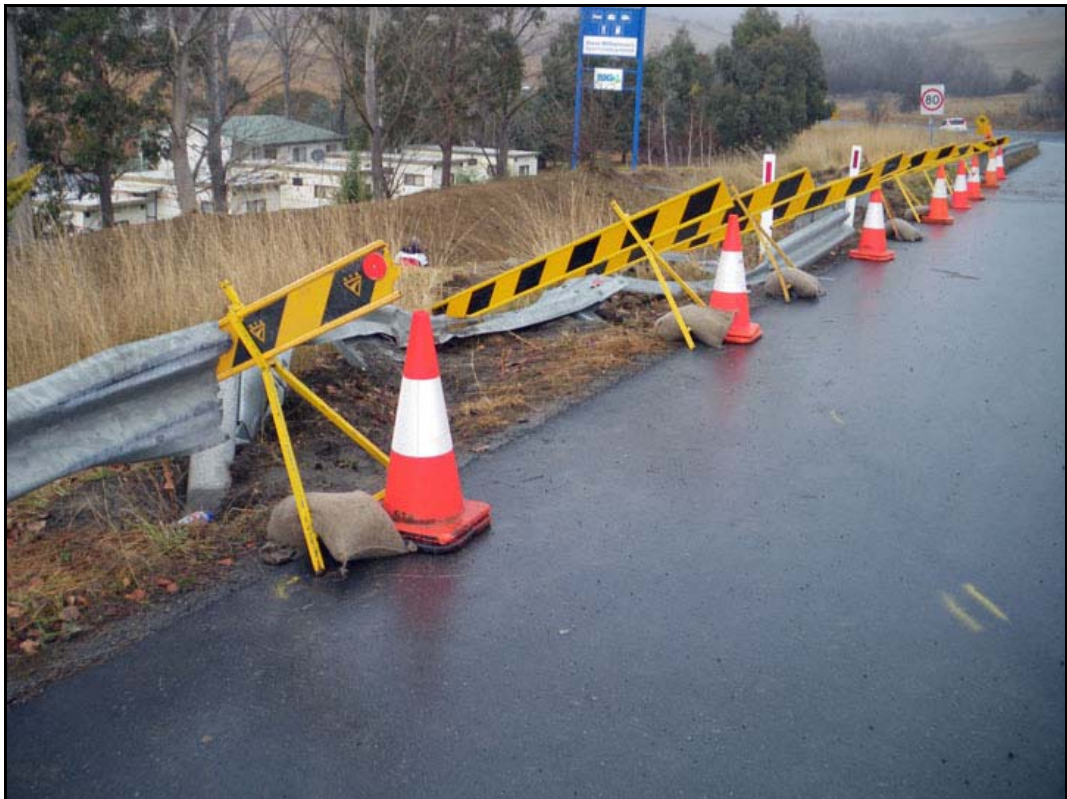
Photograph 13: Damaged guard rail

- there was no distinguishable evidence of lockup or skidding from the rear wheels on the road surface at the immediate approaches to the intersection. Dual tyre skid marks near to the front tyre scuff marks from TV 3777 were subsequently identified as not being related to this accident;
- loose road material had built up against the median strips but was not in the path taken by TV 3777;
- the collision had demolished four posts and three sections of the guard rail at the intersection (see Photograph 13); and
- there were various damaged vehicle panels and passenger effects still littering the drain where TV 3777 came to rest.

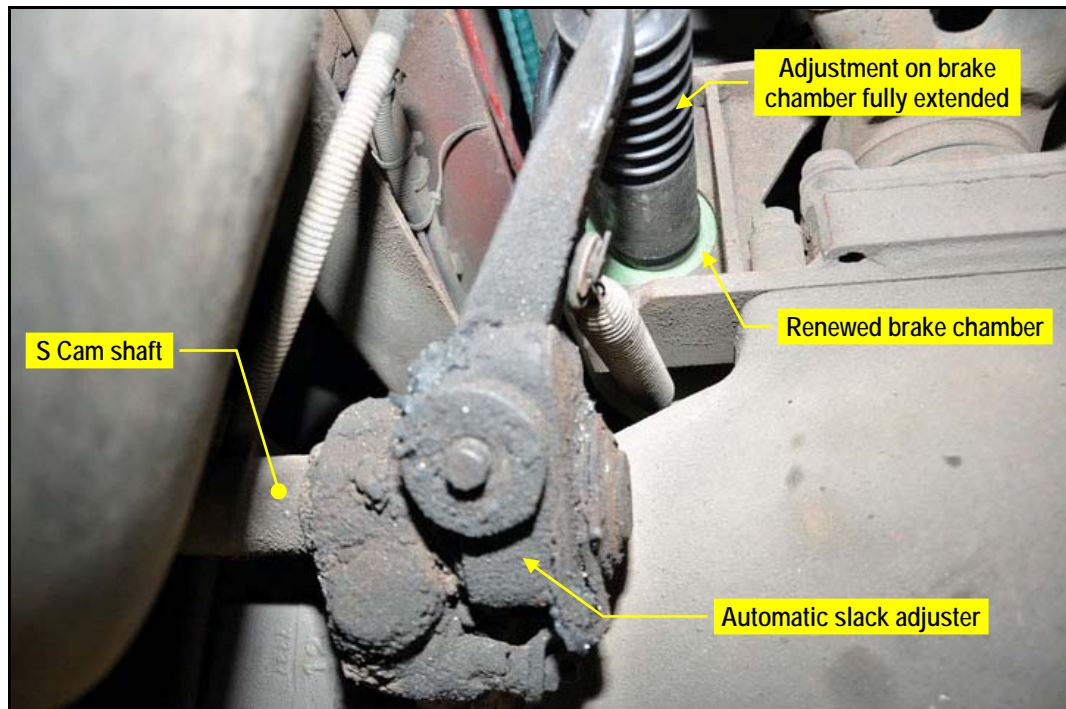
Photograph 14: Extended adjustment on brake chamber on RHS drive axle at Queanbeyan

- 2.26 Post-accident inspection and testing of TV 3777 identified that there was an imbalance in braking effort across both rear axles. The imbalance on the drive axle was caused by the lack of adjustment and setting of the slack adjuster after the right (driver's) side brake chamber had been replaced. The imbalance on the tag axle¹⁰ was caused by wear in the brake linings and the lack of regular adjustment of the manual slack adjusters on the axle.

- there was heavy accident damage to its front and left hand side;
- there was no discolouration on any of the brake drums or linings indicating overheating;
- the RHS drive axle brake chamber had recently been renewed but its adjustment was fully extended (see *Photograph 14*) with both the service and spring parking brake functions not working due to “*shoes jumped overcam*”;

- there was an 11% imbalance in braking forces recorded between the wheels on the No.1 (steering) axle which is within the 30% maximum allowable limit;
- there was a 95% imbalance in braking forces between the wheels on the No.2 (drive) axle caused by “*excess travel*”;

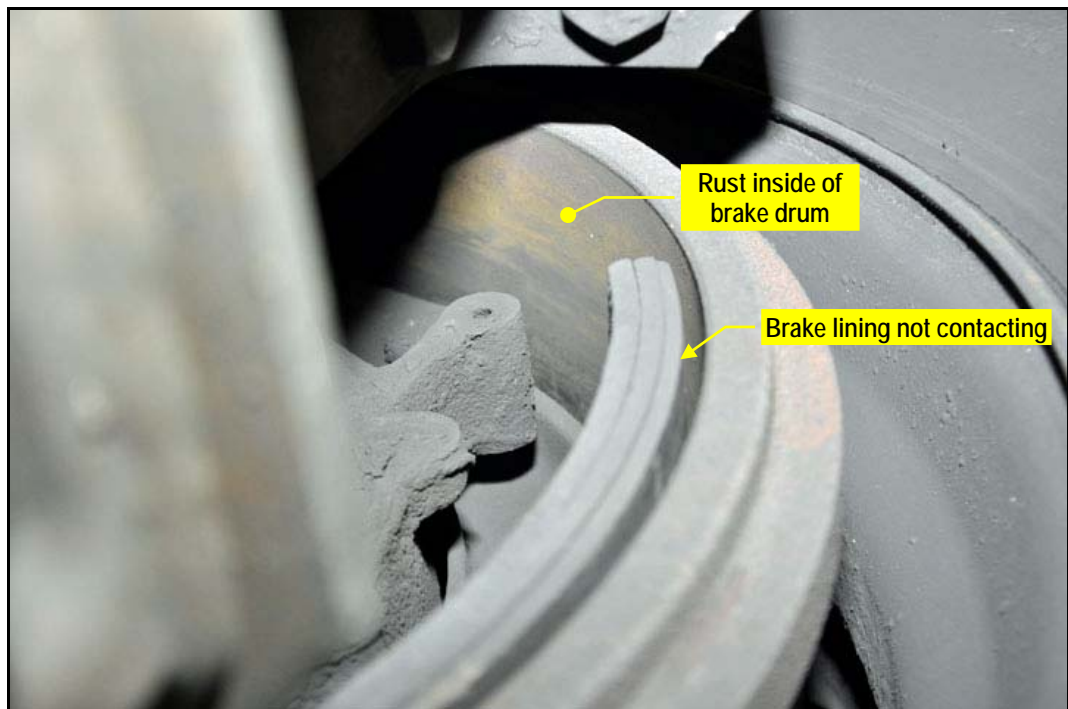
Photograph 15: Rust on the inner surface of the No.2 axle RHS brake drum

- there was a 80% imbalance in braking forces between the wheels on the No.3 (tag) axle caused by “*excess and uneven travel*”. However, despite the excessive braking force differentials on the drive and tag axles, the overall braking performance was still within minimum specifications for this class of vehicle;
- there was rust on the inner surface of the No.2 axle RHS brake drum indicating that the brake linings had not recently contacted the drum (see *Photograph 15*);

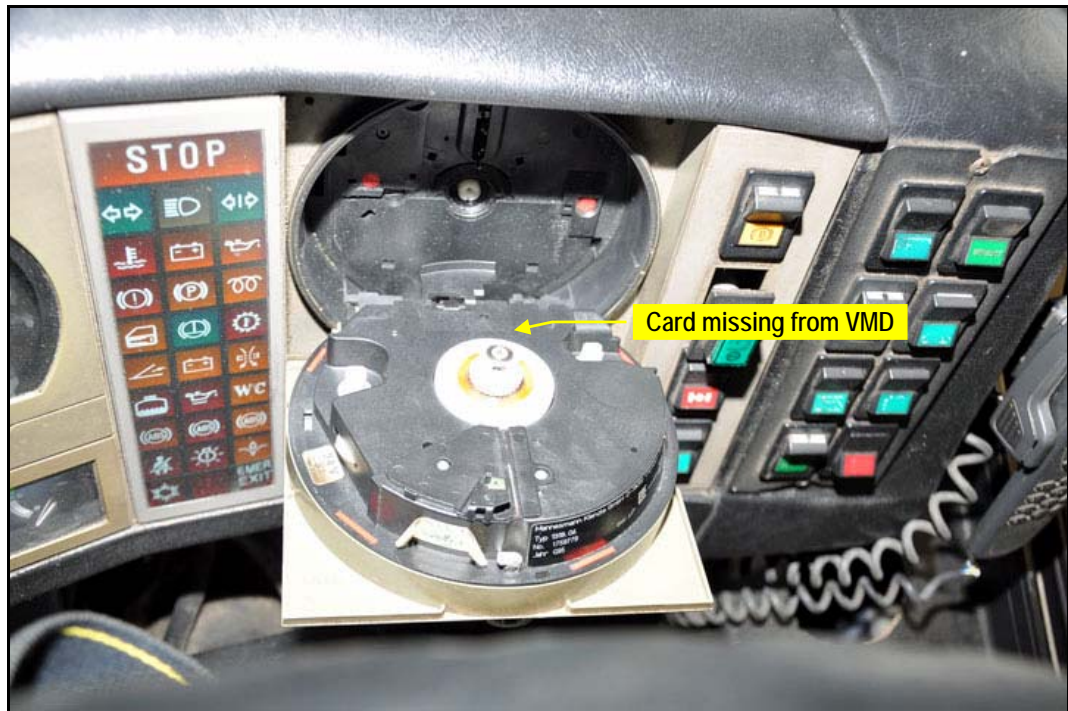
Photograph 16: Vehicle monitoring device (without card) when opened at Queanbeyan

- the left side sway bar bush on the No.2 axle was worn;
- the key to the lock of the VMD was in the lock compromising the security of the tachograph card; and
- there was no card in the VMD when the unit was opened (see *Photograph 16*).

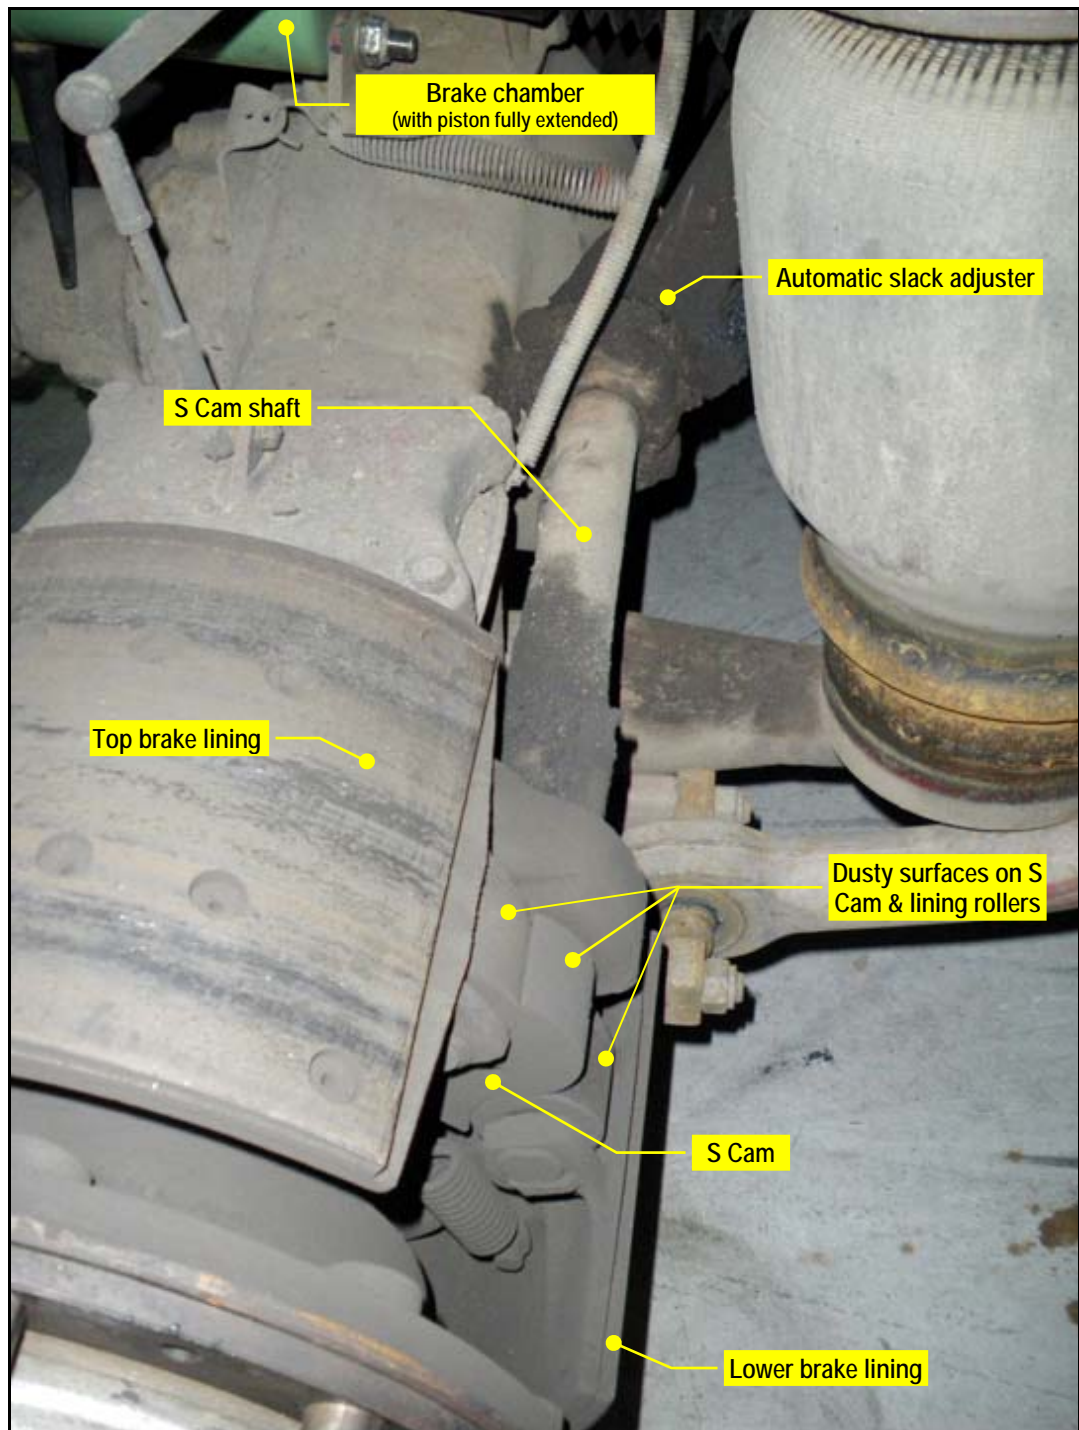
Photograph 17: Condition of brake assembly on No.2 axle RHS when dismantled

- the No.3 axle LHS wheel could still be rotated with the spring parking brake applied;
- when the brake drum was dismantled from the No.2 axle RHS hub, the S cam was observed to be in the fully retracted and released position despite the brake chamber being fully extended (see *Photograph 17*);
- the S cam and lining rollers were covered in dust indicating a lack of recent operation;
- the diameter of the No.2 axle RHS brake drum measured 410.97mm (new 410mm) indicating minimal wear;
- the thickness of the No.2 axle RHS brake linings measured between 6.3mm and 9.8mm. Although within specification, these measurements were at the lower end of the limits. All other brake linings were of serviceable condition and thickness;
- the inner surface of the No.2 axle RHS brake was rusty indicating that the brake linings had not recently contacted the drum (see *Photograph 18*);

- there was no evidence of overheating on any of the brake drums or linings;
- the control arm on the No.2 axle RHS brake automatic slack adjuster was damaged which prevented the slack adjuster clutch from functioning and the full stroke of the body. (This damage presented as a pre-accident condition. The slack adjuster operated as designed after the control arm was straightened); and
- continuous pumping of the brake pedal could not identify a reason for its reported travel to the floor by Driver 2.
