Office of Transport Safety Investigations

BUS SAFETY INVESTIGATION REPORT

BUS WHEEL SEPARATION

MEDOWIE

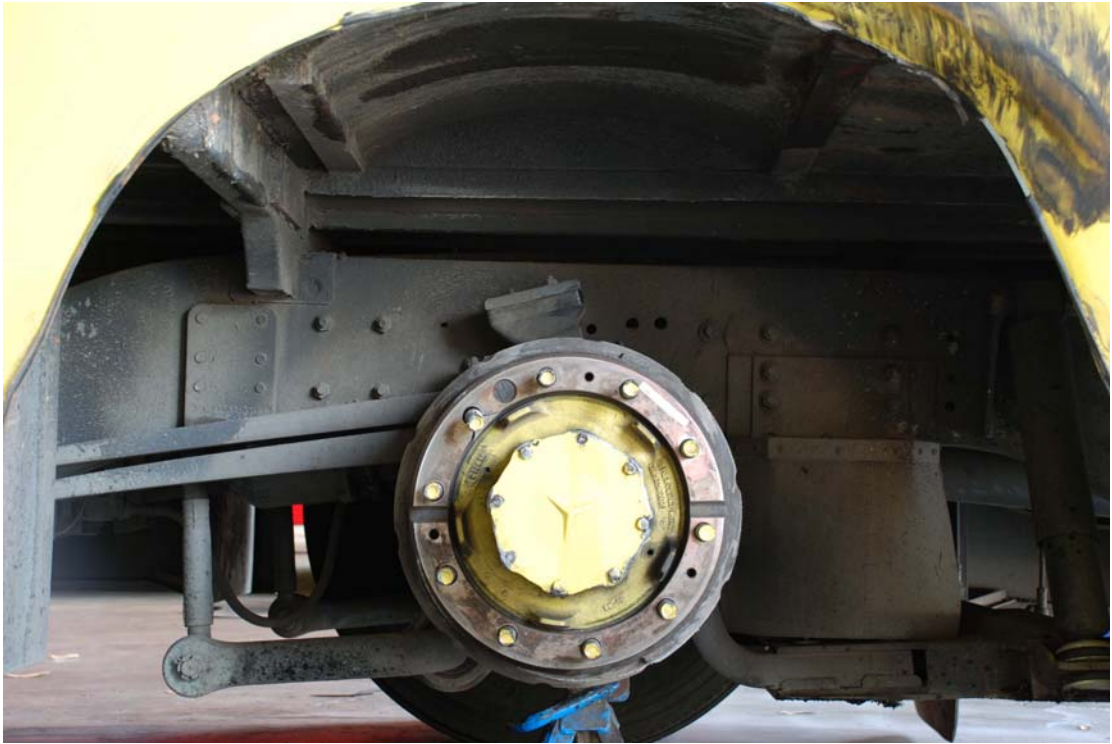
Photograph 1: Nearside Rear Hub

- 1.8 The bus was examined at the depot in an effort to determine how the wheels had come off. The evidence available included the bus, with the hub and all its studs attached, and the inner rear wheel which had been recovered after the incident. *Photograph 1* shows the hub involved.

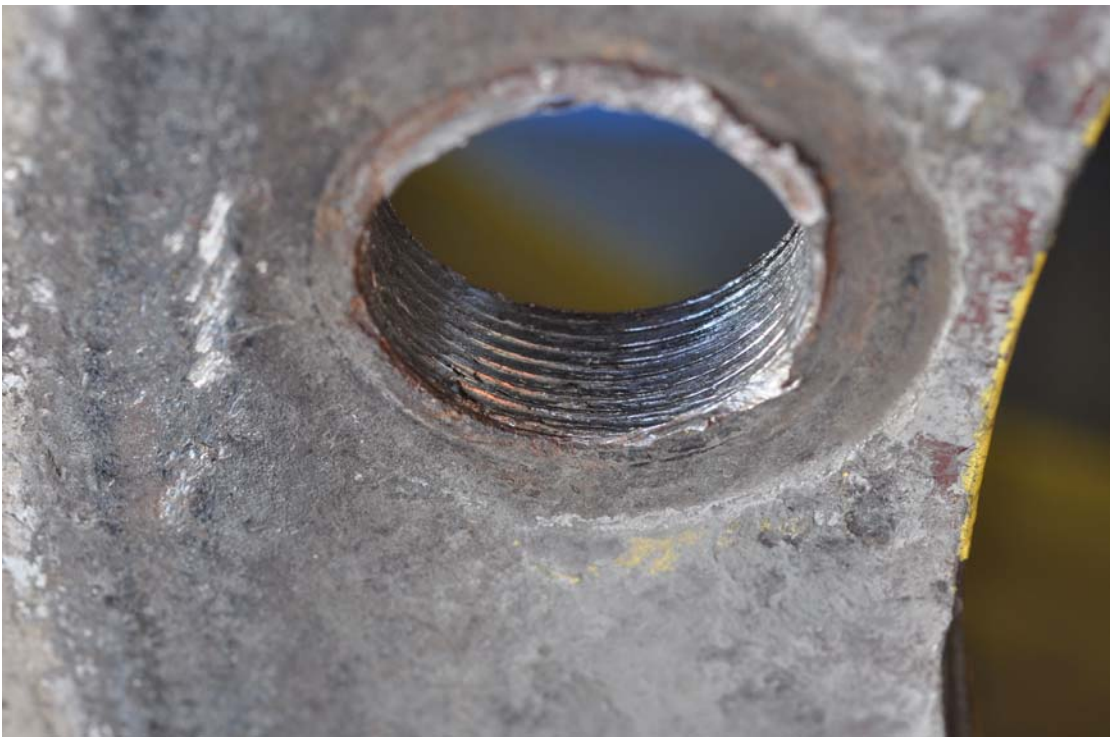
Photograph 2: Damaged Inner Rim Stud Hole

- 1.9 The inner rim showed evidence within the stud holes that most damage occurred to the rim during braking. *Photograph 2* is a close up of the marks left by one of the studs in the inner wheel.

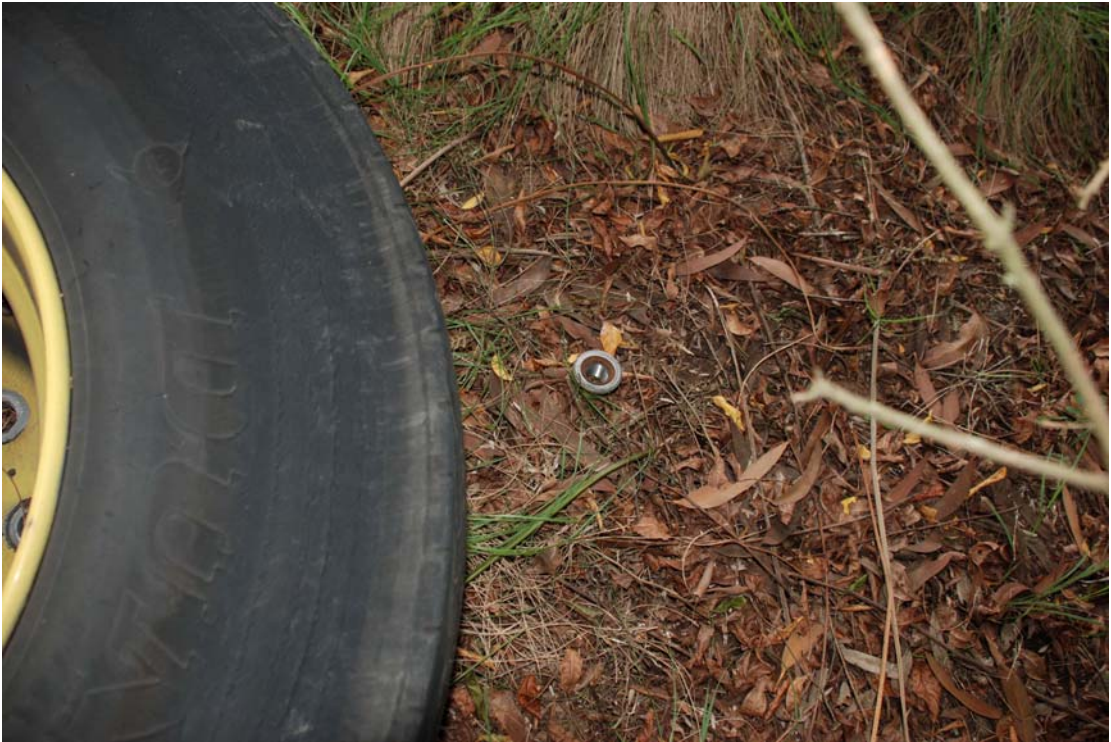
Photograph 5: Wheel Nut Located Beside Wheel

that fact that lying right next to the wheel was one of the wheel nuts (see *Photograph 5*). To have ended up where it was, the wheel had to have travelled from the bus, across the oncoming traffic lane, down the side of a slope, through a gully, up an embankment and rolled around the back of a tree.

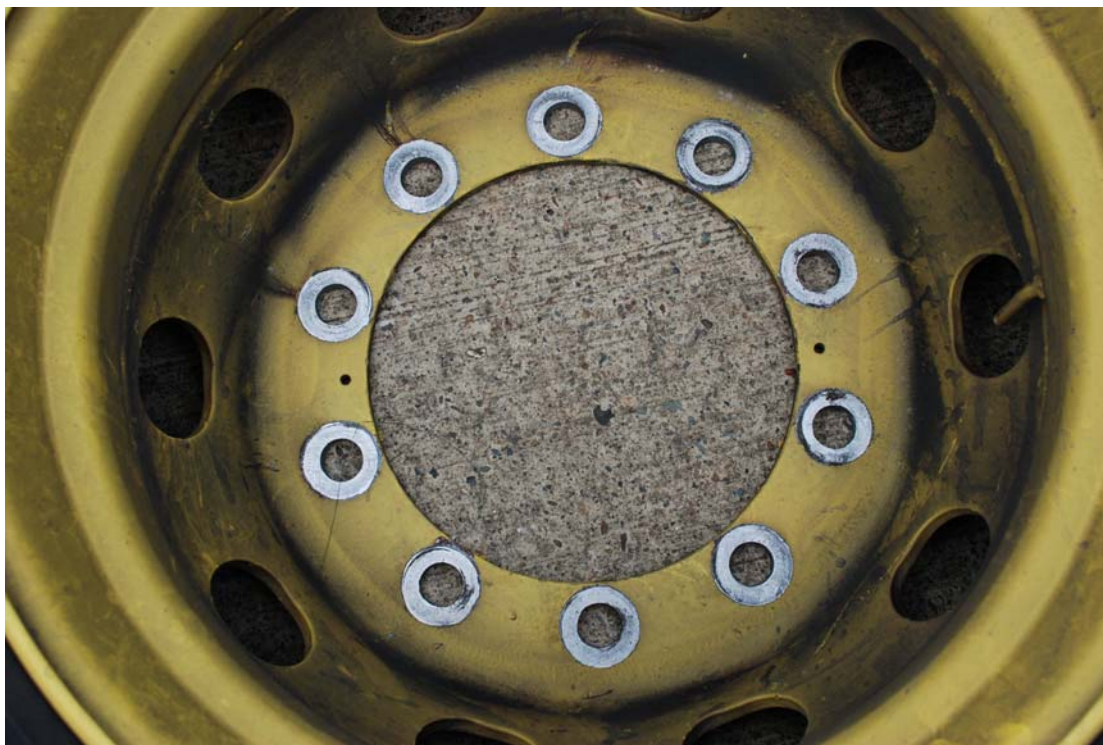
Photograph 6: All Ten Nuts Marked Rim

- 1.17 Vague impressions in the grass showed that a possible path of travel was to the top of the embankment, before hitting a post and wire fence and rolling back down to beneath the tree.
- 1.18 Investigators found a total of eight wheel nuts located within approximately two metres of where the wheel had come to rest. The two remaining nuts were not found and other search methods, such as using a metal detector, were not employed as the rim showed clear signs that ten nuts had been fitted to it (see *Photographs 6 and 7*). All stud holes showed bare metal and fretting where the nut flanges meet the rim.

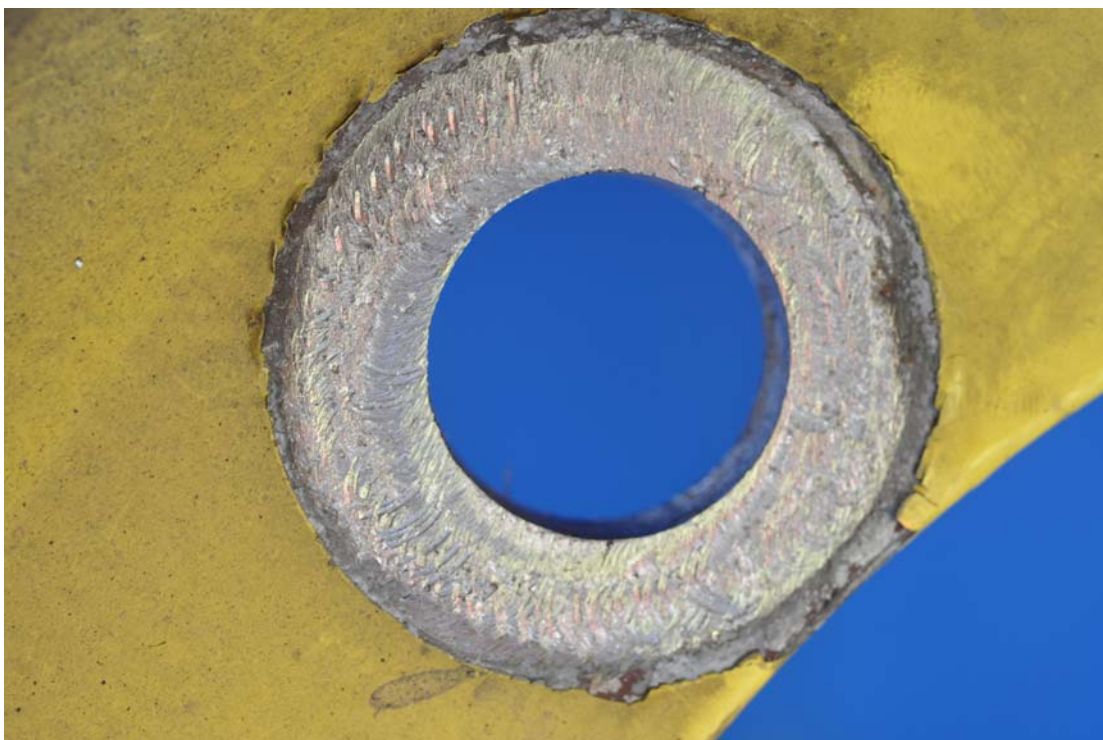
Photograph 7: Close View of Fretting Caused by Loose Nuts

- 1.19 Locating eight of the wheel nuts within close proximity to the outer rear wheel indicated they had all fallen off, rather than being ripped from the studs. This would indicate that all eight nuts must have come undone at approximately the same rate. Had that not been the case, some nuts would most likely have been torn from the studs during cornering, when the lateral loading on the rims was the highest.
- 1.20 The driver completed a pre-departure check of the bus as required during which he observed all wheel nuts fitted to the bus. Therefore, the nuts must have come undone over the short journey of approximately 25 kilometres.

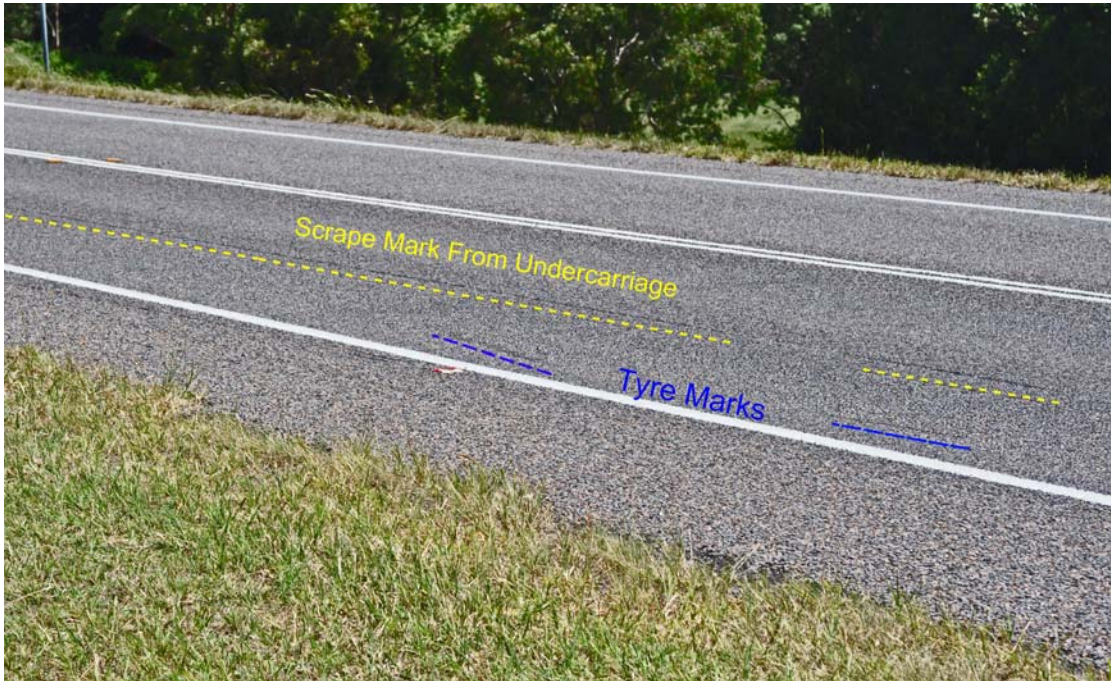
Photograph 8: Scrape and Tyre Marks on Road

- 1.23 The driver's actions in not using the brakes contributed to a controlled stop, with the scrape marks in the road depicting a course which confirmed the bus did not cross to the other side of the road (see *Photograph 8*).

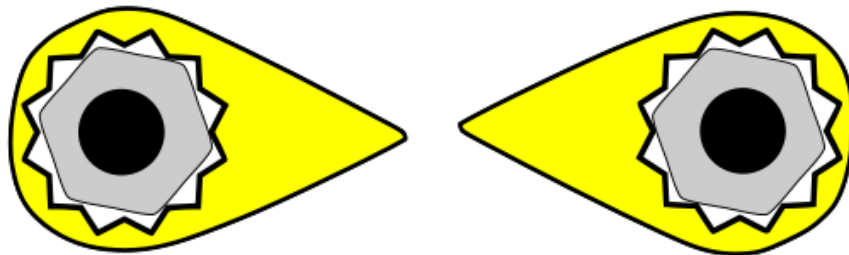
Figure 2: Illustration of Wheel Nut Tags

- 1.42 Since the Bossley Park incident, ComfortDelGro Cabcharge has implemented a trial of fitting plastic indicator tags to wheel nuts. The purpose of the tags is to provide a visual aid to determining if wheel nuts are coming loose. The tags are plastic arrows which fit over the wheel nuts and usually are fitted to pairs of nuts with the indicators facing each other (see *Figure 2*). In the event of nuts working loose, the indicator arrows will turn anti-clockwise, disrupting the pattern of original alignment (see *Figure 3*).

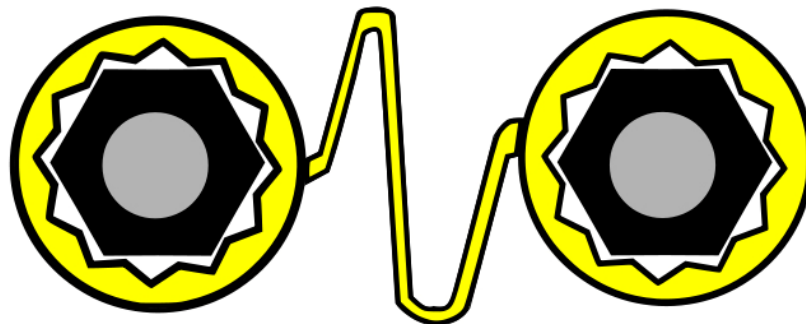
Figure 4: Alternative System

- 1.43 Another bus company has implemented an alternative to this type of indicator tag, whereby two pairs of wheel nuts are fitted with a plastic tag which effectively ties the nuts together (see *Figure 4*).
