# **BUS SAFETY INVESTIGATION REPORT**

## **PEDESTRIAN FATALITY, BUGATTI DRIVE, INGLEBURN**

**5 AUGUST 2009**

**Investigation Reference 04450**

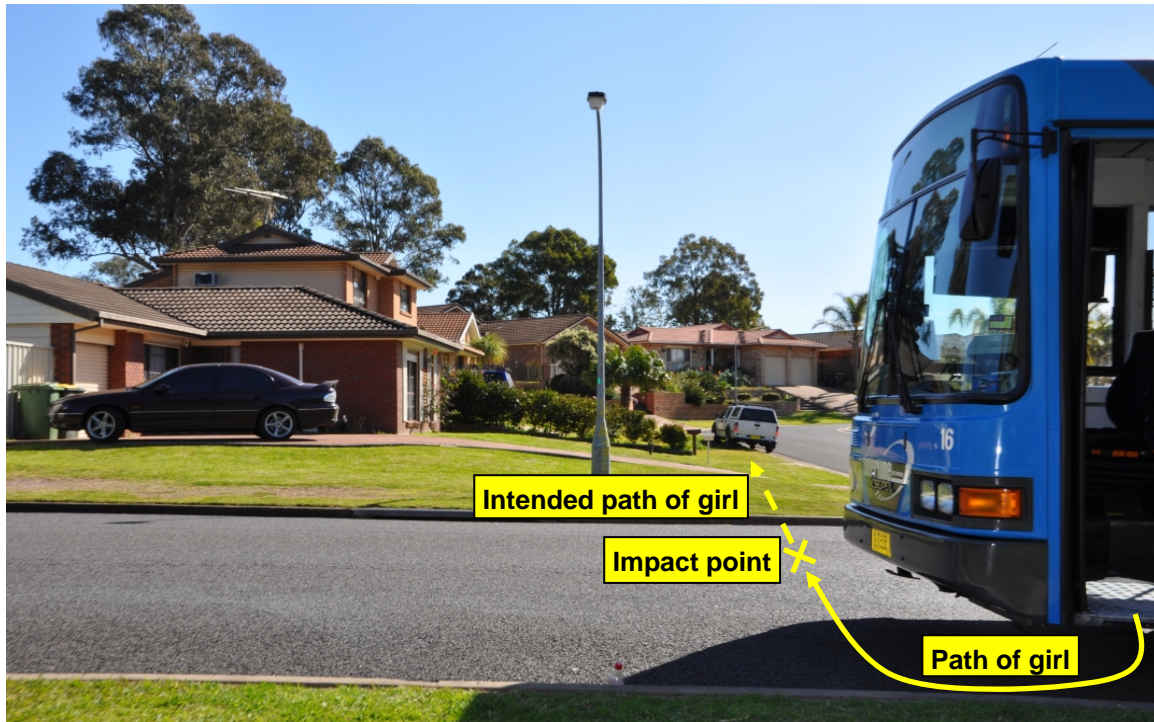
- 1.2 A Southbound bus operated by Interline Bus Services had pulled up near a designated bus stop at the Southern end of Bugatti Drive, Ingleburn, which is part of its regular school bus route. The driver of the bus indicated that the warning lights<sup>1</sup> had been activated when the bus stopped.
- 1.3 Several school children boarded including one of the victim's older siblings. As she was about to board the bus the girl suddenly changed her mind and, despite protests from the driver, ran around in front of the stationary bus (see *Photo 1*).

**Photo 1: Path of girl on alighting from stationary Interline bus**

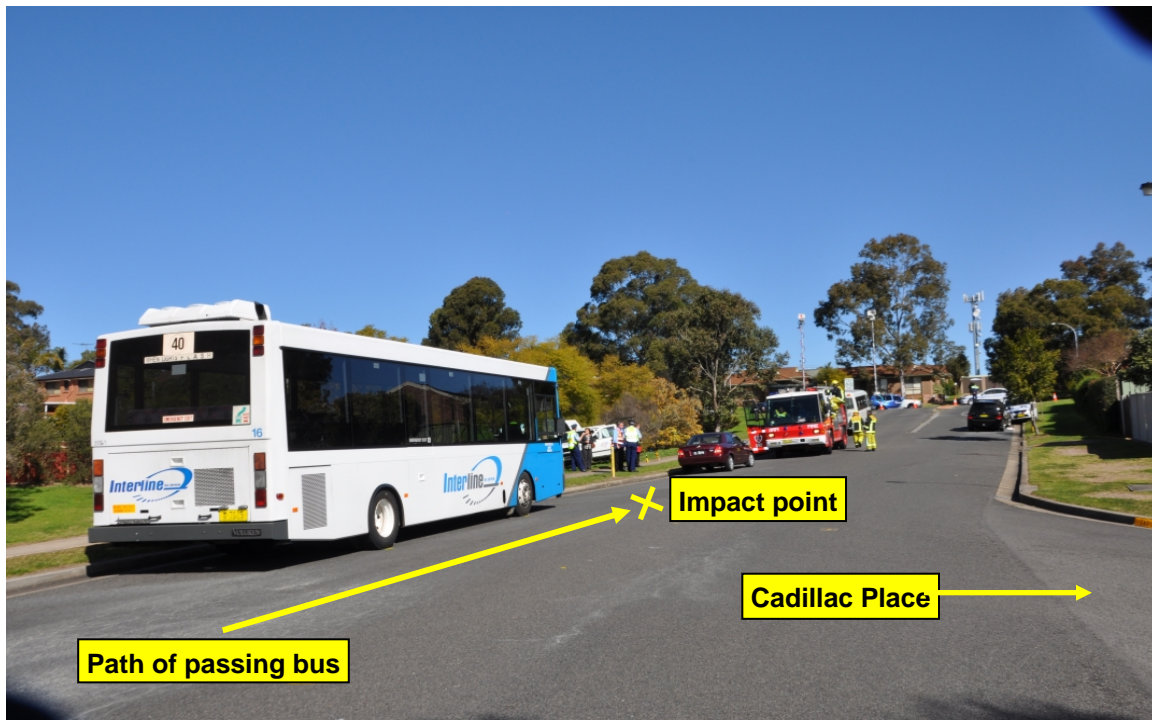
- 1.4 At that instant, another Southbound bus, a Mitsubishi Rosa (Rosa) operated by Macarthur Adventist College (MAC), was passing the stationary Interline bus and the front driver's side of the Rosa struck the girl (see *Photo 2*).

Photo 2: Path of passing Southbound bus and impact point

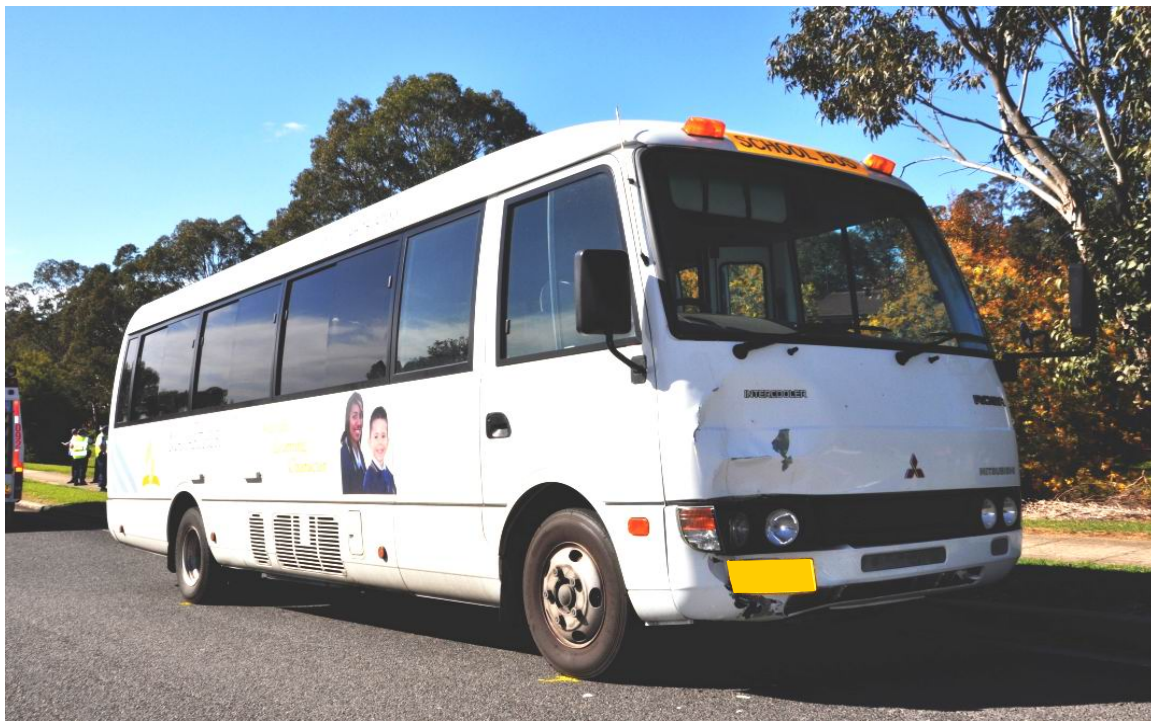
- 1.10 The bus was examined at the scene by members of the RTA and there were no immediate indications that the accident was caused or contributed to by any form of mechanical failure or defect. Subsequently, a full vehicle examination confirmed there were no significant defects with the vehicle. However, a *Vehicle Defect Notice* was issued requiring the accident damage be repaired within 14 days (see *Photo 3*).

**Photo 3: Mitsubishi Rosa showing impact damage**

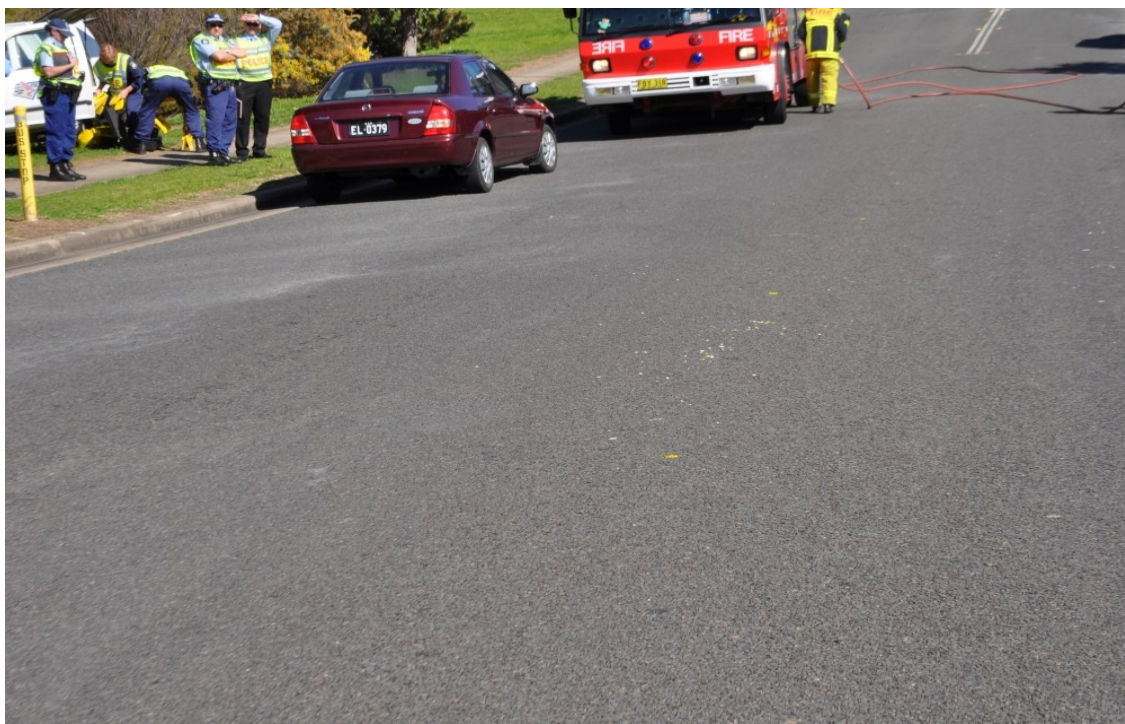
- 2.4 OTSI Investigators arrived at the scene after the victim had been conveyed to hospital but the two buses remained in situ. It was apparent that the victim had been propelled, from the point of impact, some 28 metres forwards and to the opposite side of the roadway.
- 2.5 Debris on the roadway from impact damage to the front of the Rosa assisted in determining the point at which the collision occurred (see *Photo 4*). The absence of skid marks corroborated the driver's statement that she did not brake heavily or swerve.

**Photo 4: Debris on roadway from collision damage**

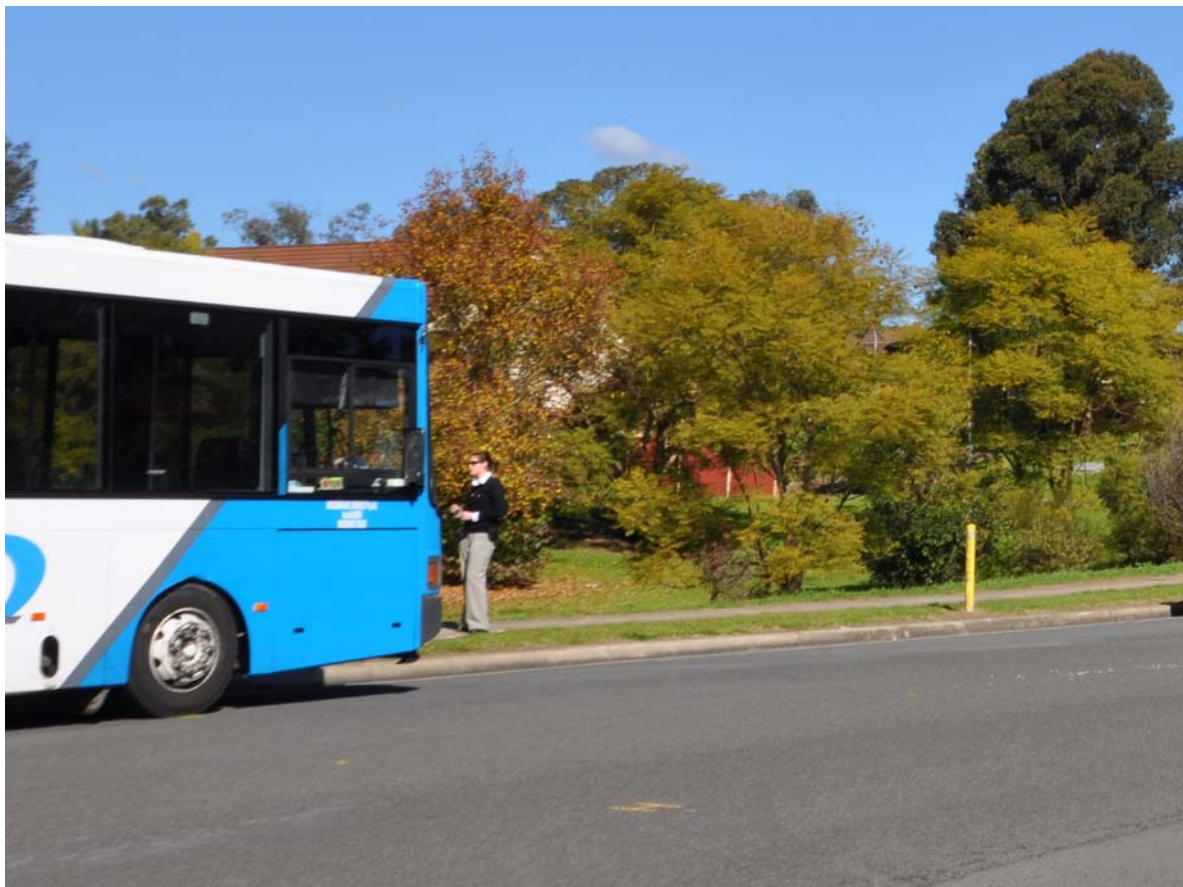
2.10 The bus stop near the intersection of Bugatti Drive and Cadillac Place is marked with a commonly used yellow post (see *Photo 5*) and is used by all bus services. Its location was established in March 1995 on the recommendation of Campbelltown Council's Local Traffic Committee.

**Photo 5: Bus stop on Bugatti Drive, relative to final stopping position of bus**

- 2.11 The Interline bus stopped some distance short of the actual bus stop marker (see *Photo 5*). This action was not unusual as there is no mandated regulation specifying where school buses (or any bus) are required to stop relative to a bus stop marker. There appears to be only a general understanding within the industry that buses stop as close to the bus stop as possible, and as close to the curb as possible, with due consideration to any site-specific risks assessed by the driver. Typical considerations at each site may include other vehicles occupying the stop, visibility of other vehicles and of the bus itself, time and space needed to merge back into passing traffic, and structures such as poles and shelters protruding into stopping spaces.

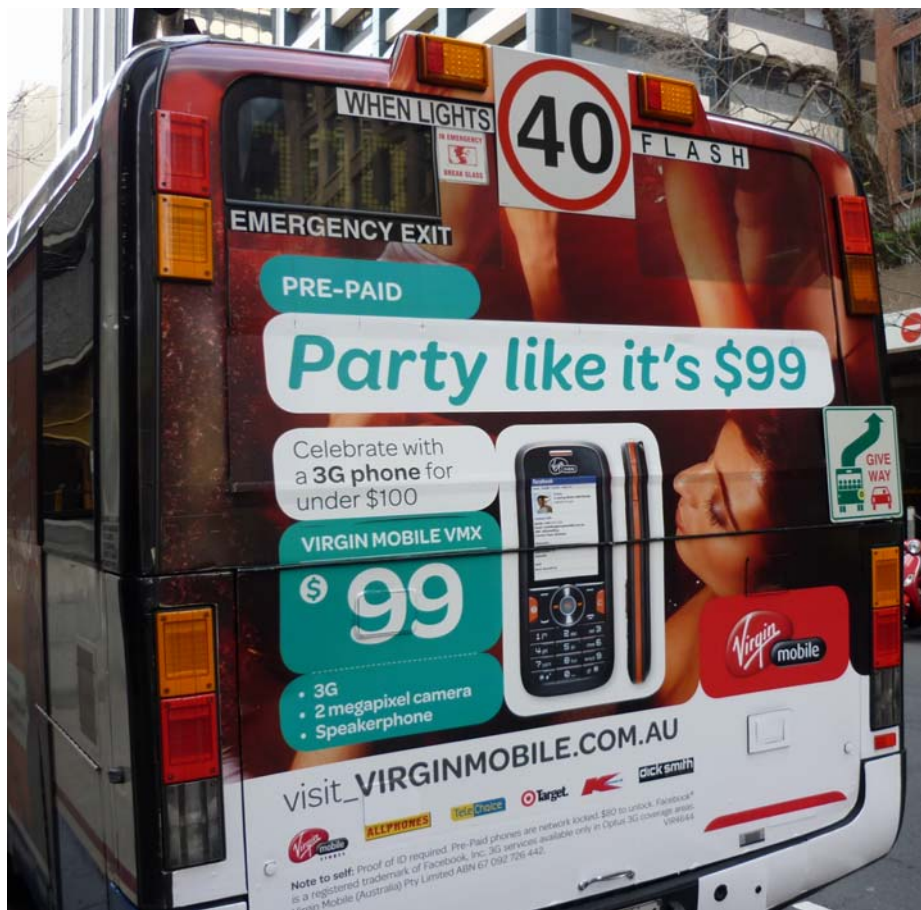
- 2.51 The space on the rear of buses is an area that has been seen as having the greatest potential for raising awareness about school buses. Debate in the 1990s over the positioning of a removable sign above the rear window resulted in this being mandated in *Technical Specification 142* for dedicated school buses, but not for route buses that doubled up as a school bus. Removing signs manually was seen as problematic, as it was impractical for the bus driver's duties to include attaching and removing the signs to suit the run. However, the proposal is worth revisiting given the technological advances and reduction in cost of LED type signage since then. MoT files dating from the 1990s contain information suggesting that advertising signage on the rear of buses should be banned, as this may detract from the visibility and impact of the wig wag lights. Advertising is now more commonly displayed on the rear of many buses, some of which is quite distracting (see *Photo 6*). This means that the flashing lights and signage have to successfully compete for the attention of a driver, before they have any effect at all. OTSI also noted that there are variations in the size of the warning signage, some of which may not be compliant with *Technical Specification 142* (see *Photo 7*).

Photo 6: Rear of bus in CBD with prominent advertising

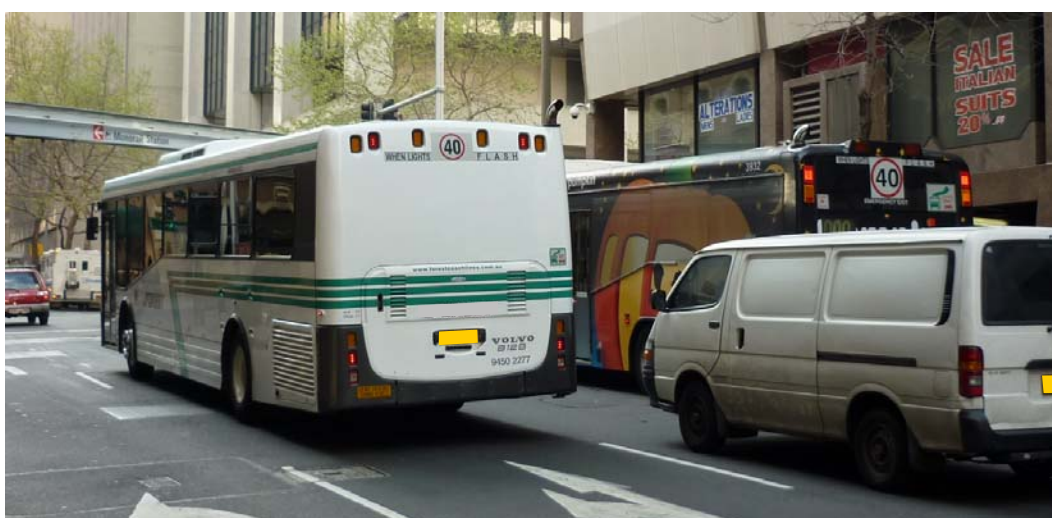
Photo 7: Rear of two buses in CBD with different sized warning signage
