BUS SAFETY INVESTIGATION REPORT

BUS ACCIDENTS OCCASIONING DEATH AND SERIOUS INJURY

WEST PENNANT HILLS, RUTHERFORD AND SYDNEY CBD

19 – 27 JUNE 2007

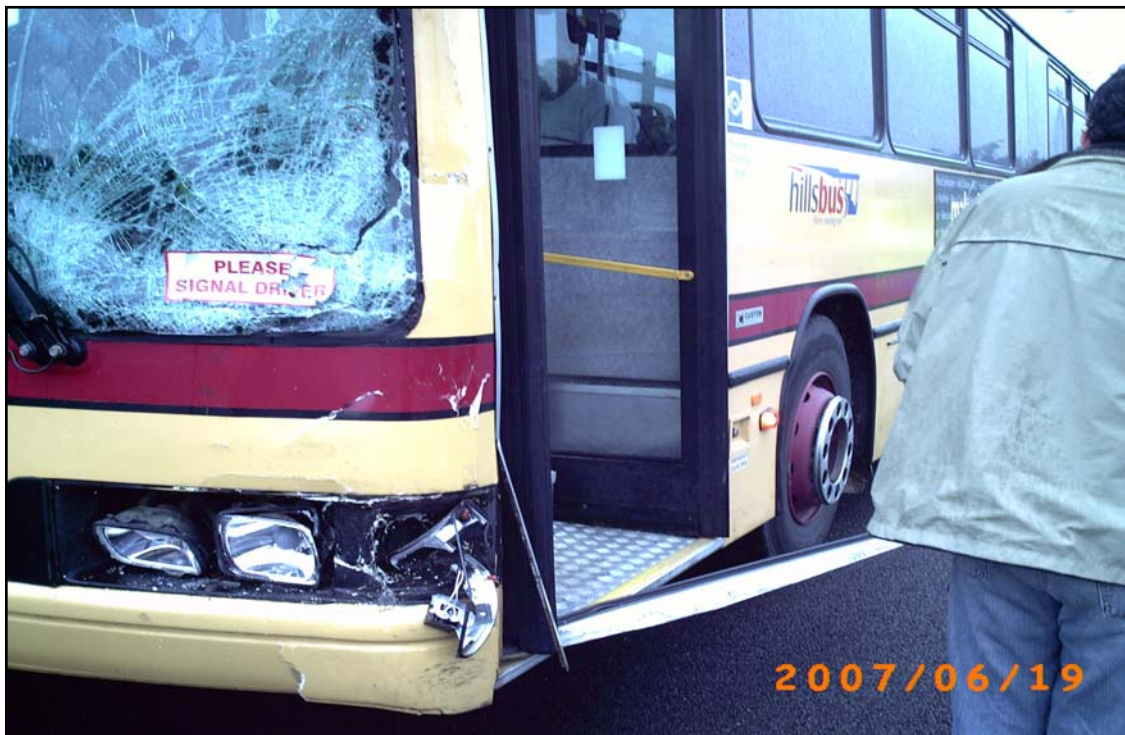
Photo 4: Damage to bus
(Photo courtesy of Hillsbus)

- 1.7 The bus was examined at the scene by the NSW Police soon after the accident and although there were obvious signs of damage because of the accident (refer to *Photo 4*), no mechanical or electrical defects that might have caused, or contributed, to the accident were discovered. A later check of servicing records also indicated that the bus had been serviced at the required intervals.

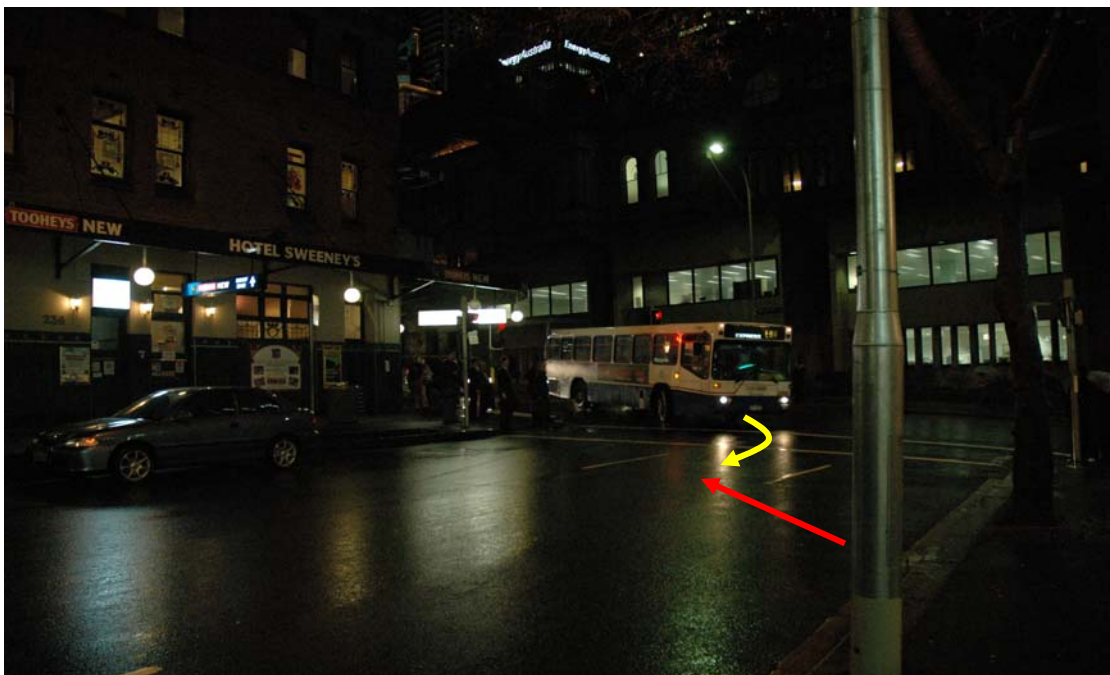
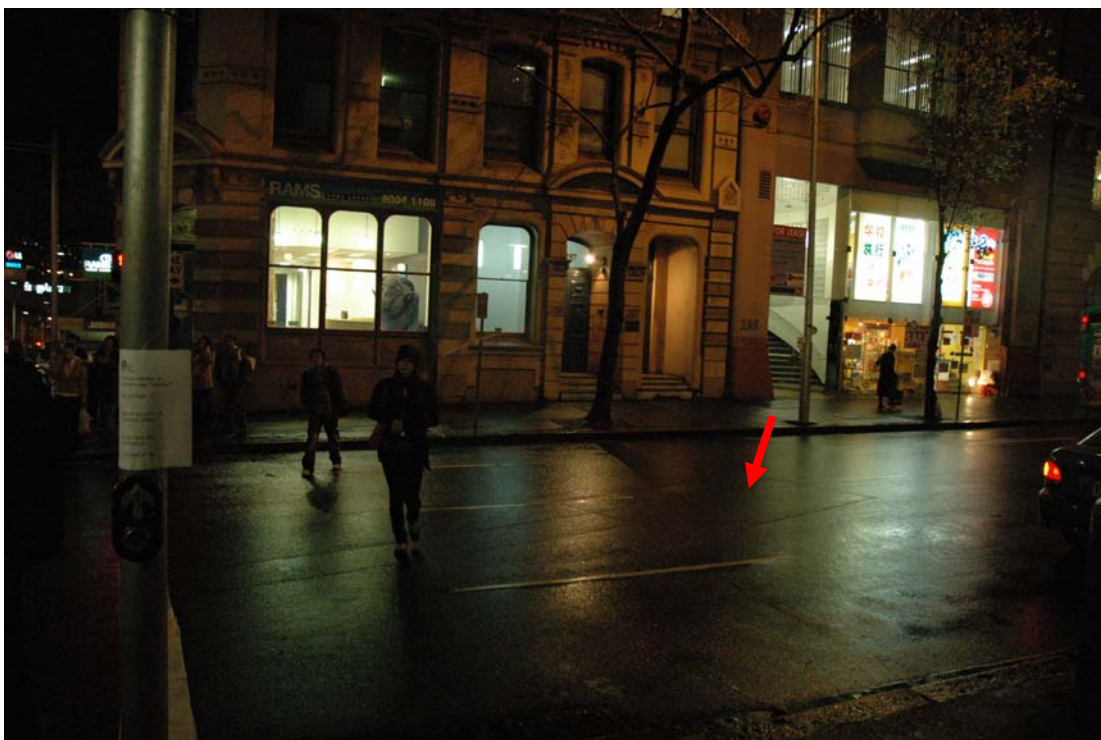
Photo 5: Lighting conditions in Clarence Street

- b. The primary source of lighting in the immediate area is three overhead high pressure sodium lamps positioned on the Southern side of Druitt Street opposite Clarence Street; on the North-Western corner of Druitt and Clarence Street; and on the Western side of Clarence Street, 13m from the intersection, respectively. Ambient light is also enhanced by shops and offices on both sides of Clarence Street. Notwithstanding these sources of illumination, the lighting under wet conditions is quite variable, as can be seen in *Photos 5 and 6*.

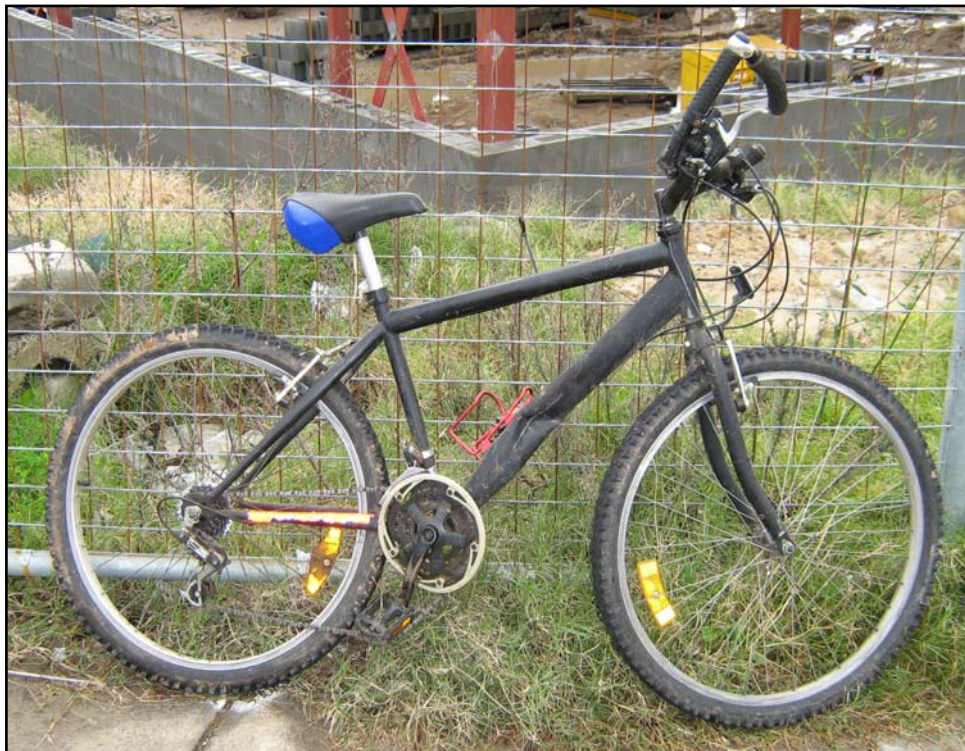
Photo 10: Bicycle involved in collision

- 3.14 Police Crash Investigators examined the bicycle, which is shown in *Photo 10*. The 18-speed/geared 'mountain bike' had front and rear quick-release calliper brakes. The front tyre was found to be in a serviceable condition but the rear tyre was quite worn.

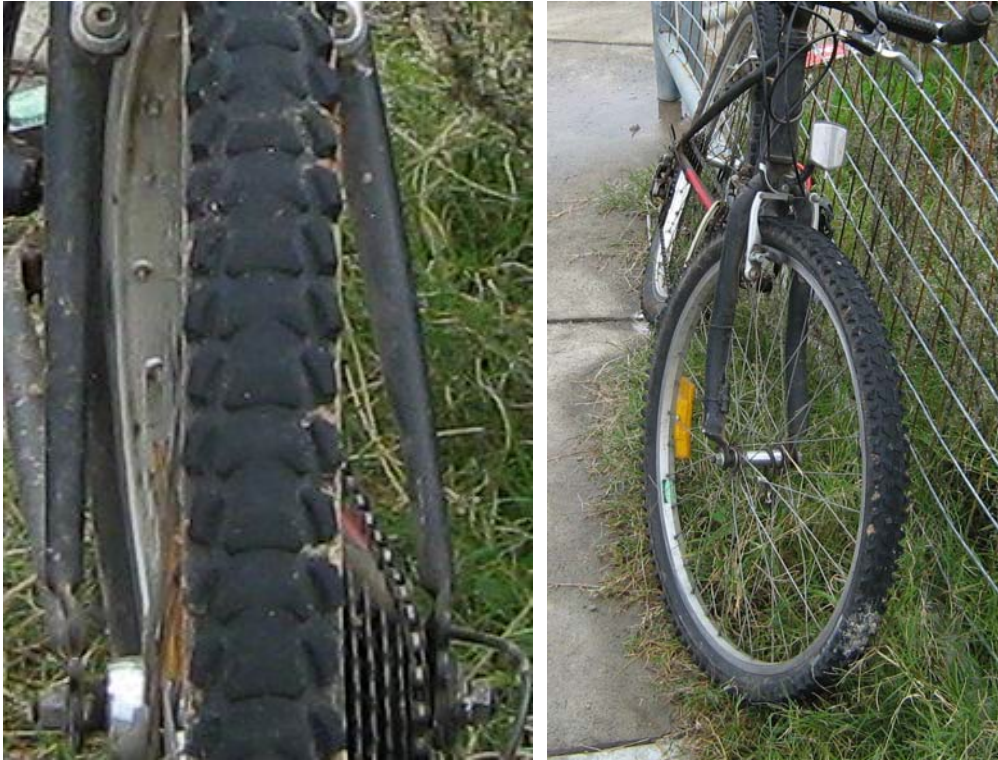
Photo 11: Rear and front tyres, left to right respectively

- i. The bike had a worn rear tyre and effective braking would have been further inhibited by wet wheel rims and brake pads and a wet road surface. These factors would have been further exacerbated by the fact that the cyclist was travelling downhill, with a tailwind.
- ii. In addition to not expecting he would be approached from the wrong direction, the bus driver's visibility of the cyclist was restricted by both moisture on his windscreen and side window, and a blind spot caused by the dimensions and placement of his vehicle's 'A' pillar and the right-hand side mirror. Because he did not see the cyclist, the bus driver was not in a position to take any avoiding action.

(Note the worn tread on the centre of the rear tyre)

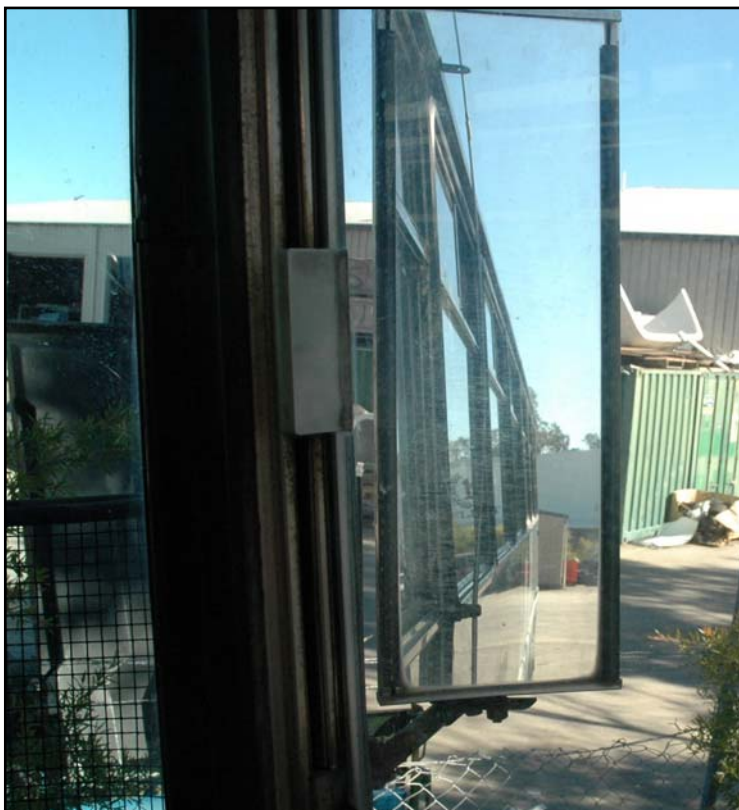
Photo 12: View from driver's side mirror

- a. The driver's side mirror provided a good field of view to the rear but it would not have allowed the bus driver to have detected the cyclist when he was trapped under the rear wheels (see *Photo 12*).
- b. The windscreen wiper and the demister were fully operational.
- c. The windscreen wipers do not clean an area approximately 112mm in width on the driver's side and the view offered by the side mirrors is affected considerably in wet conditions (see *Photo 13*).
- d. The position and dimensions of the 'A' Pillar, in combination with the side mirror, creates a significant 'blind spot' (as can also be seen in *Photo 13*).

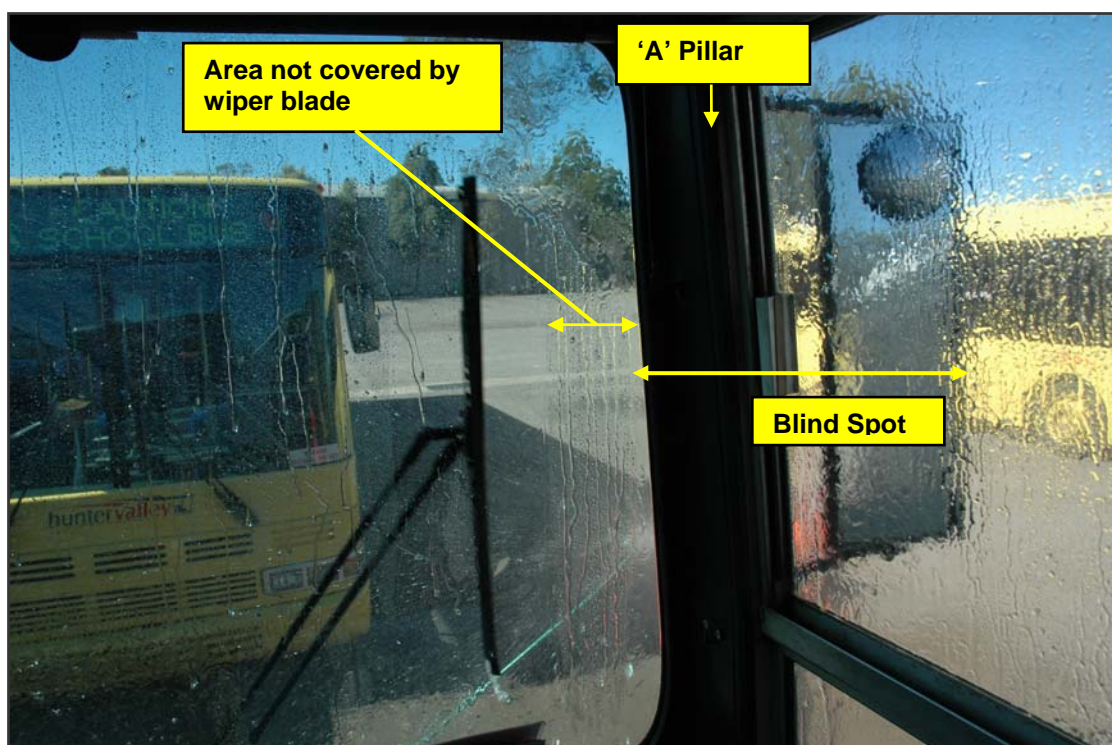
Photo 13: Effect of water on bus front and side windows

- 3.19 The witness statements indicate that the cyclist, in effect, cut across the path of the bus, but the bus driver insists that he did not see the cyclist do so. The bus driver described being on schedule, travelling South along Hillview Street and stopping at its intersection with Arthur Street. He noted that at the time it was raining and that he had both his wipers and demister on, although his view in the side mirrors and out of his side windows was affected to a degree by misting and the rain.

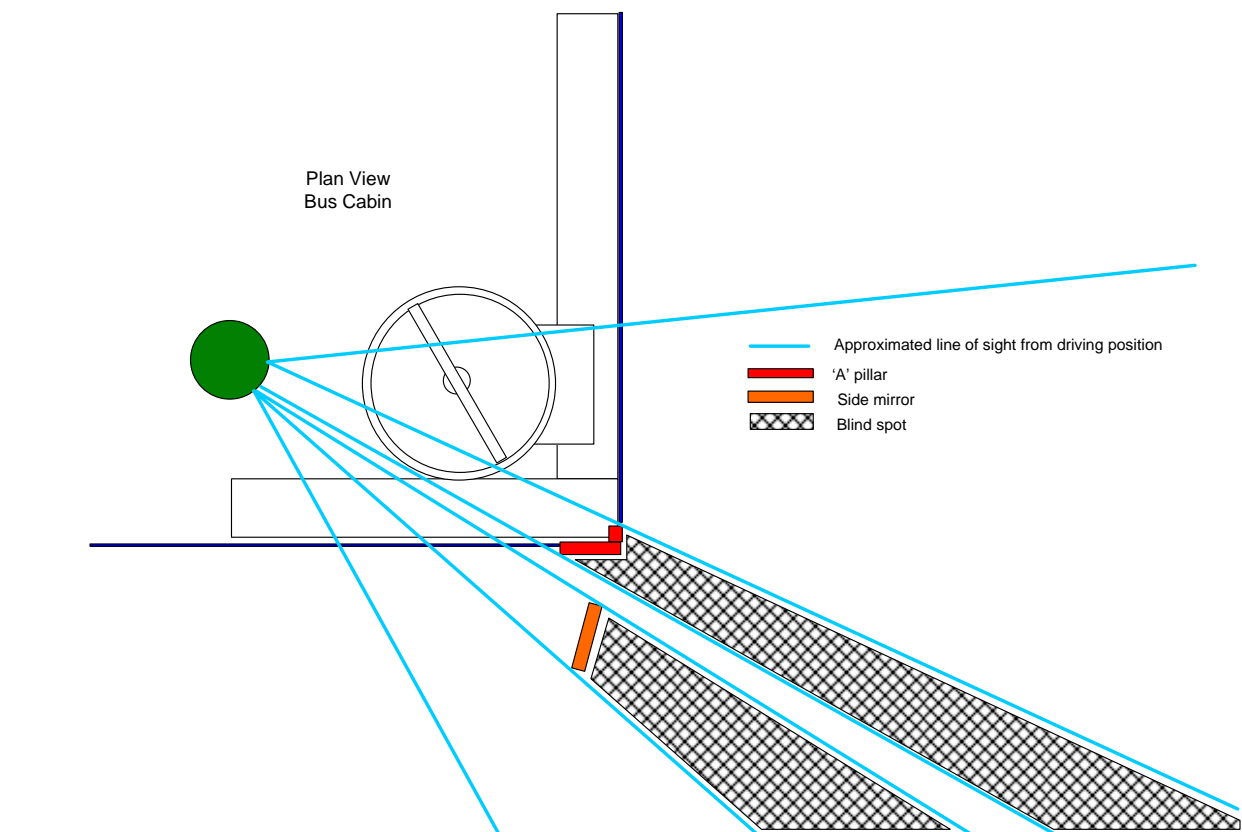
Diagram 5: Depiction of Bus Blind Spot

3.25 OTSI conducted a series of measurements to determine the extent of the blind spot caused by the 'A' pillar and the driver's side mirror and the results are depicted in *Diagram 5*. *Diagram 5* shows that the 'A' pillar and side mirror do impact on a driver's forward visibility. This is not uncommon and drivers can compensate for this to an extent by shifting their position to, in effect, look around the pillar. *Photographs 14* and *15* show the extent of the blind spots projected over distance. The person in *Photograph 14* was visible at 18m, from the left of the 'A' pillar, but was lost from view when he continued to move and did not reappear until 6.5m later. *Photograph 15* shows the same person at a distance of 12.5m after which he disappeared for 3.5m behind the side mirror.

3.26 Based on its measurements, OTSI concluded that the bus did have a blind spot and, in combination with the wet weather and the limitations of the wiper blade's coverage, this might explain why the driver did not see the cyclist until after the collision.

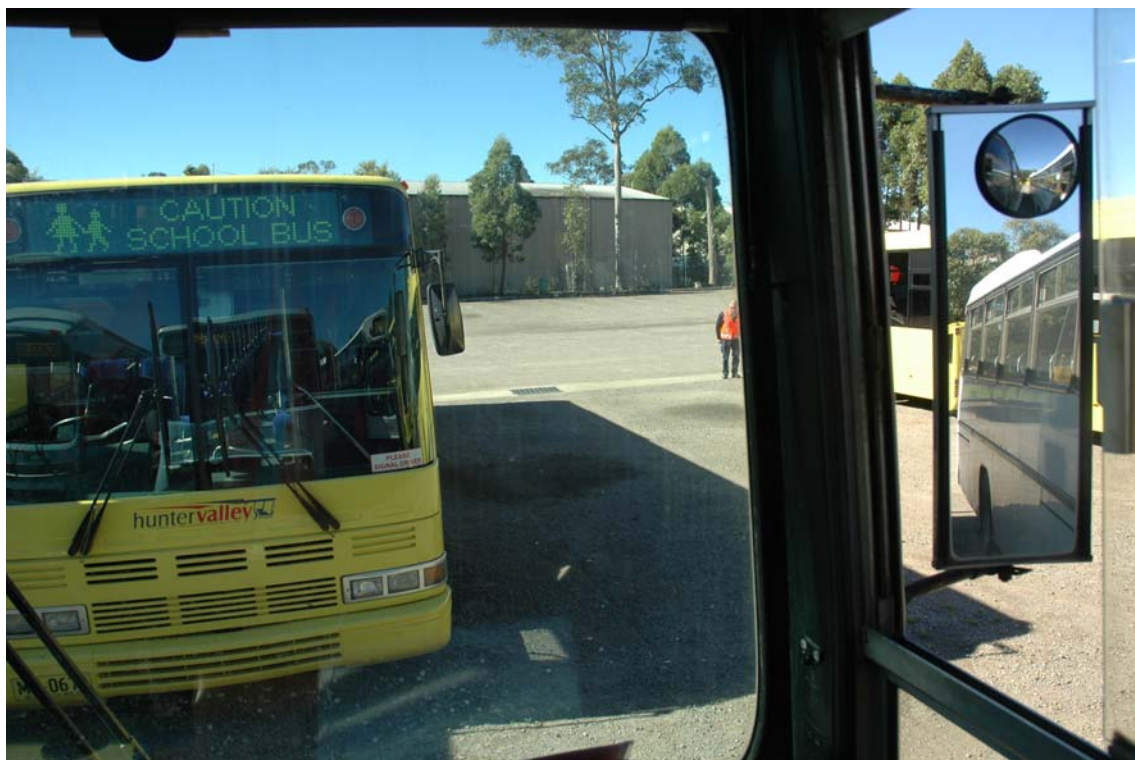
Photo 14: Pedestrian visible at 18m from bus, disappearing behind 'A' pillar for 6.5m

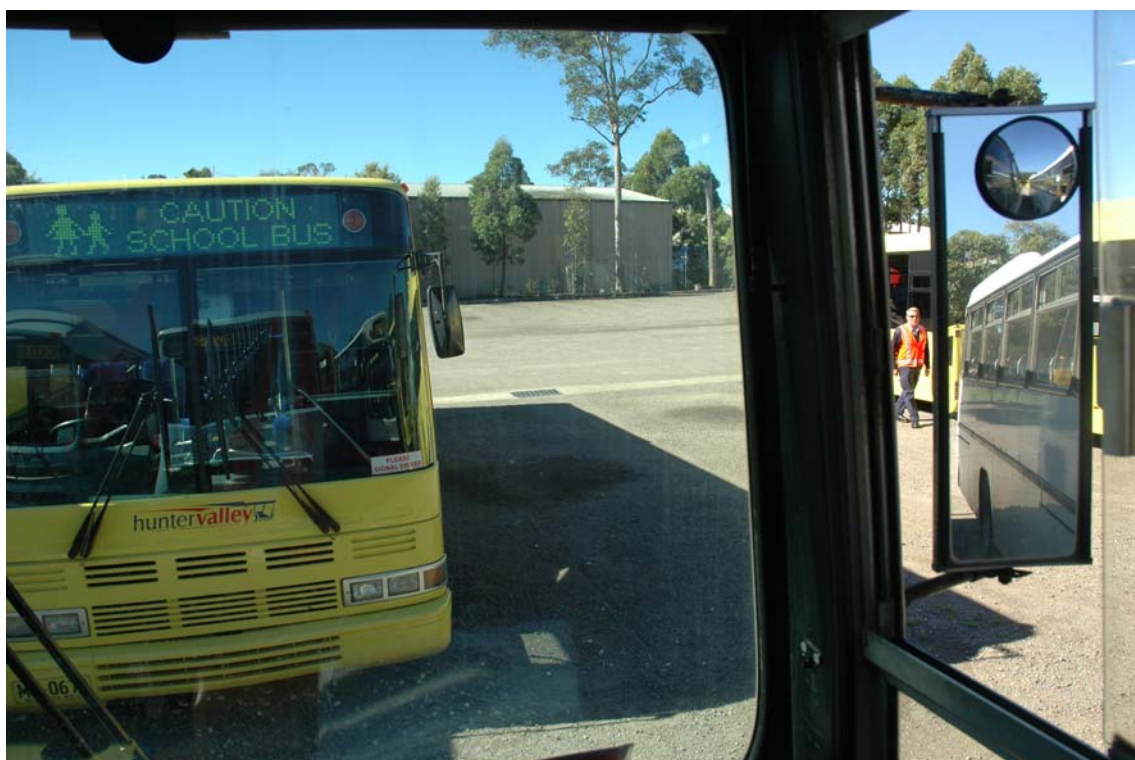
Photo 15: Pedestrian re-appearing from behind 'A' pillar to disappear again for 3.5m, behind the mirror, as he walks towards the bus

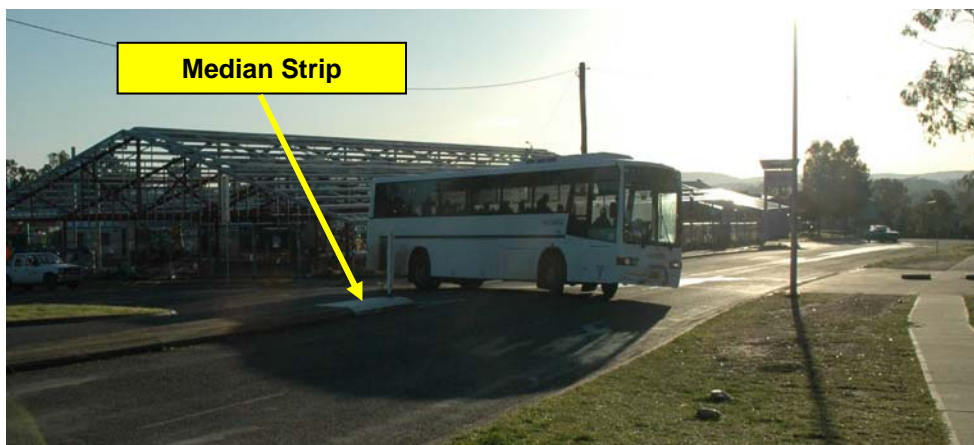
Photo 16: Bus turning from Hillview Street into Arthur Street

3.29 OTSI noted that in order to turn right into Arthur Street from Hillview Street, bus drivers are required to take quite a wide approach because of the extent of the median strip which means that as they proceed through the intersection, they initially enter Arthur Street's kerbside lane which is designated only for the use of vehicles intending to turn left to get onto the New England Highway. Unless the intention is to proceed onto the New England Highway, and the driver of the bus involved in the accident did not, drivers must then move back into the centre lane. The extent to which bus drivers have to 'swing' in order to avoid the median strip is depicted in *Photo 16*. As it happens, the effect of the median strip on bus manoeuvrability resulted from a decision by Maitland Council to extend the median strip in order to prevent semi-trailers from a nearby construction site turning right into Arthur Street.

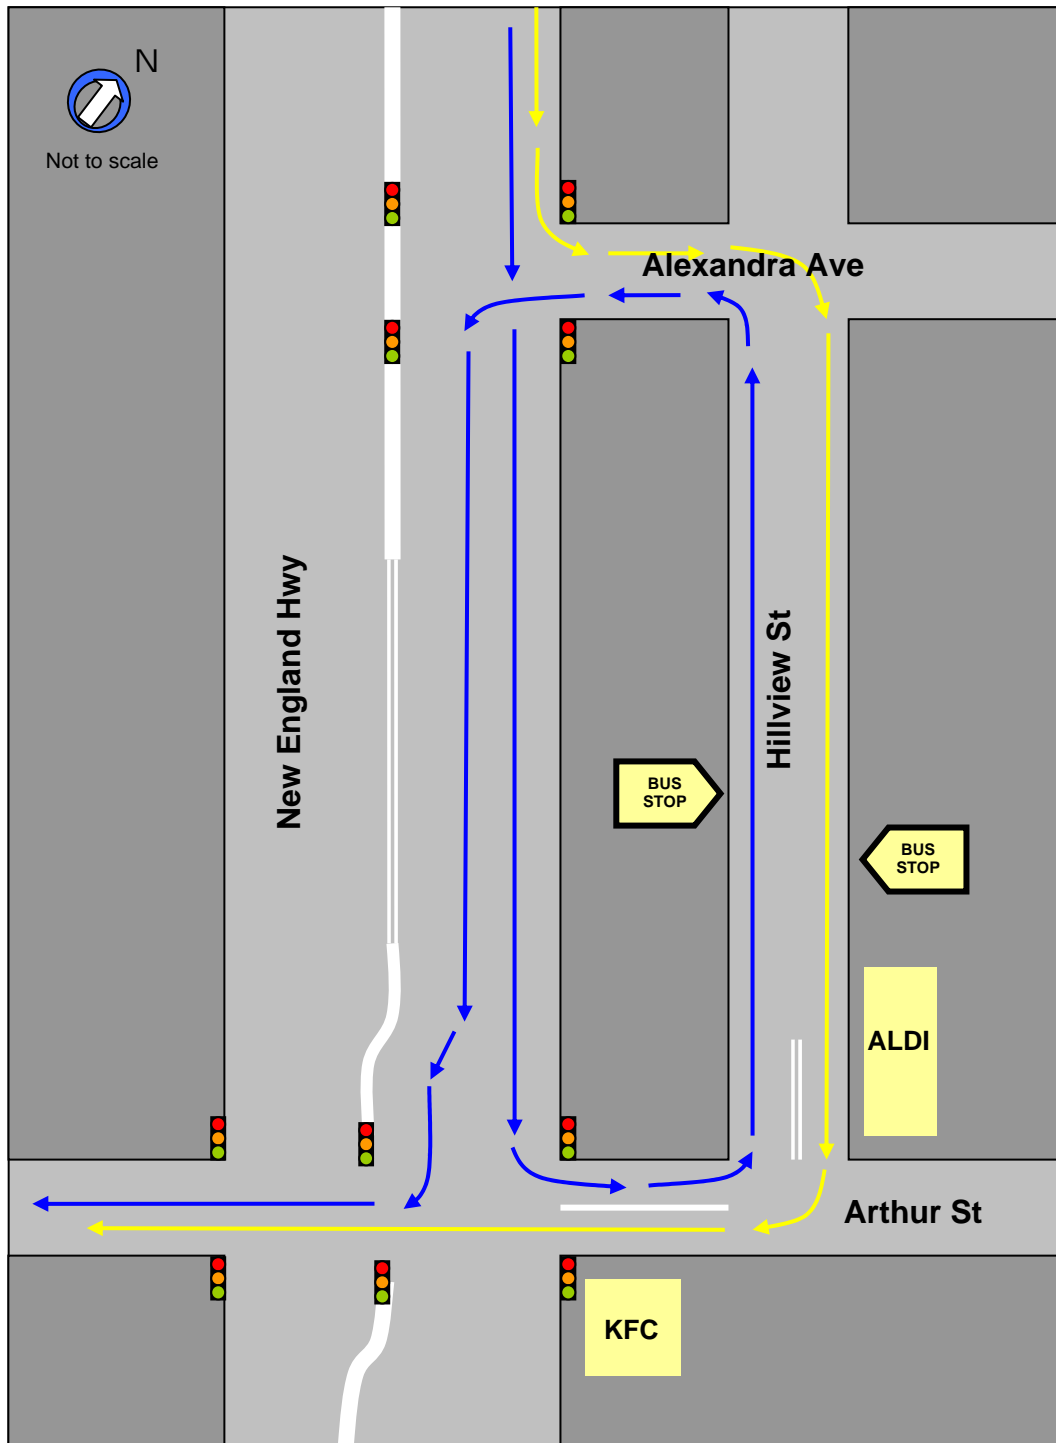
Diagram 6: Existing route and possible alternate route, in yellow and blue respectively

- 3.30 Maitland Council advised OTSI that it is considering changing the traffic arrangements in this area to accommodate its commercial re-development and that under the arrangements being considered, buses would no longer travel South in Hillview Street and be permitted to turn right into Arthur Street.

Instead, buses would enter Arthur Street by turning left from the New England Highway into Hillview Street, then travel North, stopping at a bus interchange. Thereafter, they would turn left at Alexandra Avenue and re-enter the New England Highway. These arrangements would require the installation of several sets of traffic lights but would mean that buses would no longer be required to make the difficult right turn from Hillview into Arthur Street and then to immediately move across into the centre lane. A comparison of the existing route and that which is being considered is provided in *Diagram 6*.
