BUS SAFETY INVESTIGATION REPORT

UNSECURED BUS FLOOR HATCH

CASTLE HILL

19 MARCH 2010

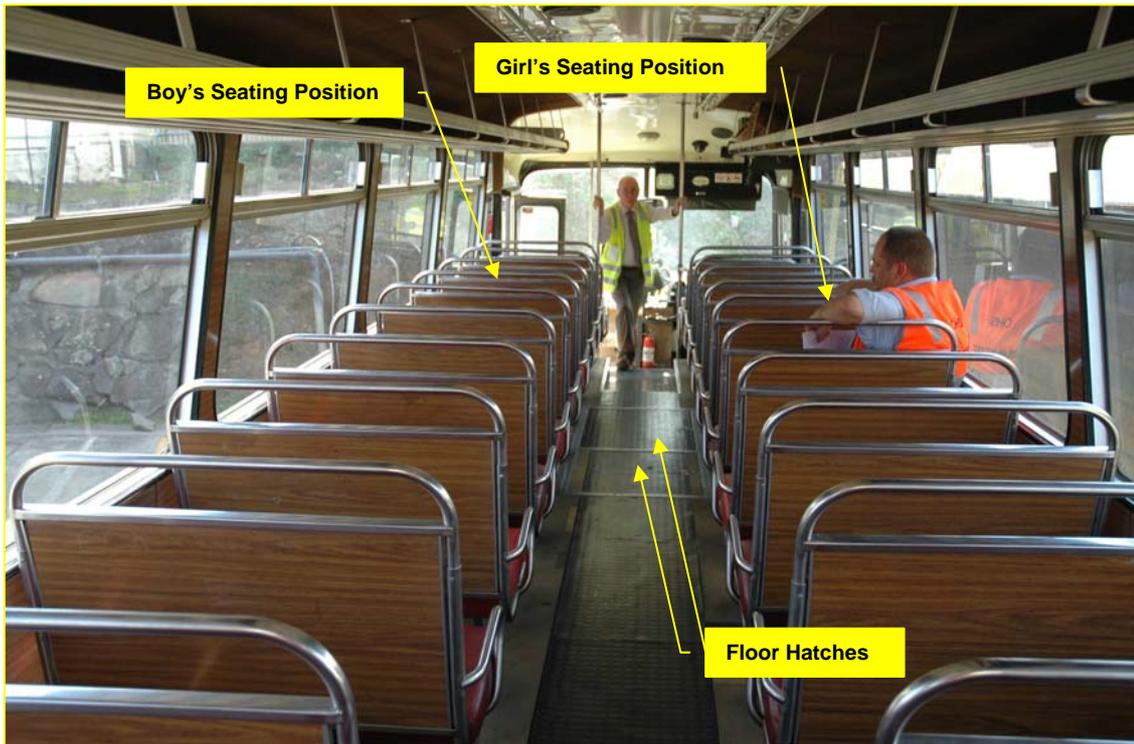
- 1.8 The first of the children to board the bus was a nine year old boy who went to a seat at the sixth row from the front on the left (nearside) of the bus. He was followed by a ten year old girl who proceeded up the aisle with the intention of sitting in the seventh row on the right hand side of the bus (see *Photograph 1*). In the process, and as the bus moved off, she placed her foot on the rear edge of a floor hatch which immediately tilted downwards tipping her feet-first partially into the space below the floor. She instinctively reached out and was able to grab hold of the rail on a seat which prevented her from falling completely through the floor. She recalled seeing the road and a "*spinning thing*" (i.e., the bus tail shaft).²

Photograph 1: Floor hatches and seating positions

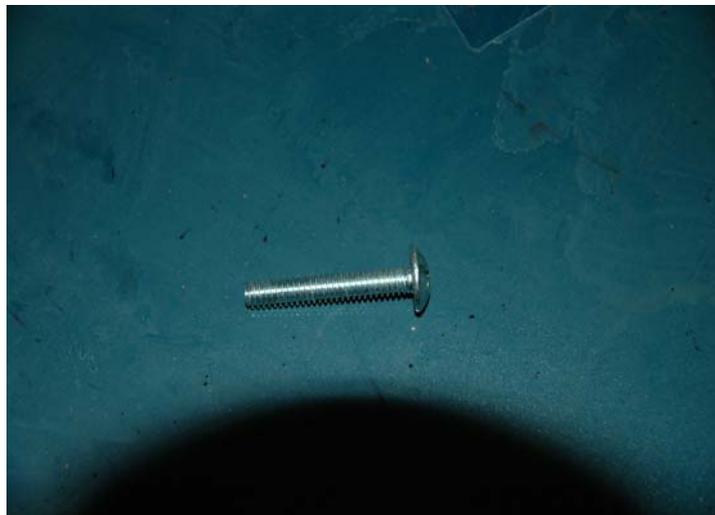
1.12 The bus, a 1986 model Volvo, registration MO 7511, has two floor hatches in the centre aisle in the forward section of the bus: a forward hatch over the engine and a hatch to its rear over the transmission. The forward hatch was firmly secured in its mounting frame in the floor with four self-tapping dome head bolts 45mm long by 6mm diameter thread (see *Photograph 2*). The rear hatch was unsecured and no bolts were found inside the bus, indicating that they had been removed prior to commencement of the bus services on 19 March 2010.

Photograph 2: Self-tapping dome head bolt used to secure hatches

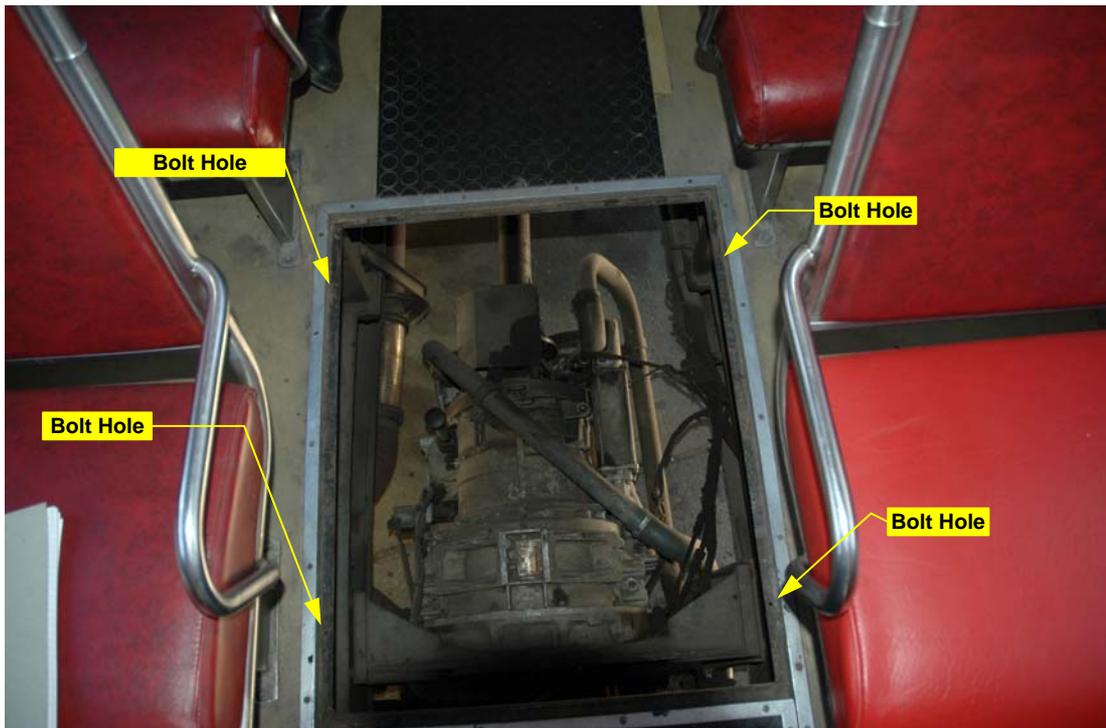
1.13 The hatch which measures 84cm by 66cm sits directly above the bus transmission. The gap between the floor level of the bus and the top of the transmission is 65cm at the forward end (see *Photograph 3*). The chassis runs parallel to the transmission and tail shaft on either side. Given the dimensions of the hatch (width, length and height above the transmission), in an open condition, it would allow a small adult or child to fall through onto the transmission and possibly then down either side of the transmission to the roadway. If the bus was moving when this occurred, it is highly likely that the person would be run over by the rear wheels of the bus.

Photograph 3: Transmission below floor hatch

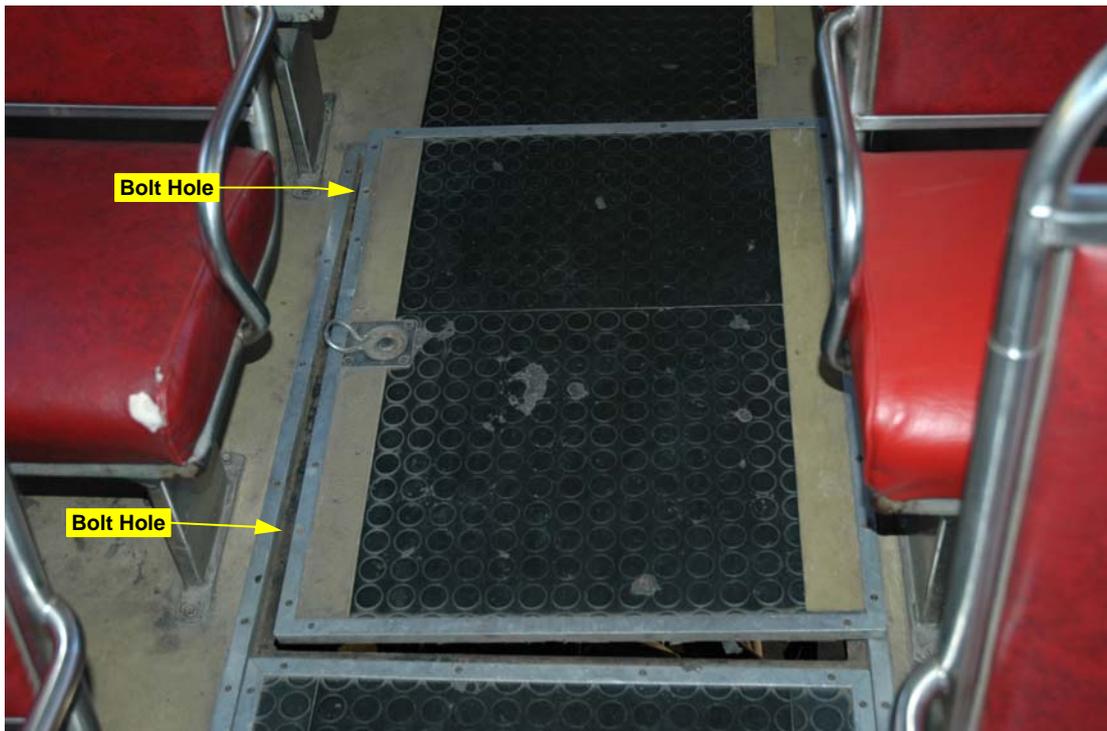
- 1.14 The driver's description of the morning run does not reveal anything that could explain how the hatch came to be unseated out of the recessed mounting on the floor (see *Photograph 4*). He claims not to have driven over any potholes or gutters prior to the incident. If the hatch was dislodged during its first morning run, it is reasonable to expect it would have been noticed to be out of position when the bus was being swept after its run from Highs Road to the Macquarie Shopping Centre.
- 1.15 Although not mentioned in his initial reports to either Hillsbus or the OTSI Investigator, the driver subsequently advised that he had visually inspected the floor while waiting at Richard Webb Reserve immediately before commencing the second run and believed the hatch to have been in position. He could not offer any explanation as to how it might have subsequently become dislodged.

Photograph 4: Floor hatch shown in a displaced position

2.1 The school girl fell through the floor of the bus immediately above the transmission because the hatch was not secured and had dislodged from the hatch frame to the extent that it was unstable when trodden on at its edge.

2.2 It is most likely the four bolts needed to secure the hatch were inadvertently not fitted when the hatch was placed back in position after having been removed as part of a transmission change. When the hatch was removed, the bolts were placed on one of the seats but were not prevented by any means from falling between the seat and back rest. At some time over the three days the maintenance work was ongoing, it is likely that the bolts fell onto the floor and through the open hatch.

3.4 Include the visual checking of floor hatches on all buses as part of the driver's daily check.
