Office of Transport Safety Investigations

TECHNICAL INSPECTION FINDINGS

FIRES INVOLVING LINQ BUSLINES COACH 4244 MO

10 SEPTEMBER 2013 and 10 NOVEMBER 2013

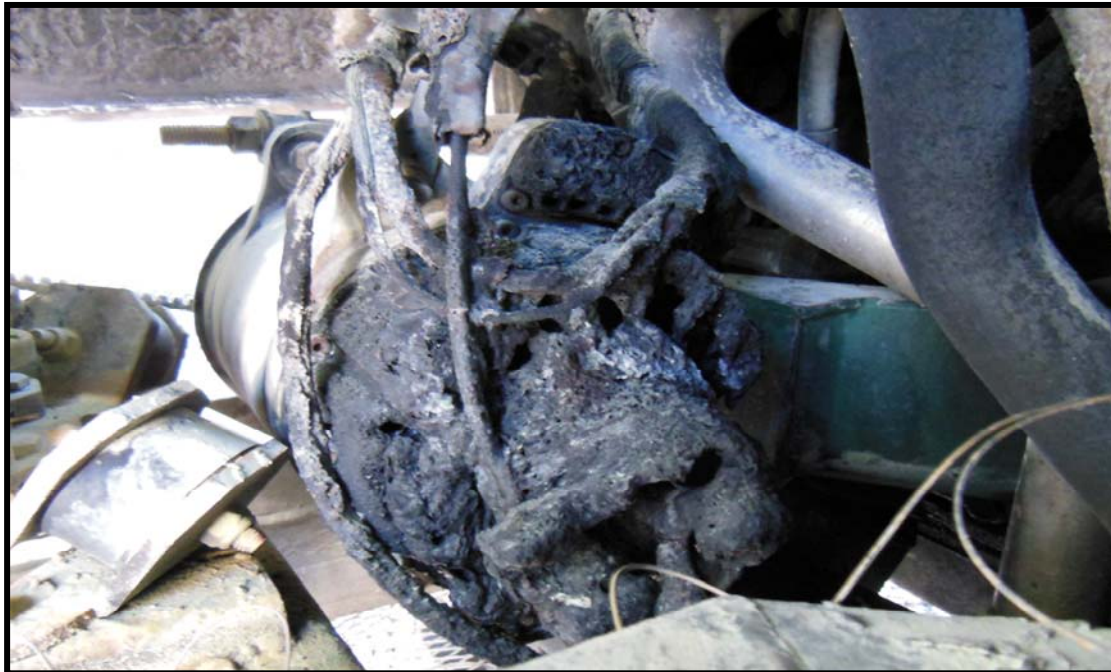
Photograph 2: Alternator damage

The coach was towed to a holding yard at Sandgate, an outer western suburb of Newcastle, where it was inspected by OTSI investigators on 12 September 2013. The cause of the fire was determined to be a short circuit at the rear of the alternator. The fire impacted on the engine components in the vicinity of the alternator but damage was restricted to the engine bay area and was repairable. The fire did not enter the interior of the coach.

The examination of all diesel injector fuel lines, turbocharger and coolant lines indicated that the fire had not originated from any of these sources. An examination of the alternator revealed that the fire had originated from a short circuit at the back of the alternator, initially melting the rear of the housing and wiring insulation in the vicinity (see *Photographs 2 and 3*).

The first fire in Linq Buslines coach 4244 MO on 10 September 2013 was caused by electrical short circuiting of the alternator wiring. The resultant fire destroyed the alternator and damaged nearby components within the engine bay.

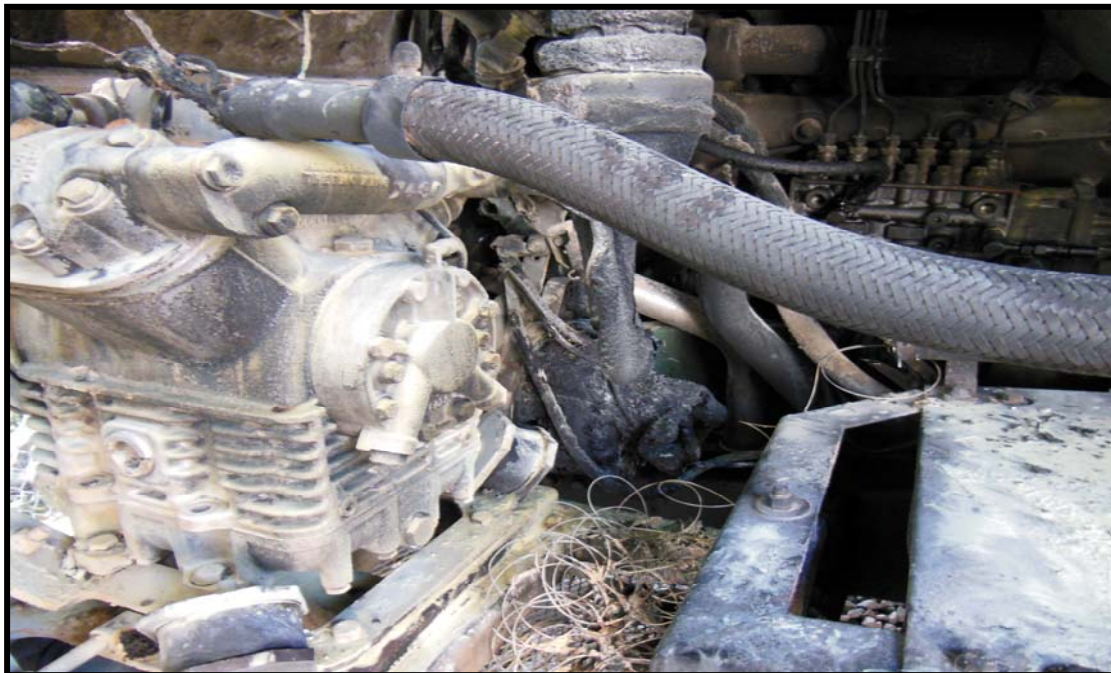
Photograph 3: Damage from the 10 September 2013 fire

The damage to the coach was confined to the area surrounding the alternator which included the following:

- alternator and associated wiring
- all engine drive belts
- coolant tank including hoses
- engine wiring harnesses
- sender wiring
- power steering hoses for reservoir and steering supply
- toilet drop pipe
- dipstick and dipstick tube assembly
- rear side engine bay door and skins
- rear bumper bar.

The last repairs to be finalised before the coach was returned to service on 7 November 2013 were to the air conditioning which had to be re-wired due to the extent of fire damage to the wiring looms.

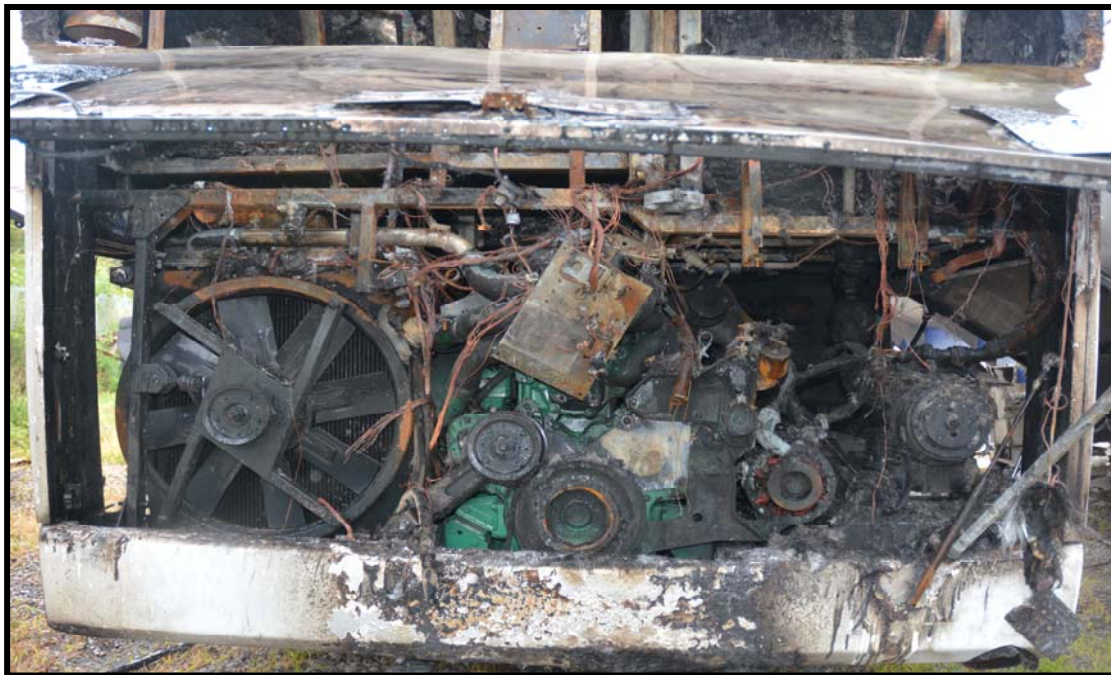
Photograph 4: Engine bay damage from the 10 November 2013 fire

The engine was intact. Its surfaces were clean and the paint work in good condition which indicated the source of the fire was not associated with the engine or its operation. The only damage was minor secondary damage from the melting of plastic covered wiring and fittings located above the engine block. This was in close proximity to the position of the rear electrical centre which had melted onto the top of the engine block (see *Photograph 4*). There was no damage to the automatic transmission gear housing or any of its supply lines and controls.

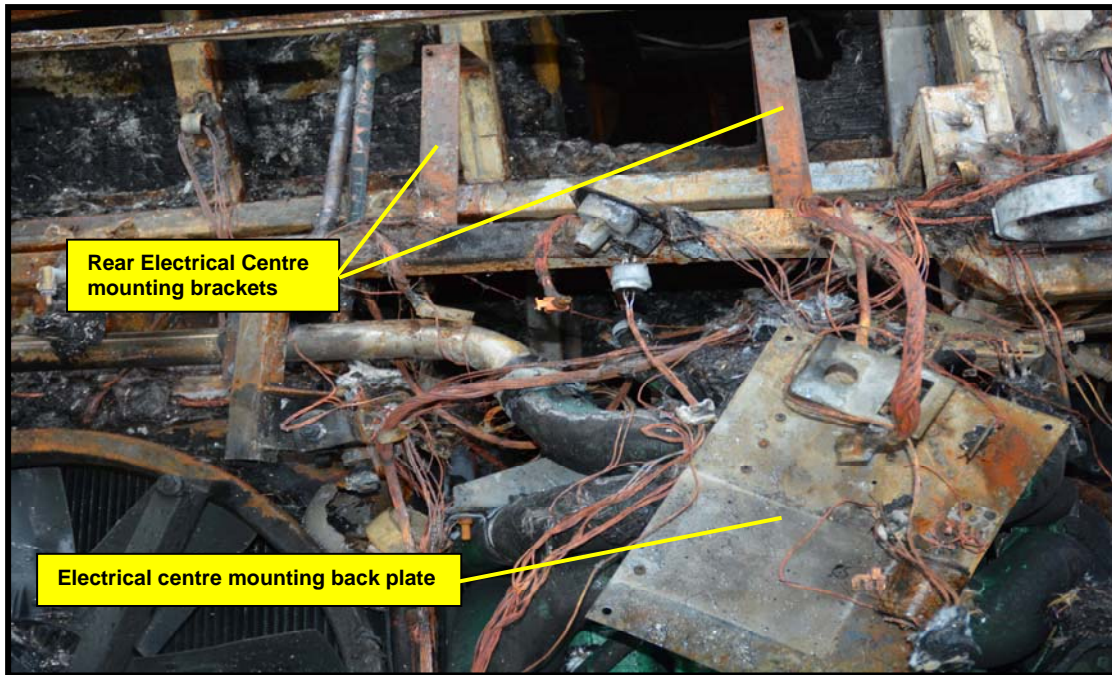
Photograph 6: Rear electrical centre

Within the engine compartment, the outer plastic covering of the rear electrical centre had completely burnt away destroying the circuit board. All wiring looms from the electrical centre to the alternator, air conditioning, engine sensors and rear lighting were destroyed. The intensity of the fire had caused the metal mounting back plate to come off its metal brackets (see *Photograph 6*).

The fire pattern and damage around the rear electrical centre indicated that the fire had commenced at this unit with the plastic/Perspex housing and cover being totally consumed. Damage radiated out from the electrical centre to other parts of the engine bay and into the interior of the coach.

The fire which severely damaged the coach on 10 November 2013 originated in the rear electrical centre mounted within the engine bay and was the result of electrical short circuiting or arcing. The exact point and cause of the short circuiting could not be accurately determined due to the extent of the damage to the electrical system. The most probable cause was a loose connection or shorting within the centre or a short circuit in wiring associated with installing the replacement air conditioning unit.

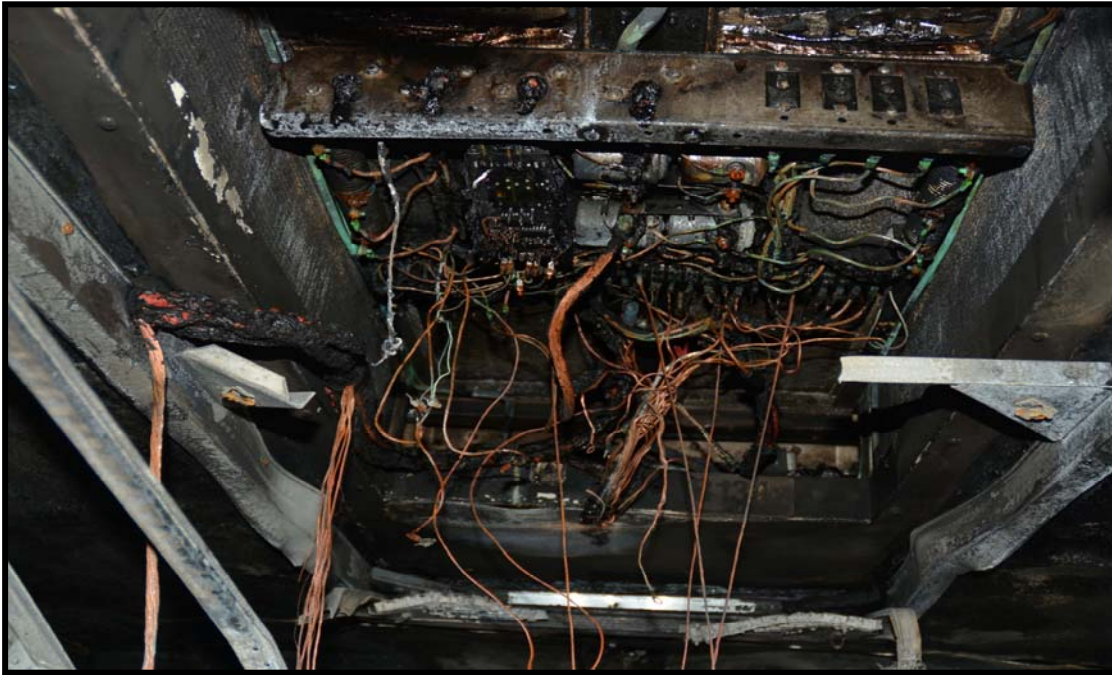
Photograph 7: Air conditioning unit damage

The roof mounted air conditioning unit was destroyed as a result of the intensity of the heat generated by the fire (see *Photograph 7*). The plastic housing module melted and all wiring and connections were destroyed, making it impossible to accurately identify evidence of shorting or loose connections. If there had been a short circuit in the wiring or a loose terminal connection in the air conditioning wiring circuit, it would probably have resulted in shorting back in the rear control centre. Although this could not be verified as having occurred, it is considered the most probable cause of the fire.

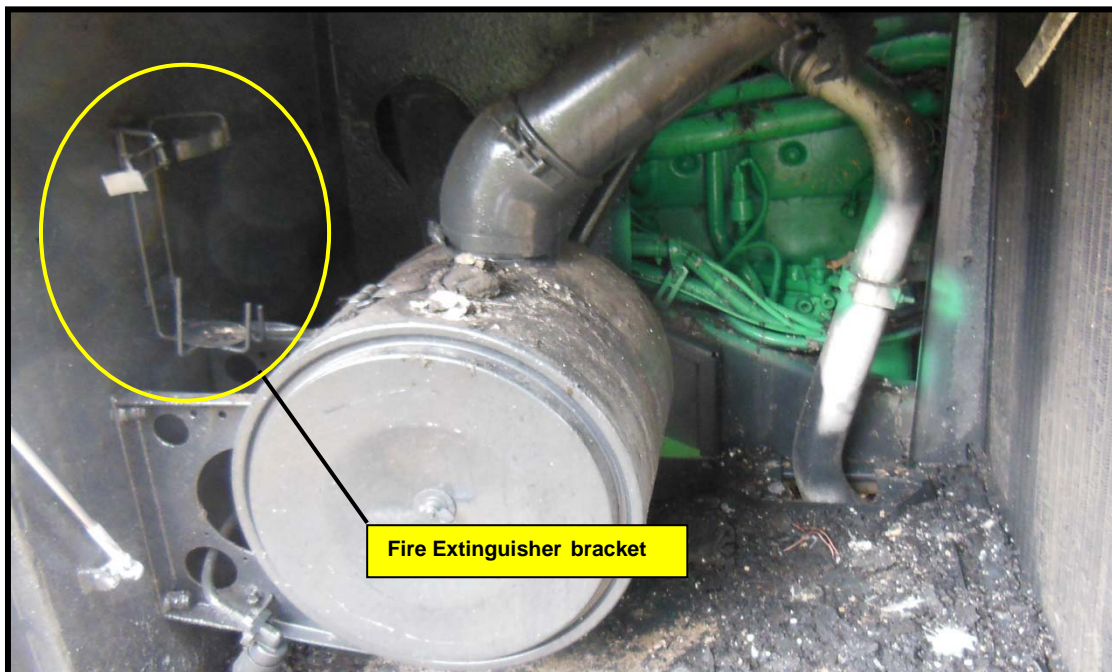
Photograph 8: Location of rear fire extinguisher

In the second fire incident, after evacuating the passengers and calling '000', the driver went to the rear nearside of the coach and opened the engine bay hatch to retrieve the extinguisher, only to find that it was missing (see *Photograph 8*). On completion of mechanical repairs following the first fire, the coach had been refitted with two new extinguishers in the provided locations. The rear fire extinguisher was subsequently removed and not refitted, and not found to be missing before the vehicle went back into service.

As a result of OTSI's bus fire investigation experience, it considers locating fire extinguishers in the engine bay not to be good practice. A report on bus fires in NSW from 2005 to 2012 identified:

In several incidents examined, the rear-mounted extinguishers on coaches could not be accessed due to a combination of their proximity to and the intensity of the fire. Additionally, they are not necessarily stored in the same location on all vehicles and there is no requirement for their location to be clearly indicated from the outside of the vehicle.²

- As a matter of policy, the driver sign-on sheet will require the driver to ensure all safety equipment is onboard at the commencement of shift. The same will be required of workshop staff on returning vehicles to service.

- An audit of the fleets found the location of fire extinguishers to be a major issue despite their complying with regulations. In addition to being placed in the engine bay, some extinguishers were on the off side of the vehicle placing the driver in additional potential danger from passing traffic. Further, some vehicles had 'budget locks' fitted to the access panels. Both companies are in the process of relocating extinguishers to the nearside of vehicles or rear engine access bay compliant with regulations and fitting an additional 4.5kg extinguisher to the luggage bin area of all vehicles undertaking long trips.

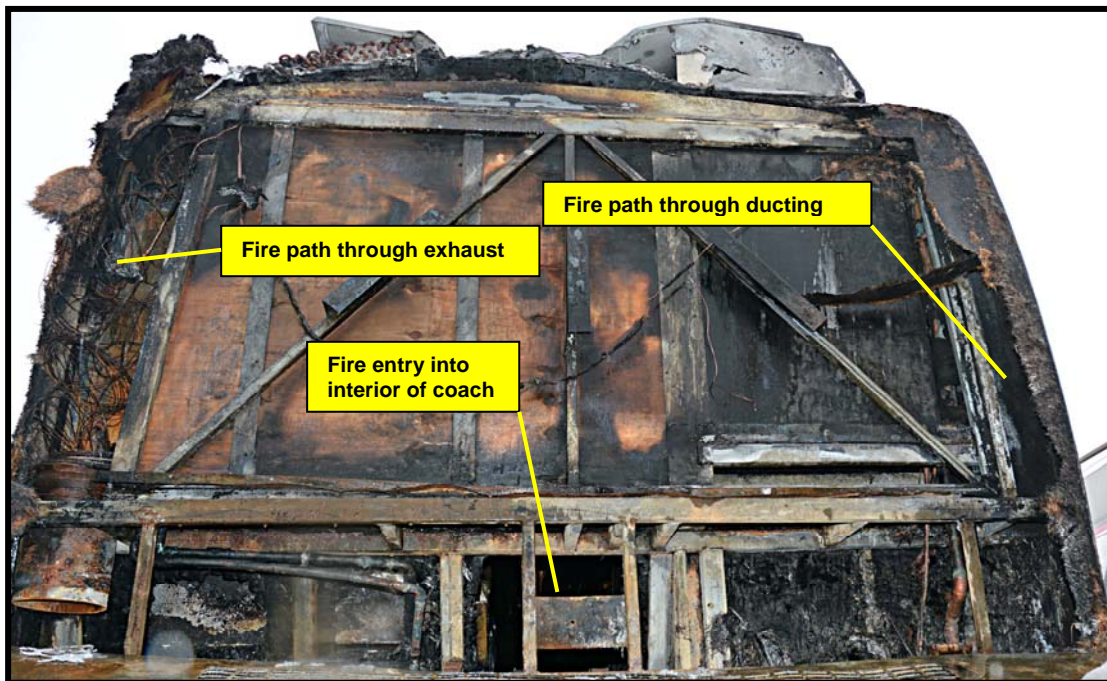
Photograph 9: Path of fire into interior and roof of the coach

Having started in the rear electrical centre, the fire progressed upwards to the plywood bulkhead separating the interior of the coach from the engine bay. It also spread to both sides of the engine bay from where it could vent to the atmosphere above the roof line through ducting housing the exhaust stack on the nearside and electrical conduit and pipes for the air conditioning on the off side (see *Photograph 9*).

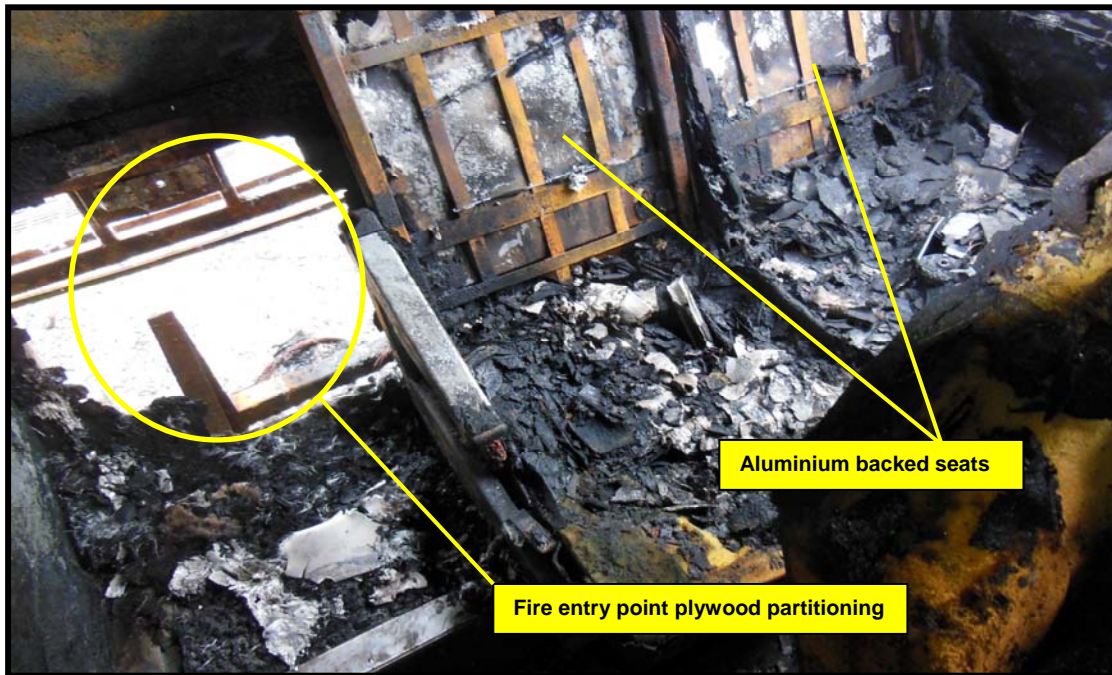
Photograph 10: Rear seating and fire penetration into the interior

As can be seen from *Photograph 10*, to penetrate the coach interior, the fire had breached the plywood bulkhead above the rear electrical centre. This was in line with the aisle which, at the rear of the passenger compartment, was between the twin rear seats on the nearside and the toilet on the off side. The seats were backed with aluminium and the toilet walls incorporated aluminium shielding. In contrast, there was no shielding to the bulkhead in line with the aisle.

The PVC drop pipe (waste outlet) into the engine bay from the toilet had melted but fire had not penetrated through the floor fitting. However, there was considerable smoke and plastic residue damage in the toilet, and the aluminium from the wall closest to the aisle had melted.

The fire entered the interior of the bus through the unshielded plywood bulkhead above the engine bay and once inside rapidly spread through the interior, consuming the air conditioning unit, rear seating and other interior fittings.

- Linq Buslines intends pursuing with manufacturers the matters of:
 - improved fire retardant materials in the engine bay as well as sealing all open spaces to the rear header area

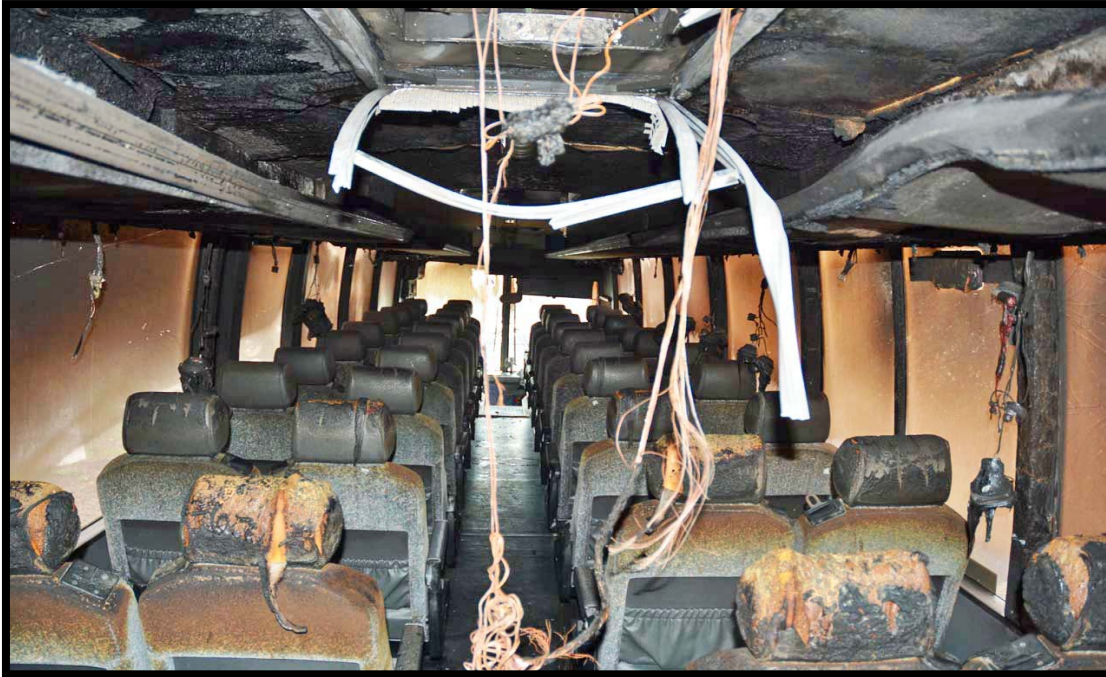
Photograph 11: Interior damage

The path and progress of heat and fire through the passenger compartment could be seen from the fire and damage pattern on the lining of the ceiling. The lining, consisting of a carpet-like fabric, was burnt in the rear section of the compartment, then scorched along towards the middle section, then only affected by smoke and residue through to the front of the coach. Both the roof-mounted air conditioning unit and the roof escape and ventilation hatch in the middle of the coach were destroyed (see *Photograph 7*).

The path and progress of the fire was also evident from the condition of the head rests and tops of the seats. The damage decreased in severity progressively from the rear of the coach to the front (see *Cover Photograph* and *Photograph 11*). The material used to cover the seats, the same as used for lining the ceiling, displayed good fire resistant properties. Molten plastic light fittings from overhead racks which had melted and fallen onto seats had not ignited the seating material. The material had charred where the fire was most intense, being at the rear seating.

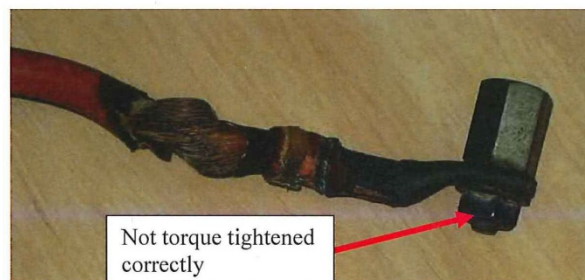
It is extremely important to torque tighten the alternator cable connections correctly!

Below is an example of what can happen when the connection is not tightened correctly.

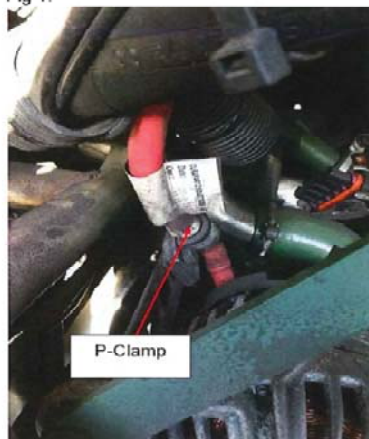
Fig 1.

Should the P-Clamp insulation be compromised or the cable loose, remove the clamp as indicated (Fig.1) and inspect for any signs of chaffing on the battery supply cable and the rubber insulator of the P-Clamp.

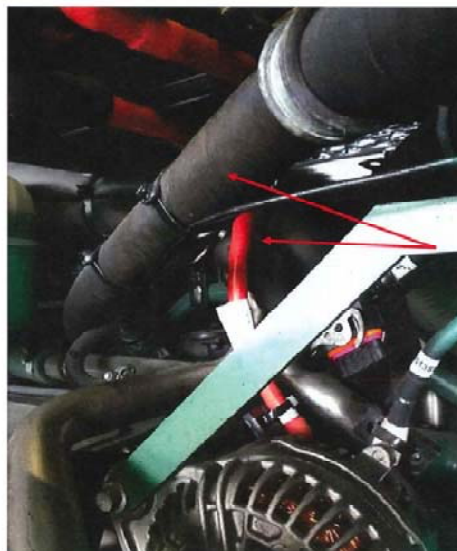
Fig 4. Displays the hoses that are important to inspect during the service routines to ensure the alternator cable does not make contact with adjacent components. Should the cable show signs of contact, the hose/s in question must be moved away from the alternator cable using a cable tie.

The Alternator Cable must not make contact with these hoses. It is important to have 10mm clearance between the Alternator cable and the hoses to prevent chaffing.
