BUS SAFETY INVESTIGATION REPORT

FIRE INVOLVING STA BUS MO 1695

MOSMAN

1 APRIL 2015

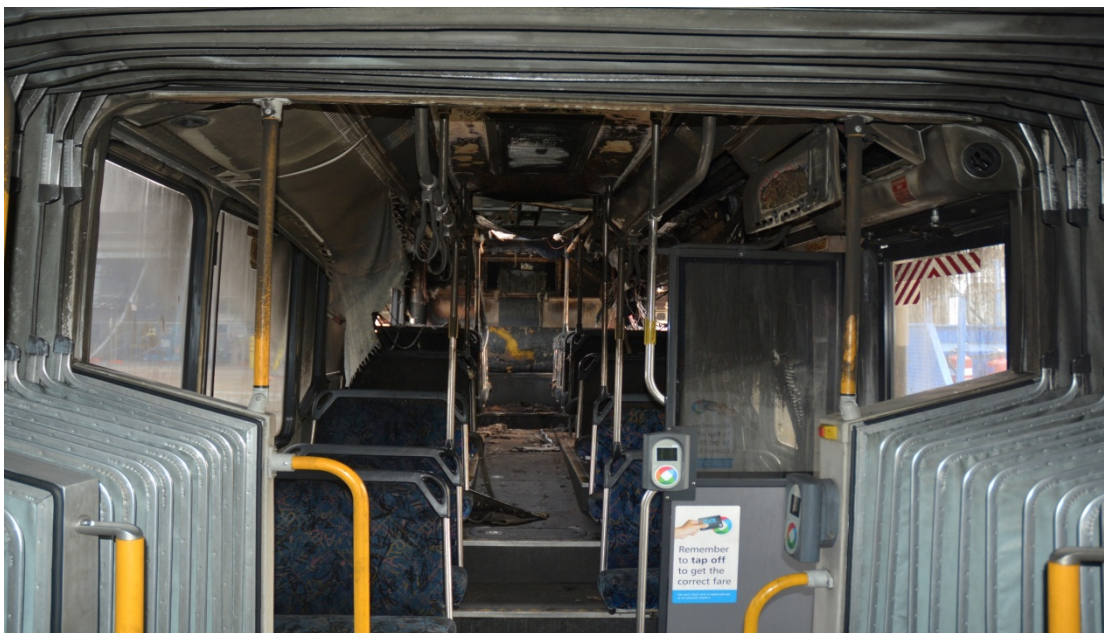
- 1.1 At 15:00 on 1 April 2015 State Transit Authority (STA) articulated Volvo bus MO 1695 experienced a fire which caused extensive damage to the trailer section. The bus with 18 passengers on board was travelling along Spit Road in Mosman en route to the Sydney CBD.
- 1.2 The driver was alerted to the fire by the driver of a following bus. The driver stopped the bus just north of the intersection with Awaba Road, evacuated the passengers, and then attempted to put out the fire with the on board portable fire extinguisher. He was not successful. The fire was eventually extinguished by NSW Fire and Rescue units who attended in response to the driver's radio call to the STA Radio Room. Damage to the trailer section of the articulated bus was extensive (see *Photograph 1*).

Photograph 1: Damage to trailer section

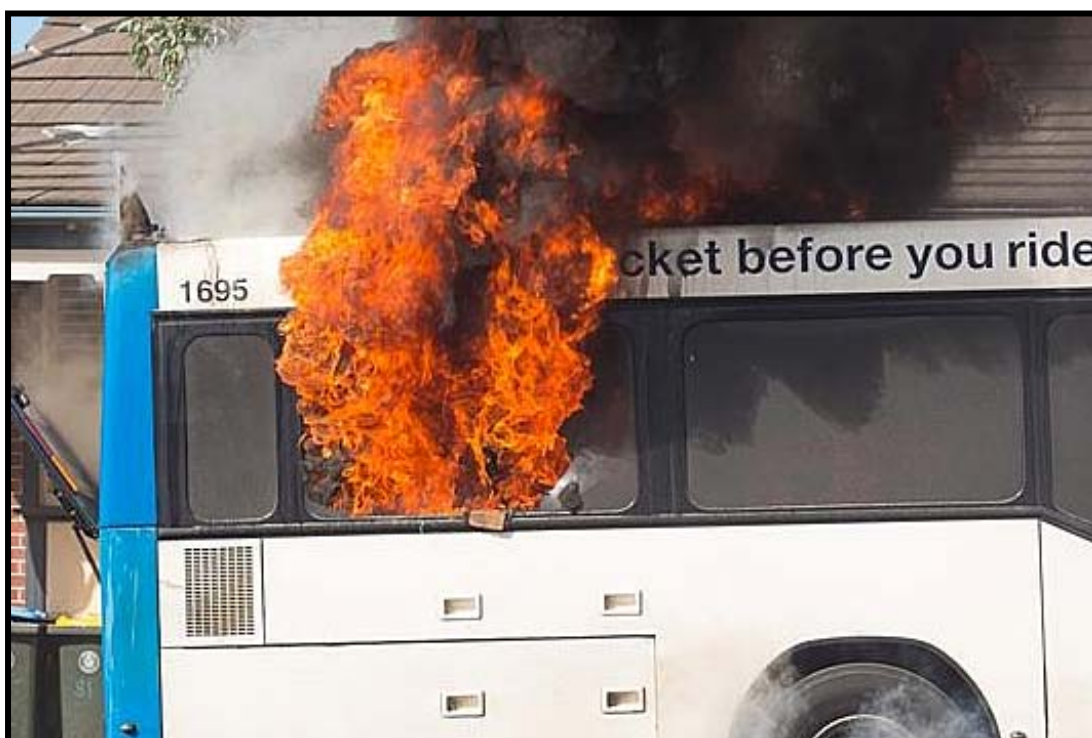
- 1.9 The TMC notified NSW Fire and Rescue who responded quickly and were on the scene seven minutes after the driver had reported the fire. When they arrived the rear trailer section and the roof of the bus were well alight (see *Photograph 2*). However, the fire was quickly extinguished.

Photograph 2: Daily Telegraph Photograph of bus at incident scene

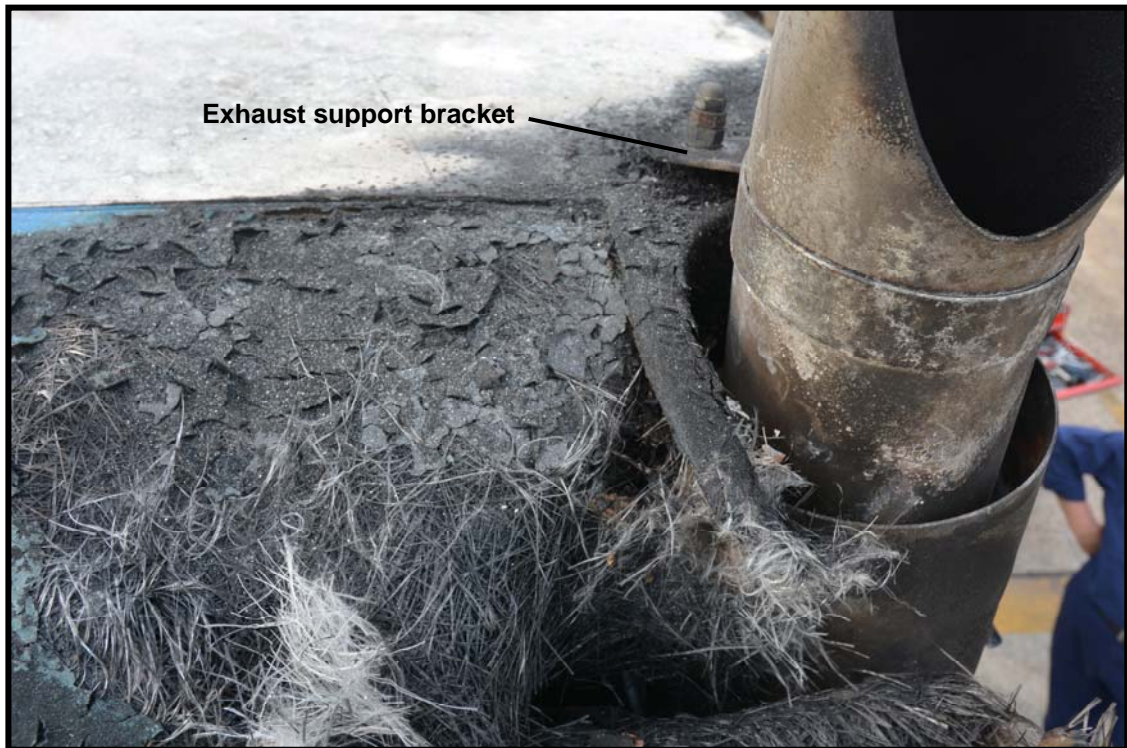
- 2.2 The fibreglass panelling encasing the exhaust pipe was removed. This revealed the initial seat of the fire as having been in the top of the exhaust pipe where it exited from the roof exterior canopy. The fibreglass roof in this area had ignited and the heat had distorted the stainless steel bracket supporting the exhaust pipe (see *Photograph 3*).

Photograph 3: Seat of initial fire at exhaust pipe exit at roof canopy

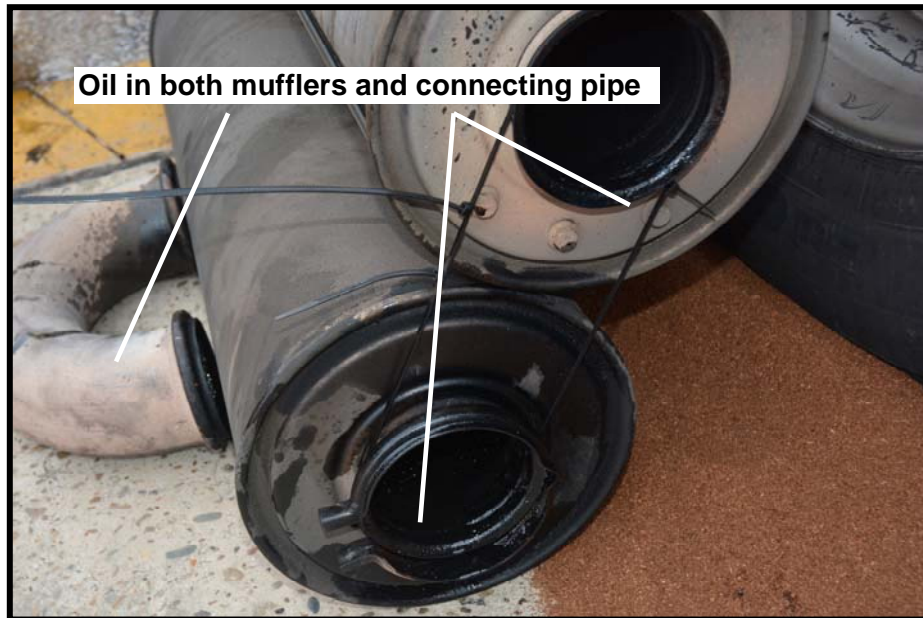
- 2.3 When the top section of the exhaust pipe was removed, carbon deposits were found in greater quantity than expected. In the lower section of the pipe there was oil present. The exhaust line was traced backwards to the twin mufflers which displayed signs of oil seepage around the clamps joining the mufflers and their connecting pipe (see *Photograph 4*).

Photograph 4: Mufflers removed showing oil residue

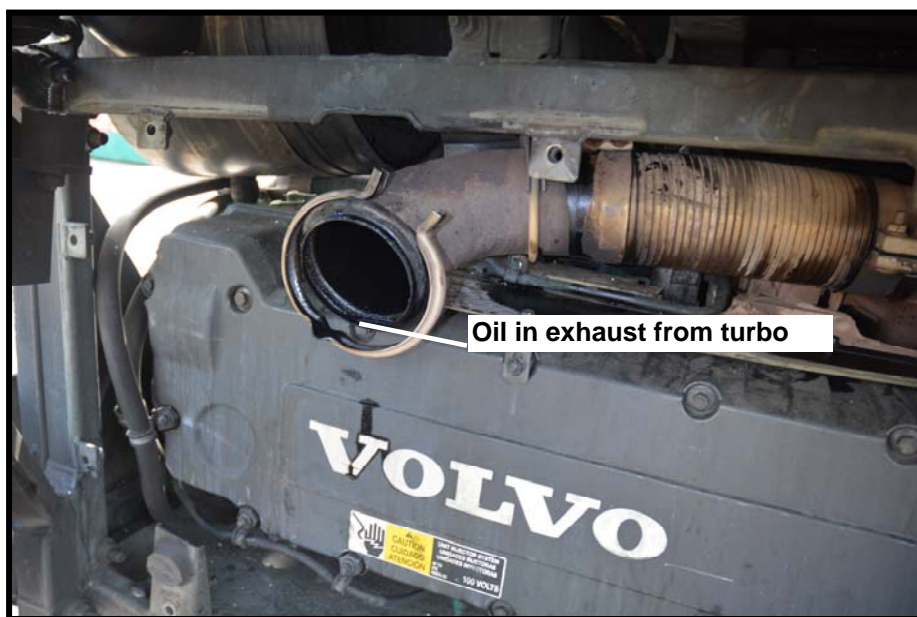
- 2.4 The exhaust mufflers were removed and a large quantity of oil was discovered in both mufflers. The exhaust line between the mufflers and the turbocharger also contained a large amount of engine oil (see *Photograph 5*).

Photograph 5: Oil in exhaust line from turbocharger

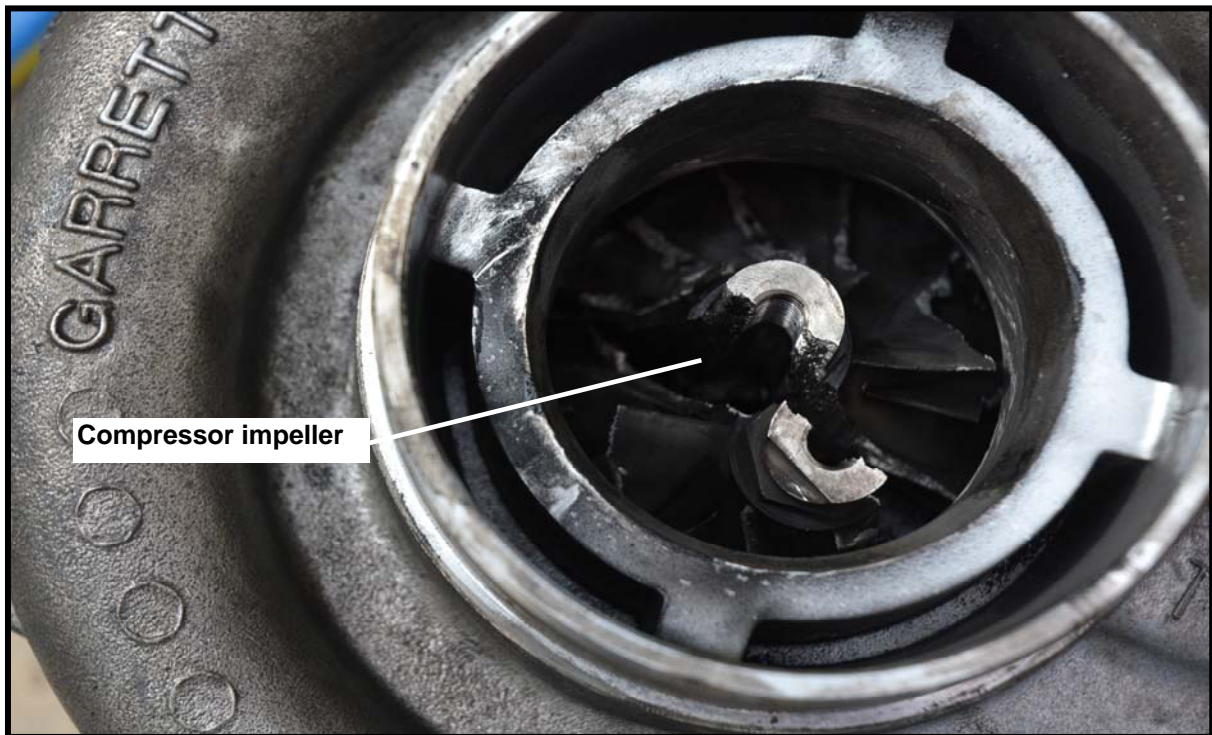
- 2.5 The turbocharger was removed and dismantled for examination. The compressor impeller was found to have split longitudinally into approximately equal halves and seized in its casing (see *Photographs 6 and 7*). The turbine wheel was intact although there was some damage to the blades resulting from them striking the housing after the impeller had failed.

Photograph 6: Compressor impeller split in housing

- 2.6 The failure of the compressor impeller would have allowed the turbocharger lubricating oil to enter the hot exhaust system and be carried along the full length of the system. The oil ignited within the exhaust pipe near the discharge point at the roof canopy where a generous air supply was available to feed the fire. The heat generated was so intense that it ignited the fibreglass canopy.

1. *At this stage of the investigation it appears that the impeller has failed as a result of the formation of two diametrically opposite fatigue cracks which initiated in the bore.*
2. *There was no visible evidence to indicate that the impeller had failed as a result of the presence of any material defects.*

- i. *Out of specification microstructure associated with incorrect heat treatment.*
 - ii. *Out of specification material composition.*
 - iii. *Out of specification hardness.*
3. *Radiography revealed no visible material defects.*
 4. *Because the impeller had failed as a result of the formation of what appear to be two diametrically opposite fatigue cracks, it is more likely than not that the failure was associated with abnormal loads in the bore of the impeller.*

The more likely cause of abnormal loads in the bore of the impeller would be material contamination in the bore of the impeller when it was fitted to the shaft.

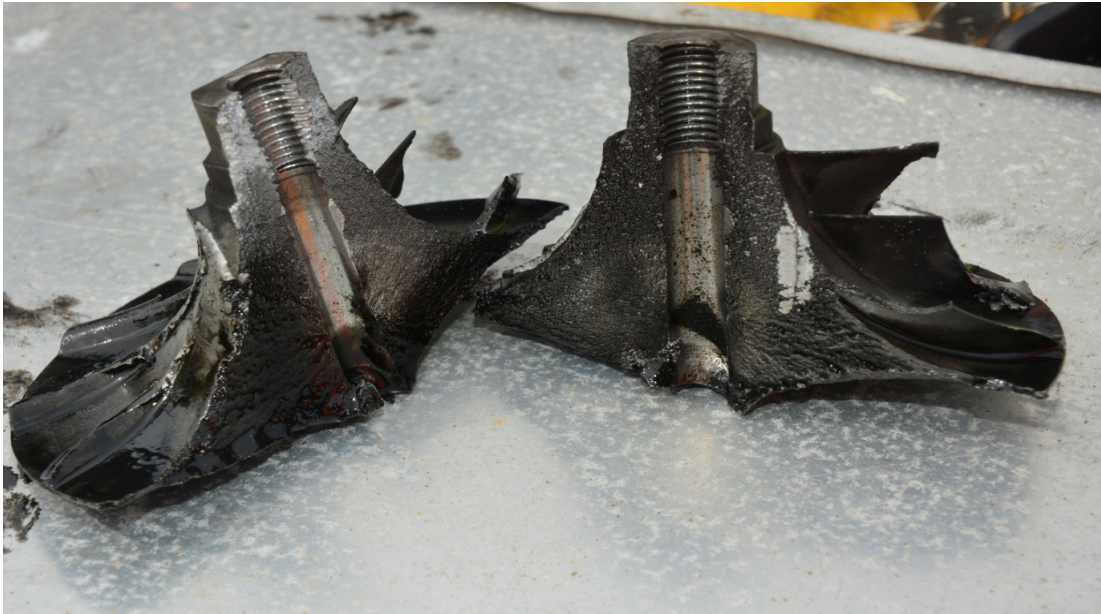
Photograph 7: Compressor impeller removed for examination

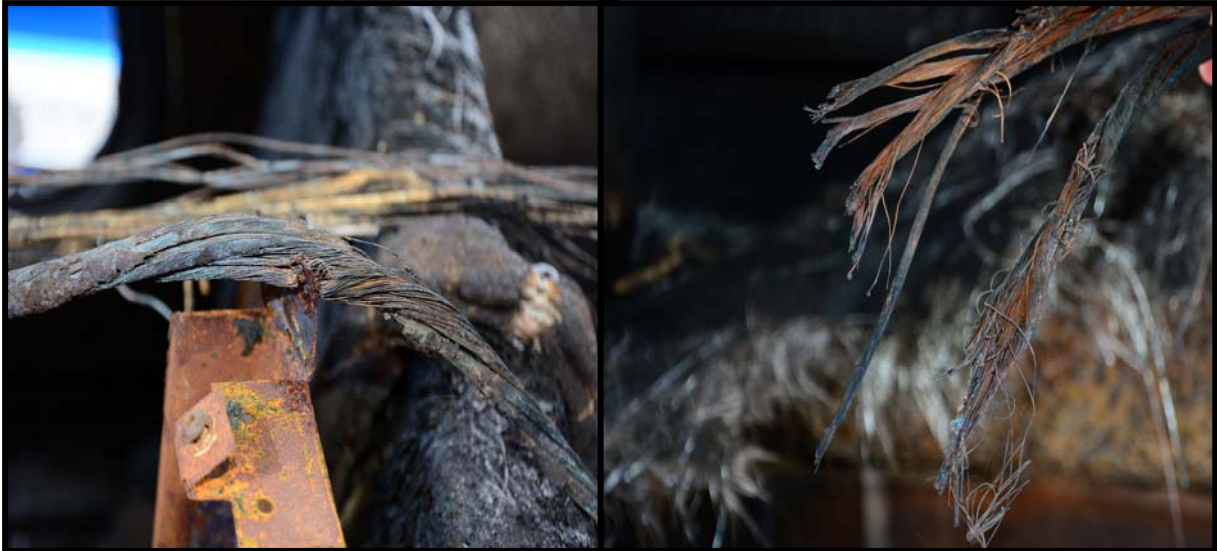
- 2.8 Secondary fires were caused when heat melted the plastic sheathing on house service electrical wiring for interior lighting, CCTV, stop bus buttons and air conditioning. This wiring ran in harnesses on either side of the bus along the interior roofline, and was retained by plastic cable ties. When the heat melted these ties along with wiring protective coverings the wires dropped. Shorting then occurred between wires and with metal objects as the circuits were live because the driver had not switched off the bus's electrical system (see *Photographs 8 and 9*). This served to further promote the fire.

Photographs 8 and 9: Internal electrical wires shorted

- 3.2 A secondary source of fire occurred once the fire had reached the internal rear area of the bus. The heat from the fire melted the electrical system wiring insulation and their plastic securing ties resulting in live wires shorting against each other and other metal objects, as the bus's electrical system had not been switched off.

- 4.1 To prevent a secondary source of fire contributing to further damage in this type of incident, it is recommended that the State Transit Authority upgrades instructions for all drivers to include the requirement to switch off the electrical supply to all systems, if possible without subjecting themselves to risk, to prevent the spread of a fire to the interior of a bus.
