Office of Transport Safety Investigations

BUS INCIDENT FACTUAL FINDINGS

**FIRE INVOLVING STATE TRANSIT AUTHORITY (STA) BUS MO
1222**

7 MAY 2012

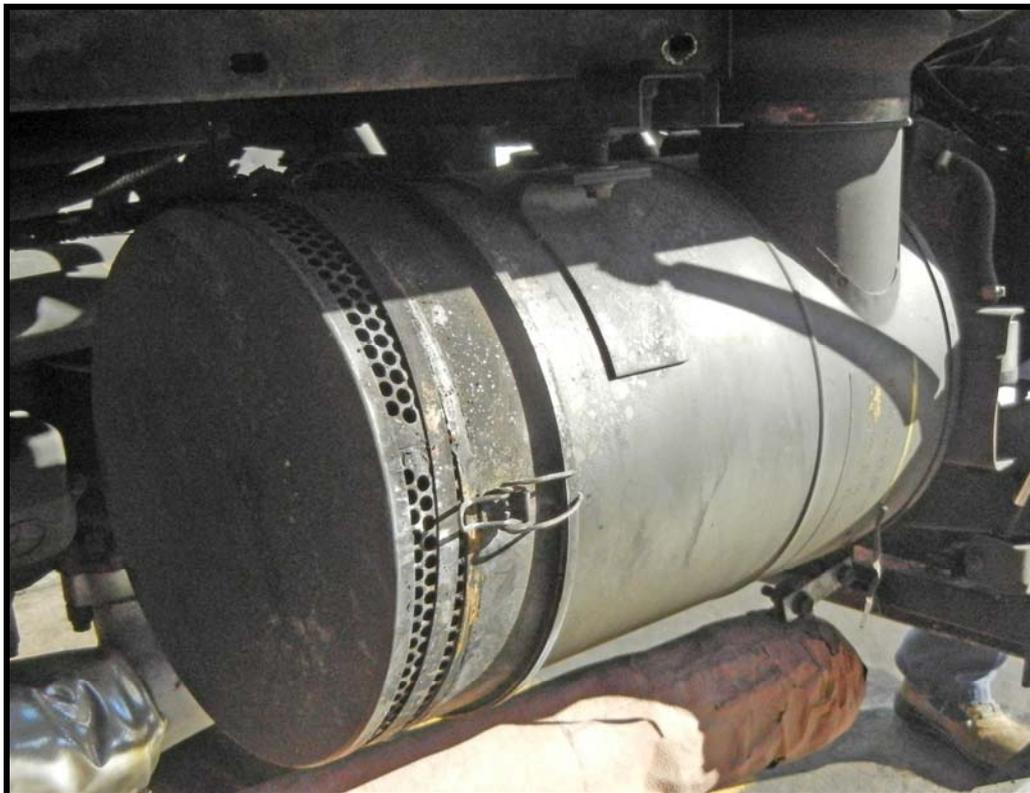
Photograph 1: Air filter housing

From an inspection of the engine bay it was evident that the likely seat of the fire had been in or around the air filter which was located low on the nearside of the engine. The fire pattern on the filter housing indicated the fire had been at its most intense at the retaining lid end of the housing as evidenced by the distortion of the lid (see *Photograph 1*). The air filter housing had contained the fire and restricted its spreading to other parts of the engine. However, there was some relatively minor heat and smoke damage to areas above the filter including the nearside back window.

It was concluded that the fire was the result of the engine misfiring and igniting excess oil which had collected in the air filter housing and saturated the air filter.

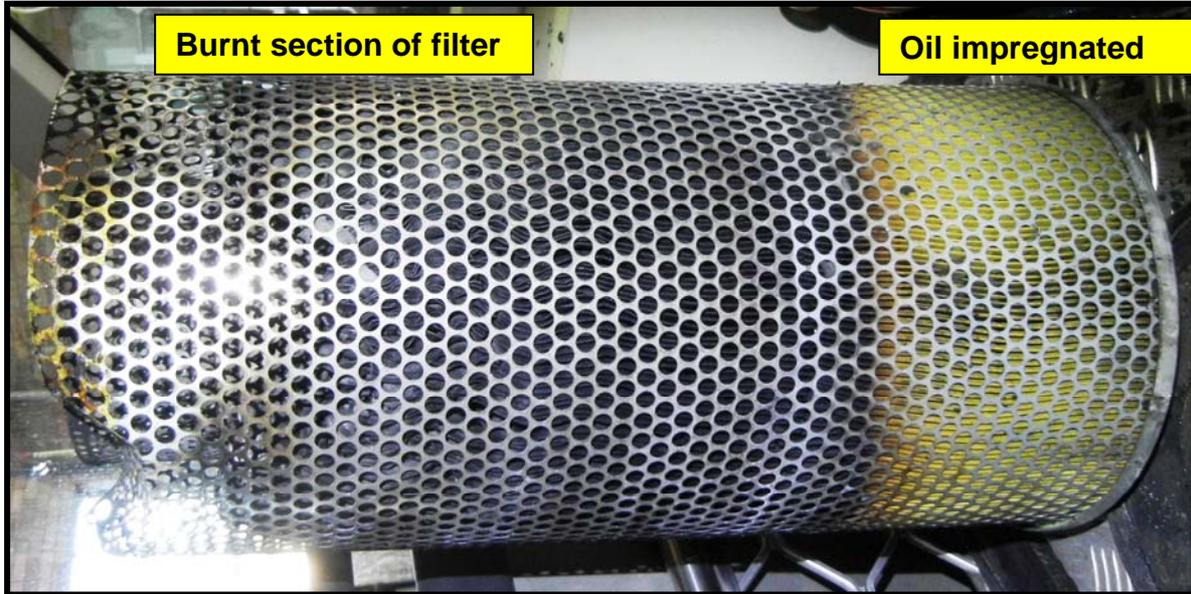
Photograph 2: Air filter cartridge

On removal of the air filter cartridge, the interior paper filter was found to have been reduced to ash and charcoal at the retaining lid end. At the opposite end, it was impregnated with oil (see Photograph 2). Further, oil residue could be seen in the air filter housing after the cartridge was removed (see *Photograph 3*).

As the engine had been backfiring immediately before smoke was seen, it is considered most likely that the backfiring ignited the oil-soaked air filter cartridge. In

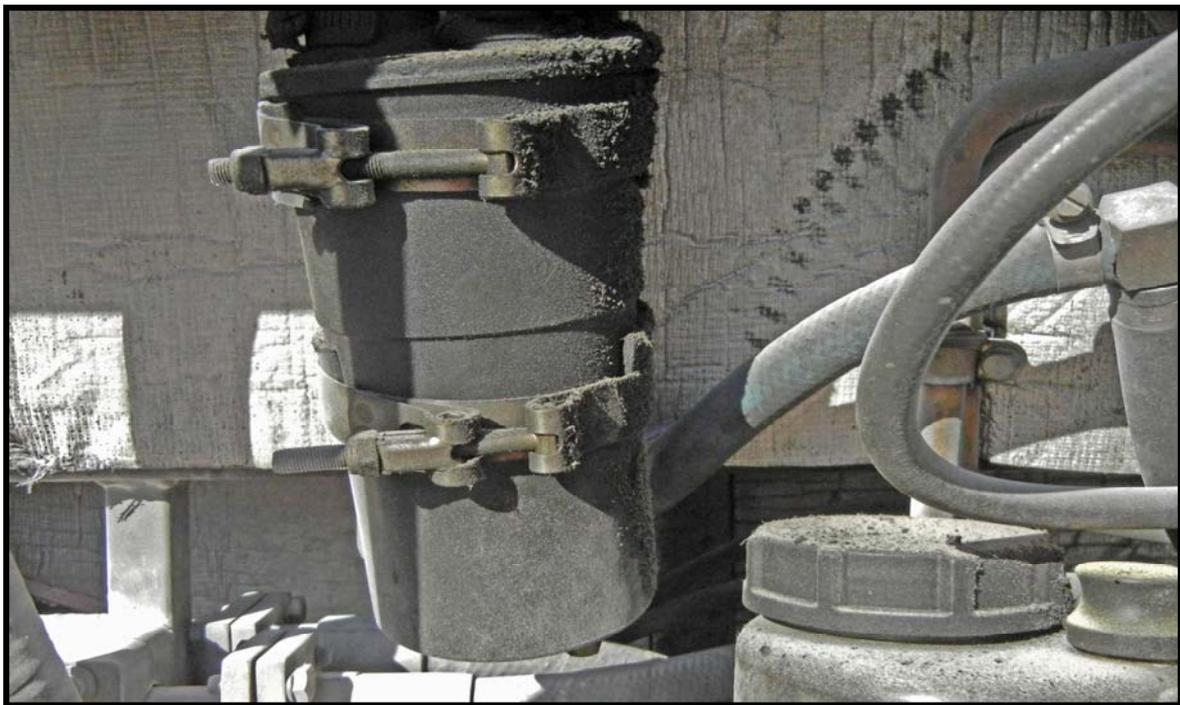
Photo 4 Separator

This system was examined, with the PCV showing evidence of oil contamination. The separator drain plug was removed and approximately 120 ml of oil which had accumulated was collected (see *Photo 4*).

Examination of the diffuser attached to the air filter also revealed an accumulation of oil which had not been retained in the separator. Oil had also passed the diffuser causing the previously noted contamination of the air filter cartridge.

An examination of the maintenance and servicing records for MO 1222 revealed that a service scheduled for 6 February had not been undertaken. This meant that oil had not been drained from the separator since the previous service which had been conducted on 6 July 2011. Draining oil from the separator is a set servicing requirement to be completed every six months.

The oil had been allowed to build up because a scheduled service was not undertaken which resulted in the separator being left undrained for much longer than the six months allowed for in servicing procedures.

- identified buses which were overdue for mandatory services and immediately serviced those buses;
- circulated a maintenance alert to all depots where Mercedes Benz 0405 NH model buses are based, requiring maintenance staff to regularly inspect the air filter elements and drain oil separator units; and
- issued a notice to all depots setting out the requirement for regular on-time servicing of all buses to the specified STA servicing standards.

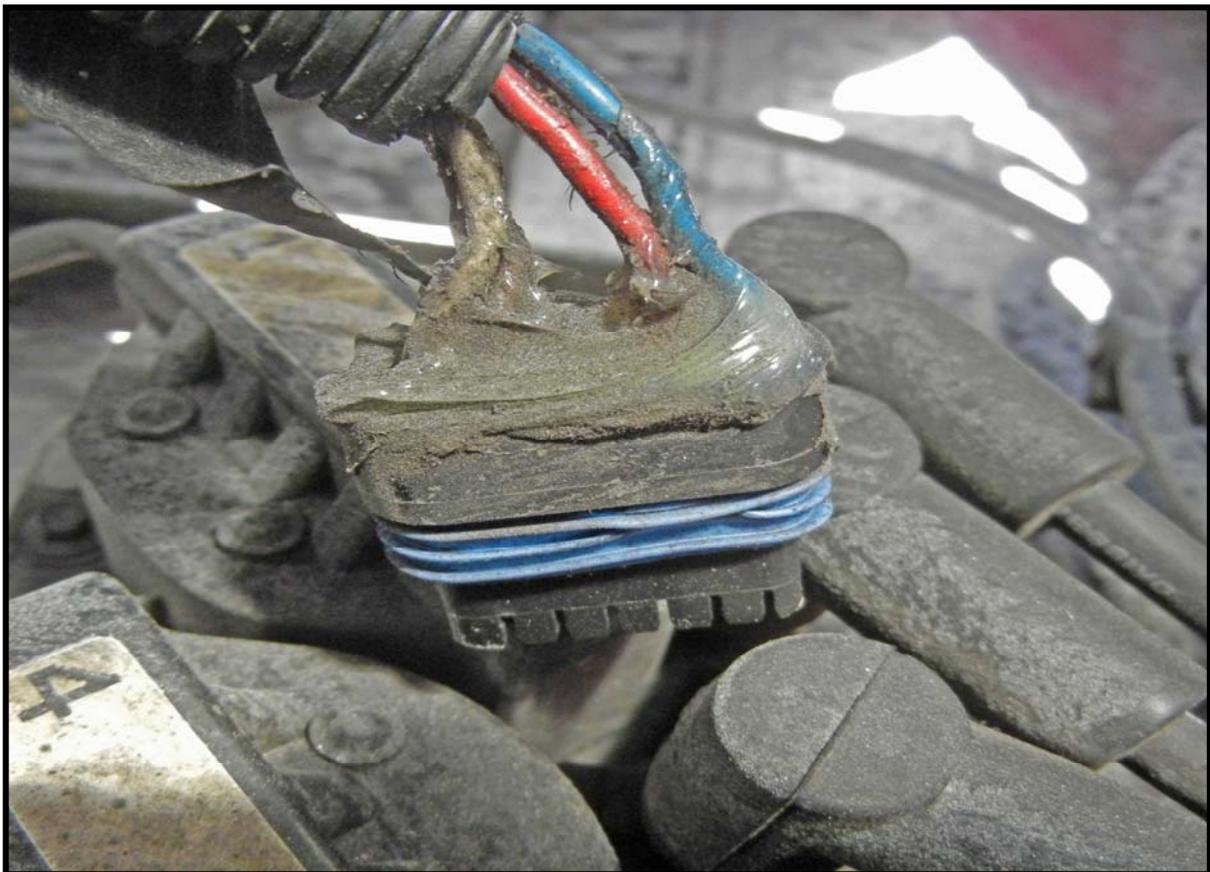
Photo 5 Silicone covered electrical lead

However, a connection for a power supply lead in the system was found sealed with silicone (see *Photo 5*) This type of repair was known to have been carried out on buses of this model which had experienced fires, to overcome electrical shorting caused by condensation or water pooling on top of the engine. Any short circuiting could result in the spark plugs firing out of order and cause the engine to backfire.
