Office of Transport Safety Investigations

BUS SAFETY REPORT

BUS FIRES IN NEW SOUTH WALES IN 2014

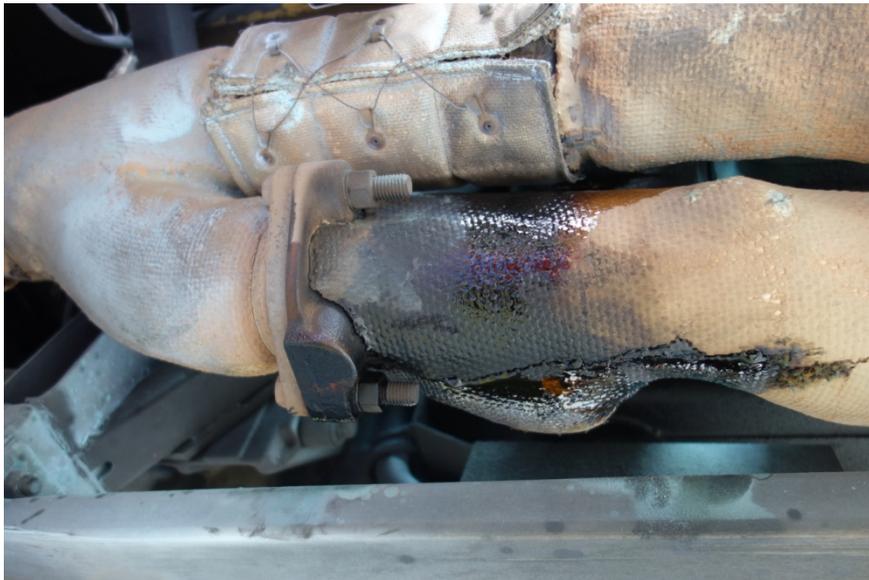
There was a small reduction in the number of incidents due to fluid leaks. Coolant was involved on five occasions, oil on four and diesel fuel on the other. The majority of incidents did not progress beyond the production of smoke from fluids coming into contact with hot surfaces, the manifold in five instances (see *Photograph 1*). No actual fires due to fluid leaks gained a hold before being extinguished by drivers with onboard portable fire extinguishers. Two fires extinguished without any intervention.

Photograph 1: Fluid leak onto manifold lagging
