BUS OCCURRENCE – FACTUAL STATEMENT

BUS TV1175 LOSS OF CONTROL

TAMBORINE MOUNTAIN, NEAR WONGAWALLAN QLD

18 MARCH 2016

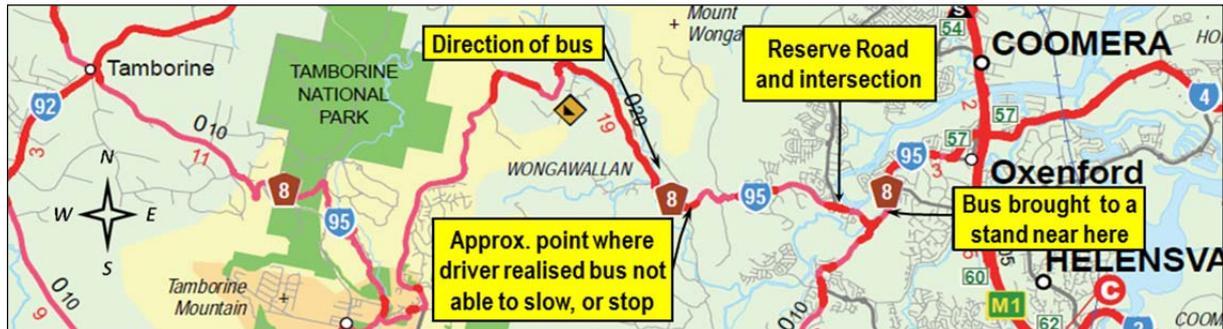
Figure 2: Incident location

became heat affected and unable to stop the bus at traffic lights at the intersection with Reserve Road, near Oxenford (refer to *Figure 2*).

- 1.3 To avoid stationary vehicles at the intersection, the driver steered onto the wrong side of the road, before passing through the intersection. The bus continued for approximately another 1.5 km before the driver was able to bring it to a halt. The driver immediately evacuated the 62 passengers and eventually they were able to continue their journey on another bus. There were no reports of any injuries or damage.

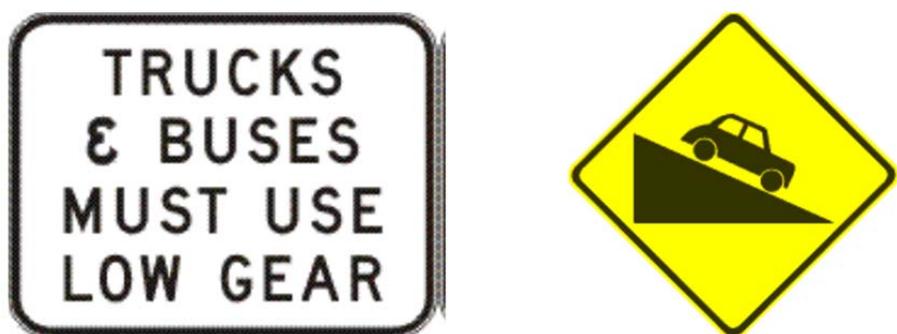
Figure 3: Traffic signage examples

and Main Roads⁶ inspected the heavy vehicle signage positioned on the Tamborine-Oxenford Road. It noted that the signs were in a clean, reflective and legible condition. They also appeared consistent and compliant with relevant Australian Standards.⁷

- 1.6 Prior to, and throughout the downhill descent, the bus passed a number of *TRUCKS & BUSES MUST USE LOW GEAR* signs, *VERY STEEP DESCENT* signs and *STEEP DESCENT* symbolic signs (two examples shown in Figure 3)

2.14 Further, the Company is evaluating the viability of a submission to the Qld Department of Transport for a review of the heavy vehicle signage in place. Specifically, the Company considered the installation of more 40km/h speed limit signs, may improve driver compliance to the speed limit.

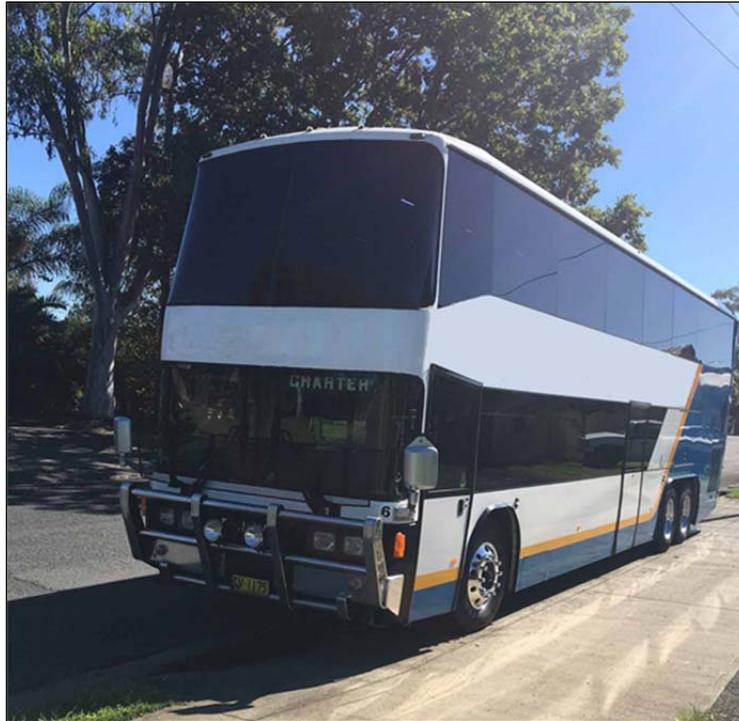
Photograph 1: Bus TV 1175 Image courtesy of SB Coaches

1.10 Bus TV 1175 was a single door Denning, 3-axle Landseer DD (double decker) model fitted with lap-sash seatbelts (refer to *Photograph 1*). It was built in February 1989 and was the only one of its particular model Denning bus in the SB Coaches fleet. The odometer reading at an inspection post incident (24 March 2016) was 835,663 kilometres. The bus had a tare weight of 16.37 tonnes.¹³

1.11 The bus was fitted with combination pneumatic/hydraulic disc brakes on the front axle and pneumatic drum brakes on the two rear axles. It was also fitted with a 5-speed automatic transmission and an Allison T450 (R) two-stage speed retarder device. Both the gearbox and retarder were fully operational and used by the driver during the descent. According to the NSW Roads and Maritime (RMS) *Heavy Vehicle Driver Handbook*, speed retarders: ‘...*may be fitted to medium and large vehicles to supplement the vehicle’s service brake system. They will not stop the vehicles completely but may help to slow it down. They are not considered service brakes as they act on the engine or drive train*’.
