## **TECHNICAL INSPECTION FINDINGS**

**ROLLOVER INVOLVING NOWRA TOURS COACH TV 4604**

**TIMBOON COLAC ROAD, PIRRON YARROCK, VICTORIA**

**15 AUGUST 2010**

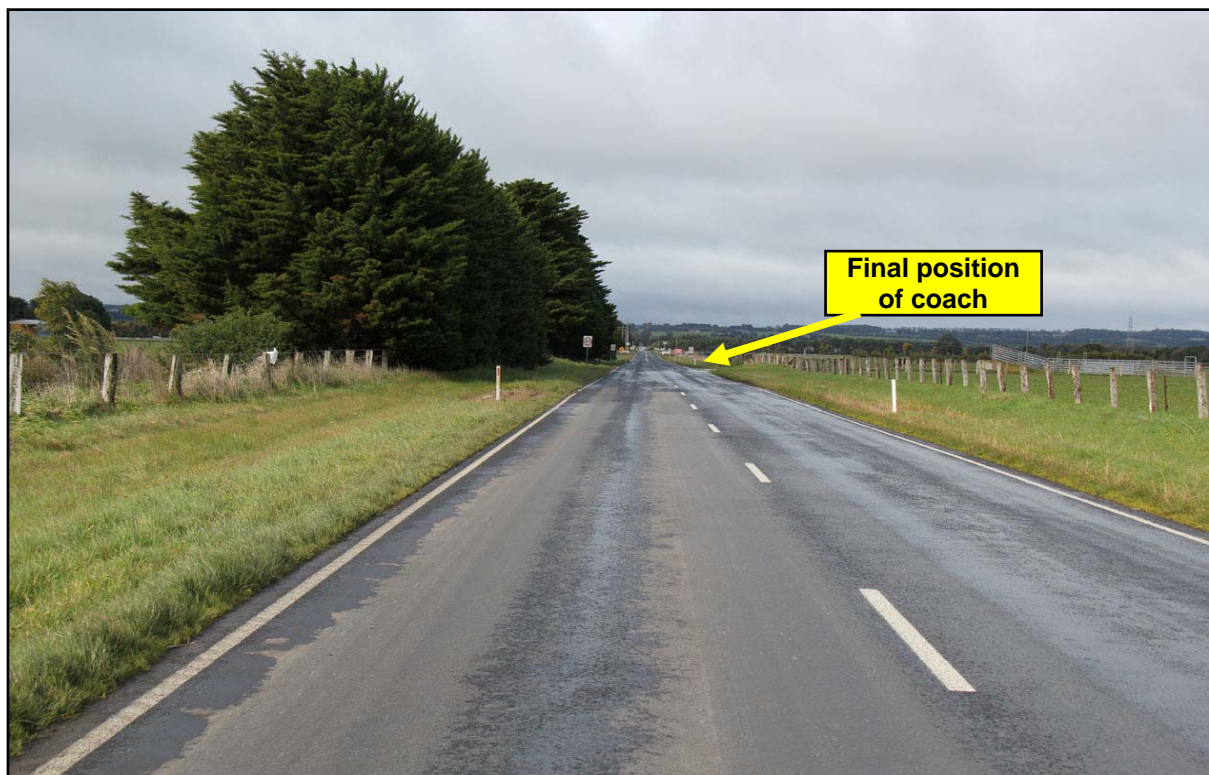
The coach had left Melbourne at 7:43am and at 9:20am arrived at Ballarat where the passengers spent some time sightseeing before having lunch. The coach left Ballarat at 12:51pm and headed South, crossing the Princes Highway from Nalangil Road to Timboon Colac Road and continuing South along the 100km/h road. The driver was braking from a speed of 96km/h in response to an 80km/h speed sign when he lost control of the coach at the location shown in *Photograph 1* and *Figure 1*.

**Photograph 1: View South on Tomahawk Creek Road to the crash site**

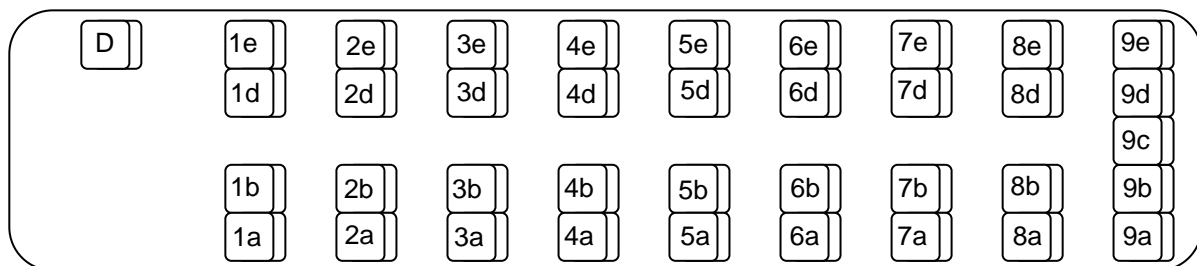
**Figure 2: TV 4604 seating layout**

Belts fitted to the seats labelled 6e and 7e in *Figure 2* had evidence of surface burnishing in an area likely to have been in contact with the upper sash guide, and it is considered probable that these belts were being worn at the time of the crash. An example of this burnishing can be seen in *Photograph 3*.

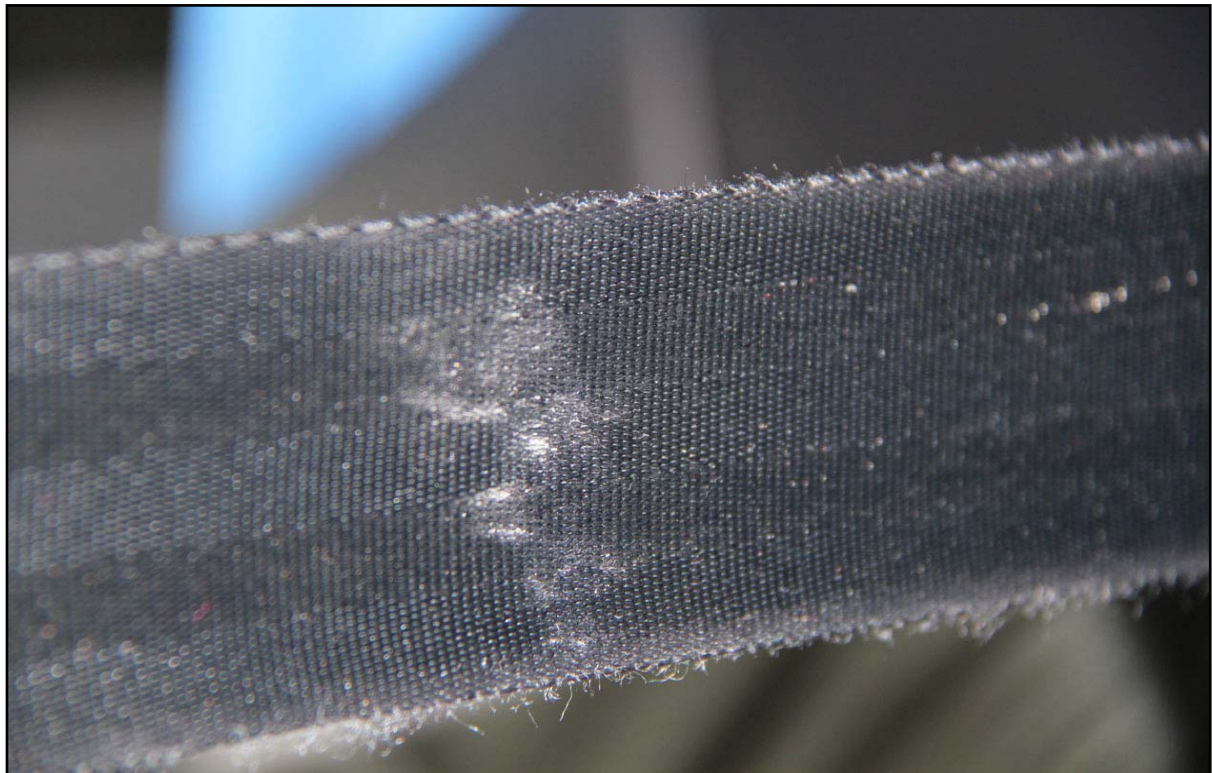
**Photograph 3: Burnishing of seatbelt fabric on seat 7e**

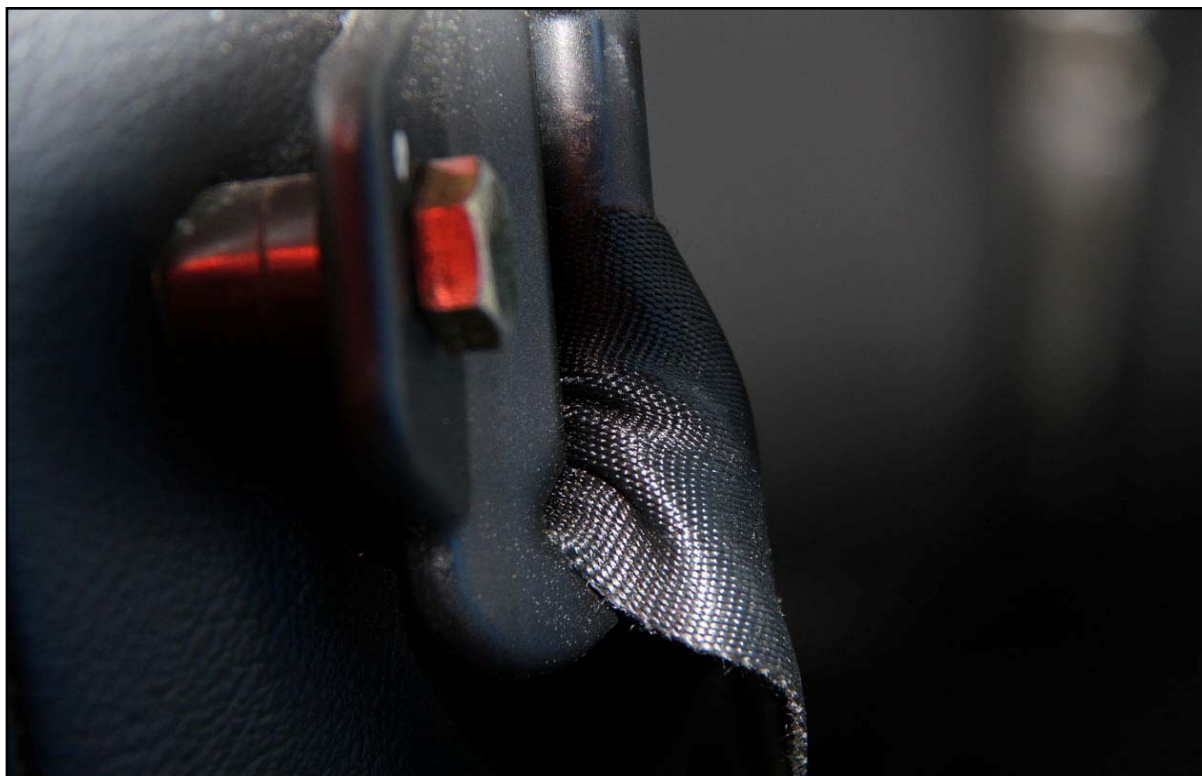
The belt fitted to seat 4d was jammed tightly into the lower side of the sash guide, indicating that considerable force had been applied to it (*Photograph 4*). It is considered that this belt was worn in the crash.

**Photo 4: Seatbelt on seat 4d jammed in sash guide**

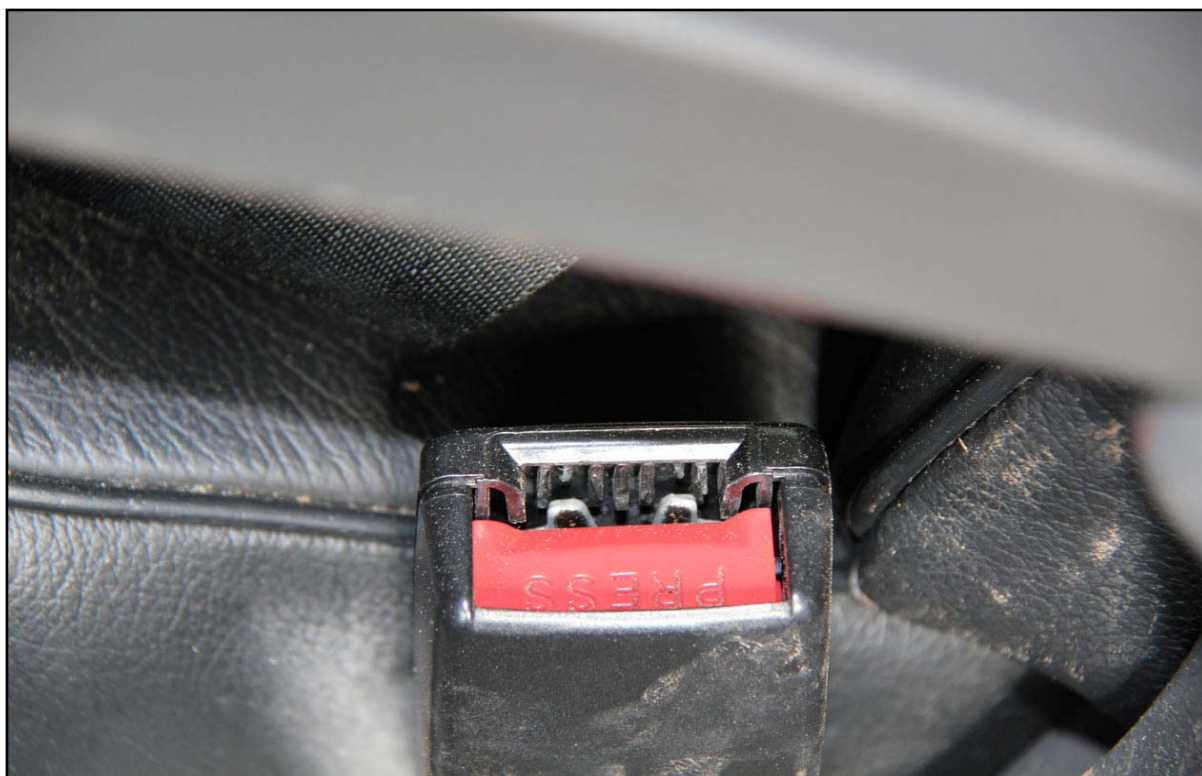
The belt buckle release button on seat 6d was jammed in a depressed position, indicating that the buckle had been damaged by loading in the crash and had jammed when depressed to release the belt (*Photograph 5*). It is considered that the occupant of the seat was wearing this belt at the time of the crash.

**Photograph 5: Jammed seat belt release button on seat 6d**

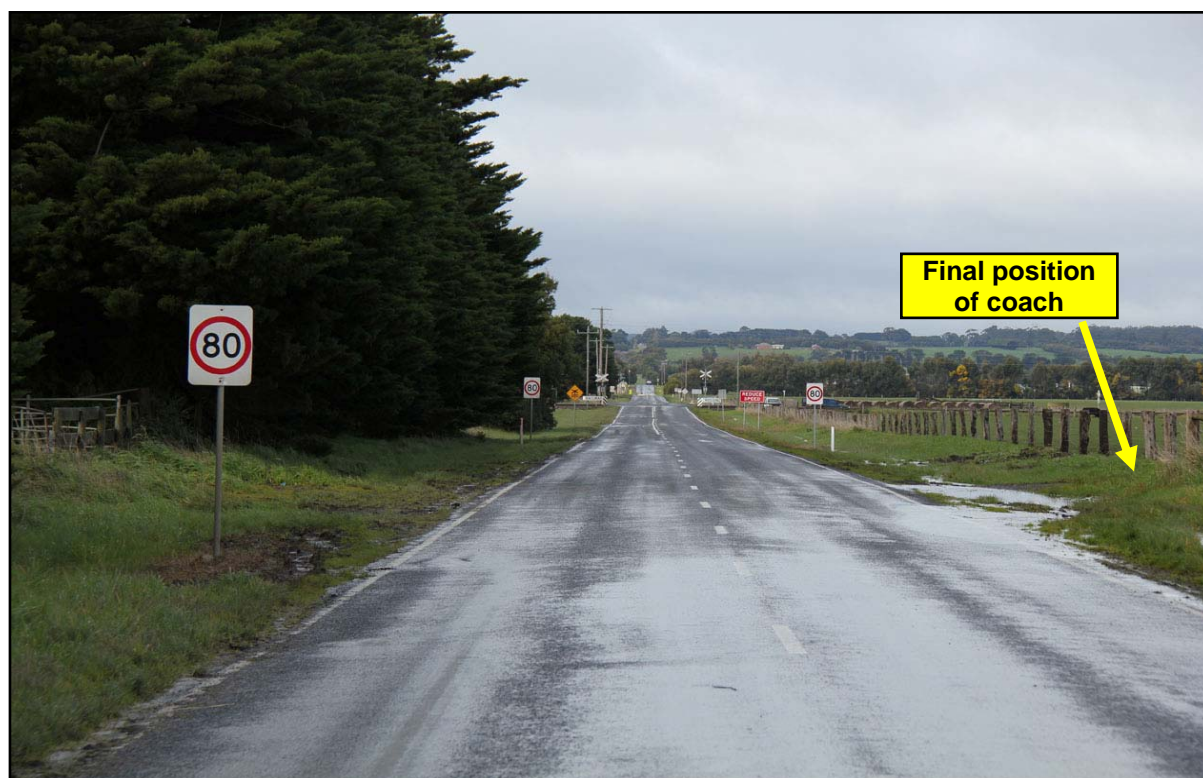
The speed limit on Nalangil Road and Timboon Colac Road is 100km/h up to 30 metres before the crash location, where the speed limit reduces to 80km/h in preparation for a railway crossing 400 metres further on. On the day of the crash, a small amount of rain had fallen, but about 25mm of rain had fallen during the preceding five days and over 50mm in the two weeks before the crash. The road, seen and photographed on 26 August 2010 (but consistent with its condition at the time of the crash), had no hard shoulders and the berm on both sides was grassy, waterlogged and boggy (*Photograph 6*).

**Photograph 6: Incident site**

As the driver approached the crash site, three 80km/h speed limit signs were in clear view (a fourth sign had been knocked over some time earlier and was lying on the right hand berm), and a further 400 metres beyond them a railway crossing could be seen (see *Photograph 6*). There was a light breeze blowing and the road was wet but it was not raining at the time.

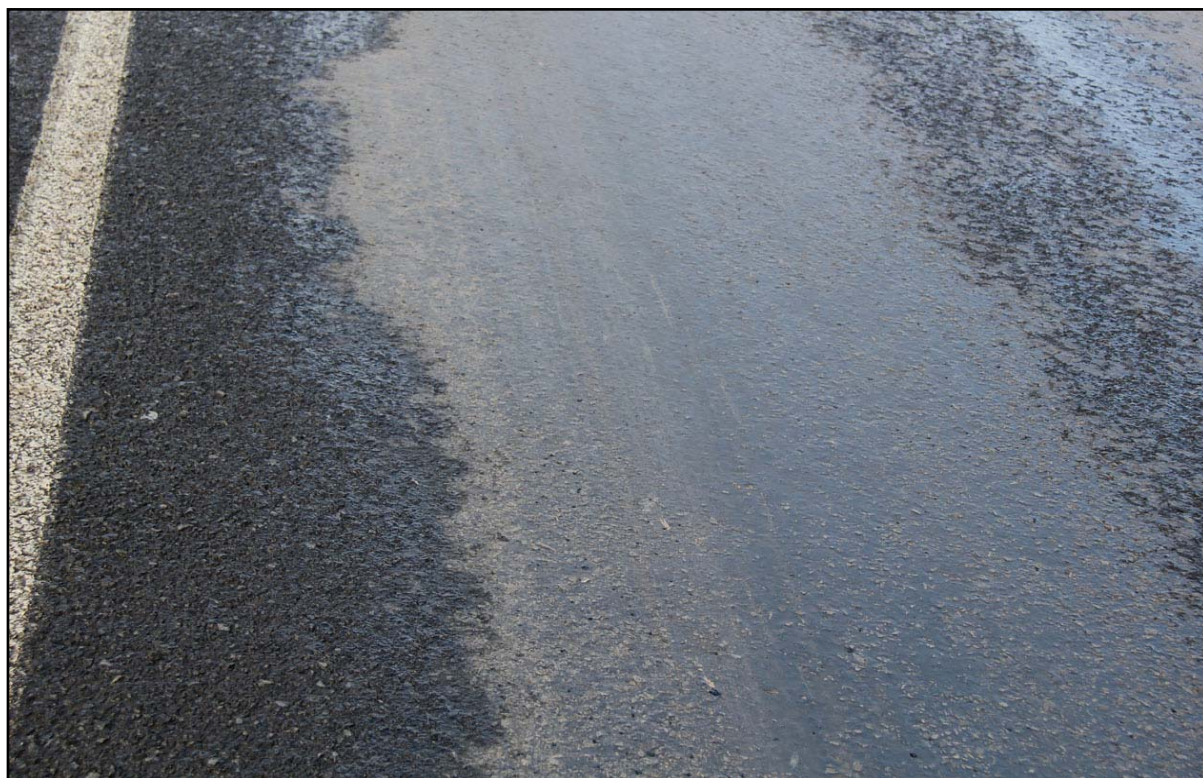
The surface of the road was of varying composition, with exposed gravel interspersed with smooth bitumen as seen in *Photograph 7*. A varying degree of surface contamination was also present as a result of mud and manure being tracked onto the road from muddy driveways of farms fronting the road, and by farm vehicles driving along the edge of the road (*Photograph 8*). This resulted in a surface with a low and inconsistent coefficient of friction. The degree to which this was a factor at the time of the incident is indeterminate, to the extent that the degree of residual road contamination would have been dependent on unknown factors such as the surface flushing effect of any recent heavy rain.

**Photograph 7: Road surface variation**

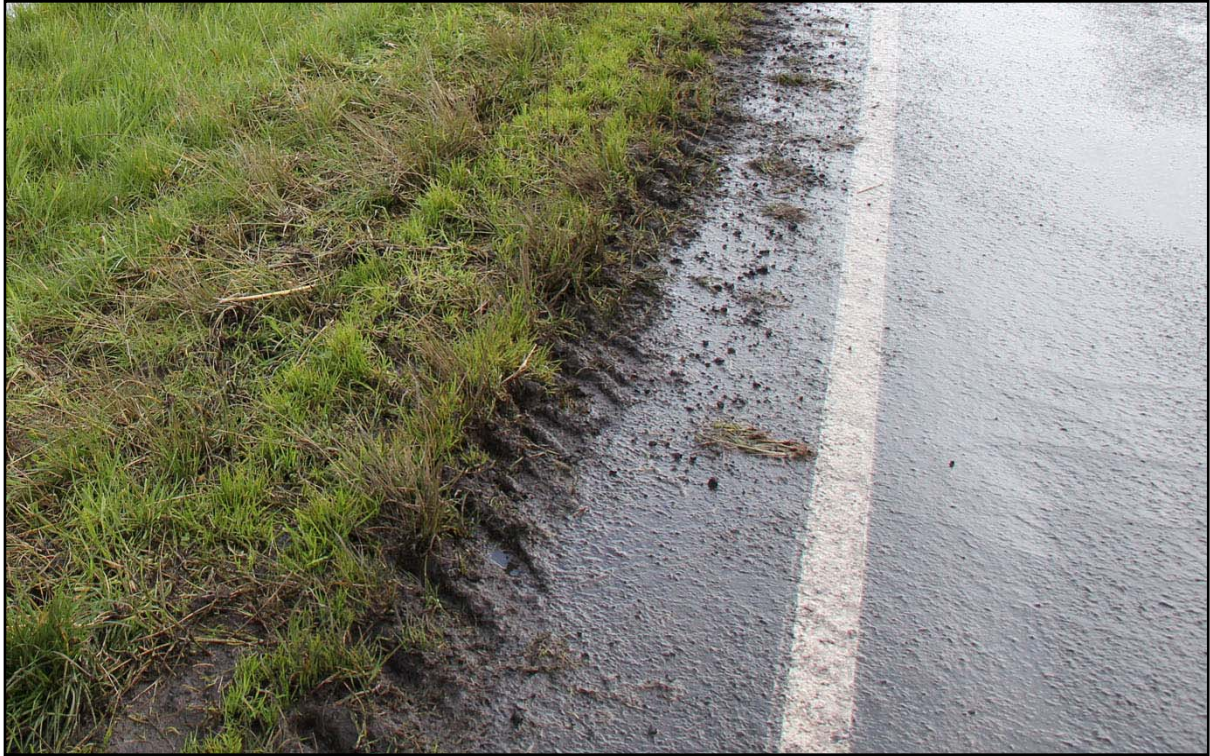
**Photograph 8: Road surface contamination**
